REPORT ON GEOTECHNICAL SITE INVESTIGATION

PROPOSED NEW DWELLING

18 ROCK BATH ROAD, PALM BEACH, NSW

Project No.: 2022-085

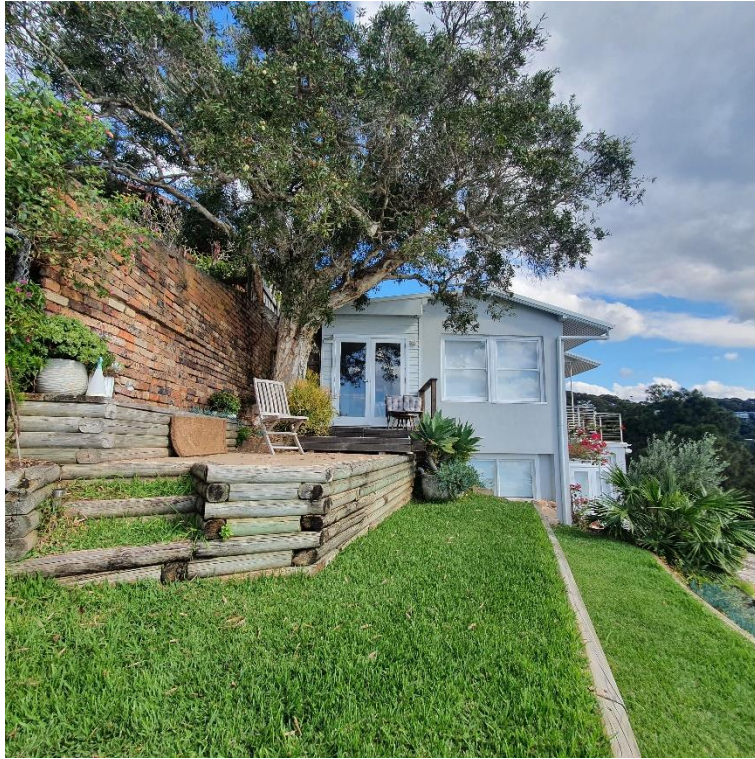
Photograph-2: Eastern portion of the site. View looking west.

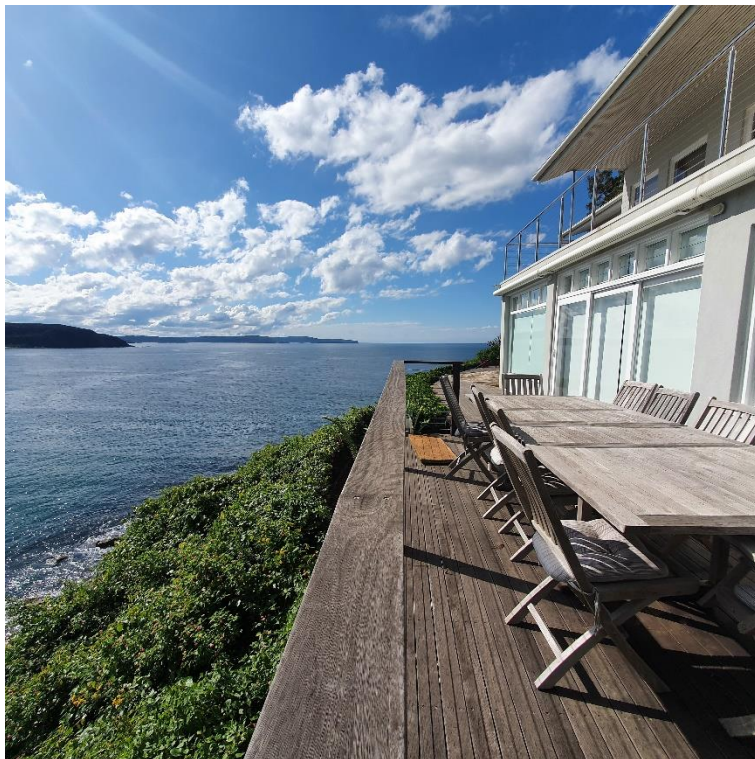
Photograph-3: Western portion of the site-dwelling. View looking east.

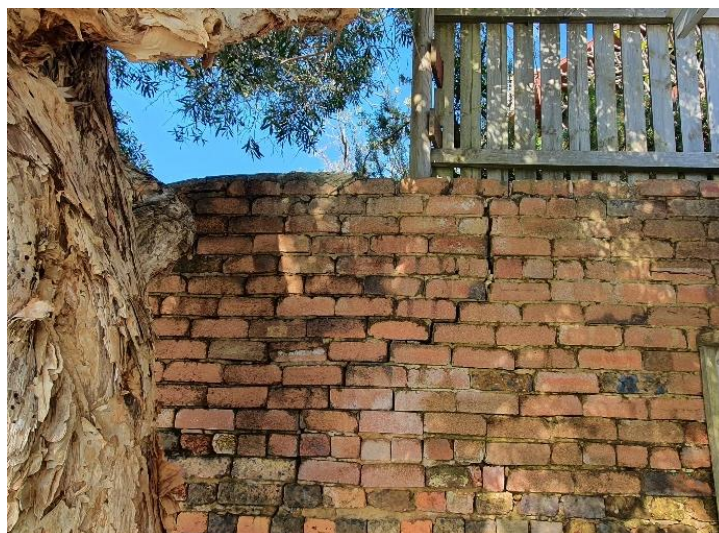
Photograph-4: Vertical cracking observed at the eastern side of common boundary wall. View looking south-east.

There were no signs of large scale or impending landslip instability or geological hazard. However, deflection was observed at the patio (to the north of the dwelling) and eastern side of the southern boundary retaining wall. The slopes to the south-east are extremely steep however there were no signs of recent or impending instability that may detrimentally impact the site.

It is recommended that at least two test pits be excavated at the base of the southern boundary retaining wall to inspect the footings and founding conditions. Where the retaining wall footings are not founded onto/within competent bedrock, it is recommended that these be extended to competent bedrock or supported sufficiently to maintain stability until the new wall is constructed within the site. It is also recommended that a Structural Engineer inspect the adequacy of the retaining wall structure and provide remedial recommendations to repair the existing cracking and minor tilting as necessary.

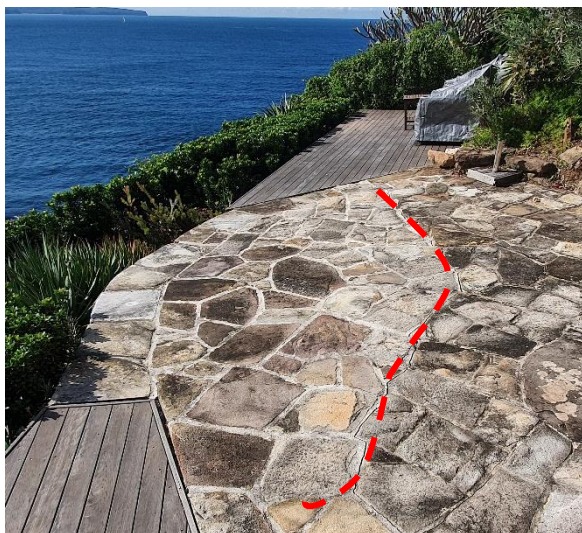
To the north of the site-dwelling is a sandstone flagging patio and timber deck with a slightly lower garden that is retained along the northern side by an east-west striking timber retaining wall ($\leq 1.40\text{m}$ high). Bordering the base of the timber retaining wall is an approximately $\leq 1.50\text{m}$ wide pathway that continues north through dense vegetation that very steeply dips north towards the north boundary. An approximately $\leq 20\text{mm}$ thick separation crack was observed within the sandstone flagging patio (Photograph-5). The adjacent timber retaining wall also contained minor tilting and a depression zone was observed at the ground located next to the base of the timber retaining wall (Photograph-6)

Photograph-5: Open crack observed within the patio. View looking down north-east.

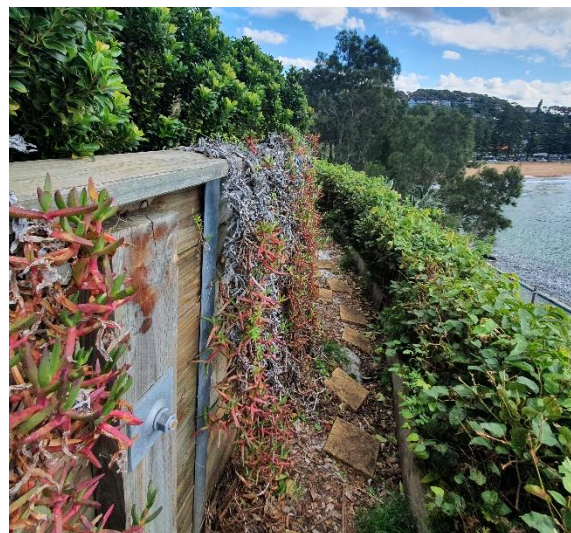
Photograph-6: Minor tilting observed at the retaining wall and a depression zone observed at the pathway. View looking south-west.

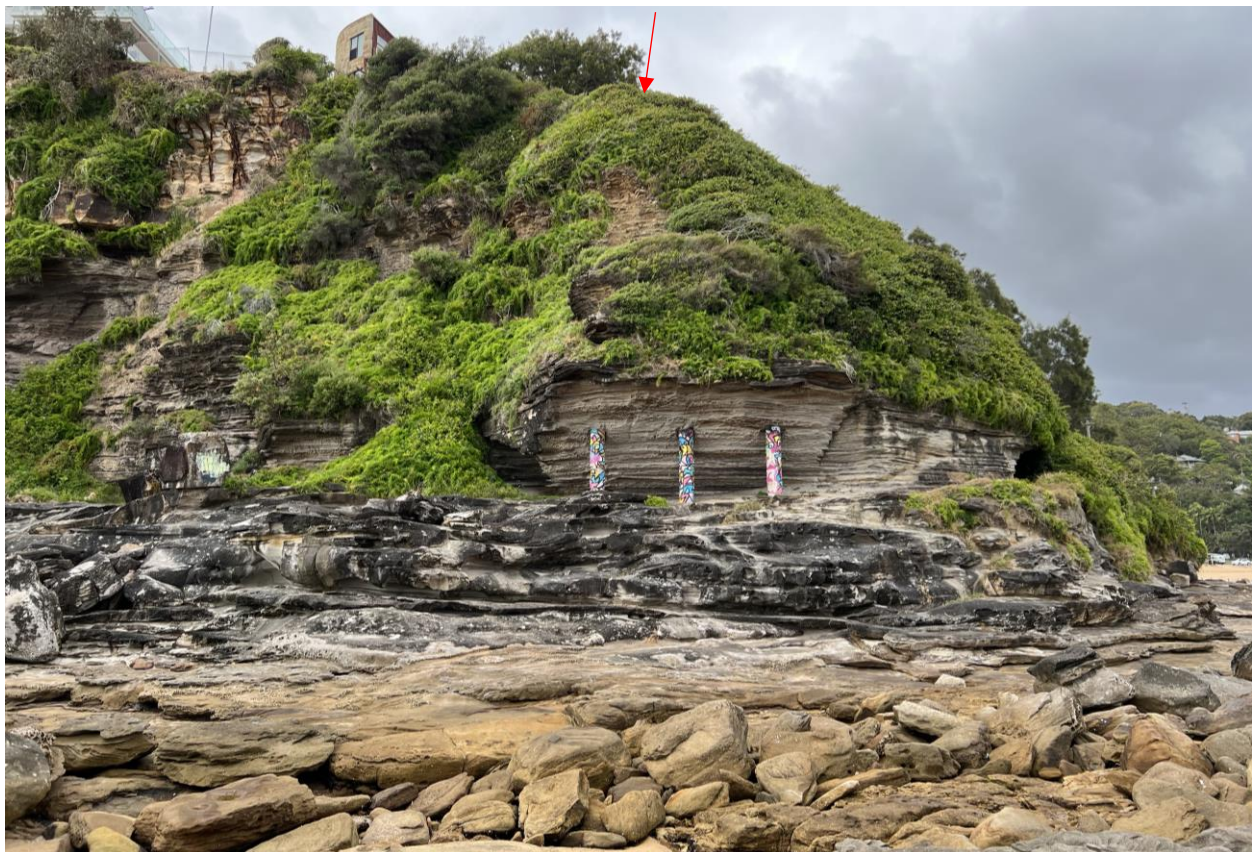
Figure 3: View of NE facing cliff at site (at arrow) on 30 November 2022, facing SW

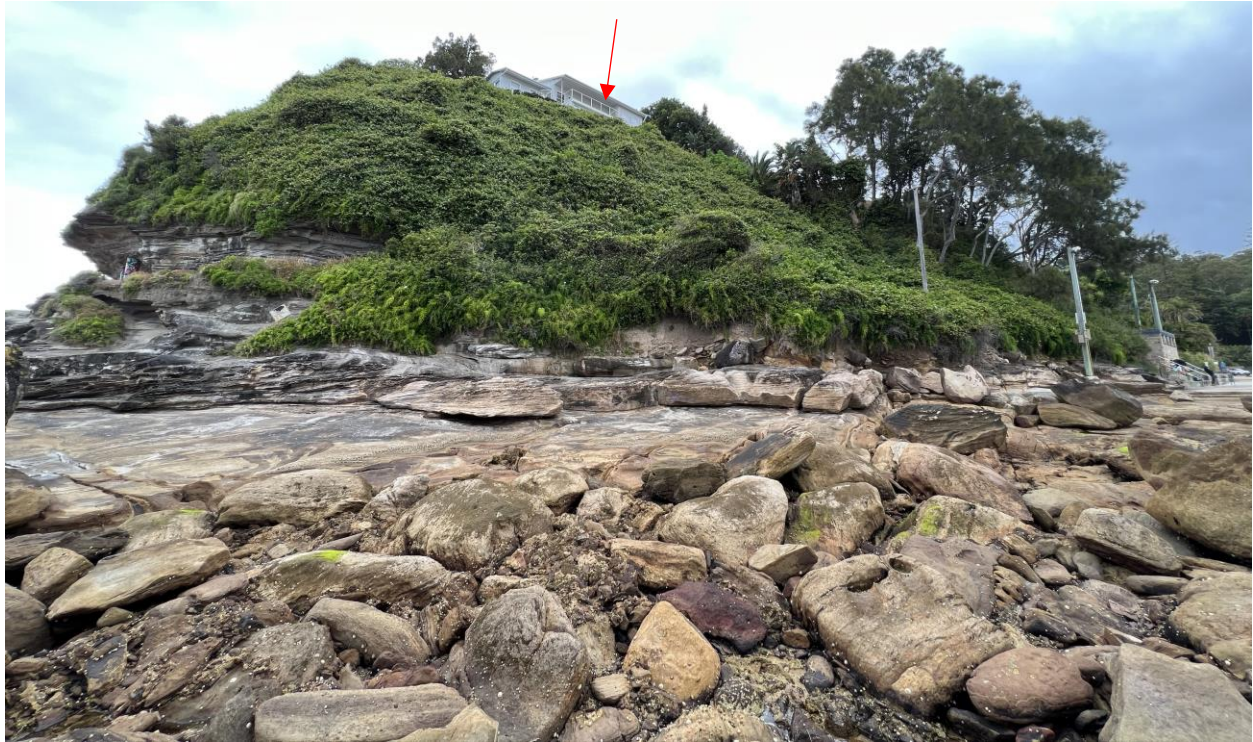
Figure 4: View of NW facing cliff at site (at arrow) on 30 November 2022, facing south
