## ARBORICULTURAL IMPACT REPORT

## 5 BAREENA ROAD AVALON BEACH NSW

### PREPARED FOR ALWILL

6<sup>TH</sup> AUGUST 2019

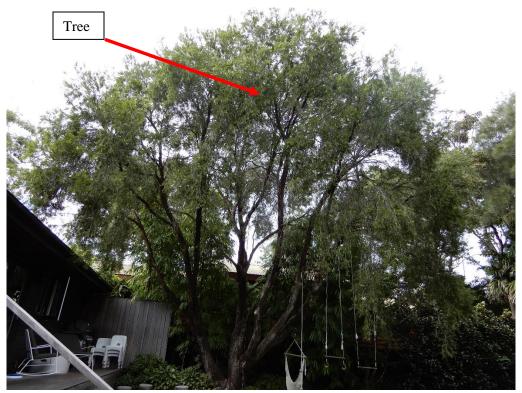
The tree is a mature, multi trunked *Callistemon viminalis* (Weeping Bottlebrush) approx. 9 metres in height with a canopy spread of 12 metres and diameters at breast height (DBH) of up to 410mm (470 and 660mm above the root flare).

Photograph 1: Illustrating the tree as viewed from within the rear garden.

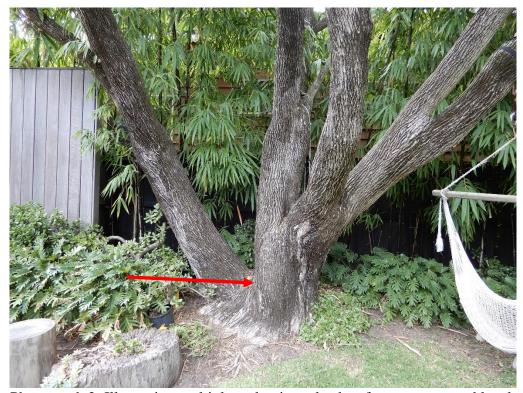
The tree displays fair branch attachment with codominant leaders from ground level and multiple leaders from near ground level with some evidence of poor attachment — while the junction is a weak point in the tree's structure with increased risk of failure it is not considered at risk of failure in the short term.

Photograph 2: Illustrating multiple codominant leaders from near ground level.

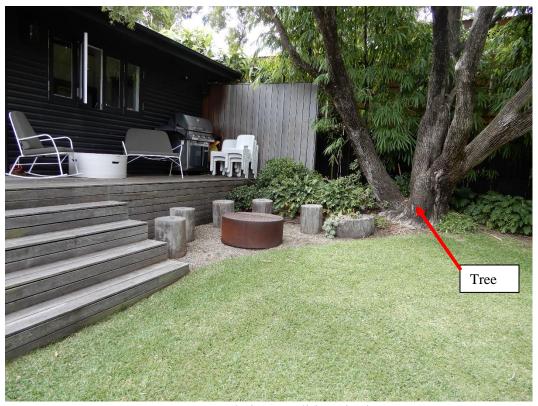
Photograph 3: Illustrating existing conditions in the tree's TPZ area.

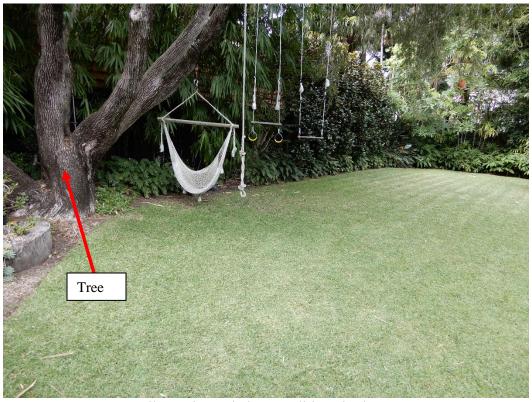
Photograph 4: Illustrating existing conditions in the tree's TPZ area.

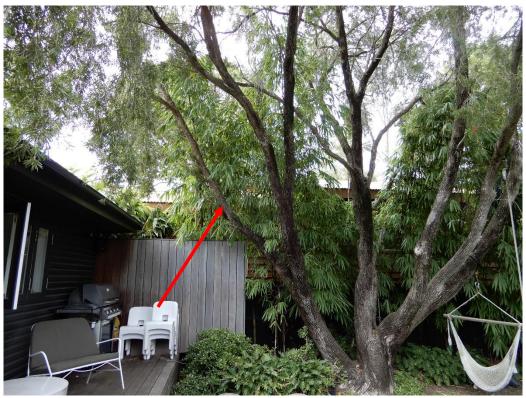
There is a second order branch of 190mm diameter at 1.7 metres on the north side of the crown that will need to be reduction pruned to accommodate the proposed pergola – this branch has been reduction pruned at the eastern boundary in the past and its pruning will impact less than 5% of the tree's live crown area and will not have any impact of substance on the tree's crown shape, form or landscape value.

Photograph 5: Illustrating the branch that will require pruning.

There is a second order branch of 190mm diameter at 1.7 metres on the north side of the crown will need to be reduction pruned to accommodate the proposed pergola – the pruning of this branch will not have any impact of substance on the tree's crown shape, form or landscape value.

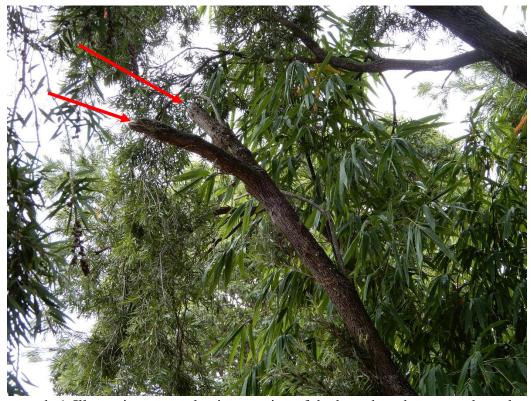
Photograph 6: Illustrating past reduction pruning of the branch at the eastern boundary.
