Geotechnical Investigation and Slope Risk Assessment Report 8 Beverley Place, Curl Curl NSW

Morrow Geotechnics Pty Ltd conducted geotechnical investigations at 8 Beverley Place, Curl Curl NSW (the site). The purpose of this investigation was to provide geotechnical advice and recommendations for proposed development at the site based on project details available at the time of the investigation.

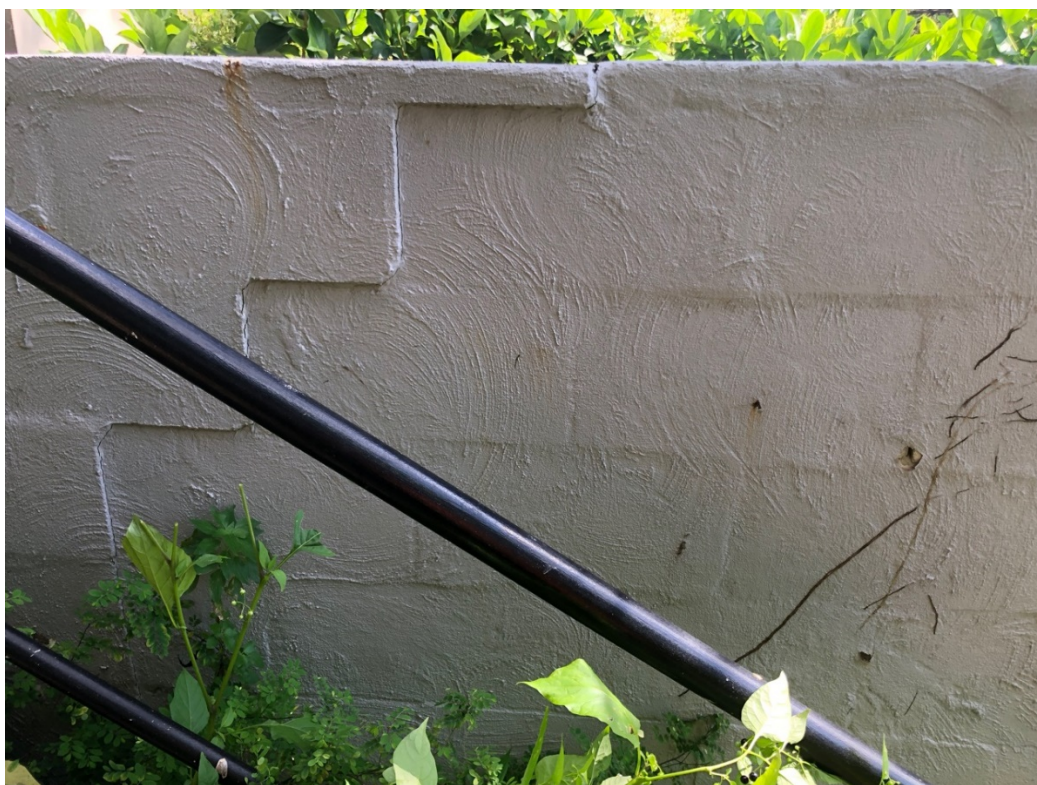
Cracking was noted within the northern boundary blockwork wall (see **Figure 1**). This is inferred to have resulted from differential foundation conditions between sandstone and colluvial material.

Figure 1: Crack in Northern Boundary Wall

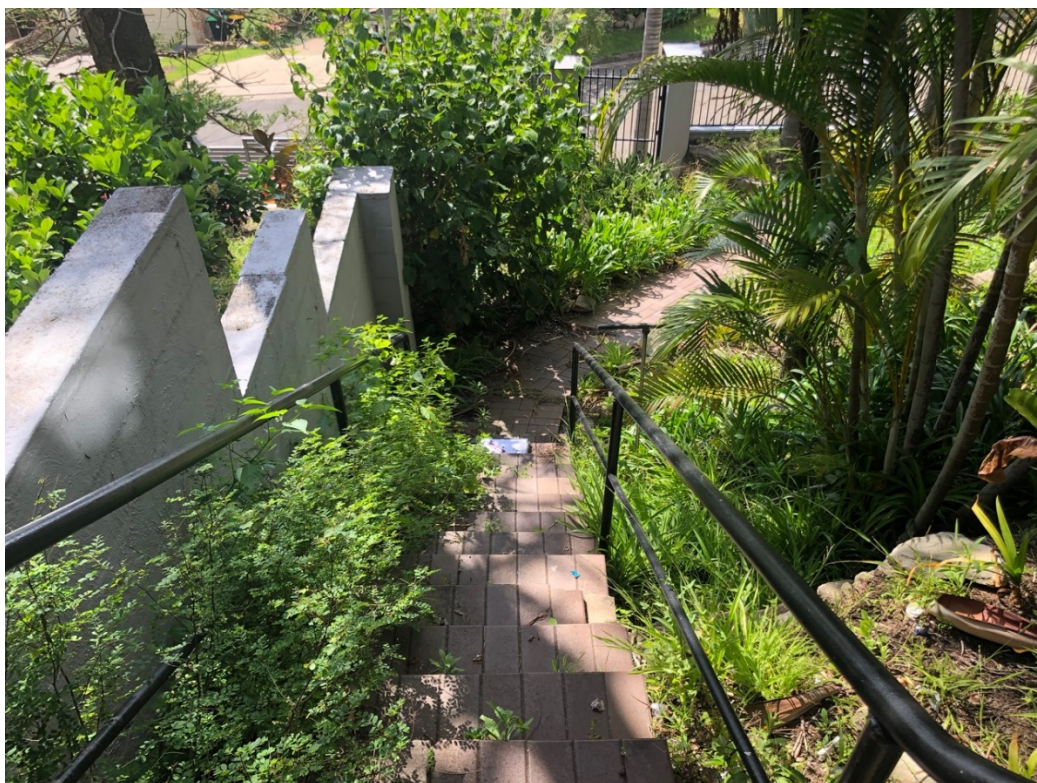
Figure 2: View down slope

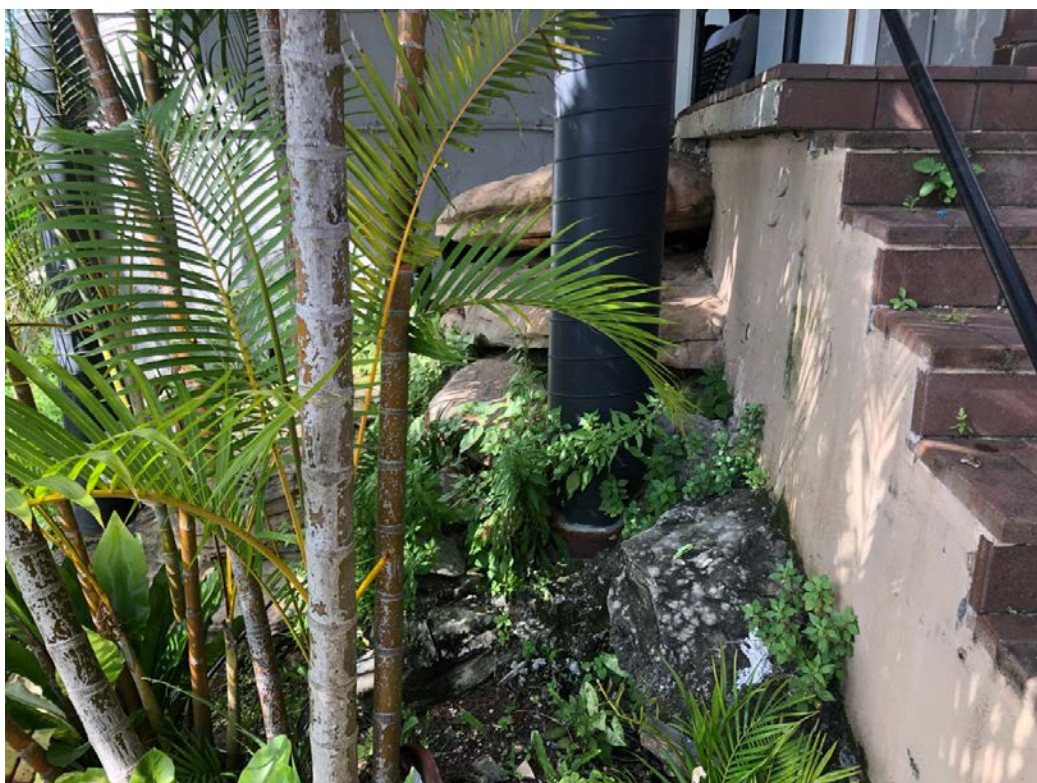
Figure 3: Upper level piers on rock outcrops

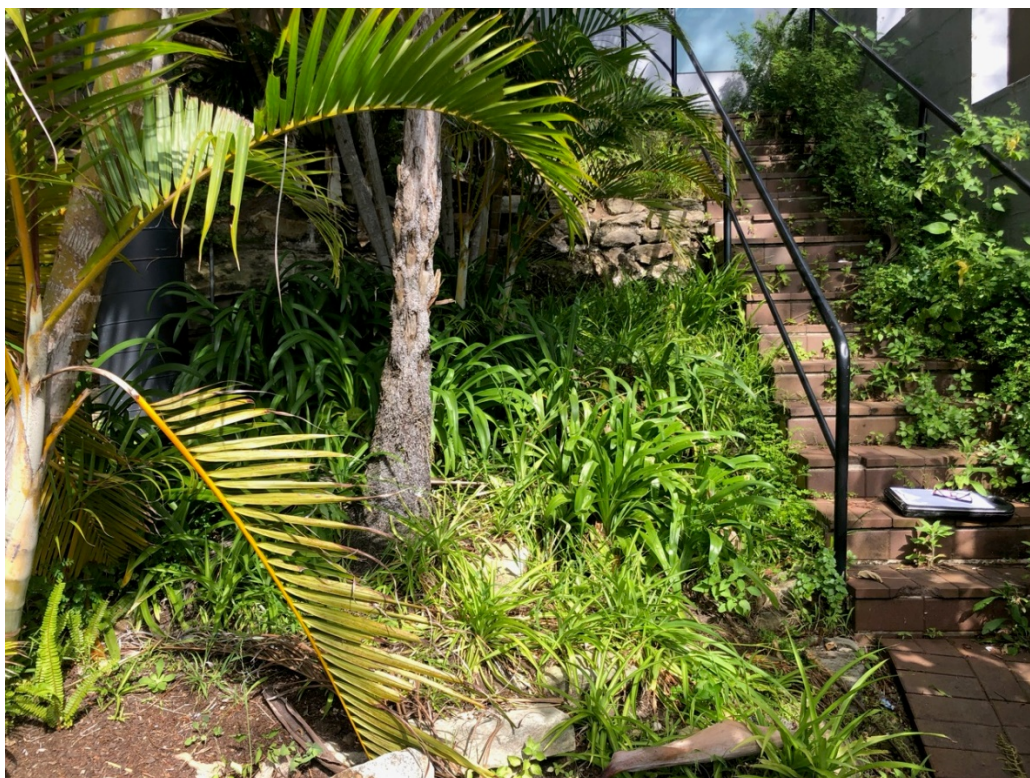
Figure 4: BH1 Location

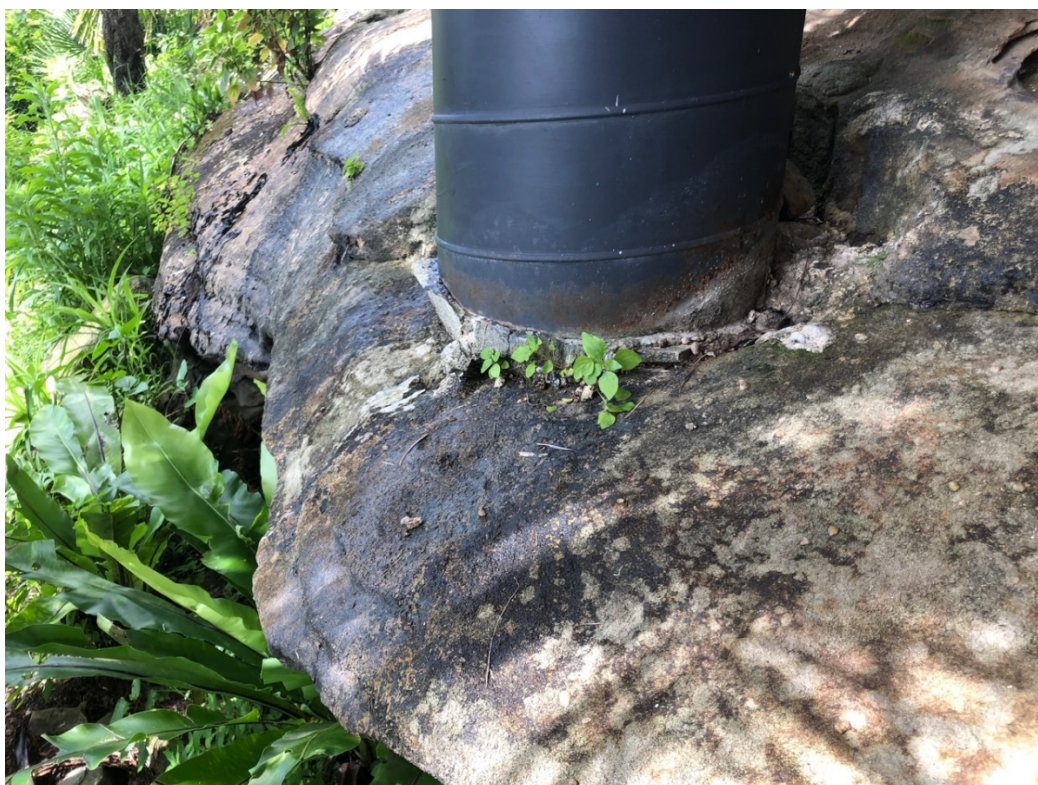
Rock outcrops typically comprise medium to coarse grained, medium to high strength Hawkesbury Sandstone. Undercuts up to 2 m depth were noted within the outcropping sandstone. Piers for the house are typically founded on exposed sandstone outcrops. One pier was noted on outcropping sandstone directly above a minor sandstone undercut (see **Figures 5 and 6**).

Figure 5: Pier founded above rock overhang

Hazard 1: Failure of the developed sandstone overhang with pier above.

- **The undercut sandstone block currently supporting a pier (Figure 5) should be propped to sandstone material below. Propping may be achieved by construction of a strip footing on the sandstone boulder below the undercut and placement of blockwork blade walls between the boulder and the undercut block. Consultation should take place between the project structural and geotechnical engineers for design of loading on the props and placement of the props.**

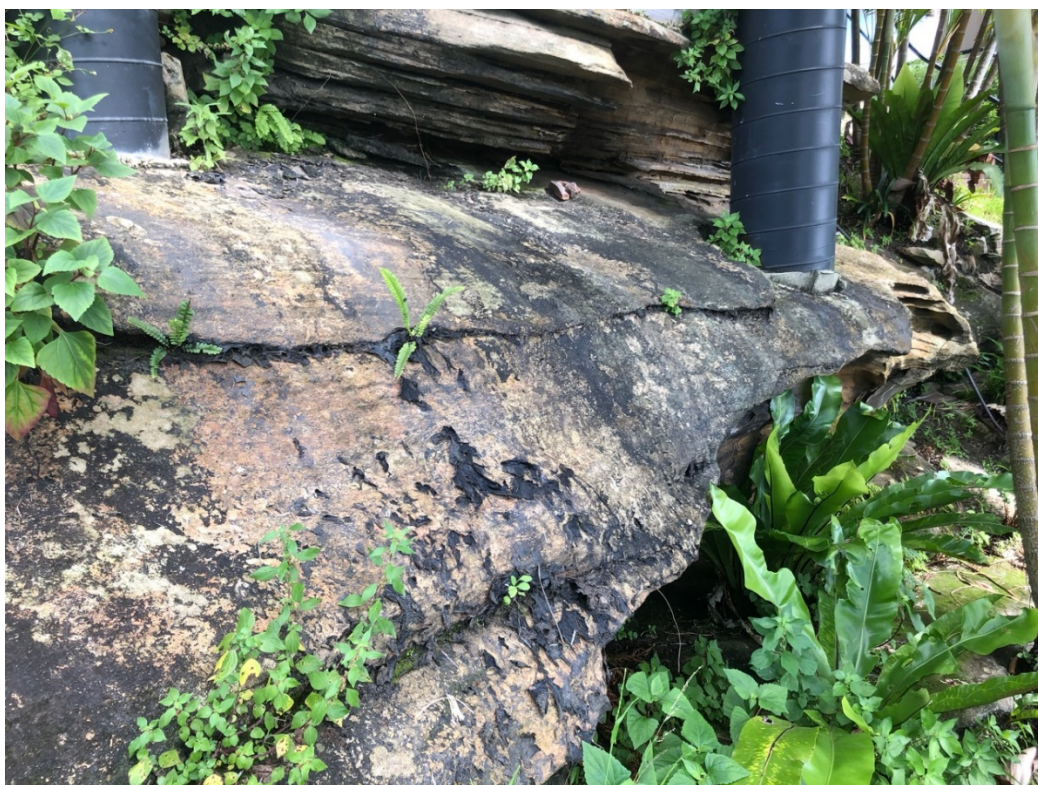
Figure 6: Pier on undercut rock shelf viewed to the north

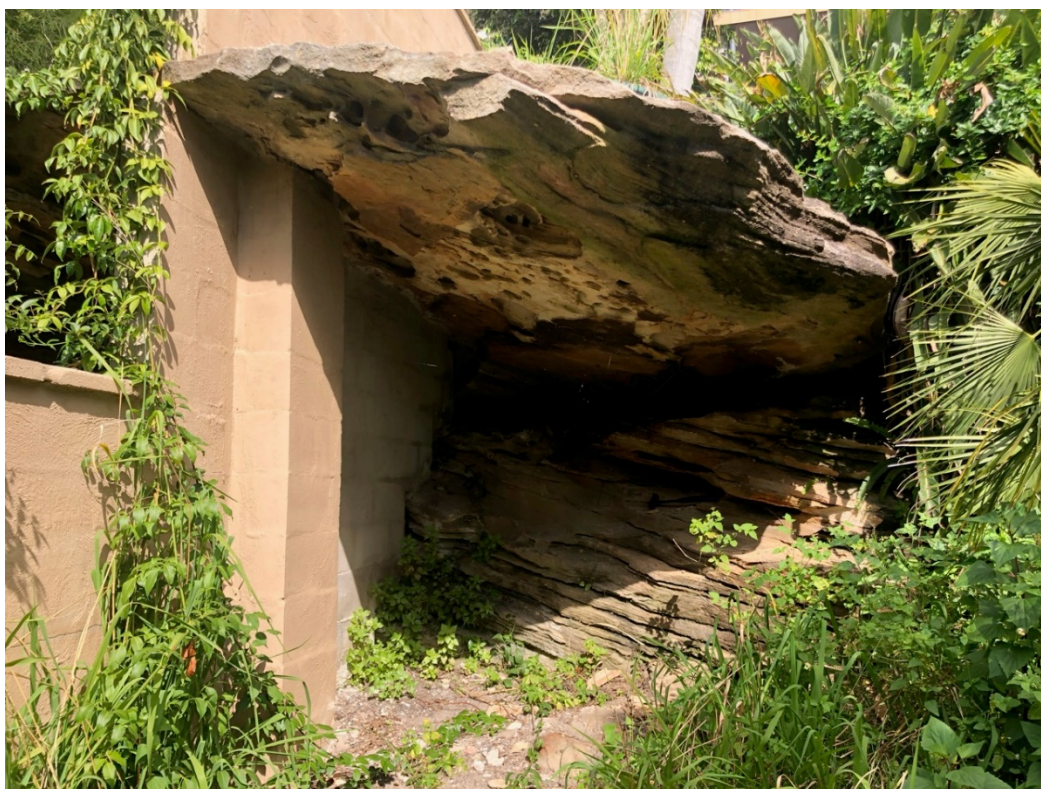
Figure 7: Sandstone overhang through boundary wall

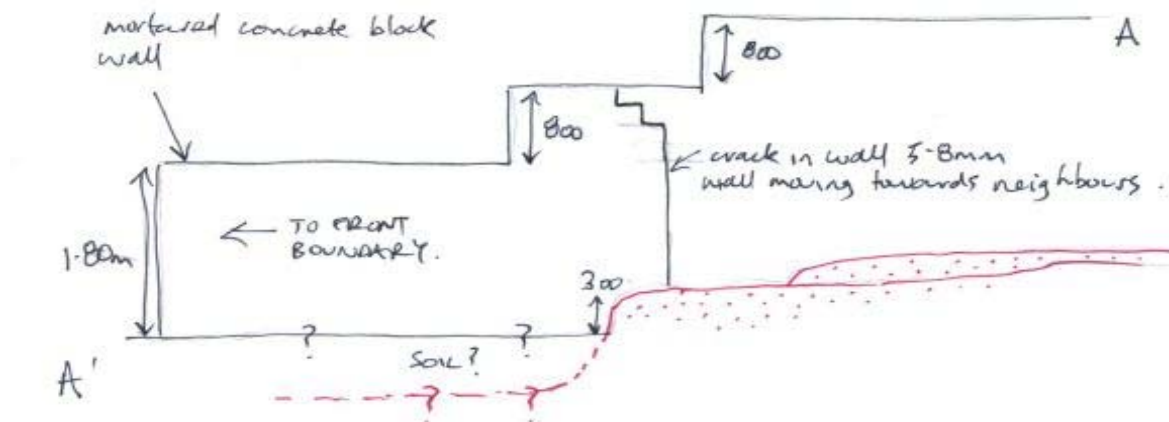
- Evacuating in wall most likely poorly founded section of wall down slope from sandstone.
- low risk failure (immediate)
- will develop over time.
- underpin lower section wall to rock.
