## **Geotechnical Assessment**

**Project:** Landscaping Works  
30 Herbert Avenue, Newport NSW

**Ref:** AG 22205  
3 June 2022

For Landscaping Works at  
30 Herbert Avenue, Newport NSW

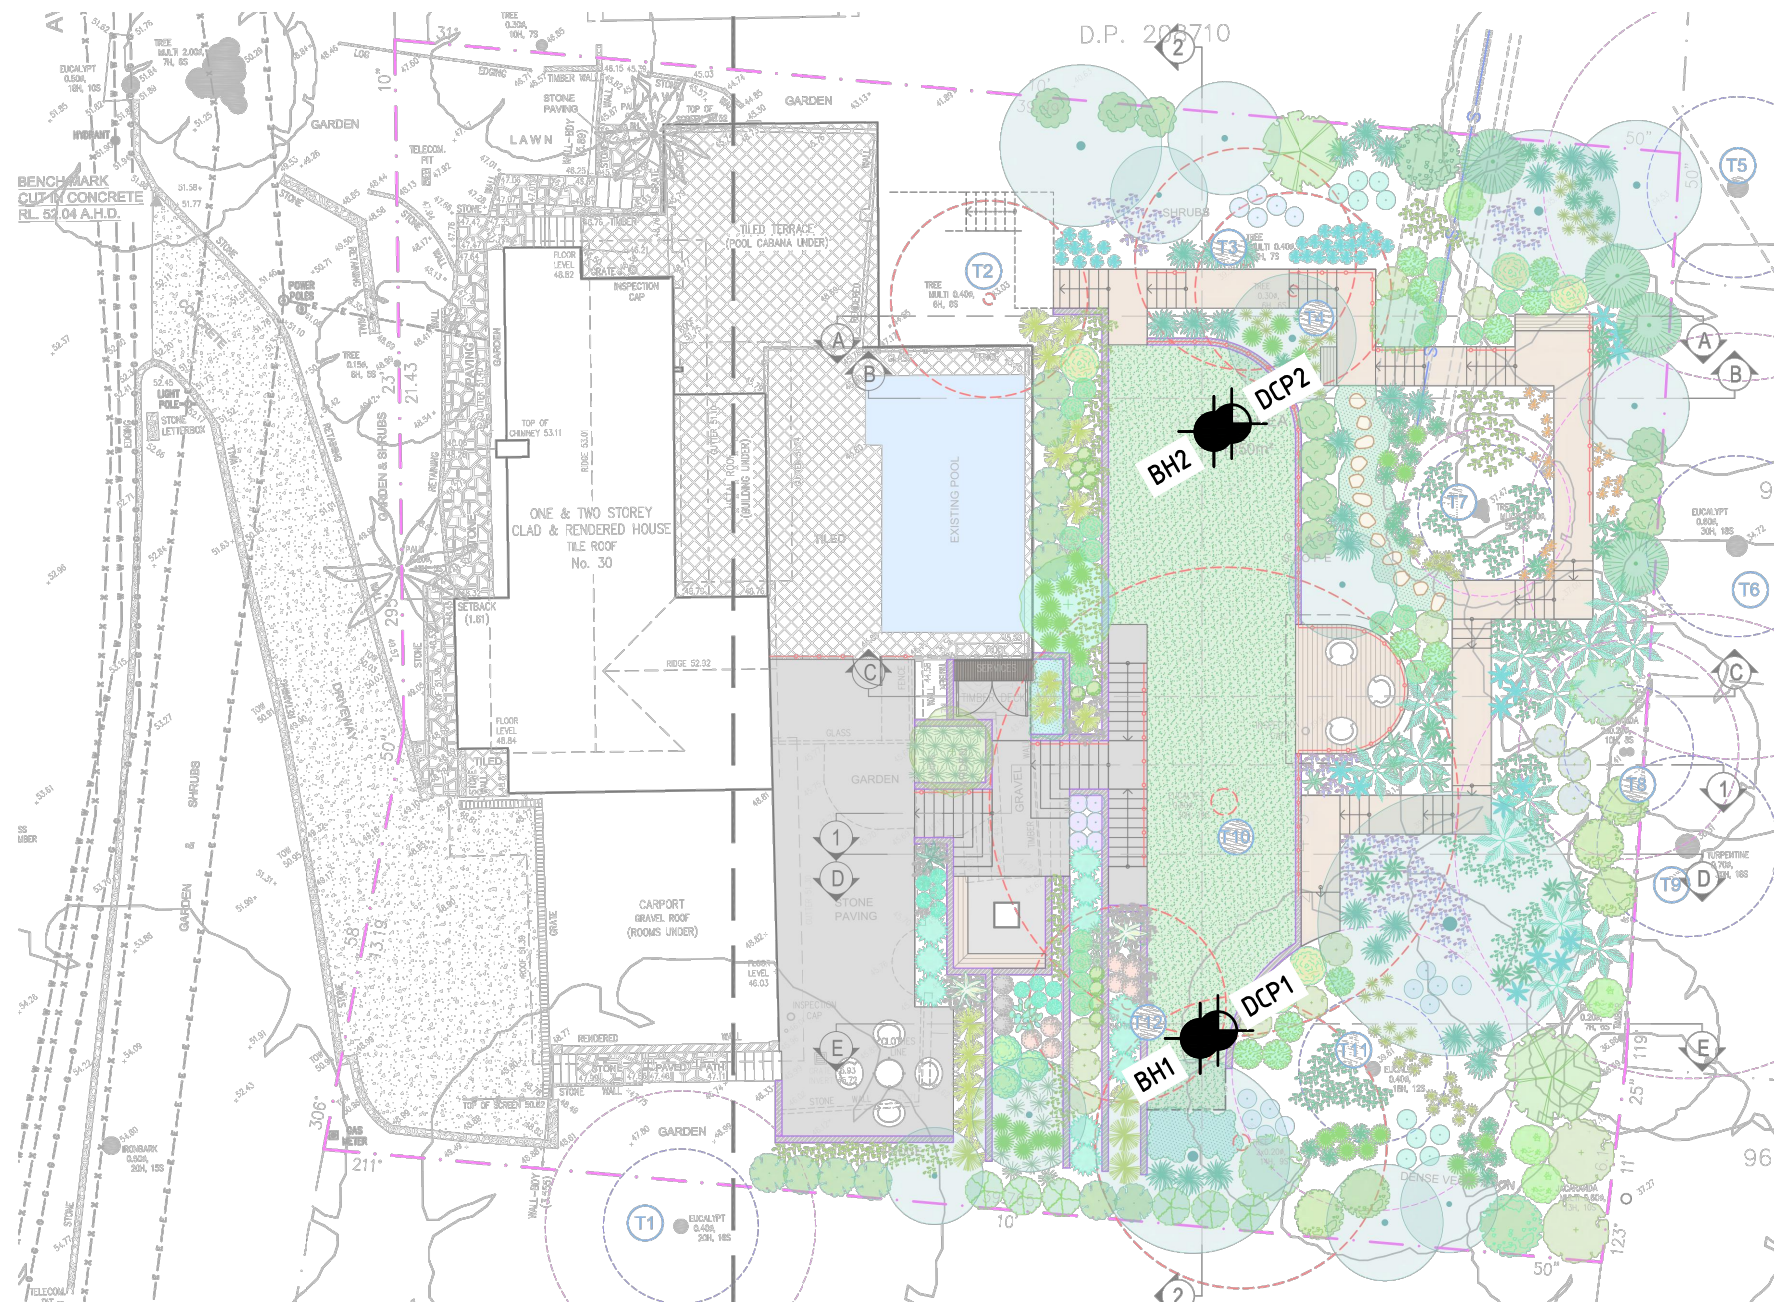
DATE:	02/06/2022
SCALE:	AS SHOWN @ A3
DRAWING TITLE:	<b>SITE PLAN</b>
DRAWING NO:	<b>AG 22205- S1</b>

**SITE PLAN/GROUND TEST LOCATIONS**

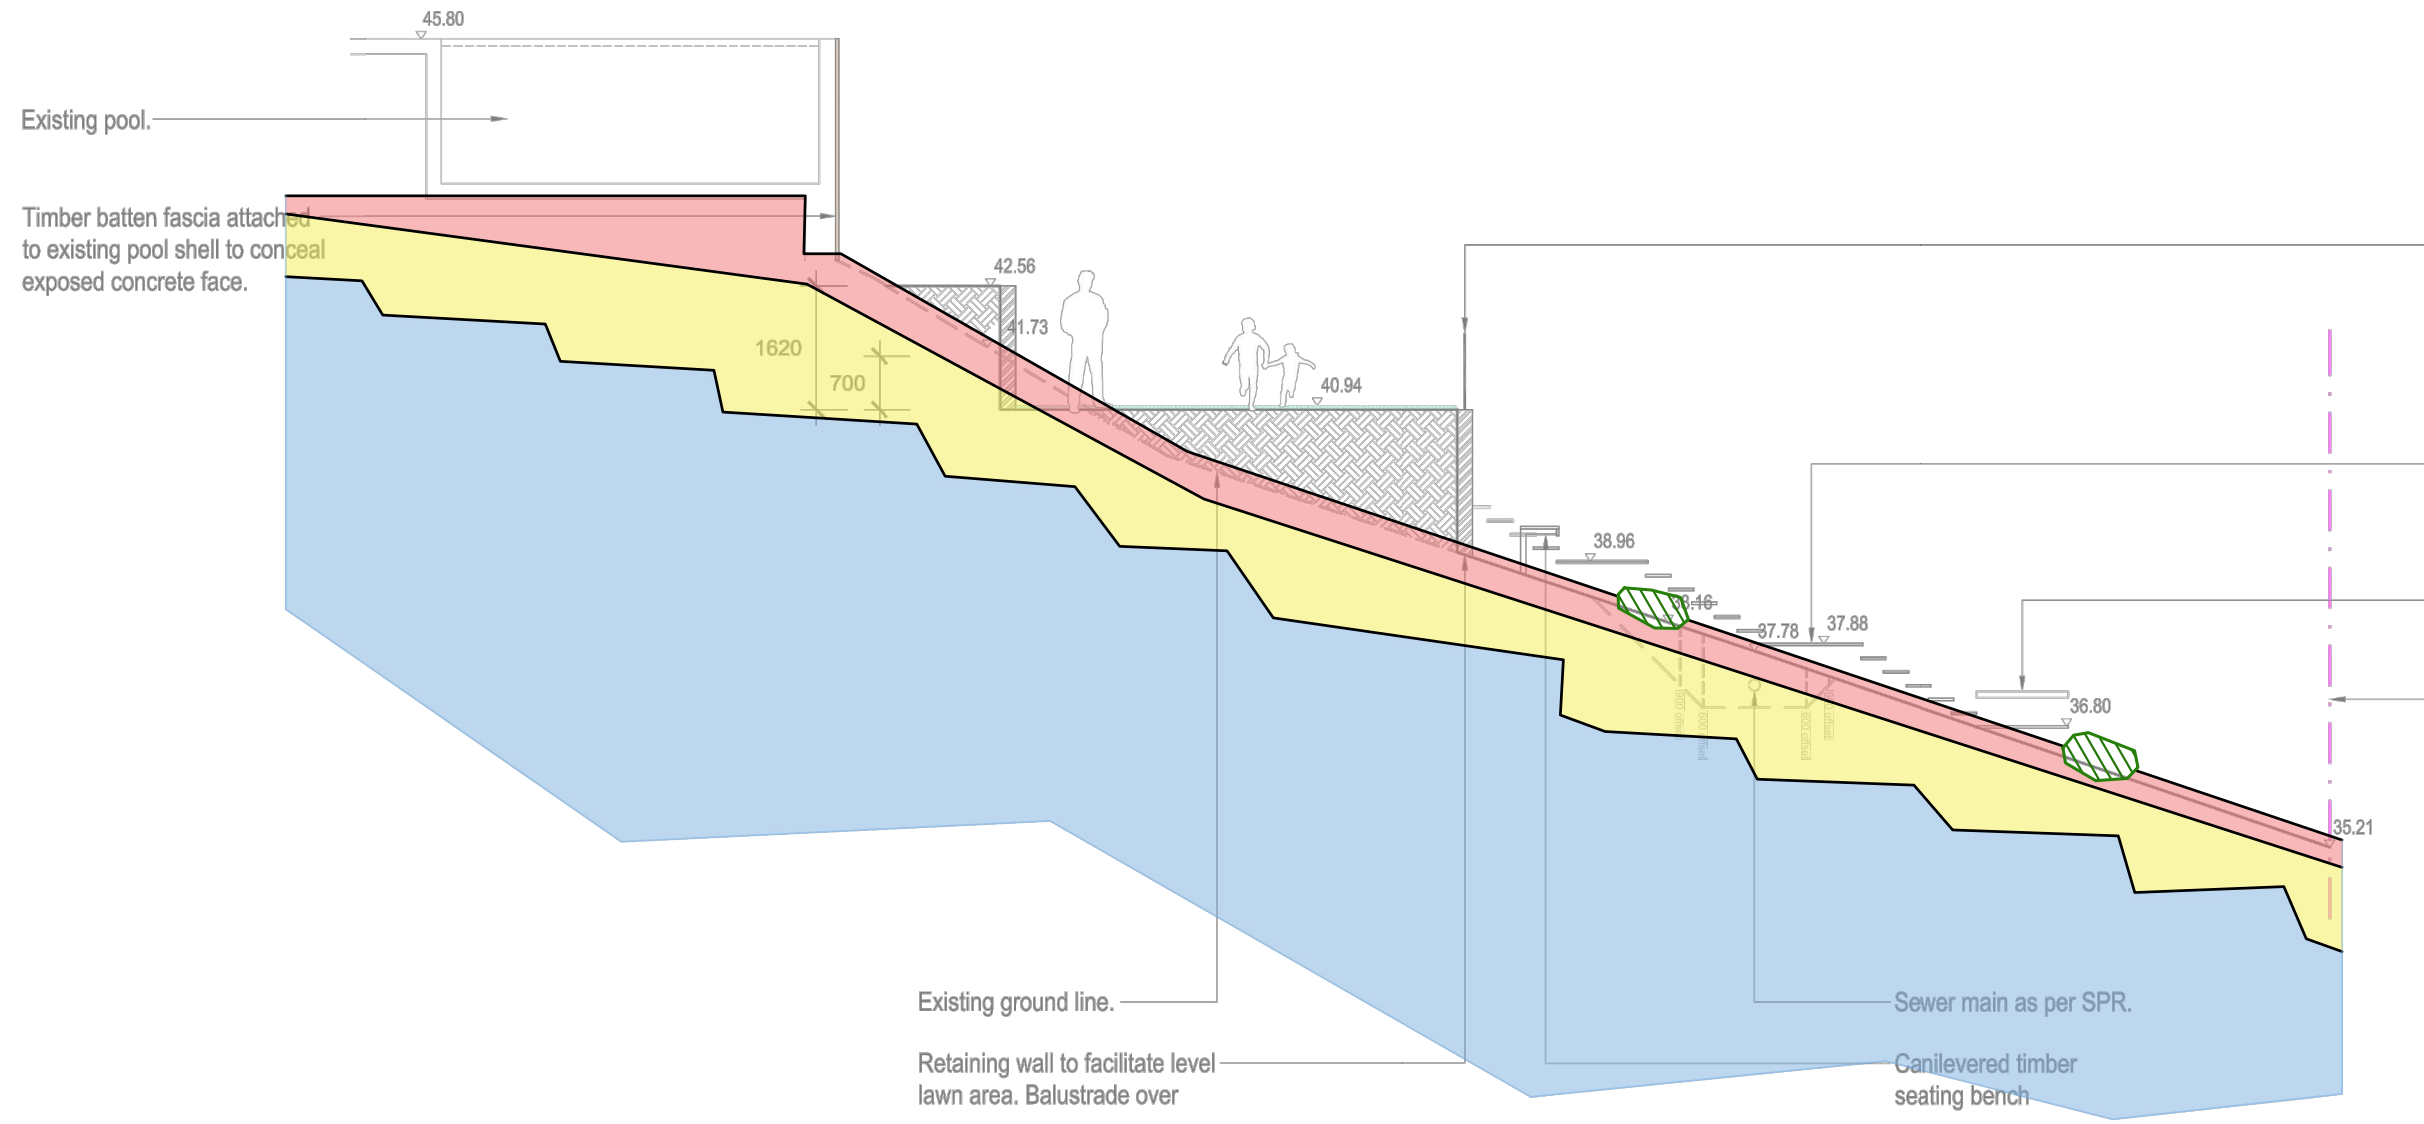
DATE:	02/06/2022
SCALE:	AS SHOWN @ A3
DRAWING TITLE:	<b>SECTION</b>
DRAWING NO:	<b>AG 22205- S2</b>

INTERPRETED SUBSURFACE SECTION ONLY.  
ACTUAL GROUND CONDITIONS MAY VARY.

**INFERRED GEOLOGICAL SECTION**  
SCALE NTS

**INFERRED GEOLOGICAL SECTION  
AT 30 HERBERT AVENUE  
NEWPORT NSW**
