Geotechnical Assessment

Project: New Dwellings
41 Ferguson Street, Forestville NSW

Ref: AG 24481
11 December 2024

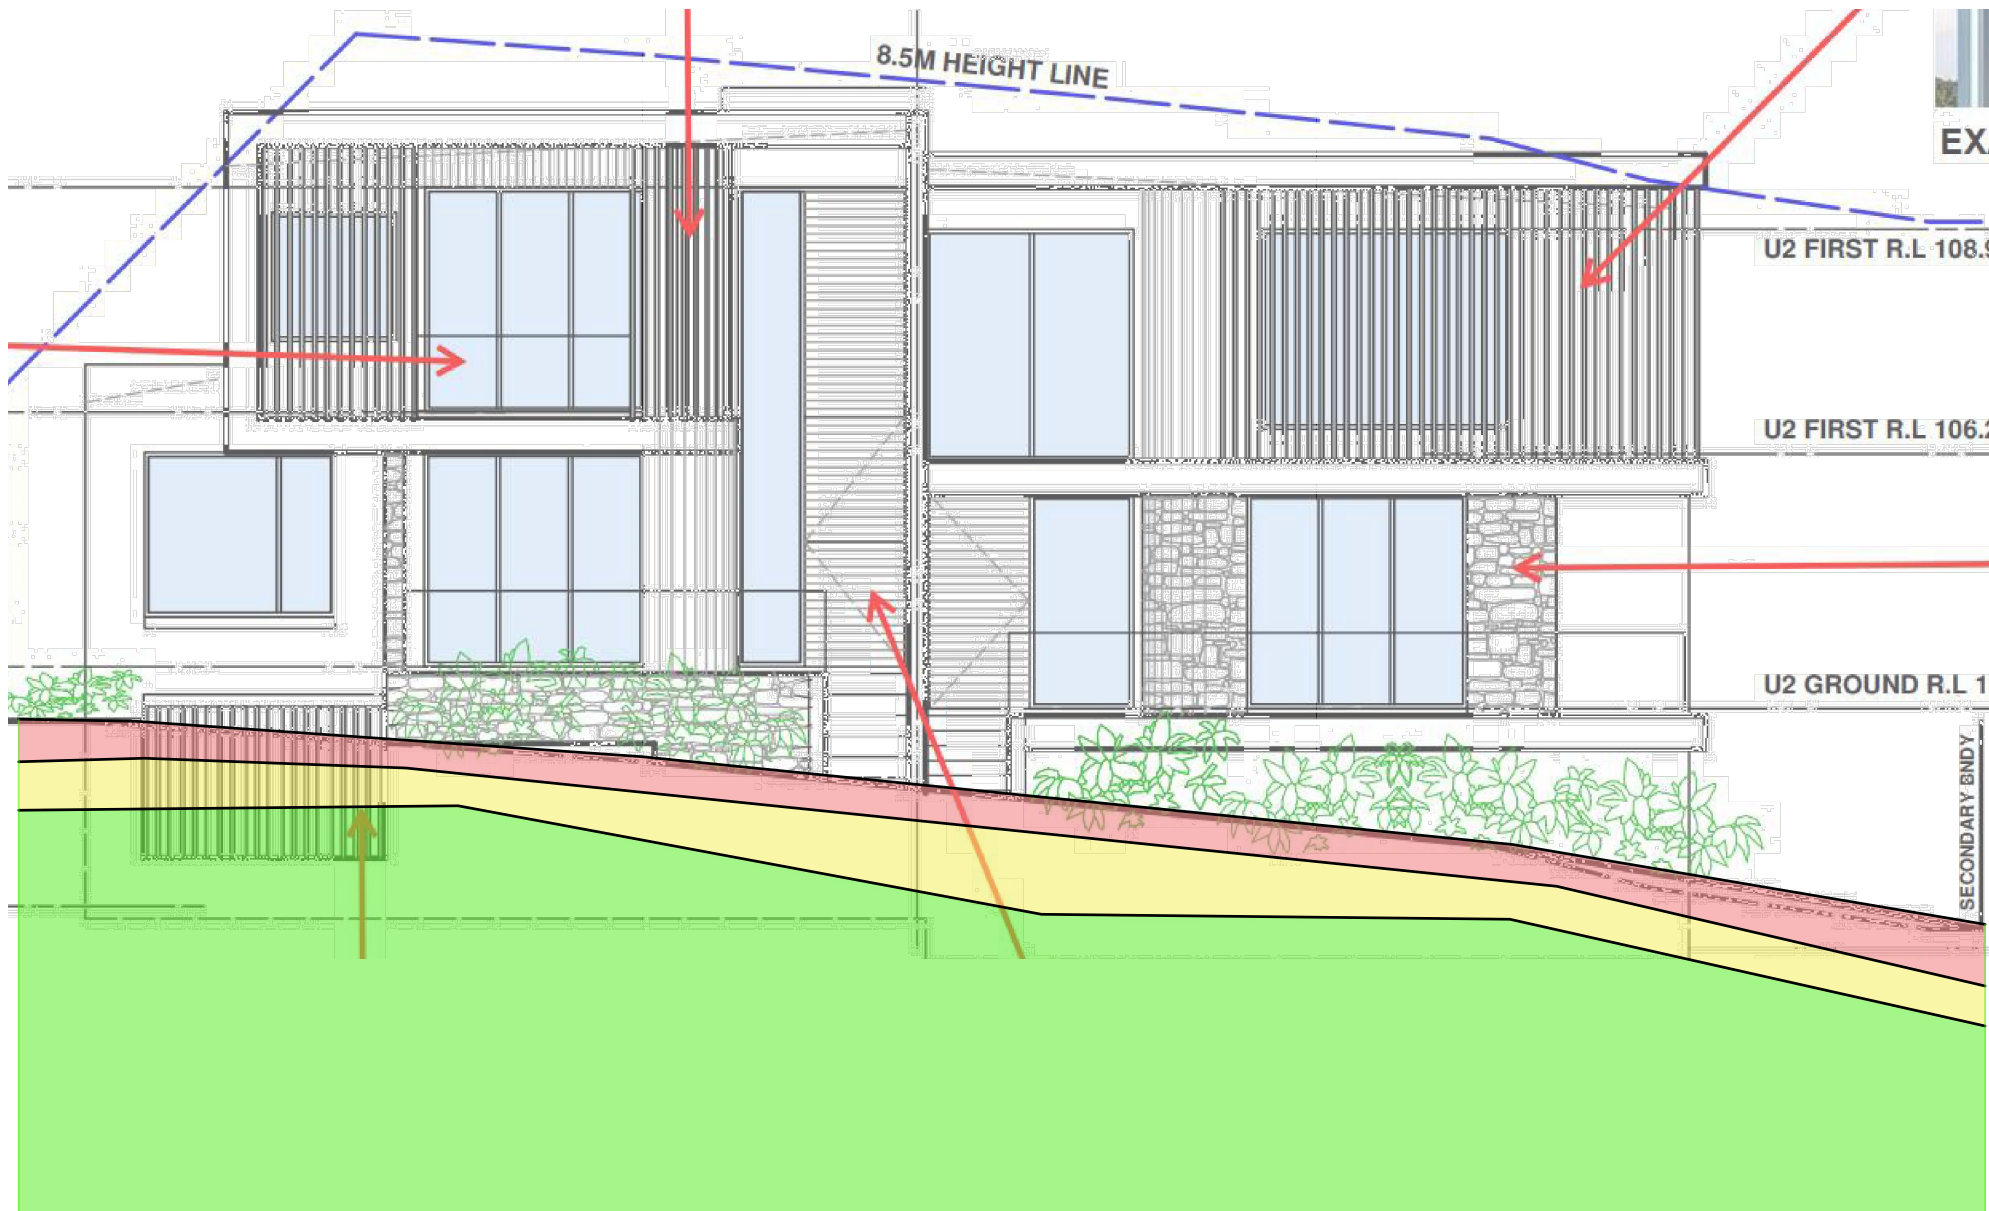
INFERRED GEOLOGICAL SECTION

INTERPRETED SUBSURFACE SECTION ONLY.
ACTUAL GROUND CONDITIONS MAY VARY.

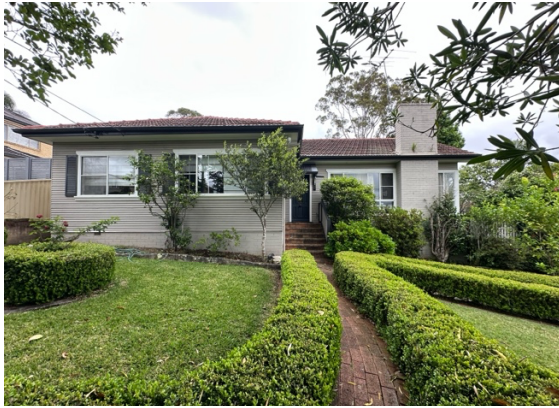
Photo 1: Site frontage, looking southwest.

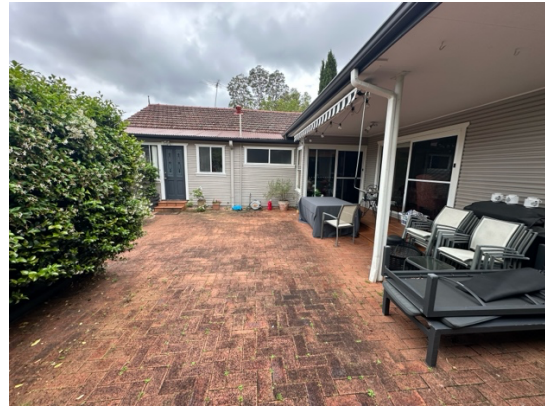
Photo 2: Rear boundary of site looking northeast.

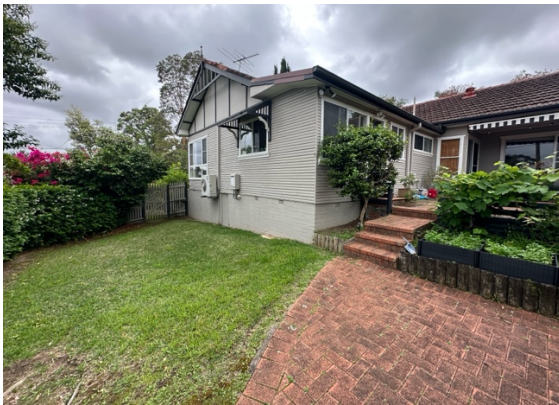
Photo 3: western boundary of site, looking northeast.

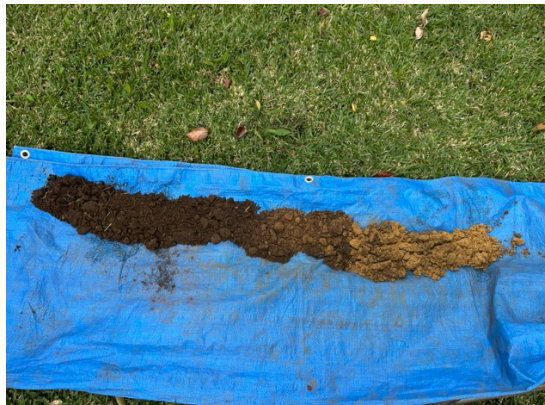
Photo 4: Subsurface soil profile of BH01.
