## **GEOTECHNICAL REPORT**

### **PROPOSED NEW DWELLING**

**18 HILLCREST AVENUE, MONA VALE NSW**

**Project No.: 2022-039.1**

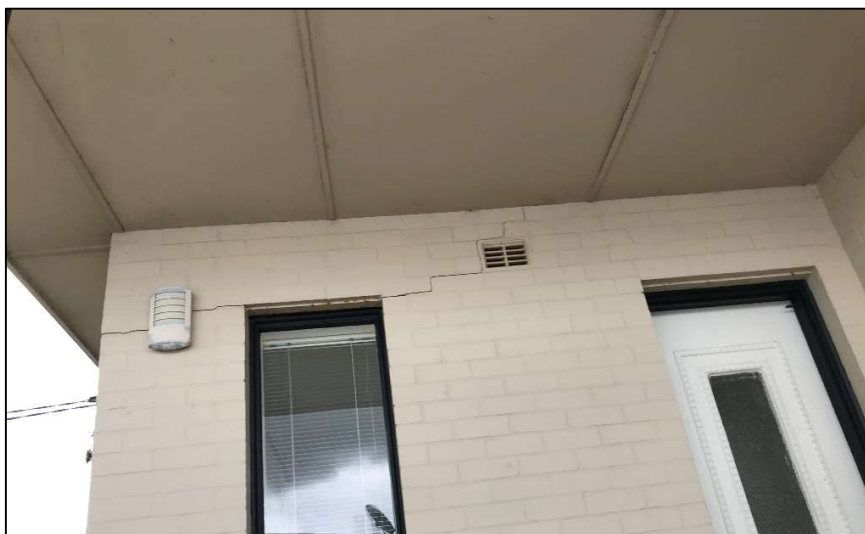
The existing site residence is generally in good condition with the exception of a crack on the external southern wall as shown on Photograph 4. The crack is present near the front of the house and is likely related to settlement of founding strata rather than an indicator of a deep-seated landslip hazard.

*Photograph 4: Cracking observed in the external wall.*

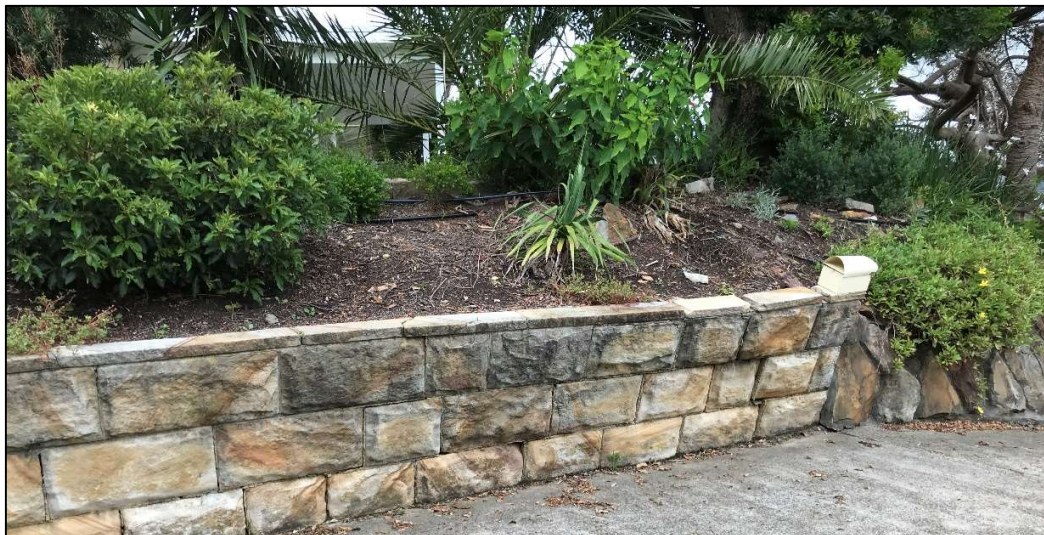
The retaining wall (located adjacent to the site driveway) did display some rotation which may be related to the growth of an adjacent tree or inadequate construction and is considered unlikely to represent a deep-seated geotechnical issue.

*Photograph 5: View of rotating wall at the front with the site.*

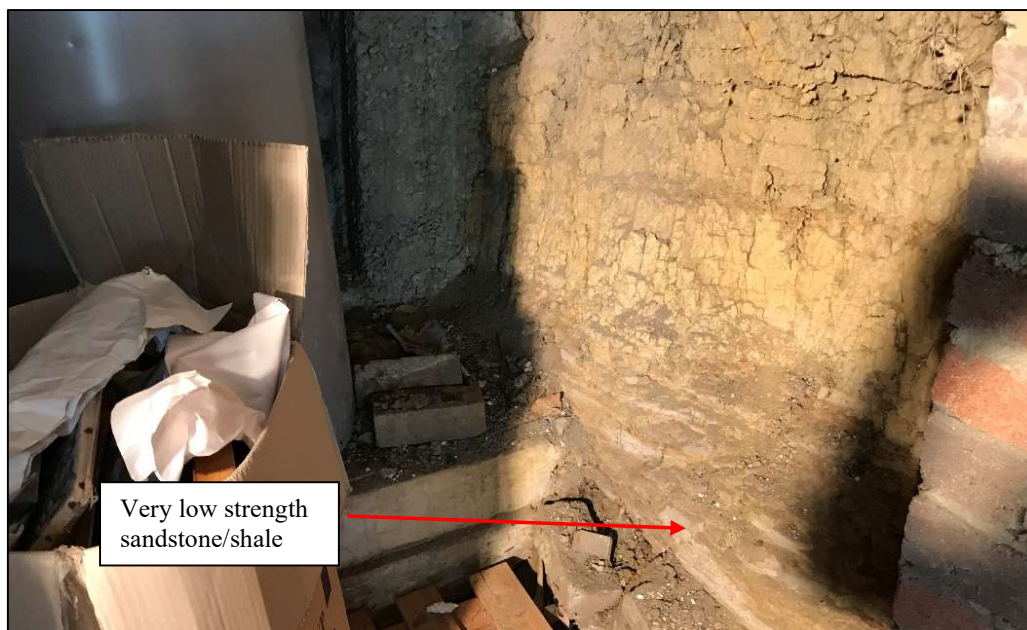
Within the site garage an outcrop of very low strength sandstone interbedded with shale was observed and overlain by approximately 0.8m thickness of residual clay soils (See Photograph 6)

*Photograph 6: View of bedrock outcrop in the garage*

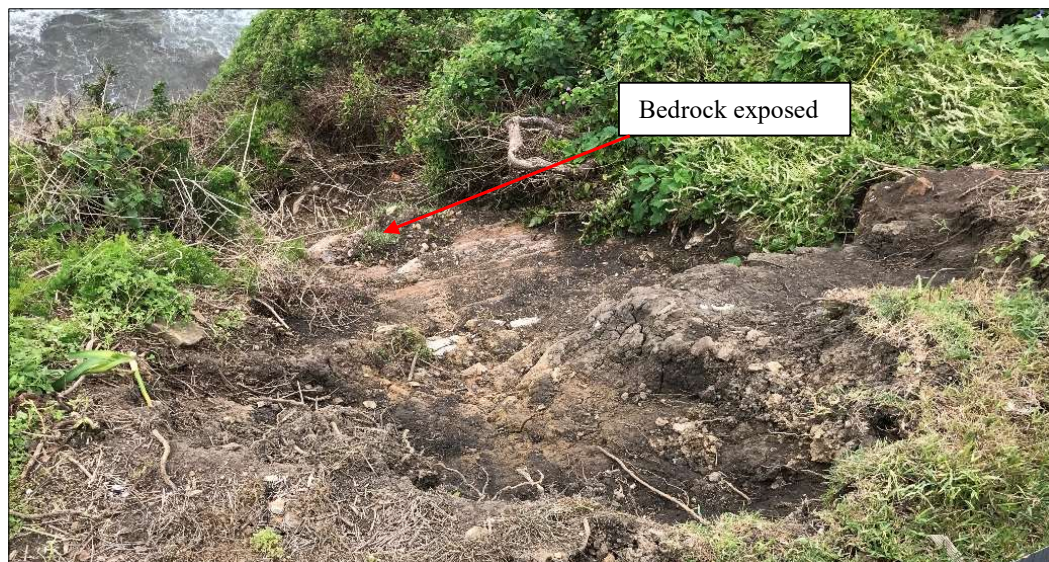
Adjacent to the rear deck of the site dwelling and near the crest of the cliff, recent erosion/landslip of topsoil/residual soils exposed bedrock approximately 1.5-2.0m below the elevation of the garden and is shown in Photograph 7.

*Photograph 7: View of bedrock outcrop near crest of the cliff*

Significant geotechnical hazards were not observed however erosion/previous landslip was observed near the crest of the cliff adjacent to the site deck. This feature is typical following heavy rainfall which occurred before the fieldwork was undertaken and represents a normal cliff process which periodically exposes bedrock and not representative of a significant deep seated landslip hazard.

Apparently stable bedrock was observed within an area of landslip/erosion near the crest of the cliff adjacent to the existing site residence deck however it appears the results of erosion and not representative of a larger or continuing landslip hazard.

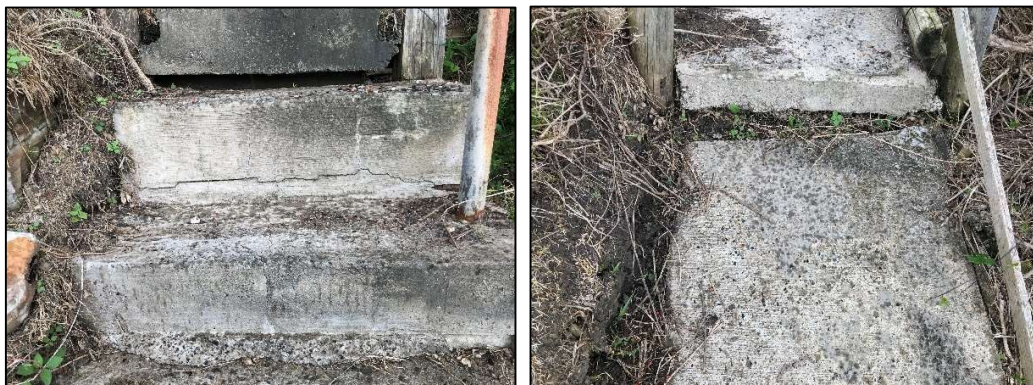
Within the site indications of distress were observed within the access steps which lead down to Bungan Beach to the east and indicated in Photograph 8. The separation/cracking observed is considered to be the result of settlement/creep of colluvial soils and the shallow founding of the path in this material and not an indication of a significant geotechnical issue.

*Photograph 8 and 9: View of separation with the beach access steps looking west*

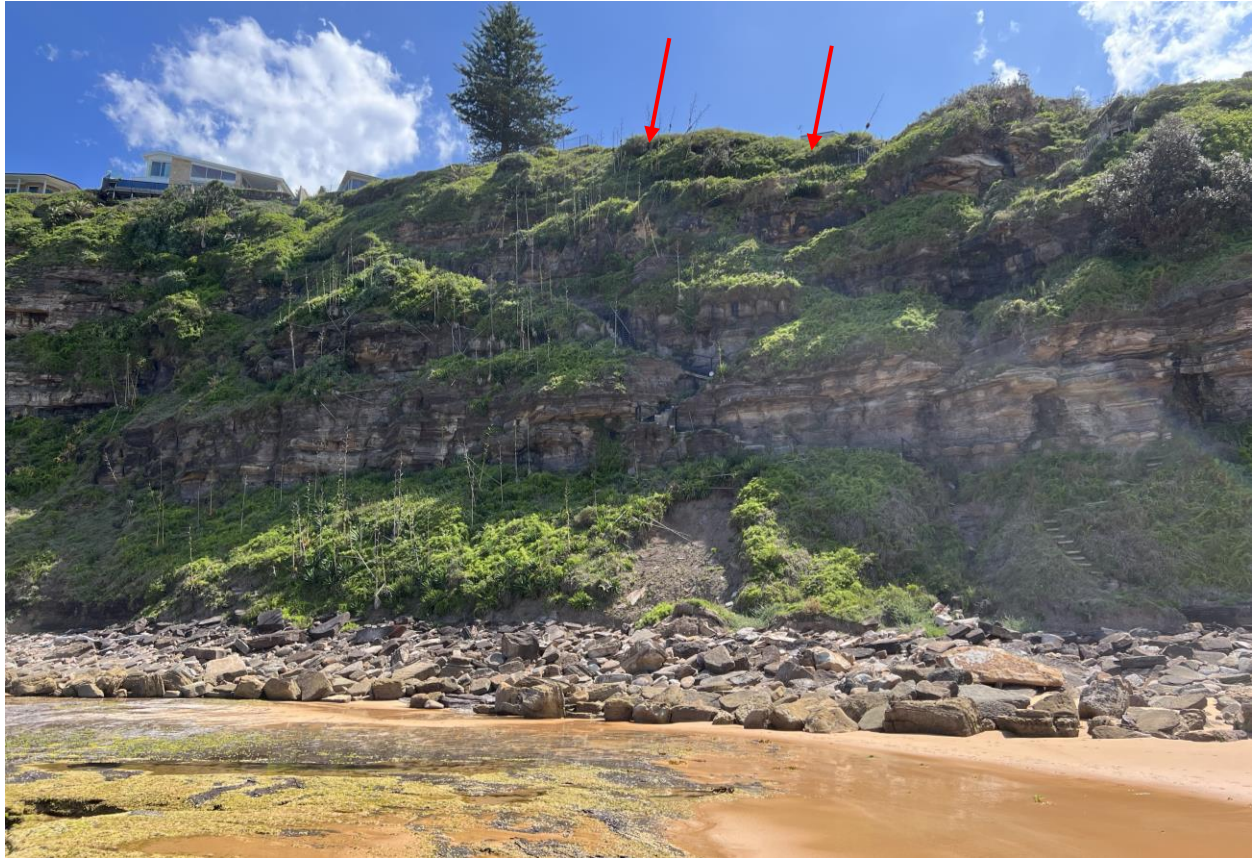
**Figure 3: View of cliff face at subject property (development area extent approximately between arrows) on 2 February 2023, facing WSW**
