15 Tutus Street, Balgowlah Heights

Comments on updates to Plans

GEOTECHNICAL INVESTIGATION:

New House at **15 Tutus Street, Balgowlah Heights**

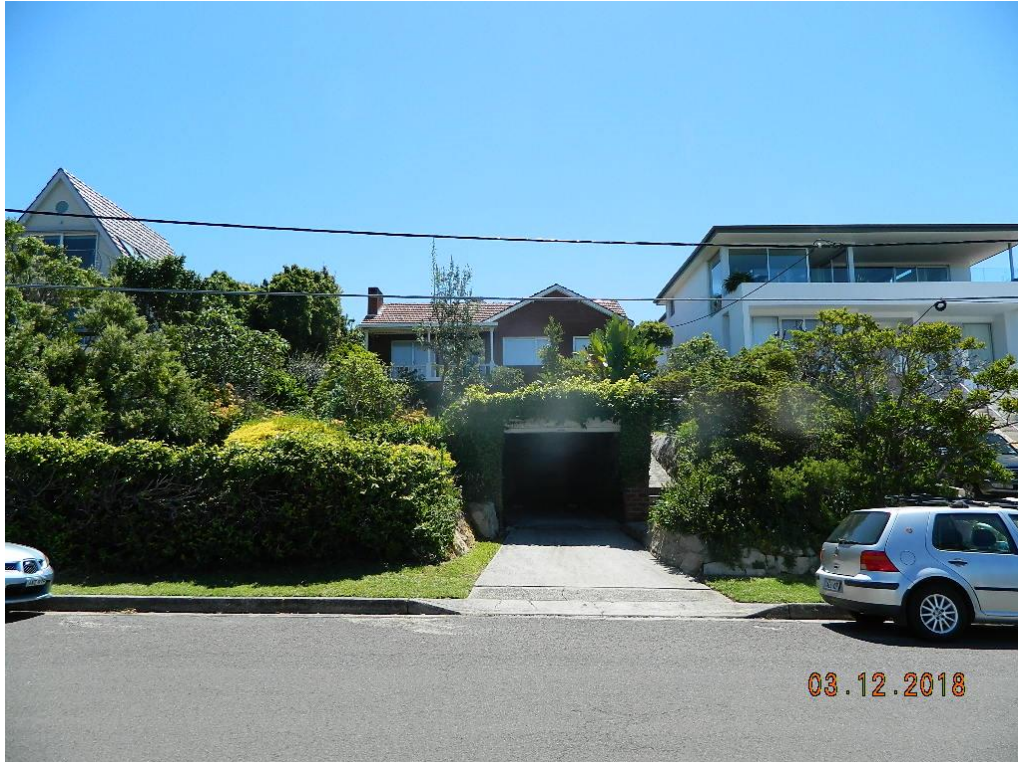
Photo 1

- 2.3** At the road frontage a concrete driveway runs to a garage on the downhill side of the property (Photo 1 & 2). The garage has been cut into the slope. The cut for the garage has been taken through competent Medium Strength Sandstone (Photo 3). The garage will be demolished as part of the proposed works. Medium Strength Sandstone was observed outcropping on the S side of the driveway (Photo 4). A gently sloping

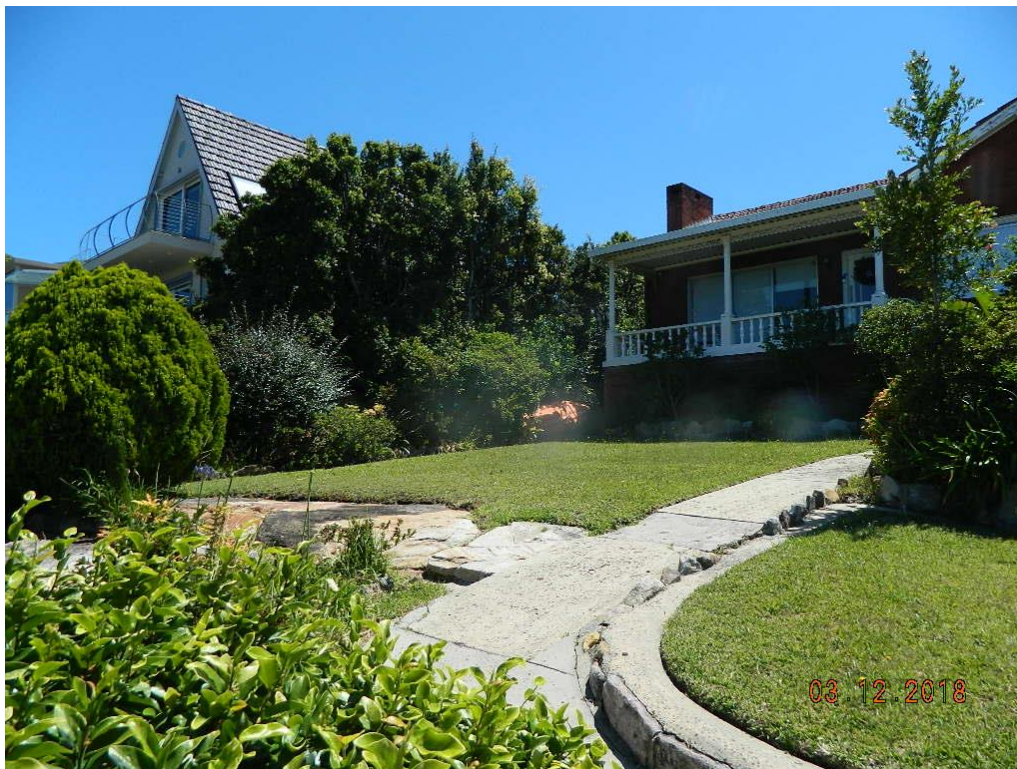
Photo 5

lawn rises from the garage to the downhill side of the house (Photo 5). Gardens encompass the N and S common boundaries. The single-storey brick house will be demolished as part of the proposed works (Photo 6). Medium Strength Sandstone was observed outcropping on the N side of the house (Photo 7). A near level lawn area extends from the uphill side of the house to the uphill boundary (Photo 8). A timber deck on the N side of the lawn will be demolished as part of the proposed works (Photo 9).

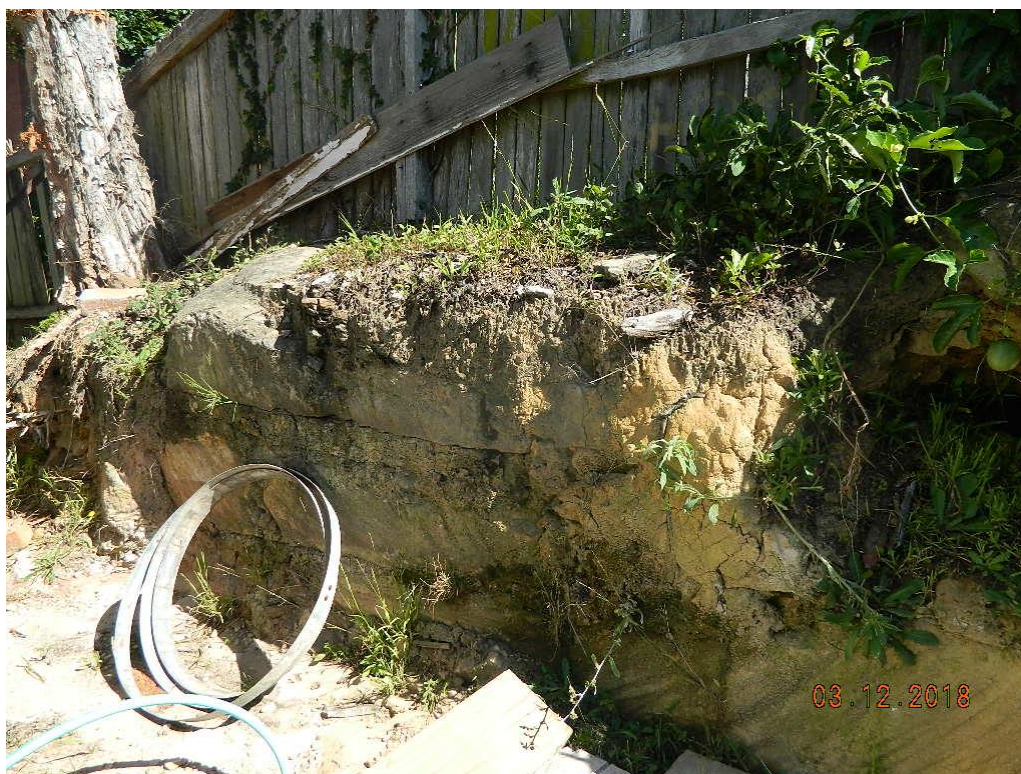
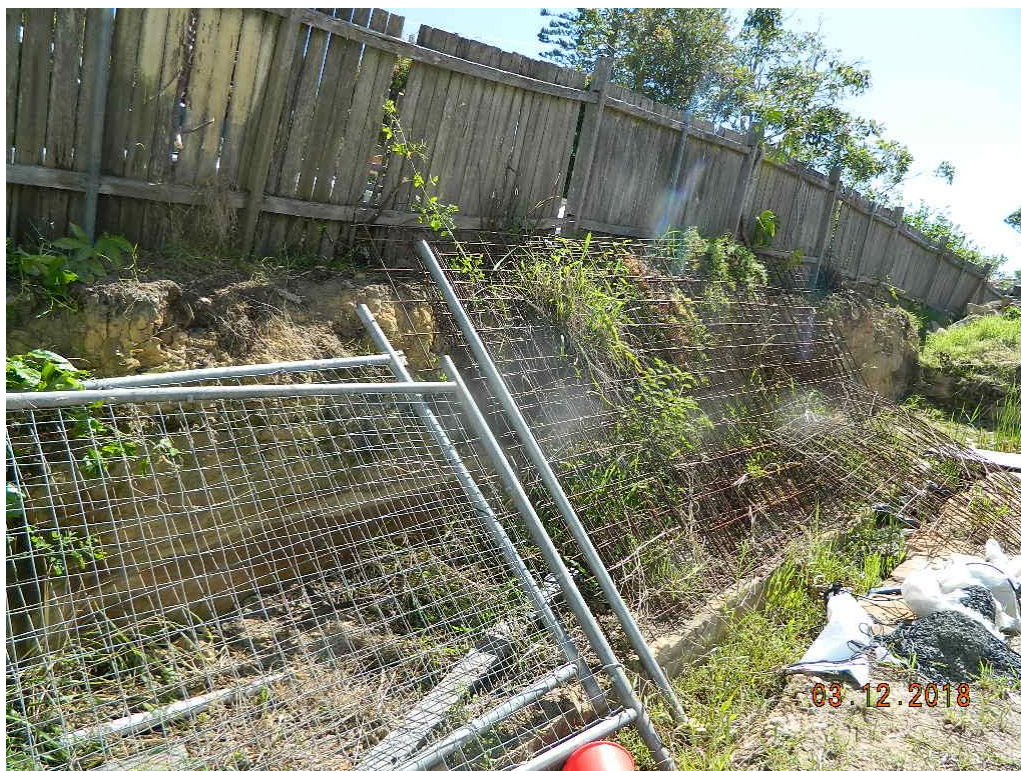
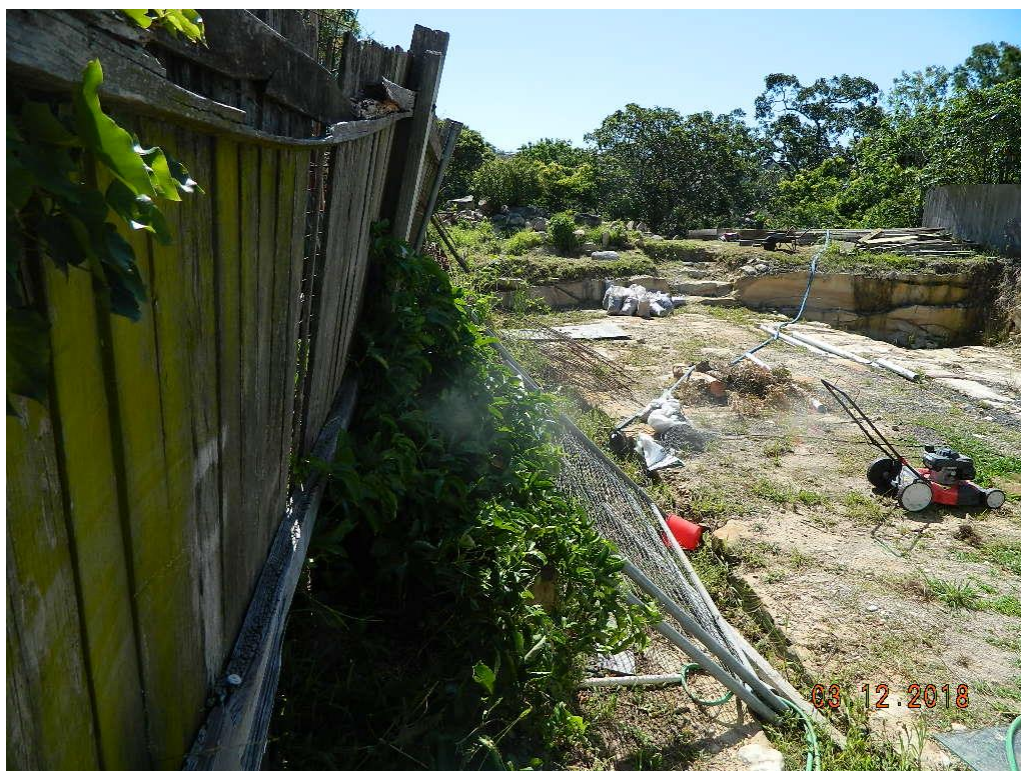
As the excavation will be ~2.0m from a ~1.0m high cut face on the N neighbouring property, a rock saw is to be used along the perimeter of the excavation in this location prior to commencement of the excavation regardless of the equipment used. This is to prevent any vibrations damaging the 2.0m wide pillar of rock that will be left on completion of the excavation between the subject and N neighbouring property.

Accounting for back wall drainage, a portion of the N side of the proposed excavation for the house will be ~2.0m from a ~1.0m high cut batter of shallow soil and clay over sandstone on the neighbouring property to the N (Photos 10, 11 & 12). The proposed excavation will extend parallel with the cut on the N neighbouring property for some 5.0 metres before the neighbouring cut tapers to level to the E. On completion of the proposed excavation a ~2.0m wide pillar of shallow sandy soil and clay over rock will be left between the subject property and the N neighbouring property. To prevent damage to the cut on the neighbouring property it is critical that the advice in **Section 12** vibrations be followed and a rock saw be used on the excavation perimeter adjacent to the low cut on the neighbouring property to the N before the bulk excavation takes place.

The soil portion of the cut for the house is to be battered at 1.0 Vertical to 1.7 Horizontal (30°) until the retaining walls are in place. The clay portions of the cut will stand at near-vertical angles for short periods of time until the garage structure is constructed, provided the cut batters are kept from becoming saturated. Excavations through Medium Strength Sandstone or better will stand at vertical angles unsupported subject to approval by the geotechnical consultant.

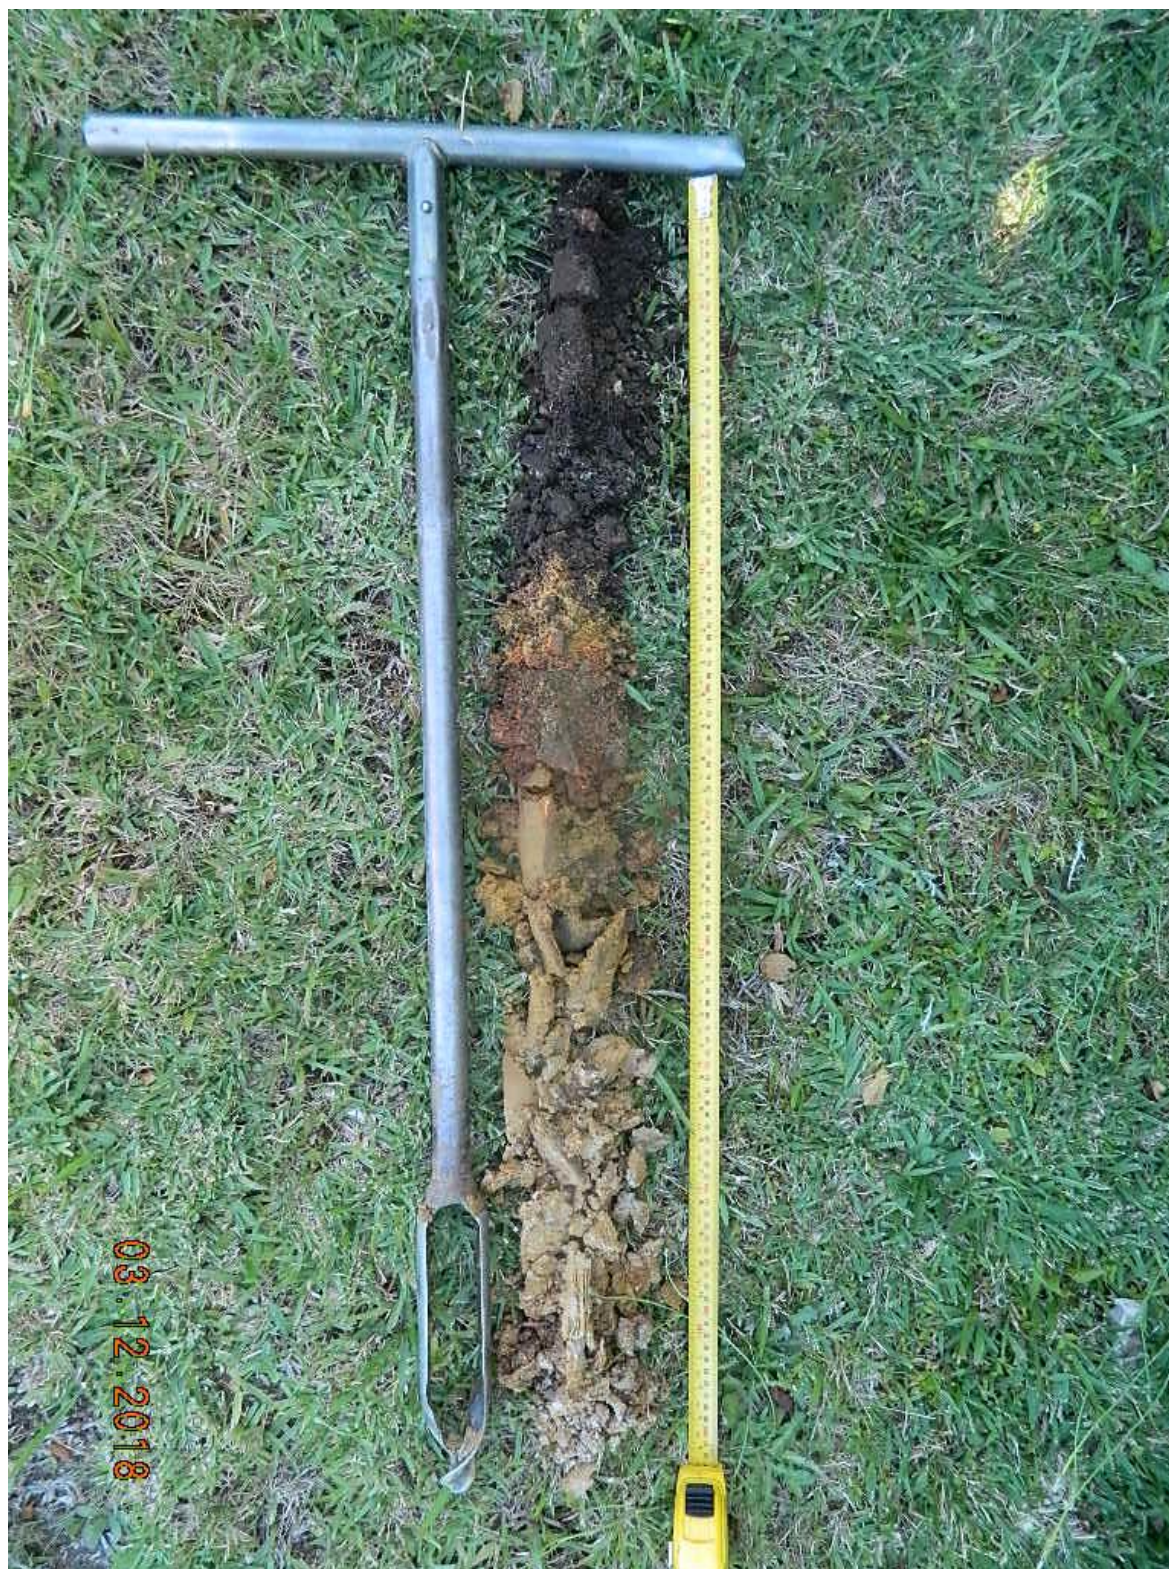
AUGER HOLE 1 (~RL46.4) – AH1 (Photo 13)

Depth (m)	Material Encountered
0.0 to 0.3	SANDY SOIL , loose, dark brown, fine to medium grained, rock fragments, dry.
0.3 to 0.5	SILTY SAND , orange to light brown, loose, medium grained, dry.
0.5 to 0.7	SANDY CLAY , orange/brown, firm, fine to medium grained, dry.
0.7 to 1.0	SANDY CLAY , weathered sandstone, light brown/orange, white mottling, fine to medium grained, dry.

End of hole @ 1.0m in sandy clay. No watertable encountered.

Photo 13: Ager Hole 1: Top of Auger at top of hole
