PRELIMINARY GEOTECHNICAL ASSESSMENT:

8 Walker Avenue, Narrabeen

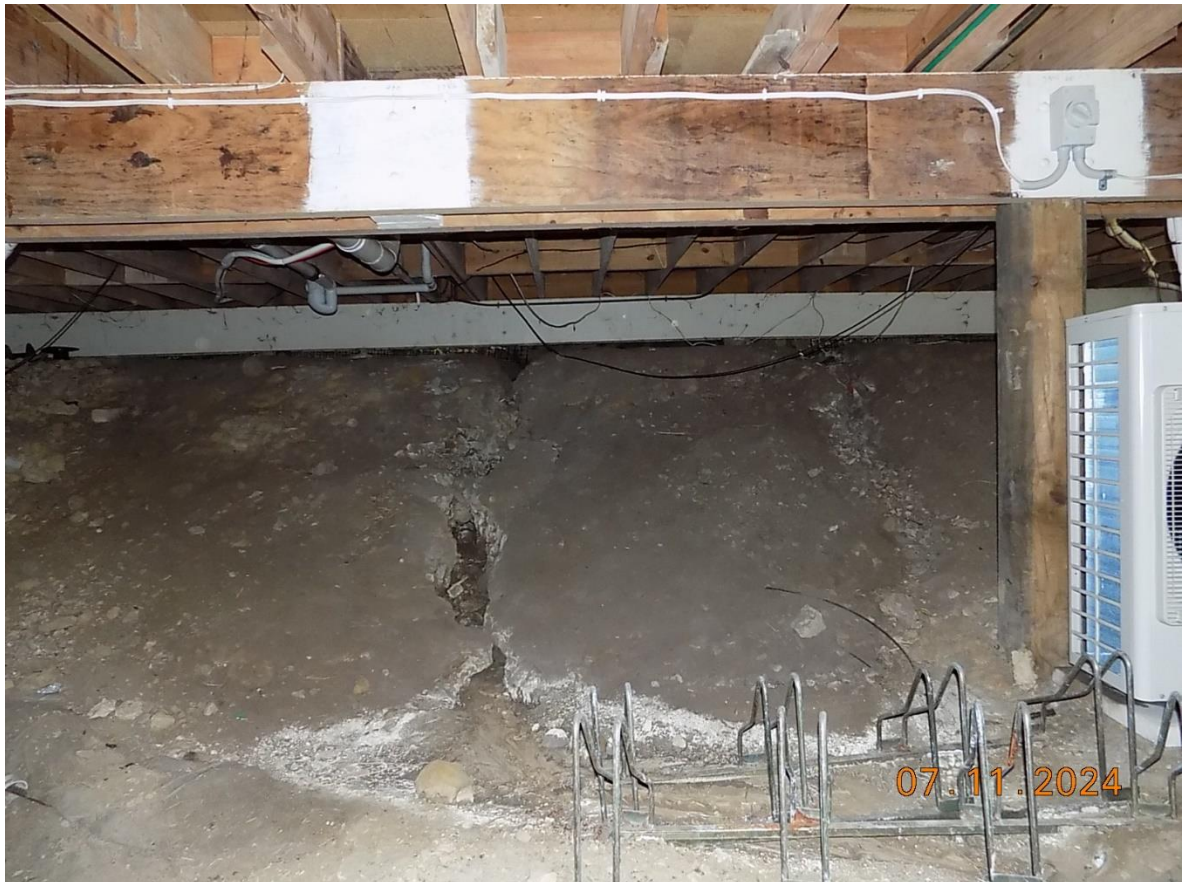
Photo 1

The erosion which was observed underneath the first floor of the house does not yet appear to be negatively affecting the foundations (Photo 1). However, Consideration should be made to improve the drainage of the property. This will need to be designed by the stormwater engineer in consultation with the geotechnical consultant.
