GEOTECHNICAL INVESTIGATION:

House Extension and New Garage at 120 McCarrs Creek Road, Church Point

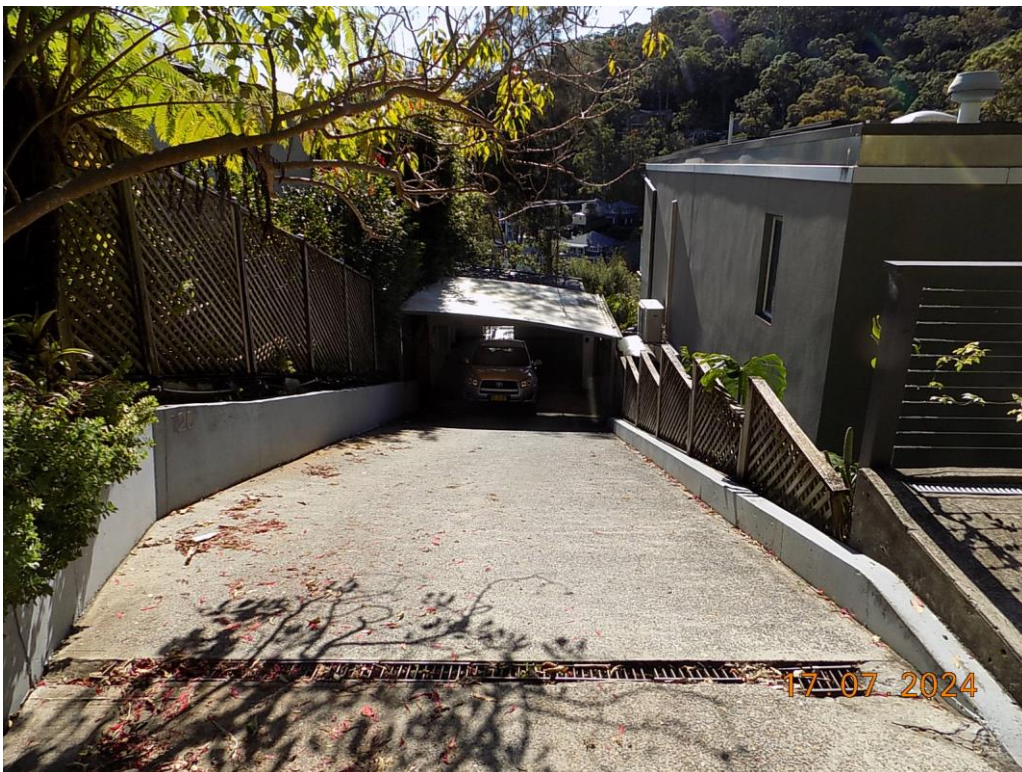
Photo 2

- 2.1** The site was inspected on the 18th July, 2024.
- 2.2** This waterfront residential property is on the low side of the road and has a NE aspect. It is located on the steeply graded lower reaches of a hillslope. The natural slope falls across the property at an average angle of ~21°. The slope above the property continues at similar steep angles.
- 2.3** At the road frontage, a shared concrete ROW (Right of Carriageway) runs down and across the slope (Photo 1) to a driveway (Photo 2) and garage on the uphill side of the subject property. The steep slope above and below the cut for the ROW has a covering of dense vegetation and is currently considered to be stable (Photo 1). A cut for the driveway on the subject property is supported by a stable low rendered masonry retaining wall that approximates the W common boundary (Photo 2). Below

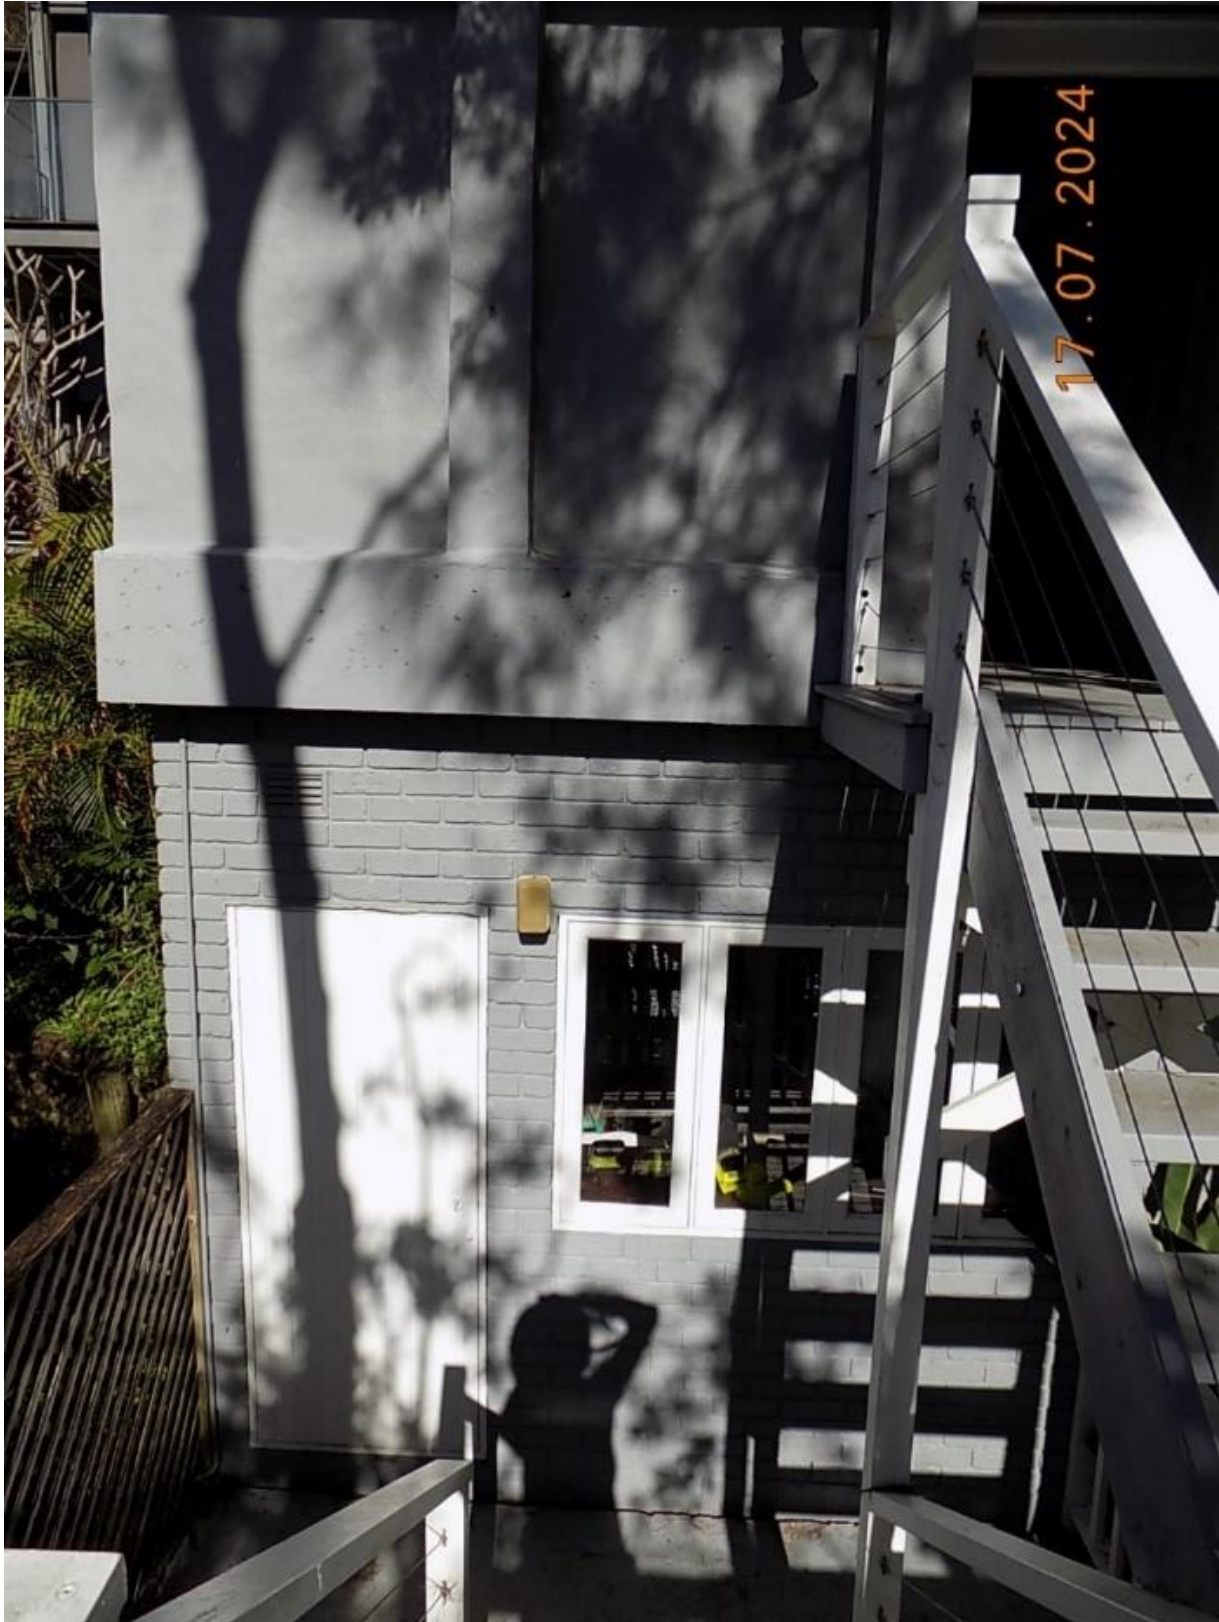
Photo 3

the driveway, a cut for the neighbouring house has been taken through Low to Medium Strength Sandstone bedrock. The garage (Photo 3) is supported on brick and concrete block walls. No significant signs of movement were observed in the supporting walls.

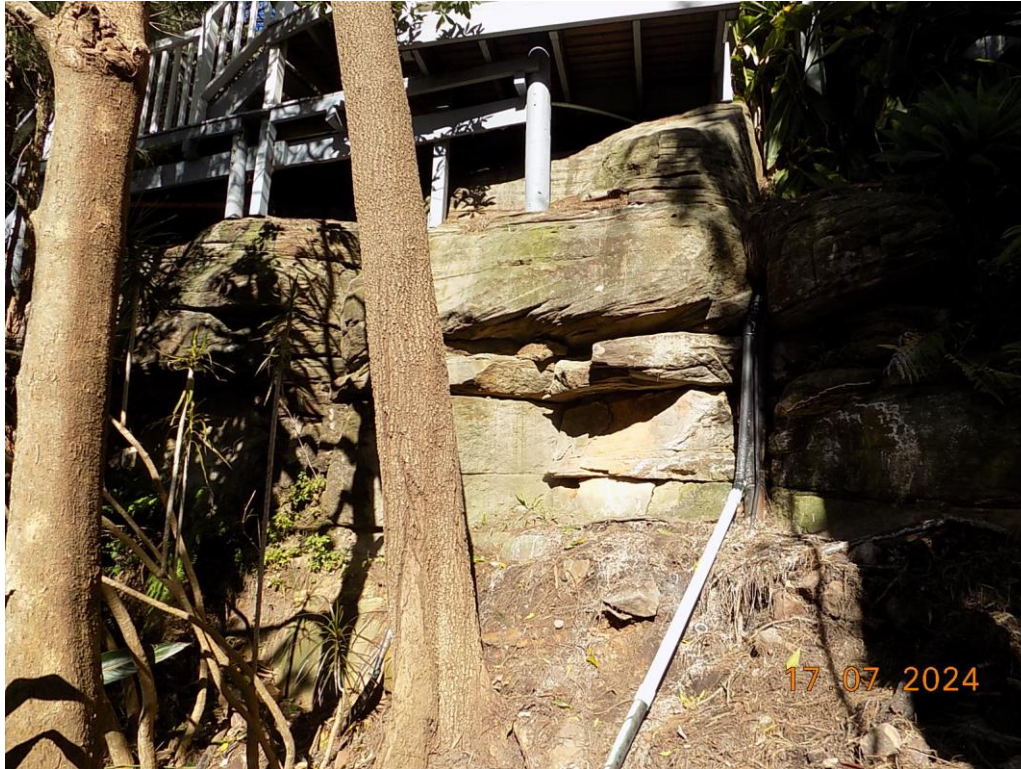
Photo 4

A band of Medium Strength Sandstone outcrops and steps ~4m vertically down the property below the garage (Photo 4). The outcrop exhibits jointing up to 80mm wide and was slightly undercut in places. Any significantly large jointed or undercut portions are sufficiently thick relative to the overhang length and display no horizontal cracking when viewed from above or below. Additionally, the wooden posts for the stairs are sufficiently set back from the undercut portions of the rock. As such, we consider this outcrop stable.

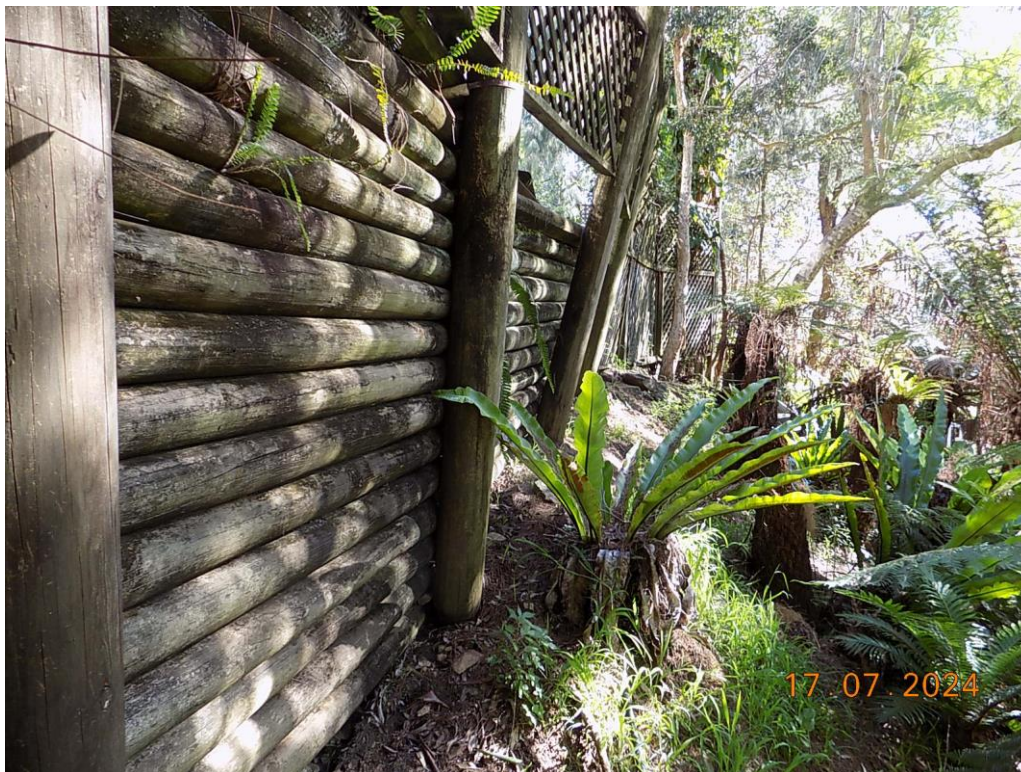
Photo 5

A timber log retaining wall (Photo 5) reaching ~1.5m high approximates the uphill common boundary and supports a fill for a level lawn on the uphill neighbouring property. The wall was measured to be tilting downslope up to ~15° and some of the upper log sleepers had failed. See **Section 12** for advice regarding this retaining wall. A cut on the uphill side of the house is supported by a stable mortared sandstone block retaining wall reaching up to ~1.7m high (Photo 6). To maintain ongoing stability, these walls require occasional maintenance which may involve re-mortaring/restacking. The part three-story brick and timber clad house (Photo 7) is supported on brick walls. No significant signs of movement were observed in the visible supporting walls. A series of low timber log retaining walls terrace the slope below the house (Photo 8) and support fill for garden bedding. Some of the retaining walls were measured to be tilting downslope up to ~10°. Additionally, the timber walkway (Photo 9) tilts up to ~4° (from horizontal) in some locations. See **Section 12** for advice regarding the retaining walls and timber walkway. Detached joint blocks are scattered on the steep slope in this location and were observed to be sufficiently embedded in stable positions (Photo 10). The slope below the walkway is retained by

HAZARDS	Hazard One	Hazard Two
TYPE	The steep slope that falls across the property and continues above failing and impacting on the proposed works.	Further movement of the log retaining walls and timber walkway (Photos 5,8, and 9) that that will eventually result in failure.
LIKELIHOOD	'Unlikely' (10^{-4})	'Possible' (10^{-3})
CONSEQUENCES TO PROPERTY	'Medium' (15%)	'Minor' (10%)
RISK TO PROPERTY	'Low' (2×10^{-5})	'Moderate' (5×10^{-5})
RISK TO LIFE	9.1×10^{-7} /annum	5.3×10^{-6} /annum
COMMENTS	This level of risk is 'ACCEPTABLE', provided the recommendations in Section 7 & 12 are followed.	This level of risk to property is 'UNACCEPTABLE'. To move the risk to 'TOLERABLE' levels, the recommendations in Section 12 are to be followed.

The ~1.5m high timber log retaining wall which approximates the uphill common boundary was measured to be tilting downslope at a maximum angle of ~15° (Photo 5) and some of the sleepers had failed. Similarly, the low timber log retaining walls, as well as the timber walkway (Photos 8 & 9) were tilting downslope. As such, a plan is to be formulated with the uphill neighbouring residents, and the dilapidated portion of the ~1.5m timber retaining wall is to be rebuilt or remediated as part of the proposed works so that it meets current engineering standards. The low timber log retaining walls and walkway are to be monitored by the owners on an annual basis, or after heavy and prolonged rainfall events, whichever occurs first. A photographic record of these inspections is to be kept. Should further movement occur these structures are also to be remediated so they meet current engineering standards. We can carry out these inspections upon request.

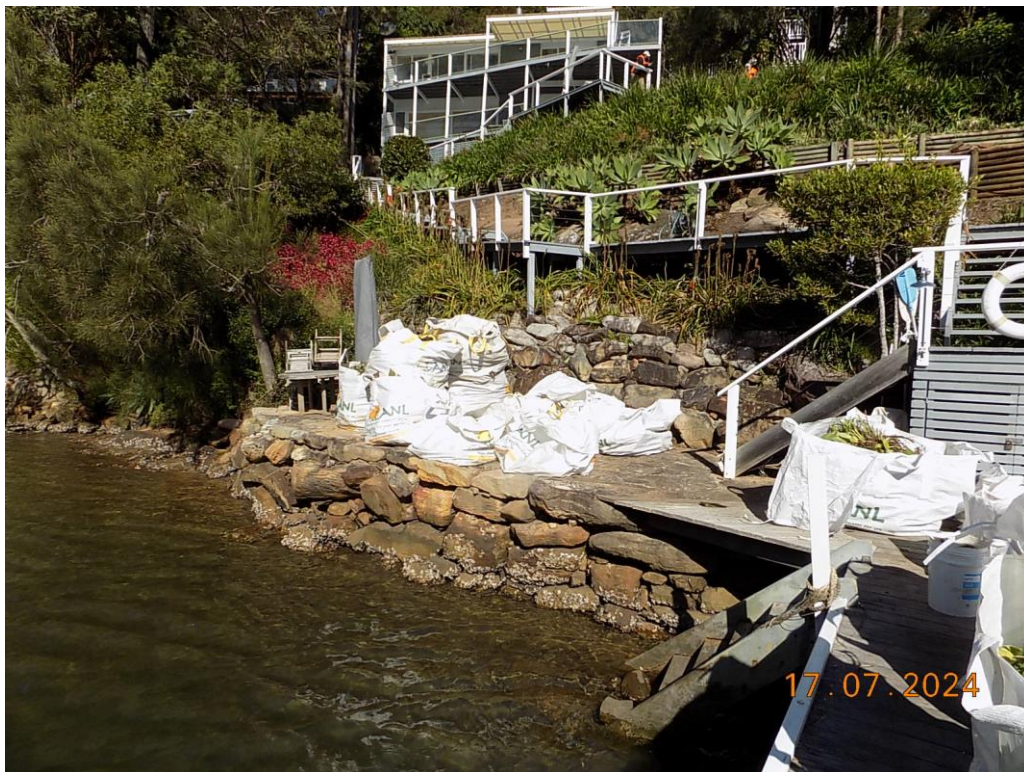
Photo 11

a stable stacked boulder retaining wall (Photo 11). Rounded rocks have been laid at the waterfront to manage erosion (Photo 12).

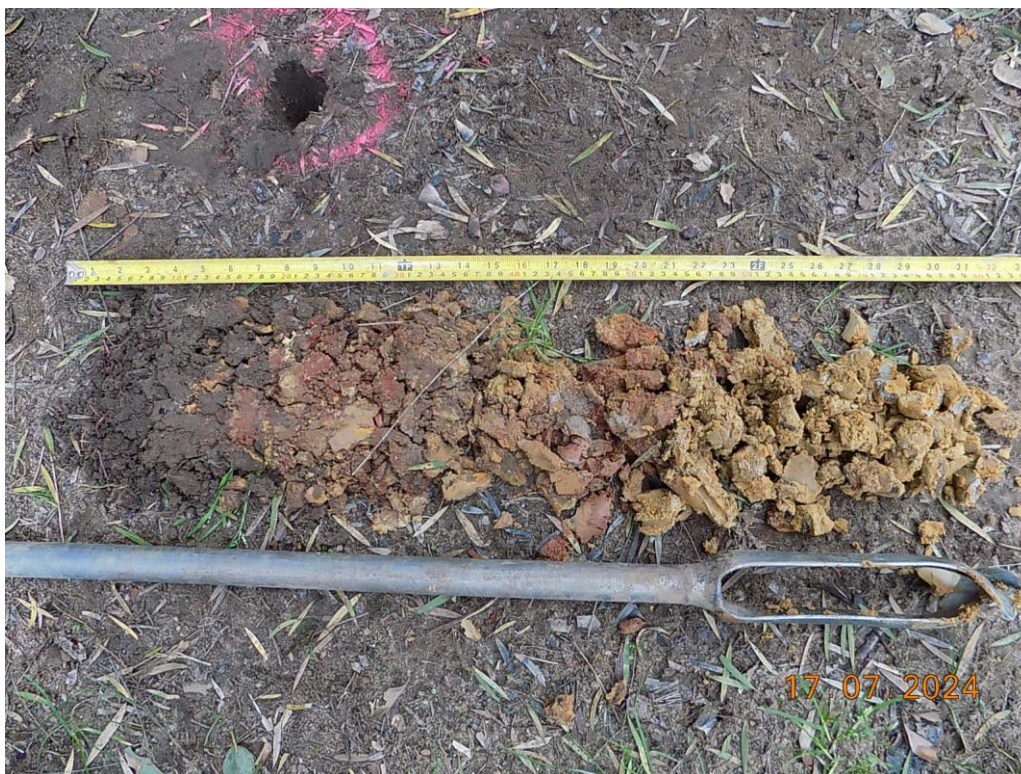
Depth (m)	Material Encountered
0.0 to 0.2	CLAYEY TOPSOIL , brown, stiff, dry, fine to medium grained.
0.2 to 0.5	SANDY CLAY COLLUVIUM , mottled maroon, brown, and yellow, very stiff, damp, fine to medium grained, organic material (roots) present.
0.5 to 0.8	SANDY CLAY COLLUVIUM , mottled yellow and grey, very stiff, damp, fine to medium grained, soil lenses throughout the mottling, organic material (roots) present.

End of test @ 0.8m in Sandy Clay Colluvium. No water table encountered.

Photo 13 – Ah1 – downhole is left to right
