MARGOT BLUES
CONSULTING ARBORIST

Arboricultural Impact Assessment (AIA) V4

Prepared for: Erin Isle Investments Pty Ltd
Site Address: 29 Dobroyd Road Balgowlah Heights
Inspection Date: 1 November 2021
Report Revision Date: 11 May 2023

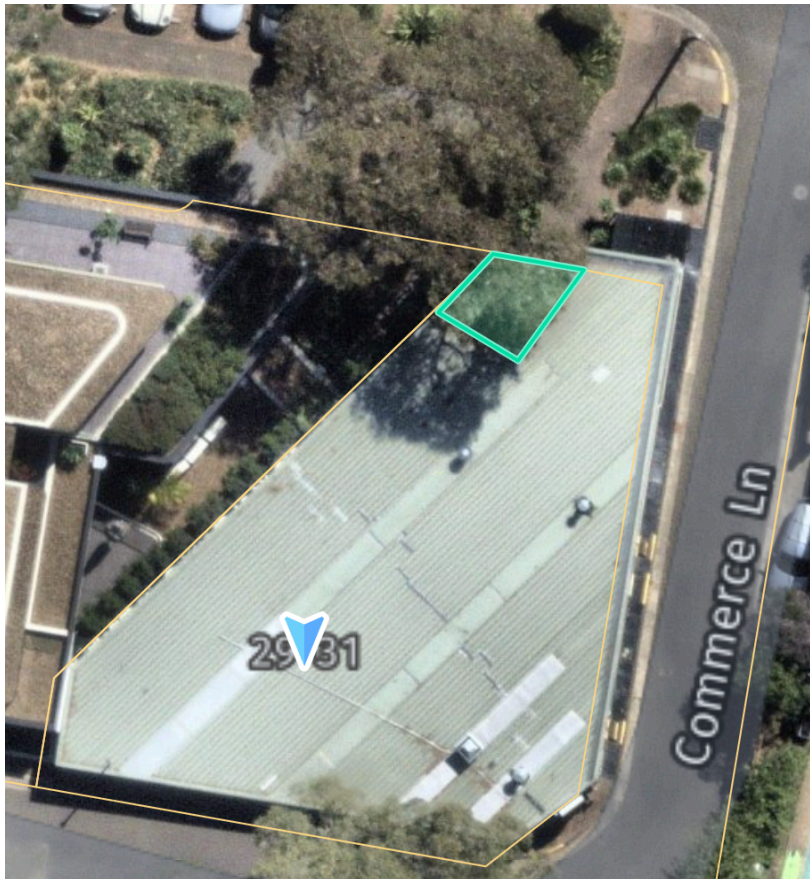
At the time of inspection two branches extend above the front of current building. The lower branch crosses the front boundary and building at an approximate height of 8 metres above ground. The height of the existing building was approximately 5 metres above ground. The branch angles upwards at an approximate 45 degree angle. The second branch is higher above the building.

Figure 2: Required pruning (Green Highlight). Foliage overhanging building. Image courtesy Nearmap. Image captured 19/03/2023.

3.2.2 Minor pruning (less than 10% of total canopy). See Figure 2.

- 4.1.3 The estimated pruning to clear the building is less than 10% of the total canopy and be limited to two branches which overhang the current building. Additional pruning should not be required if scaffolding along the Dobroyd Road frontage is required.

- 4.1.4 It is recommended any pruning is undertaken by a suitably qualified arborist and performed in accordance with the Pruning Standard AS4373-2007 *Pruning of Amenity Trees*.

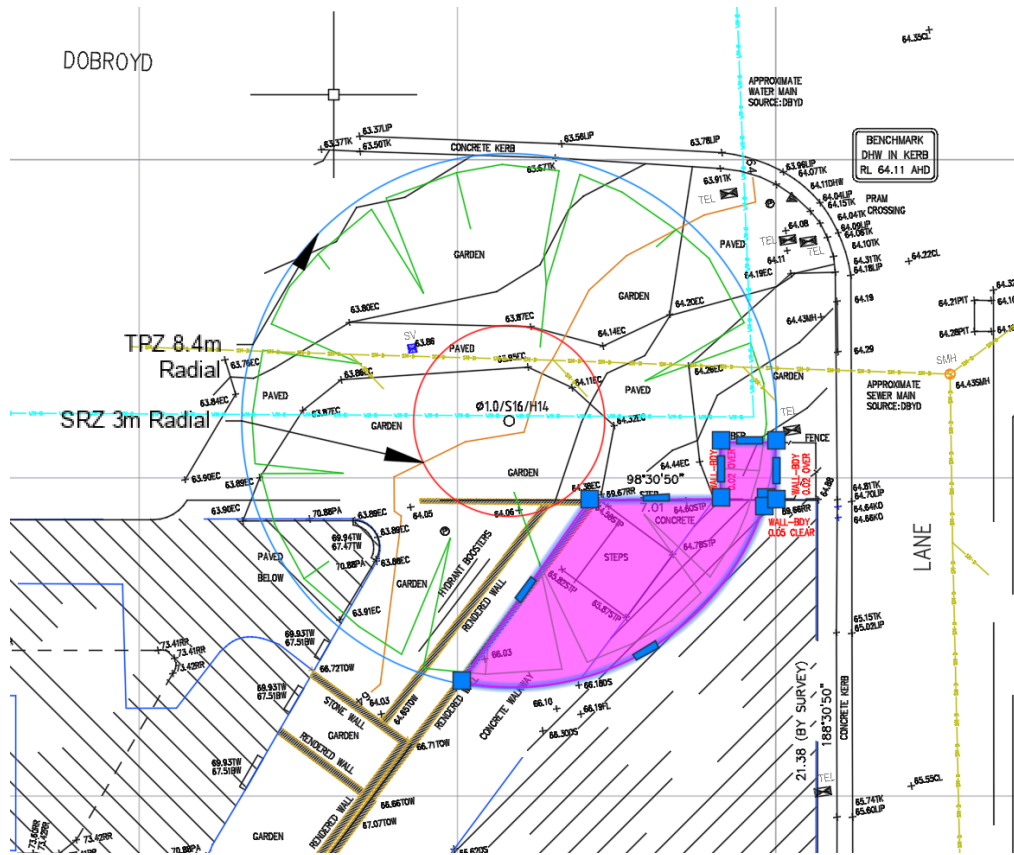
Existing property No 29 Dobroyd Road has an incursion into the TPZ (inclusive of SRZ) of 16% being the current building alignment along the northern boundary. This percentile does not include existing infrastructure on the public verge being footpaths, kerb and guttering, inground services etc – See figure 3.

Figure 3: Existing incursion (magenta hatch) 16% of total TPZ (Blue outer circle). The existing pathways and infrastructure outside the property boundary has not been included in this incursion figure.

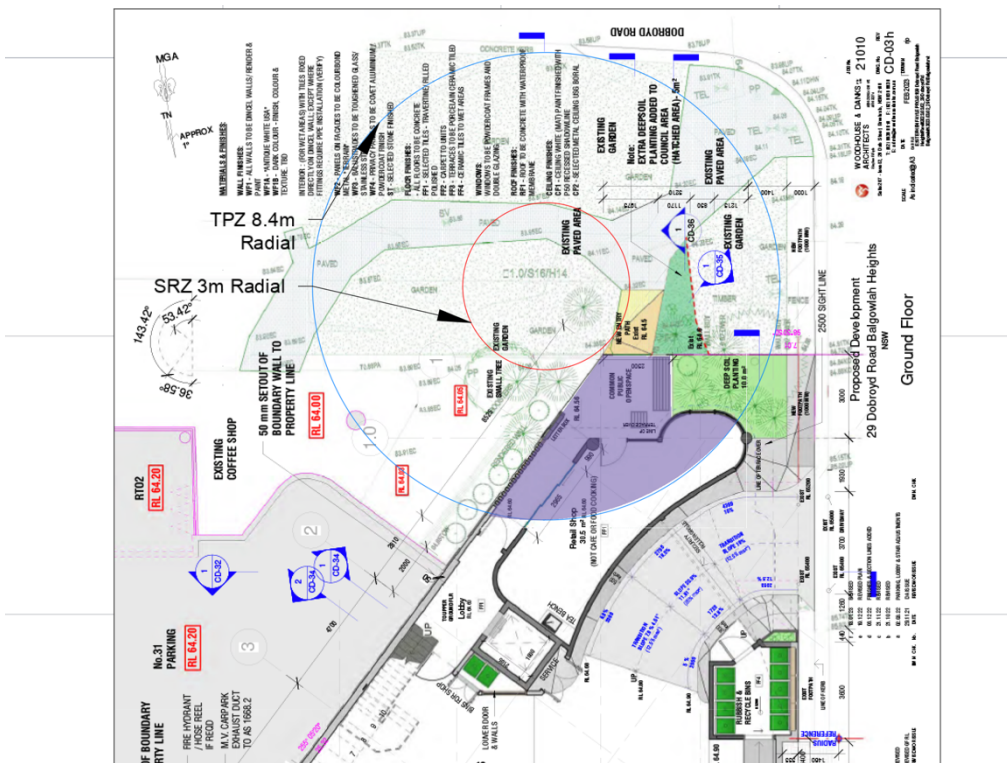
Architectural plans show the building slightly setback from the front boundary. See Figure 4.

Figure 4: New Building set back and contiguous area for planting shown in green. Purple shading represents building incursion 13%.

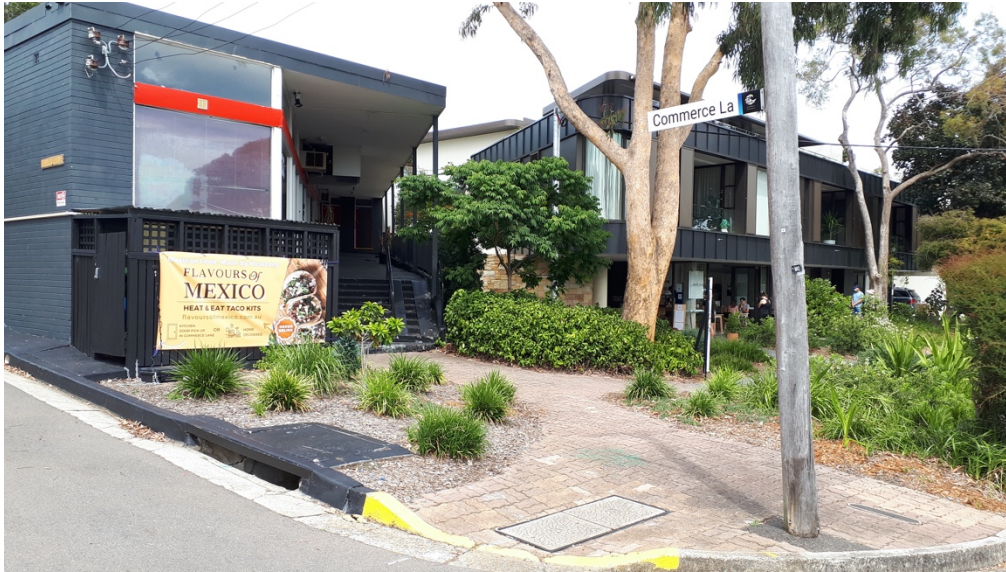
Photo 1: The tree relative to building and infrastructure within the verge.

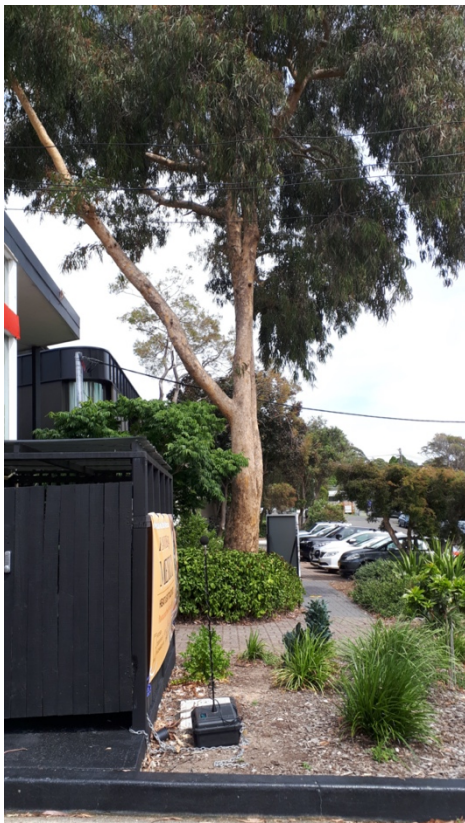
Photo 2: Looking west. Branching towards existing building.

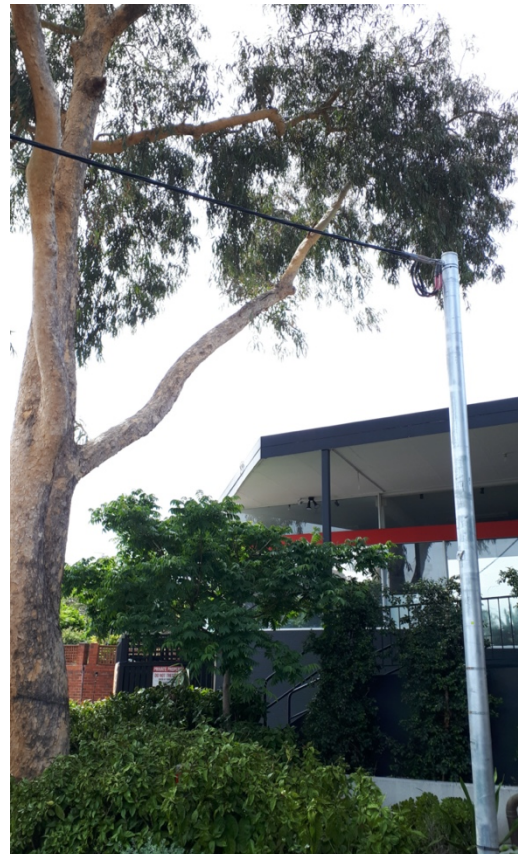
Photo 3: Looking East: Branch positioning above building.

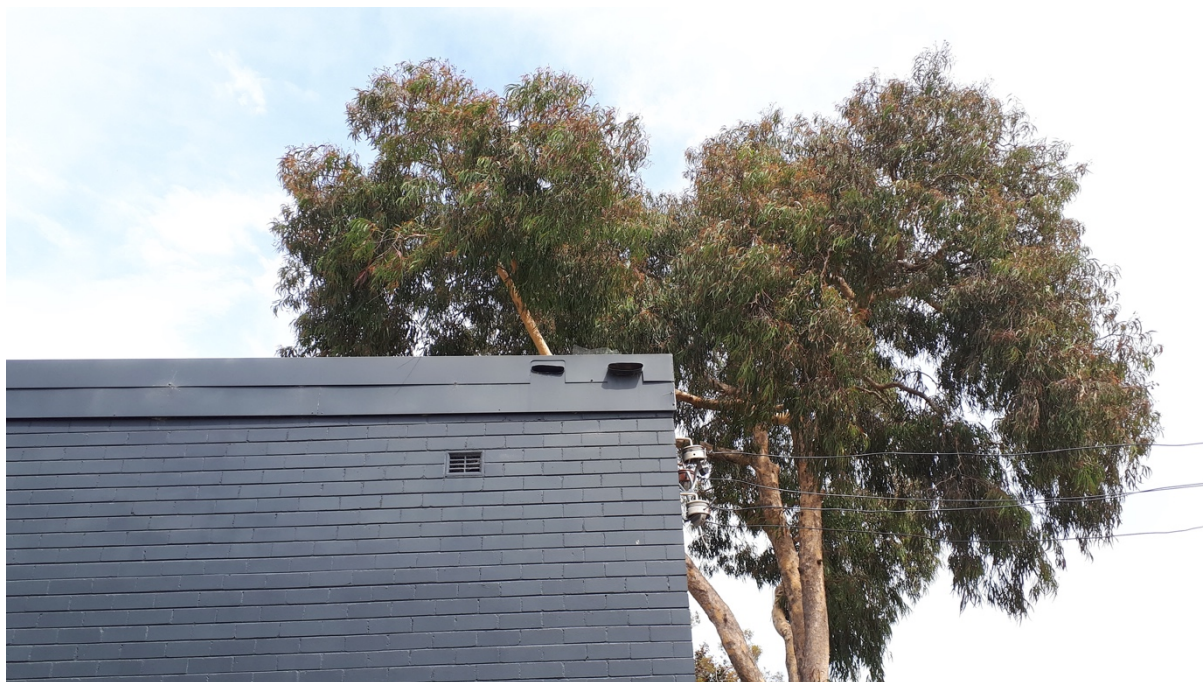
Photo 4: Extent of canopy overhanging building.
