# Arboricultural Impact Assessment

**Prepared for Construct By Design  
Site Address: 27 Bellevue Avenue Avalon**

**3<sup>rd</sup> September 2020**

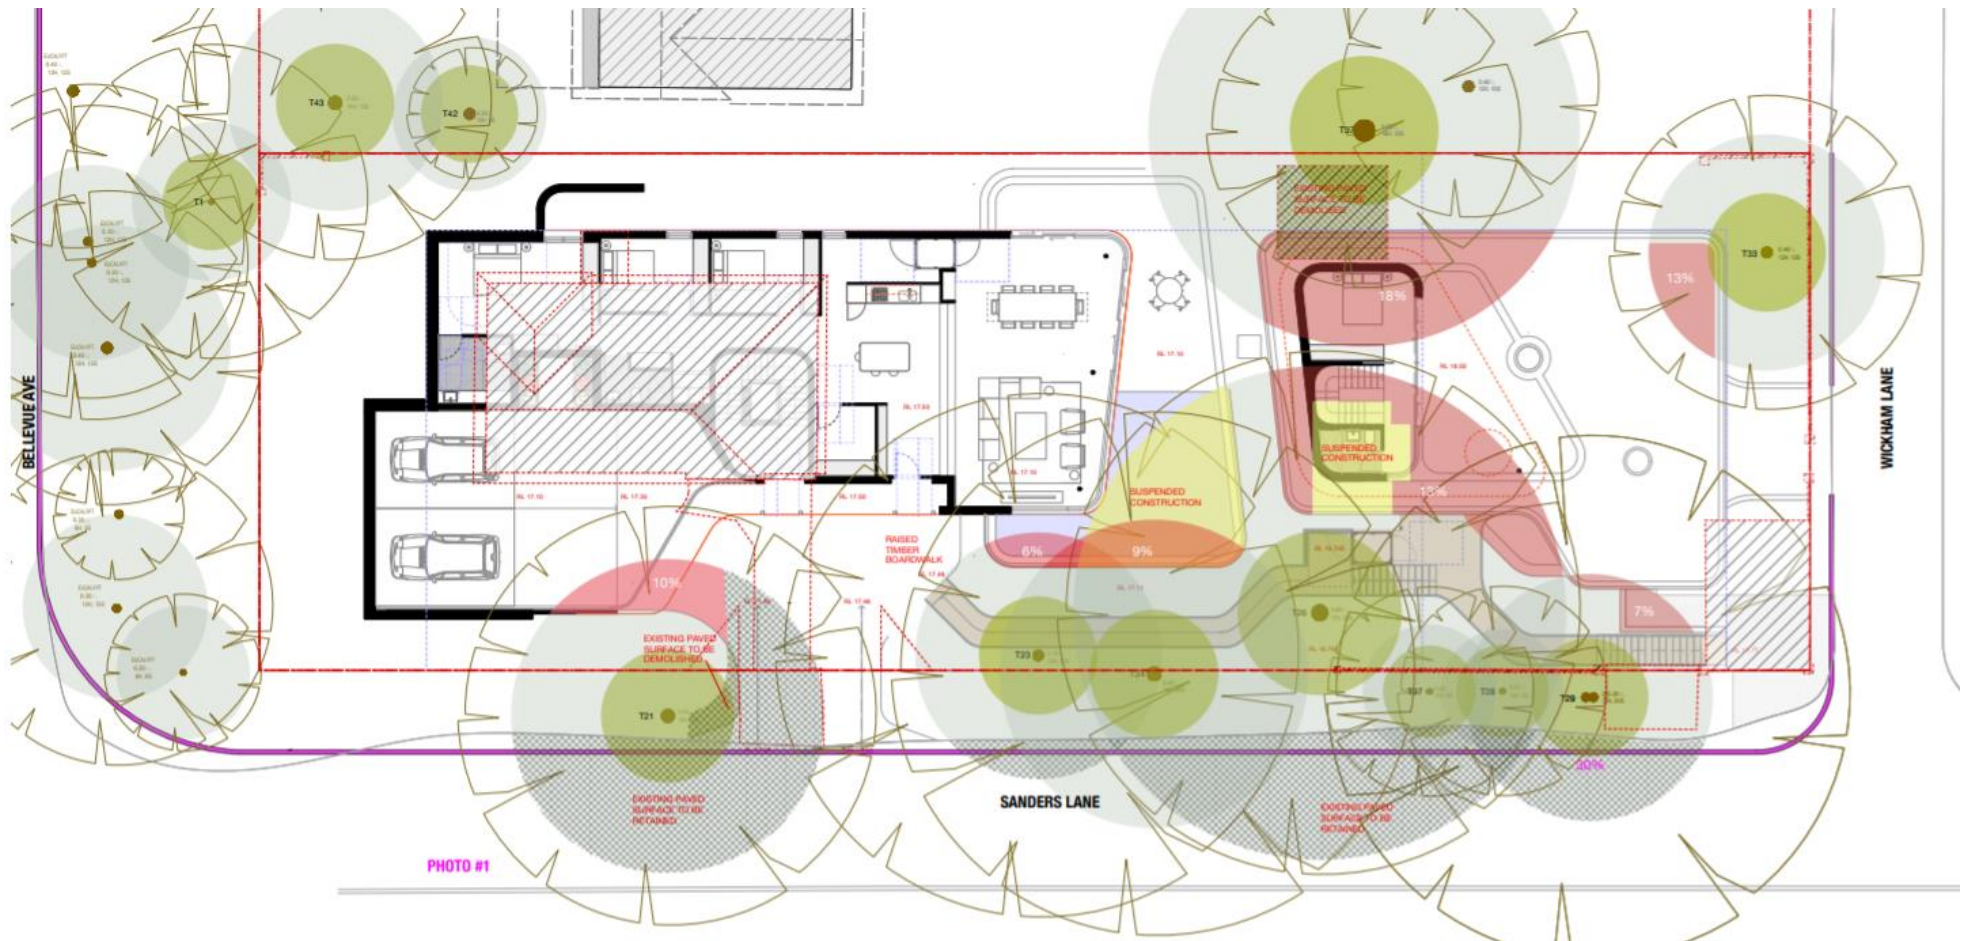
## 6.2 TPZ incursion of retained trees

Of the remaining 37 trees, trees 37, 42 and 43 are in the neighbouring property of 29 Bellevue Avenue Avalon. There is no impact projected for trees 42 and 43. The encroachment to tree 37 is 18%. This is a major encroachment as per Australian Standard 4970-2009, however this species is very tolerant to root disturbance and the development is unlikely to affect the long term health or condition of the tree. If construction works are proposed through the summer months irrigation is recommended to compensate for root loss.

Tree 21 has a projected incursion of <10%, the impact is from the entry driveway and turning area. The entry driveway will have very little impact as this is an existing driveway. It is proposed this driveway is removed and replaced. New driveway levels are very similar to the existing driveway. There should be no excavation deeper than the existing driveway, this will maintain the existing root system of the tree that is likely under the driveway.

Trees 26 and 33 have a 13% incursion to the TPZ this is marginally more than the acceptable 10% as per AS 4970-2009. It is recommended these trees are irrigated through the construction process. Irrigation times are to be scheduled by the project arborist.

7. Retain and protect trees as per tree protection plan section 6.3. This is a combination of physical fencing, trunk protection and ground protection. See Section 7 Appendix G for specifications.

8. Irrigation is recommended for all trees retained. Scheduling of irrigation times to be coordinated by the project arborist. See section 8 regarding irrigation installation specifications.
