1B BOLINGBROKE PARADE

MANLY BOATSHED REDEVELOPMENT PROPOSAL

ARBORICULTURAL IMPACT ASSESSMENT REPORT

Report Ref No- RTC-2120

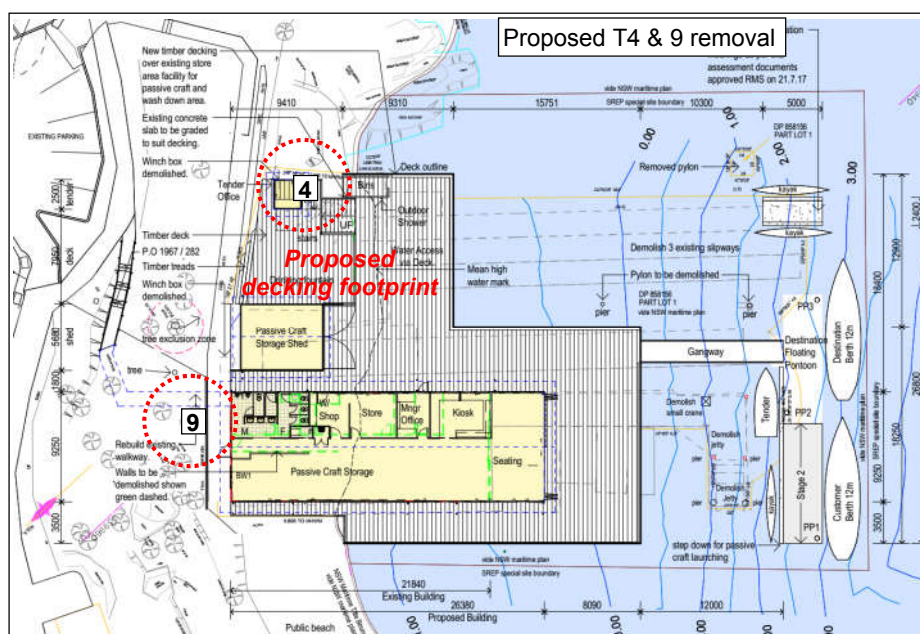
Figure 1, proposed development footprint & tree removal plan

Tree 4 located within the boundary requires removal to accommodate design consisting of new bin loading bay, outdoor shower and associated decking.

Undesirable Coco's palm T9 located within the adjoining reserve has been requested for removal to eliminate nuisance and invasive exotic palm colonization within the reserve area.

- 2.1.1 With the consent of Council under the current proposal the removal of two (2) trees T4 & 9 are required or recommended to accommodate design.

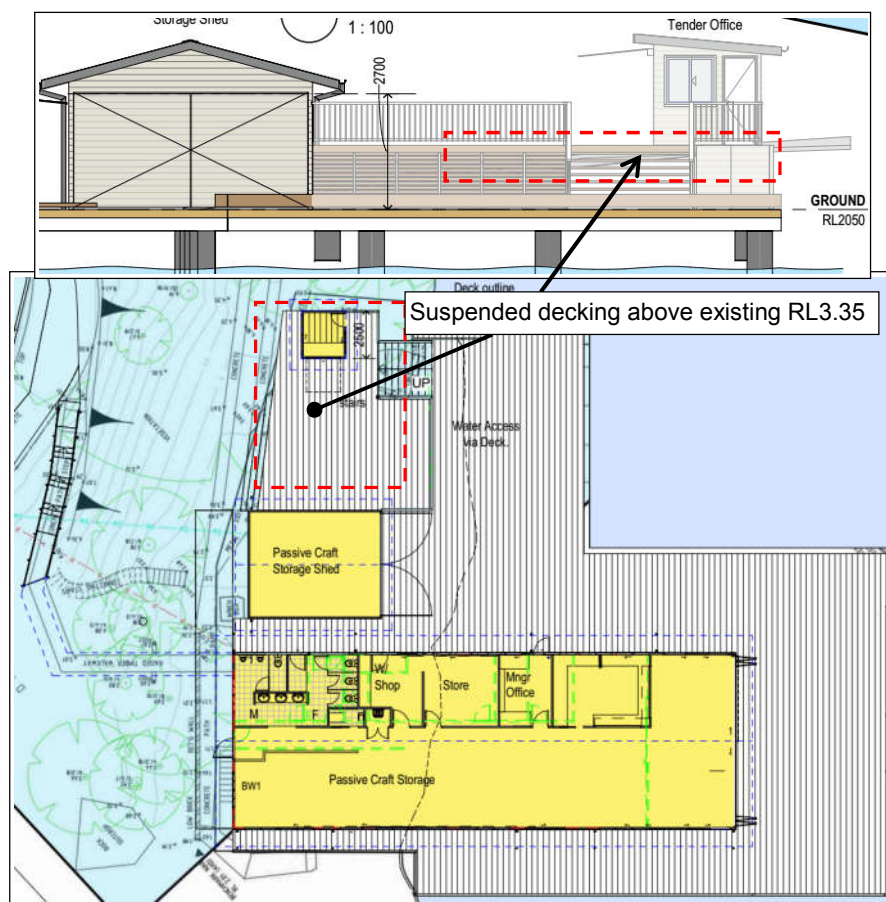
Figure 2, showing proposed suspended structure areas

- 1.2.1 Within the boundary limits new works primarily consist of suspended decking supported by pier and beam construction spanning from an existing driveway. Being suspended above ground the tree protection zone coverage adjacent surrounding trees is likely to be minor having low to negligible root zone impact on trees 3 & 5. As a guide for minimising development impacts during works the following recommendations are provided:
- i. *Trunk & tree protection.* Prior to works commencing the trunk of tree 5 is to be protected with 2m high timber beam trunk protection with tree protection fencing to be installed adjacent tree 3, to mitigate the potential for trunk damages during works and vehicle access.

- ii. *Canopy pruning.* The pruning of low extending limbs above the driveway access may be required, where material delivery vehicle heights are to be provided to determine extent of pruning to achieve appropriate clearances.
- iii. *Excavation activities.* Trees 3 & 5; there is to be no excavation within SRZ setbacks as indicated within Appendix- C, the SRZ & TPZ distance column. Should excavations be required within the SRZ further advice from an appointed project arborist is required prior to works commencing. Where minor cut may be required to accommodate timber tread access to decking works within the TPZ are to be supervised by an appointed site arborist.
- iv. Where additional demolition or excavation is required for modification of works, all works are to be supervised by an appointed project arborist within designated TPZ areas

1. Trees 3 & 5. The trees require trunk or tree protection fencing to be installed prior to works commencing. No excavation is to occur within SRZ setbacks, with minor excavation within tree protection zones ensuring no tree root at or >30mm(Ø) is cut without prior site arborist advice. No continuous trench excavation should occur with the TPZ unless approved, supervised and certified by an appointed site arborist.
