Report Title: Geotechnical Report 54 McCarrs Creek Road, Church Point
Report Date: 19/4/21

GEOTECHNICAL INVESTIGATION:

Alterations and Additions at **54 McCarrs Creek Road, Church Point**

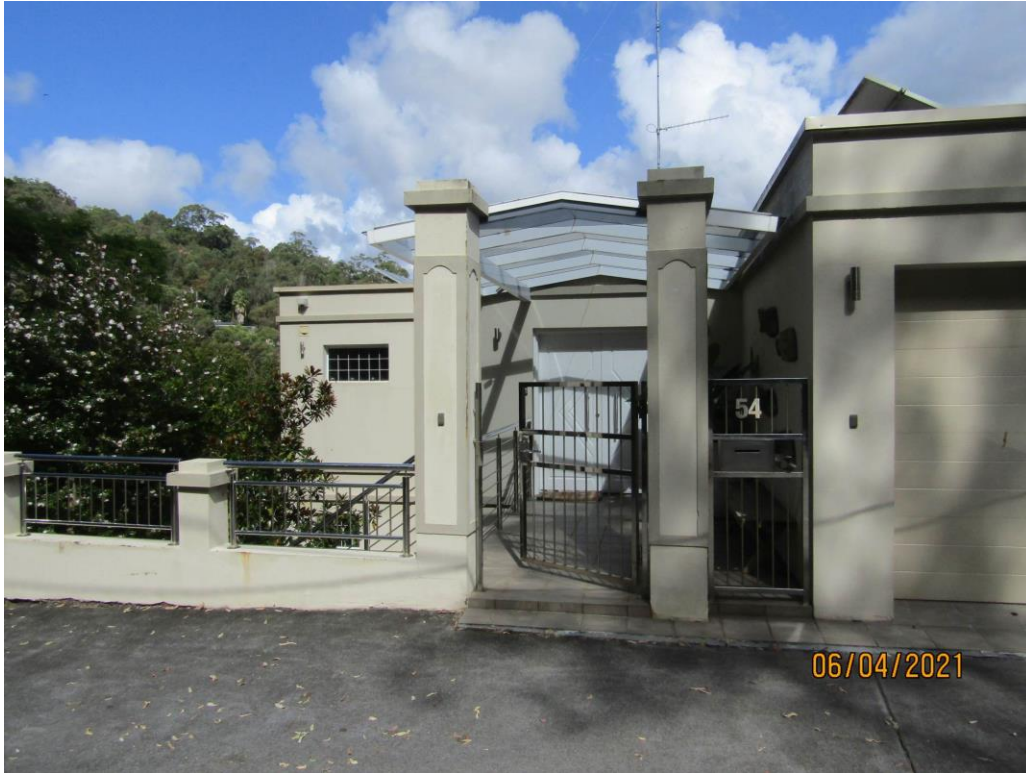
Photo 3

- 2.1** The site was inspected on the 6th of April, 2021.
- 2.2** This waterfront residential property is on the low side of the road and has a SW aspect. It is located on the steeply graded lower reaches of a hillslope. The natural slope falls across the property at an average angle of ~27°. The slope above the property continues at similar steep angles for ~70m before gradually easing.
- 2.3** Sandstone bedrock is outcropping on the uphill side of the road (Photo 1). At the road frontage, a concrete right of carriageway (ROW) runs to a garage attached to level 3 of the house (Photo 2). The three storey rendered masonry house is supported

by rendered masonry walls and a concrete slab (Photos 3 & 4). The external supporting walls show no significant signs of movement. Levels 1 and 2 of the house are cut into the slope. A stable sandstone block retaining wall up to ~2.4m high supports a cut and fill on the downhill side of the ROW (Photo 5). A paved area is located downhill of the wall (Photos 5 & 6).

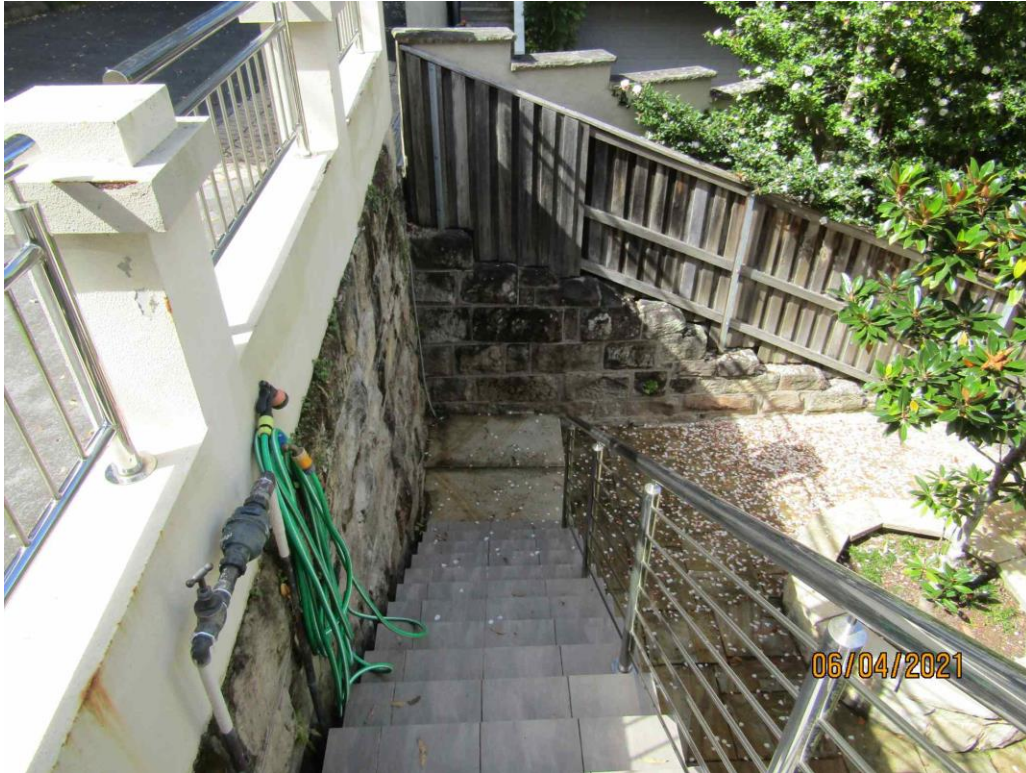
Photo 5

The proposed excavation is a potential hazard until retaining structures are in place (**Hazard Two**). The proposed excavation undercutting the subject house and nearby steps and sandstone block retaining walls (Photos 5 & 6) is a potential hazard (**Hazard Three**). The vibrations produced during the proposed excavation impacting on the subject house is a potential hazard (**Hazard Four**). The additional surcharge loads from the proposed pool structure is a potential hazard to the existing sandstone block retaining wall (Photo 7) (**Hazard Five**).

Rock sawing through the existing slab (~0.3m to ~0.5m thick) will be required to minimise the potential to cause vibration damage to the subject house and sandstone block retaining walls (Photo 5).

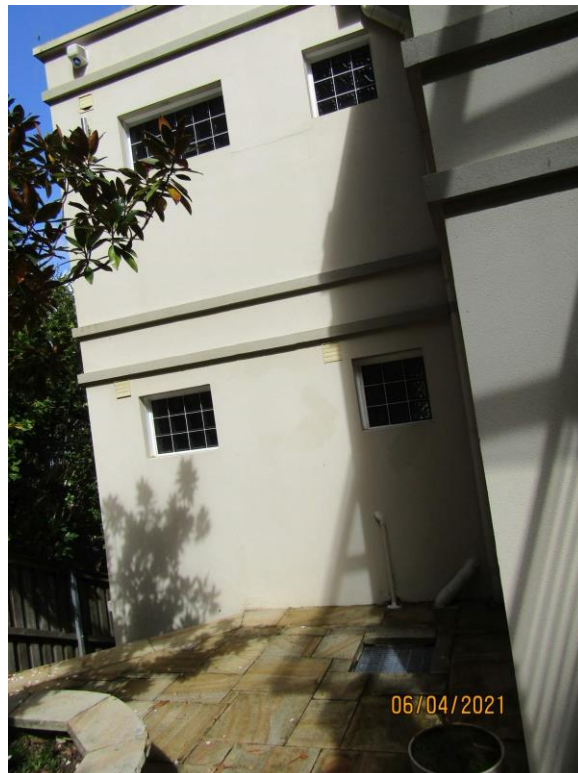
Photo 6

The excavation is expected to be carried out using a small excavator craned on to the pavement below the driveway (Photo 6) and hand tools such as rock saws and jack hammers.

It is envisaged that the top portion of the excavation be carried out using a small excavator craned on to the pavement below the driveway (Photo 6). The existing NE house wall that is flush with the excavation can be demolished and propped as the excavation is lowered to provide access from the side and from where the excavation can be continued from. Hand tools such as rock saws and jack hammers can be used to excavate from the inside of the house.

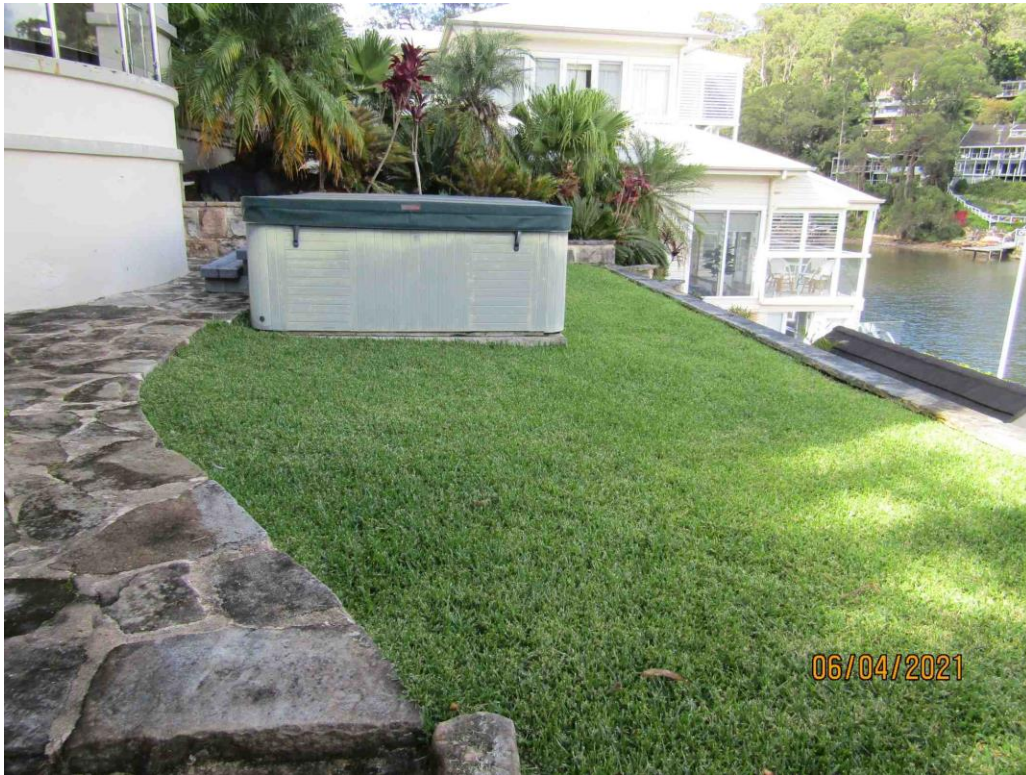
Photo 7

Fill provides level platforms for lawn and garden areas on the downhill side of the house (Photos 7 & 8). The fills are supported by sandstone block and concrete retaining walls up to ~1.9m high (Photos 8, 9 & 10). The sandstone block retaining walls are in good condition. The concrete retaining wall (Photo 10) displays fine cracking but no deflection and is considered to be stable. A rendered masonry outbuilding is located beside the concrete retaining wall. A rendered masonry boathouse, timber ramp and pontoon are located at the waterfront (Photo 11). A stable concrete retaining wall up to ~2.2m high supports a cut and fill on the SE side of the boathouse (Photo 12). No signs of slope instability were observed on the property. The adjoining neighbouring properties were observed to be in good order as seen from the street and subject property.

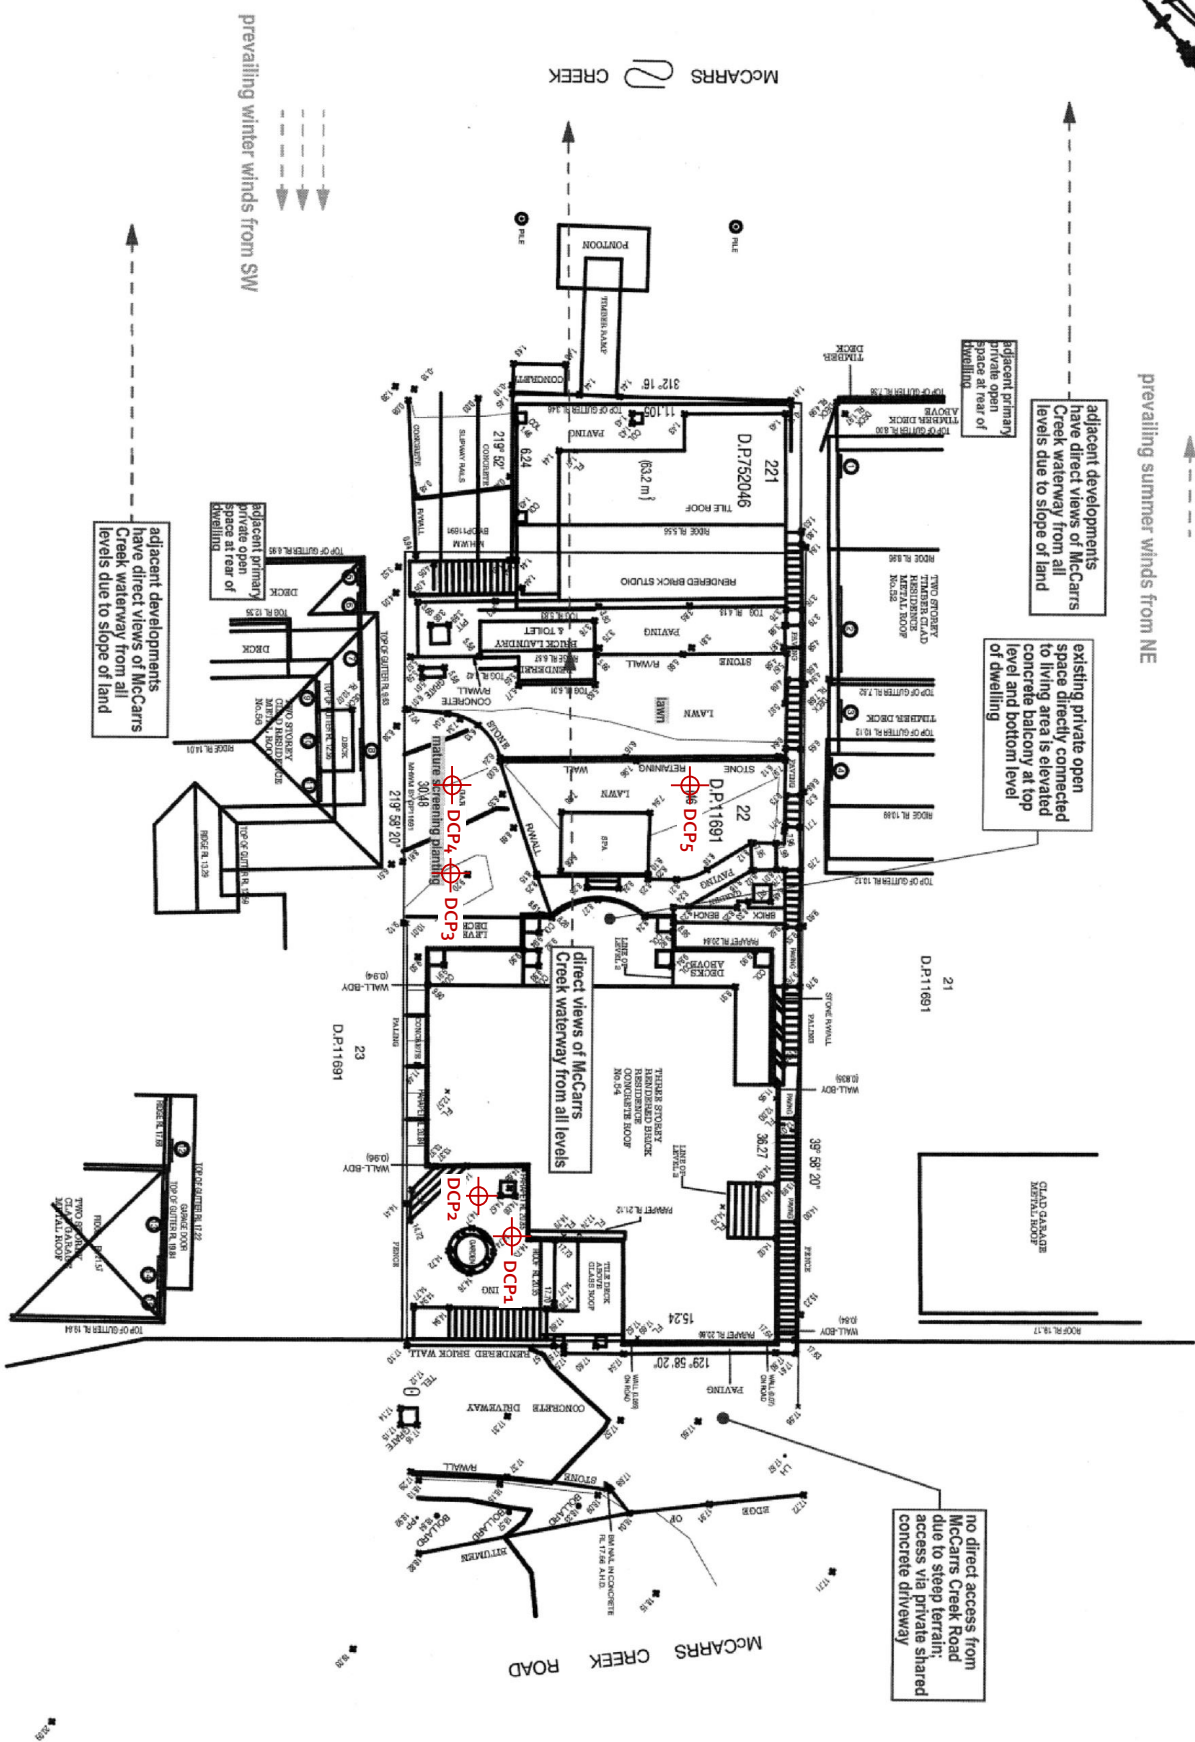
SITE PLAN – showing test locations

Five Dynamic Cone Penetrometer (DCP) tests were put down to determine the relative density of the overlying soil and the depth to weathered rock. The locations of the tests are shown on the site plan. It should be noted that a level of caution should be applied when interpreting DCP test results. The test will not pass through hard buried objects so in some instances it can be difficult to determine whether refusal has occurred on an obstruction in the profile or on the natural rock surface. This is not expected to be an issue for the testing

Due to the depth of the excavation and its proximity to nearby structures, the NE, SE and SW cuts through soil, clay and rock up to Low Strength are to be supported by sprayed concrete retaining walls or a similar suitable support installed in stages as the excavation progresses. The shoring is to be designed/approved by the structural engineer so that not more than a depth of 1.2m of excavation face is left unsupported before shoring is installed. See the site plan attached for the minimum required extent of the shoring shown in blue.

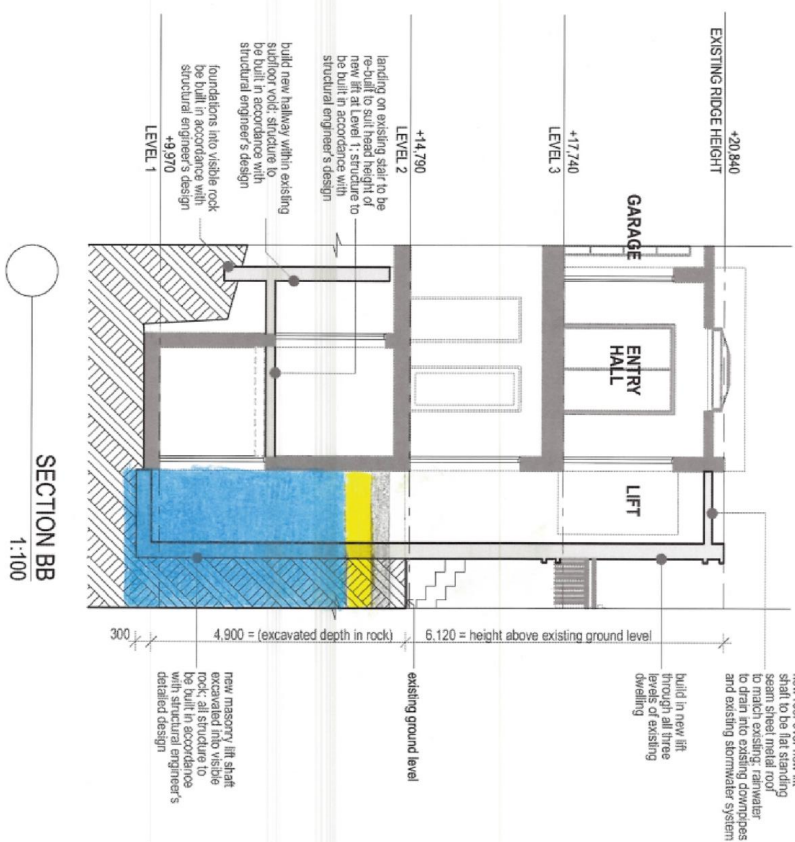
TYPE SECTION – Diagrammatical Interpretation of expected Ground Materials

The slope materials are colluvial at the near surface and residual at depth. In the test locations, the ground materials consist of fill and a sandy topsoil over sandy clays. Fill to a maximum depth of ~1.9m provides level platforms for lawn and garden areas on the downhill side of the house. The clays merge into the weathered zone of the under lying rock at a depths from between ~1.1m to ~2.7m below the current surface, being deeper in the filled areas. The underlying rock is interpreted as Extremely Low to Medium Strength Rock. Most of the site is expected to be underlain by Extremely Low Strength Rock. DCP1 hit refusal and bounced off the rock which indicates Medium Strength Rock may be present. Sandstone bedrock was observed on the uphill side of the road and at the base of existing cut for the house. These are expected to be sandstone bands in an otherwise shale dominated profile. We note Medium Strength Rock in the shale dominated profile is often discontinuous. See Type Section attached for a diagrammatical representation of the expected ground materials.
