Geotechnical Assessment

Project: Landscaping
3 Thompson Street, Scotland Island

Ref: AG 22223
31 May 2022

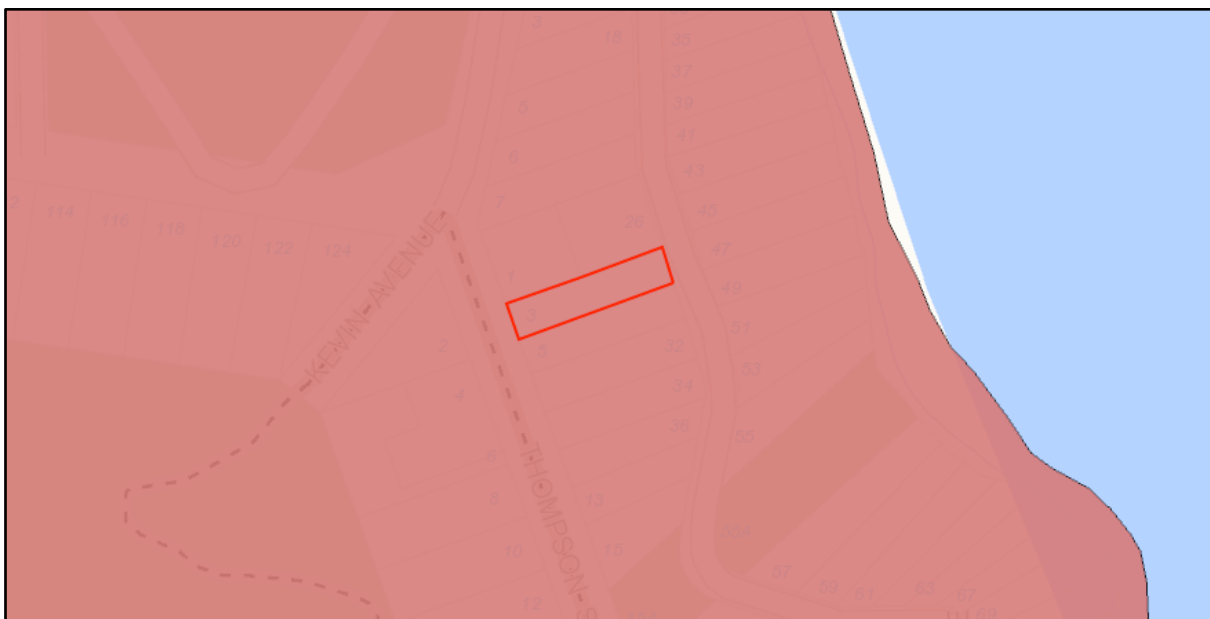
- No evidence of significant soil creep, tension cracks or landslip instability were identified across the site or on adjacent properties as viewed from the subject site at the time of our inspection.
- Based on reference to the plan entitled "Geotechnical Hazard Mapping" (Ref. P21DCP-BC-MDCP2002, dated 2007) prepared by GHD LONGMAC on behalf of Pittwater Council, the site is mapped as a **Geotechnical Hazard H1** zone.

Image 2. PLEP Geotechnical Hazard Map
– 3 Thompson Street, Scotland Island NSW (NBC Maps)

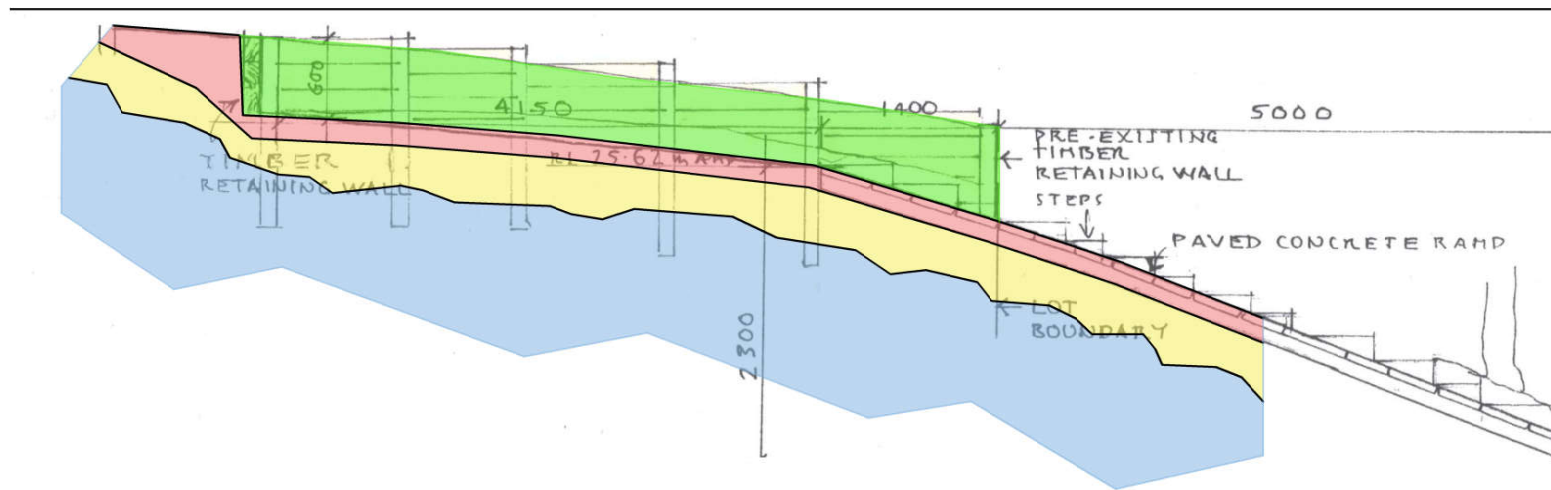
INFERRED GEOLOGICAL SECTION
SCALE NTS

The soil profile consists of shallow uncontrolled silty fill and silty topsoil (O & A Horizons), silty clay (B Horizon) and weathered low strength bedrock (C Horizon). Detached sandstone floaters are also expected on and within the shallow soil profile on site. Based on our observations and the results of testing on adjacent sites, we would expect weathered low strength bedrock to be found within 0.50 to 1.50 metres below current surface levels across the area of the proposed works, and deeper where filling has been carried out.

INTERPRETED SUBSURFACE SECTION ONLY.
ACTUAL GROUND CONDITIONS MAY VARY.
