Geotechnical Assessment

Project: Proposed Driveway
9 Taminga Street, Bayview NSW

Ref: AG 25006
16 January 2025

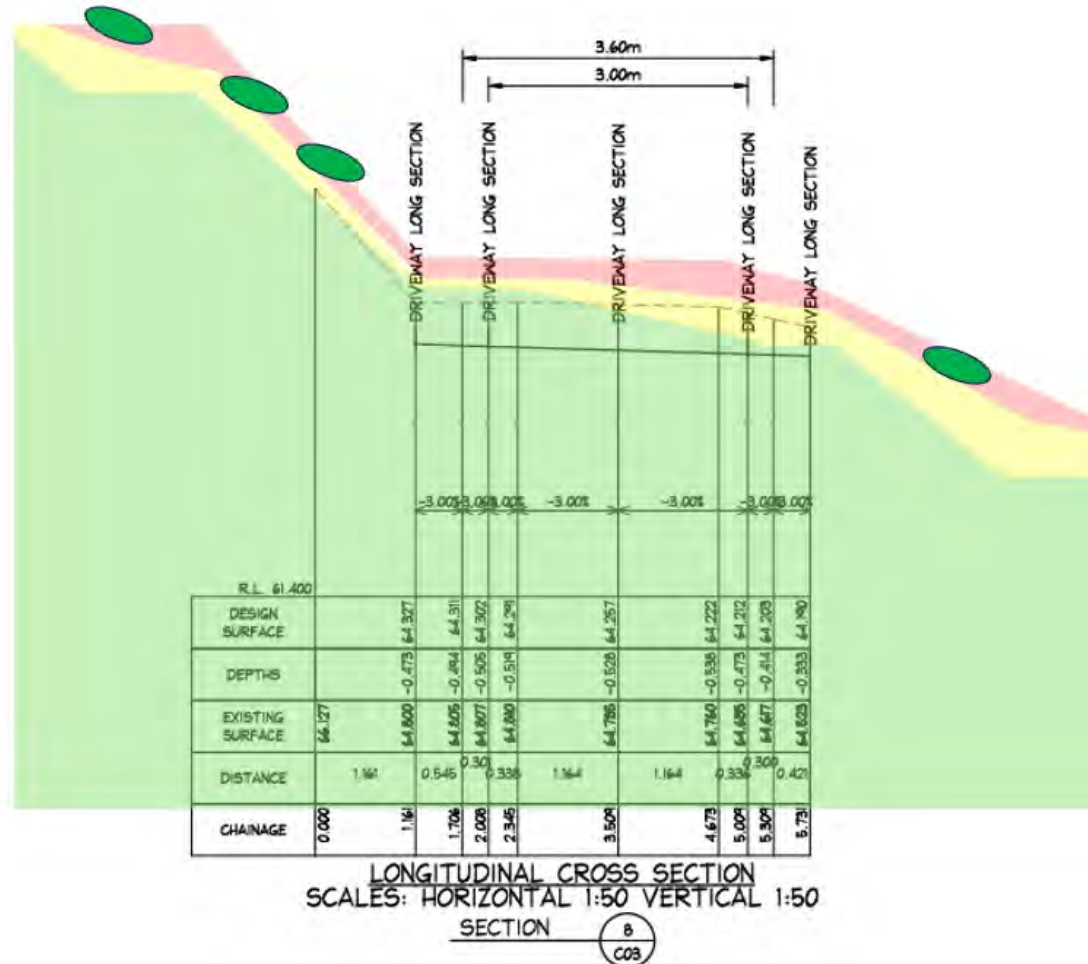
INFERRED GEOLOGICAL SECTION
SCALE NTS

INTERPRETED SUBSURFACE SECTION ONLY.
ACTUAL GROUND CONDITIONS MAY VARY.

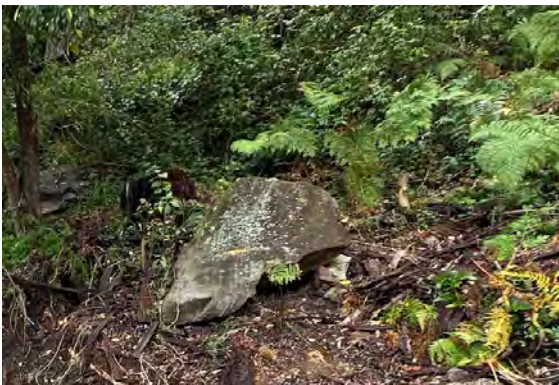
Photo 5: Sandstone boulder embedded in soil profile.

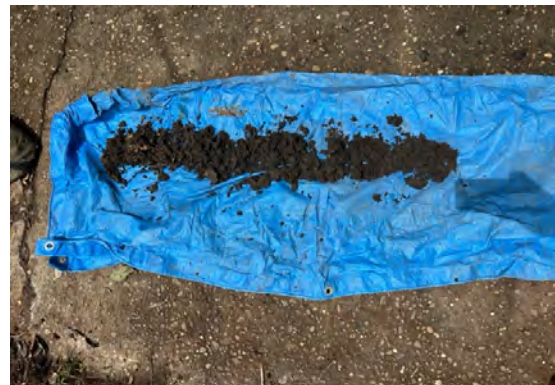
Photo 6: Subsurface soil profile of BH03.

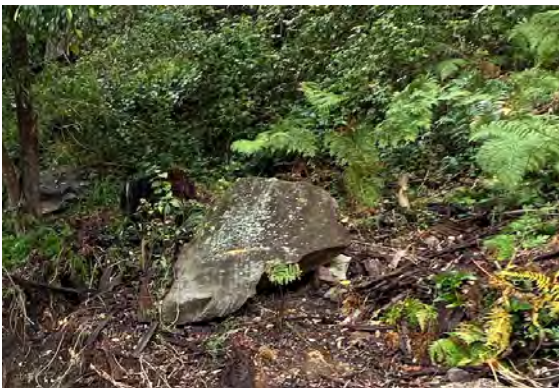
Photo 5: Sandstone boulder embedded in soil profile.

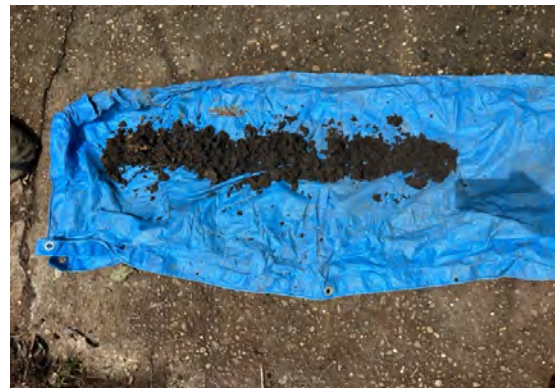
Photo 6: Subsurface soil profile of BH03.
