Arborist Report

Project **812 Pittwater Road and 4 Delmar Parade**
Dee Why NSW 2099
Ref: 2021-1061
Job: 65488

Client **Dee Why 3 Pty Ltd & Dee Why 4 Pty Ltd**
c/o Willow Frank
Suite 110 , Level 1
13A Montgomery St
Kogarah NSW 2217

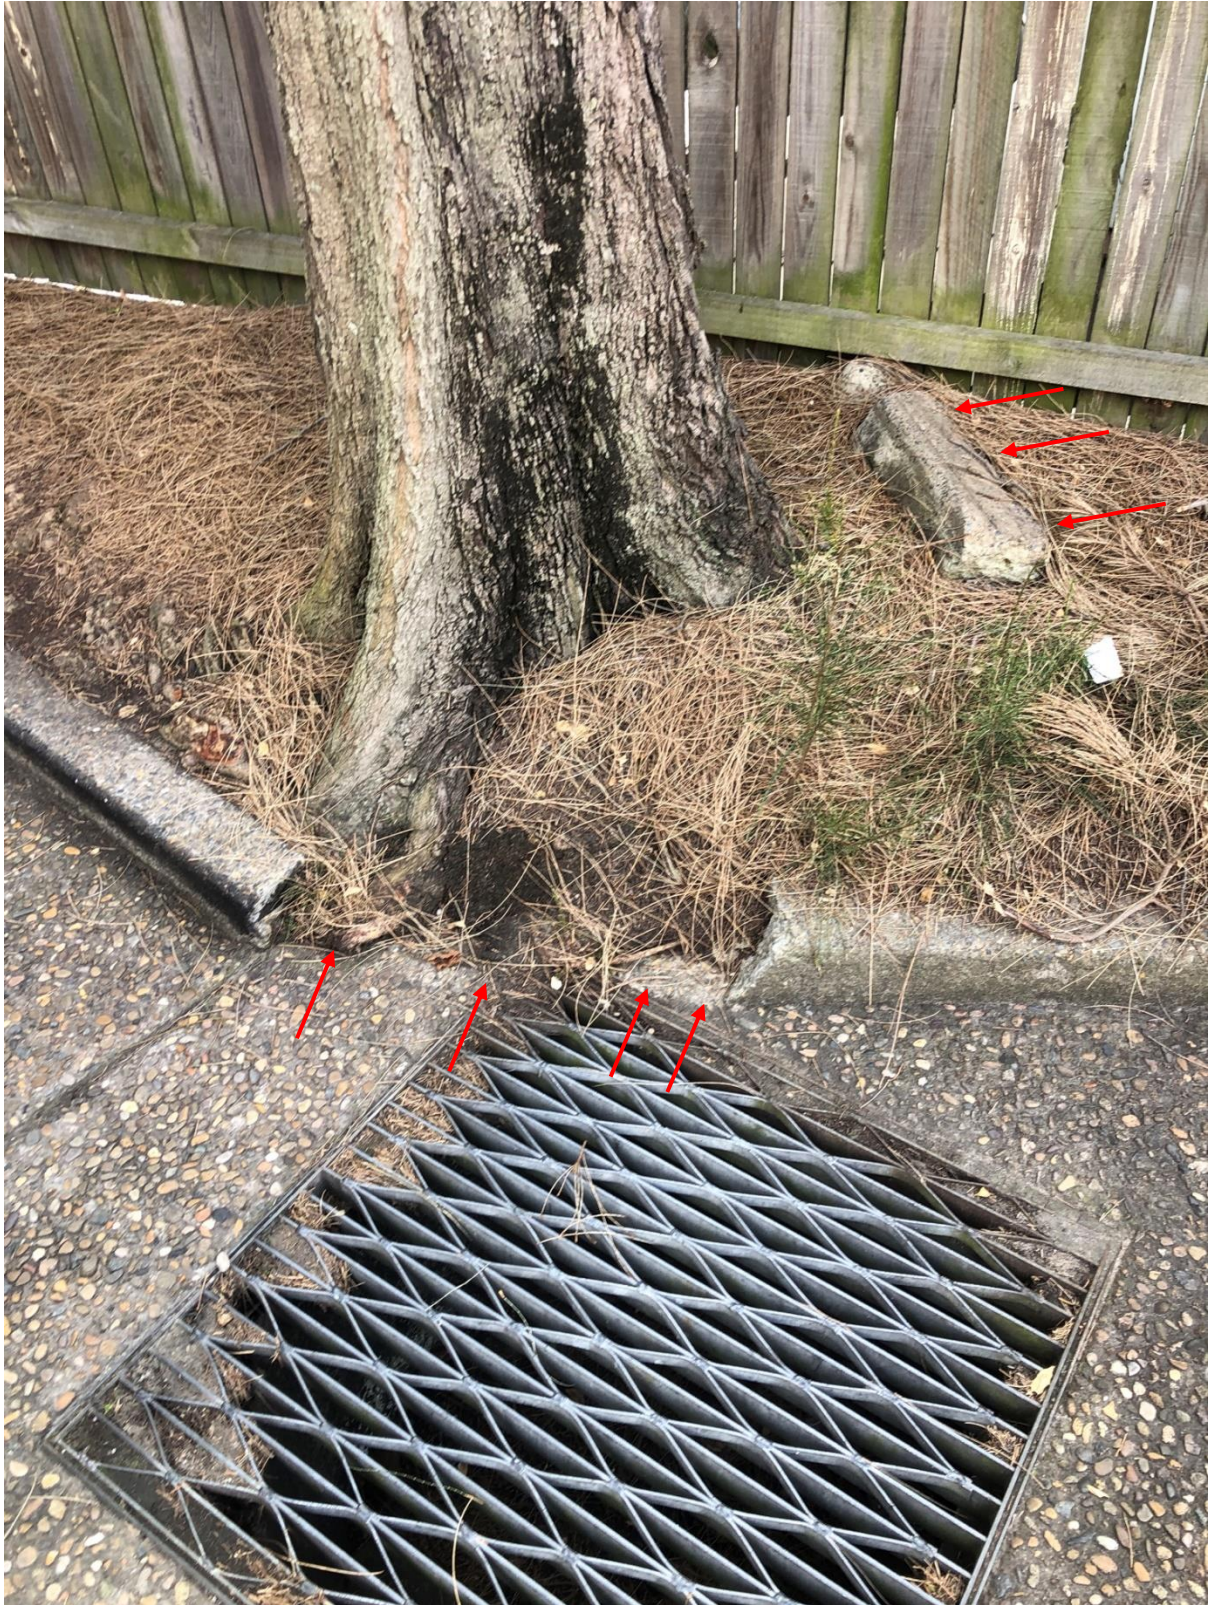
PHOTO 1

- 4.33 Tree 55 - Casuarina - has a trunk diameter of 60 cm, a height of 12 metres and a canopy spread of 8 metres. The tree is mature in age with a health rating of 5 out of 5. and a structural rating of 5 out of 5. It is a dominant tree with 60% canopy cover. Surface roots have damaged the kerb and guttering. (See photograph 1).

Tree 55 - Casuarina - has impacted concrete kerb

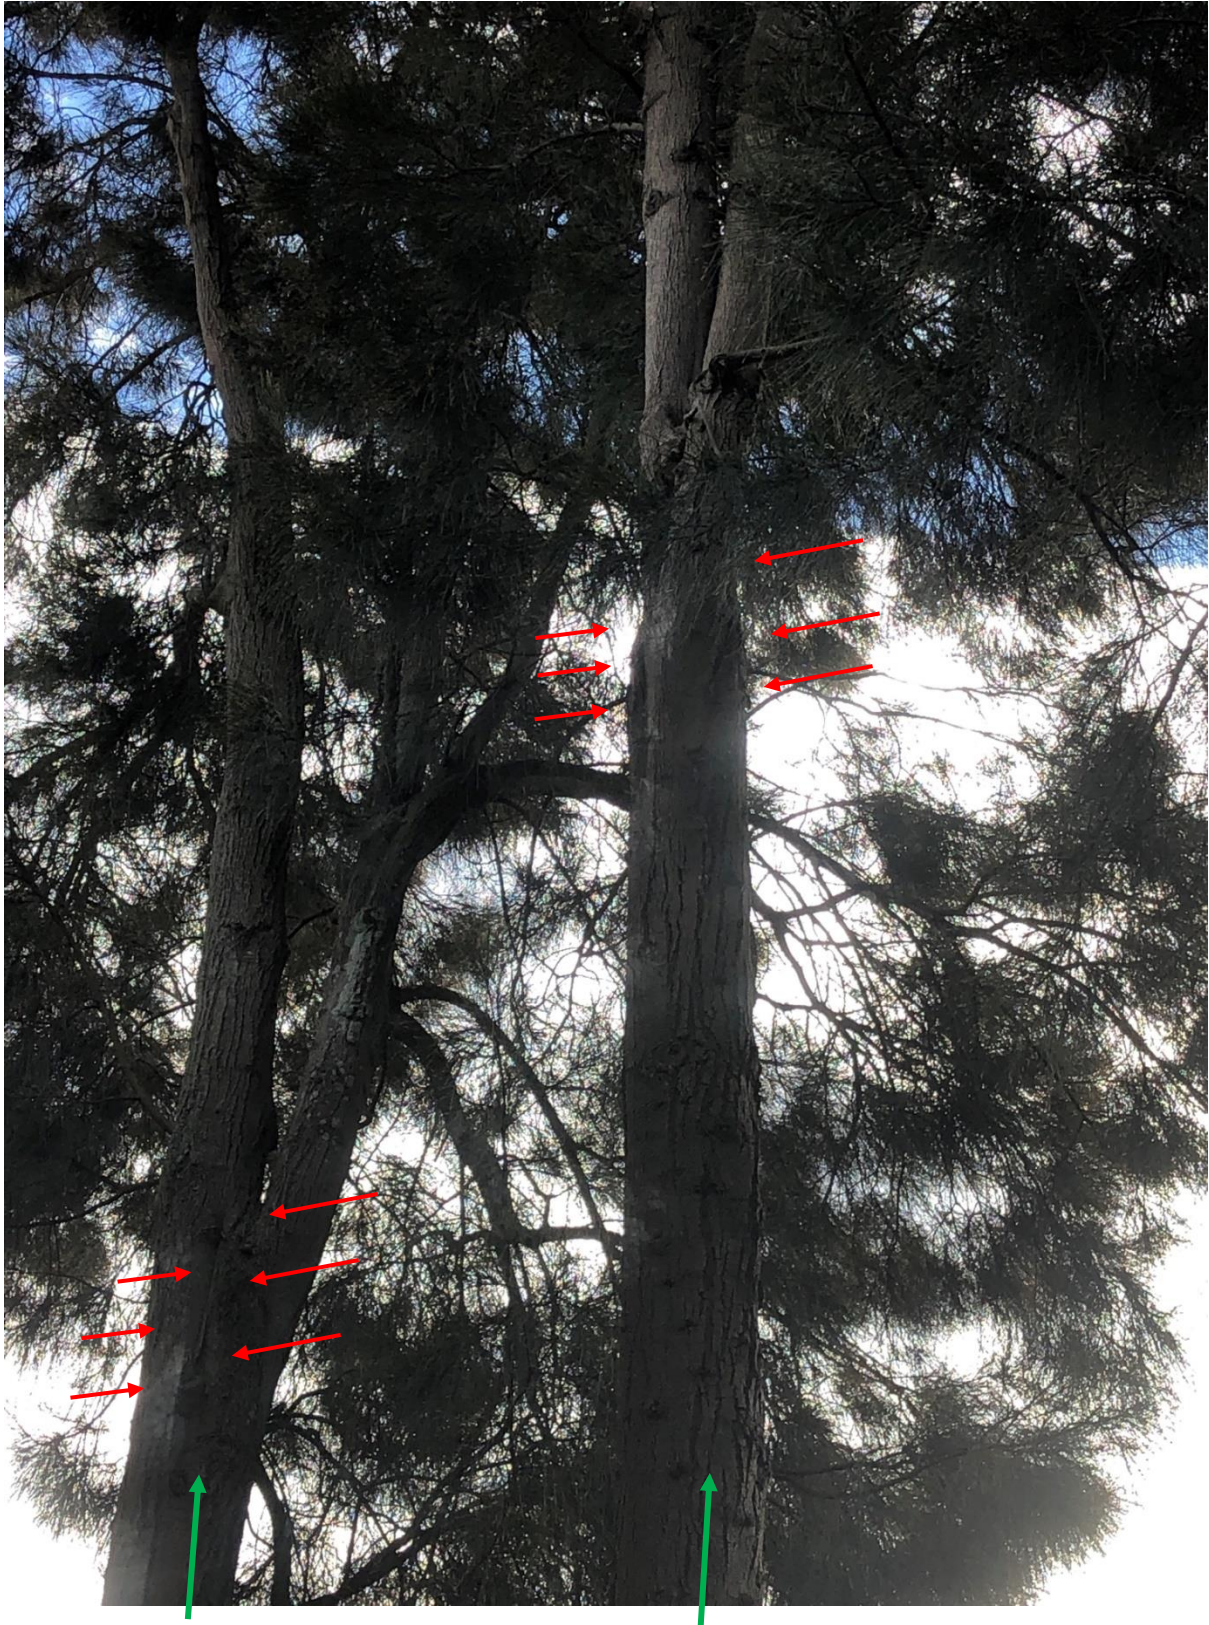
PHOTO 2

Trees 58 -has trunk inclusions at 6.5 metre mark and Tree 57 has trunk inclusions at 6 metre

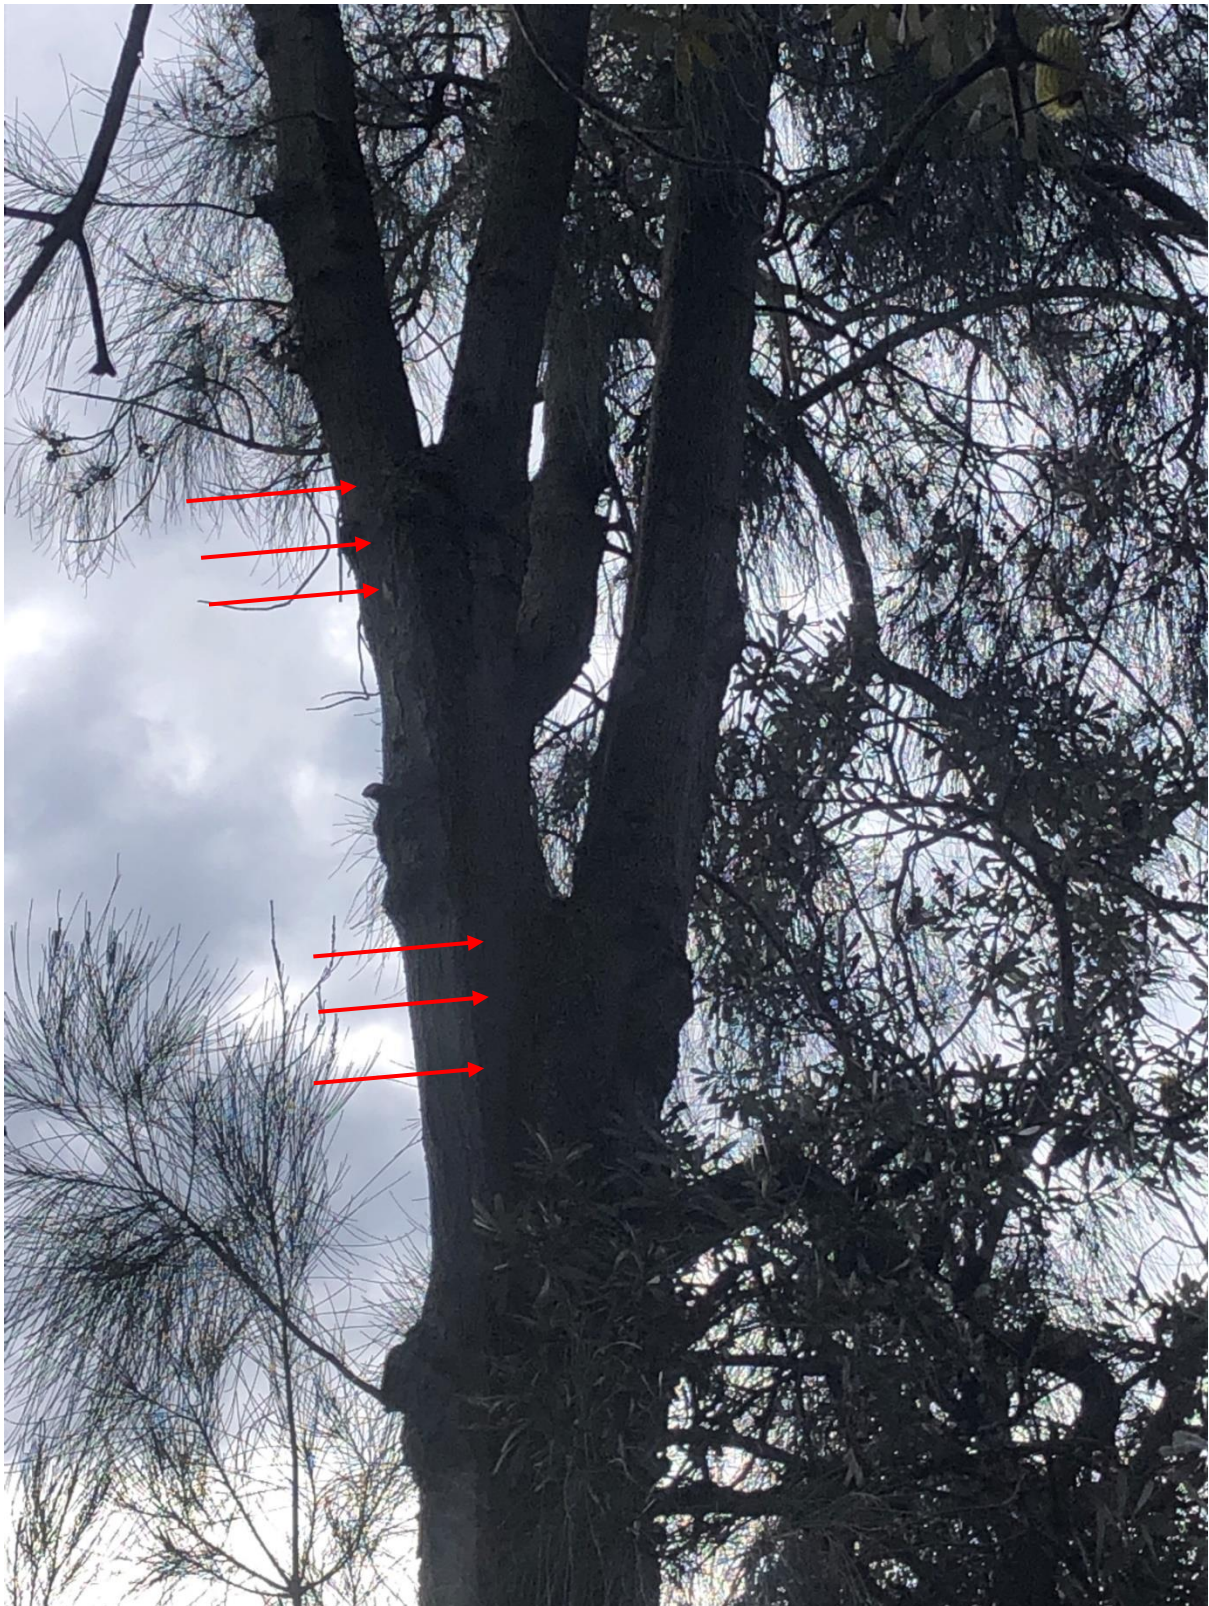
PHOTO 3

Tree 59 - Casuarina - has major branch inclusions

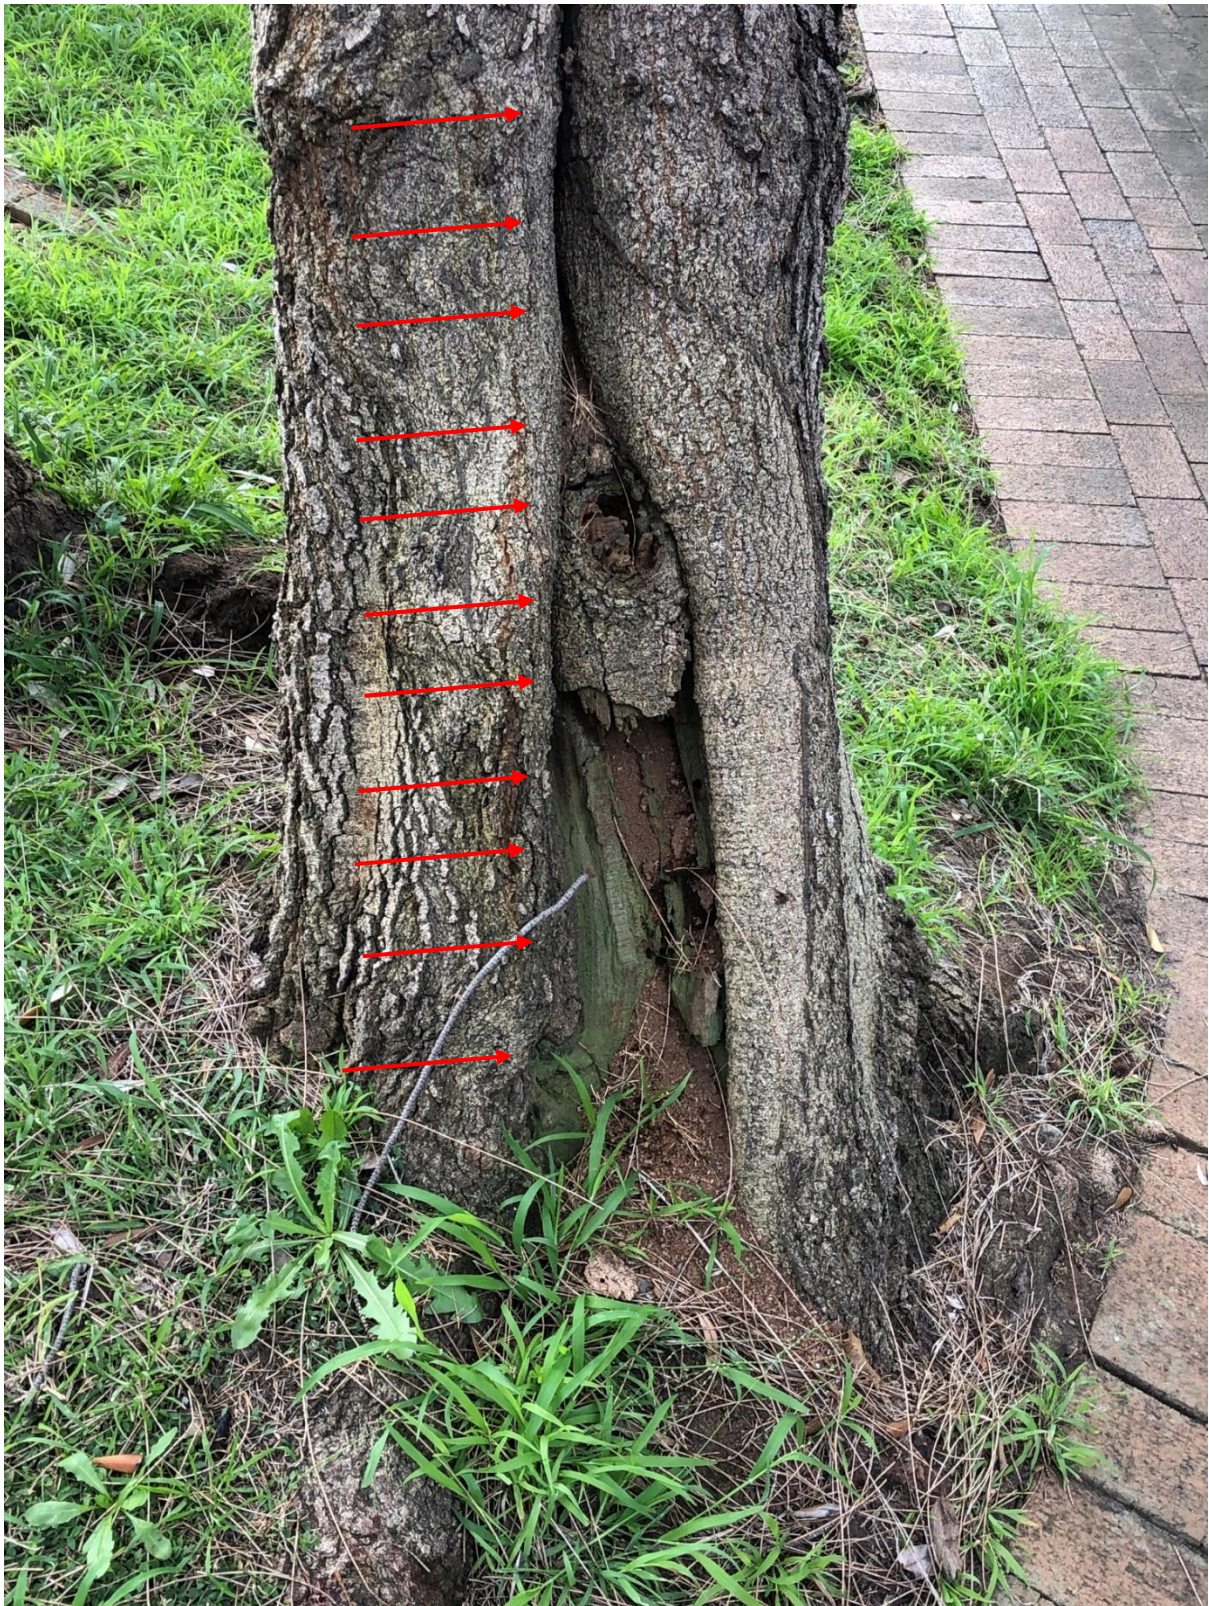
PHOTO 6

Tree 64 – has major cavity extending up the trunk from the base of the tree. Major structural issue.

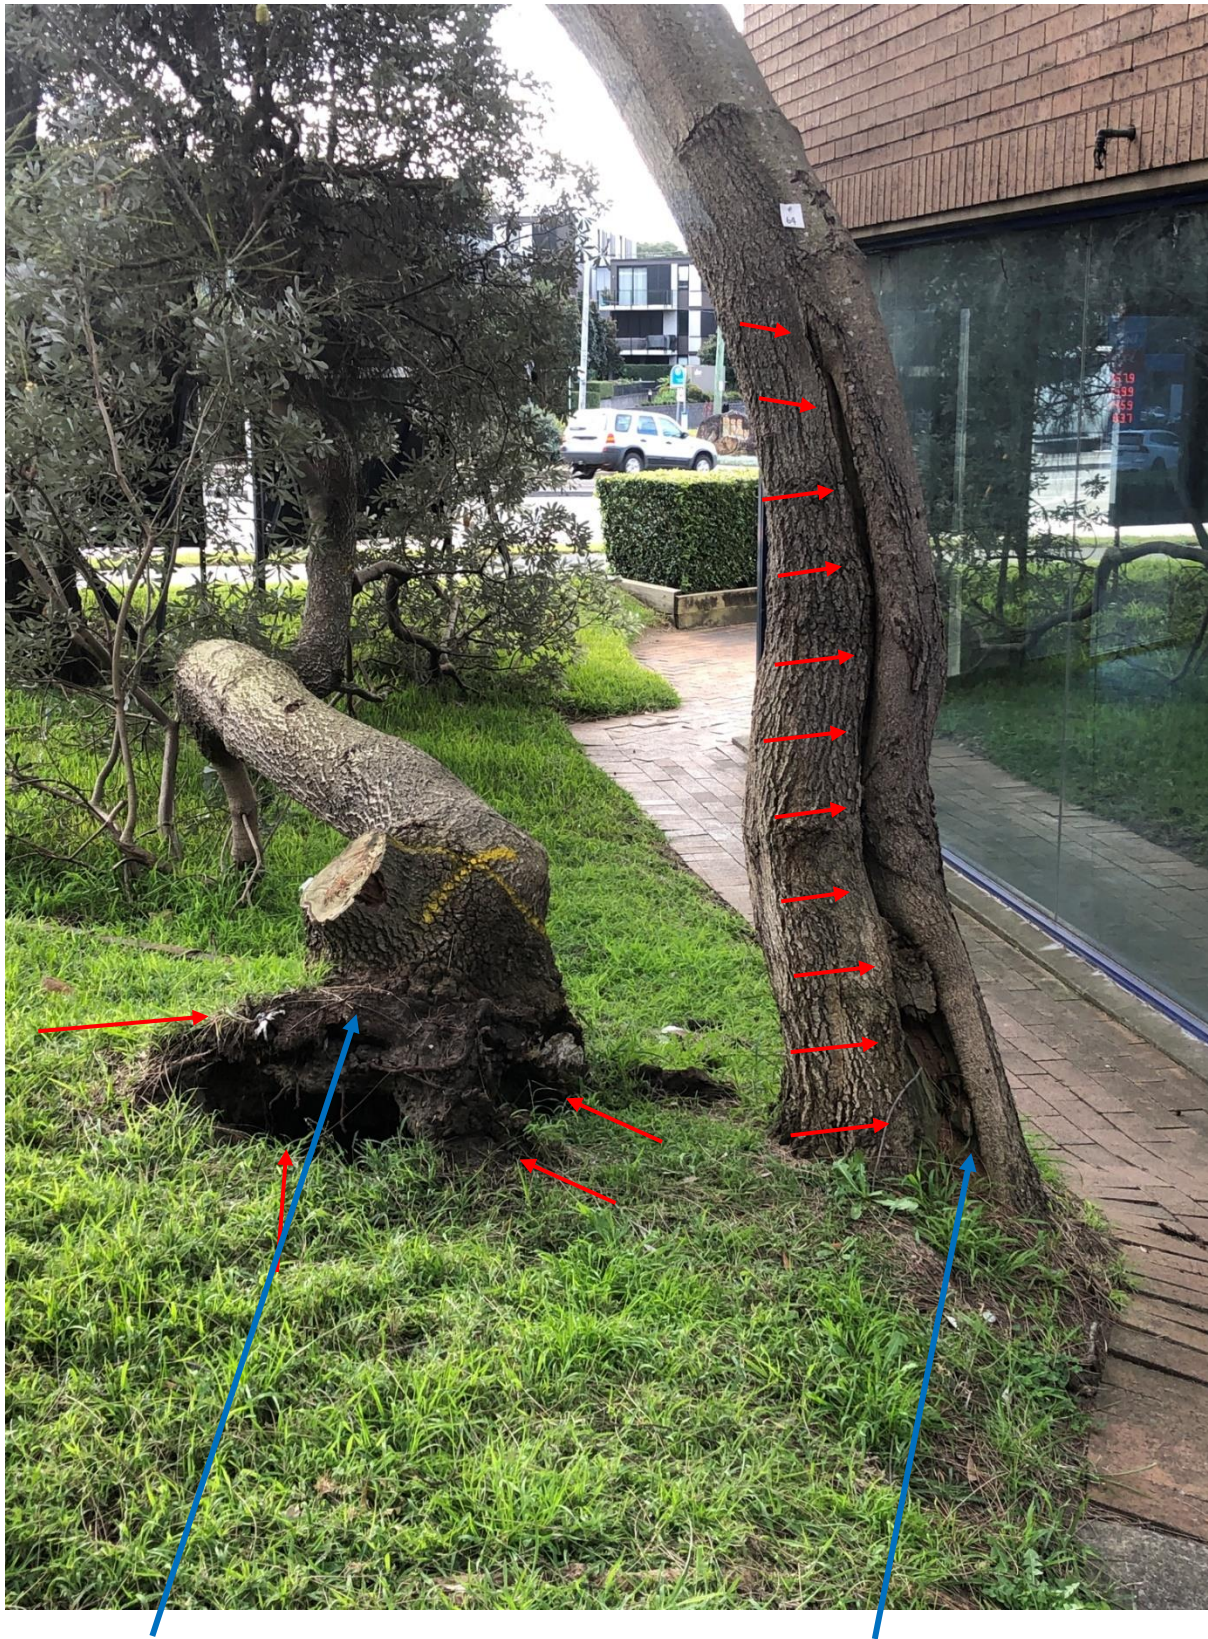
PHOTO 7

- 4.43 Tree 65 -Banksia - has a trunk diameter of 30, a height of 10 metres and a width of 4 metres. The tree is over- mature in age with a health rating of 4 out of 5 and a structure rating of zero out of 5. It currently has a suppressed crown class and has had major root plate failure. (See in photograph 7).

Tree 65 – Root plate failure

Tree 64 – Major cambium damage on trunk.

- 5.10 Trees 62 and 63 Tree Protection Zones are outside the proposed site boundary and building footprint and can be retained.
 - a) Tree 65 has had major root plate failure and needs to be removed.

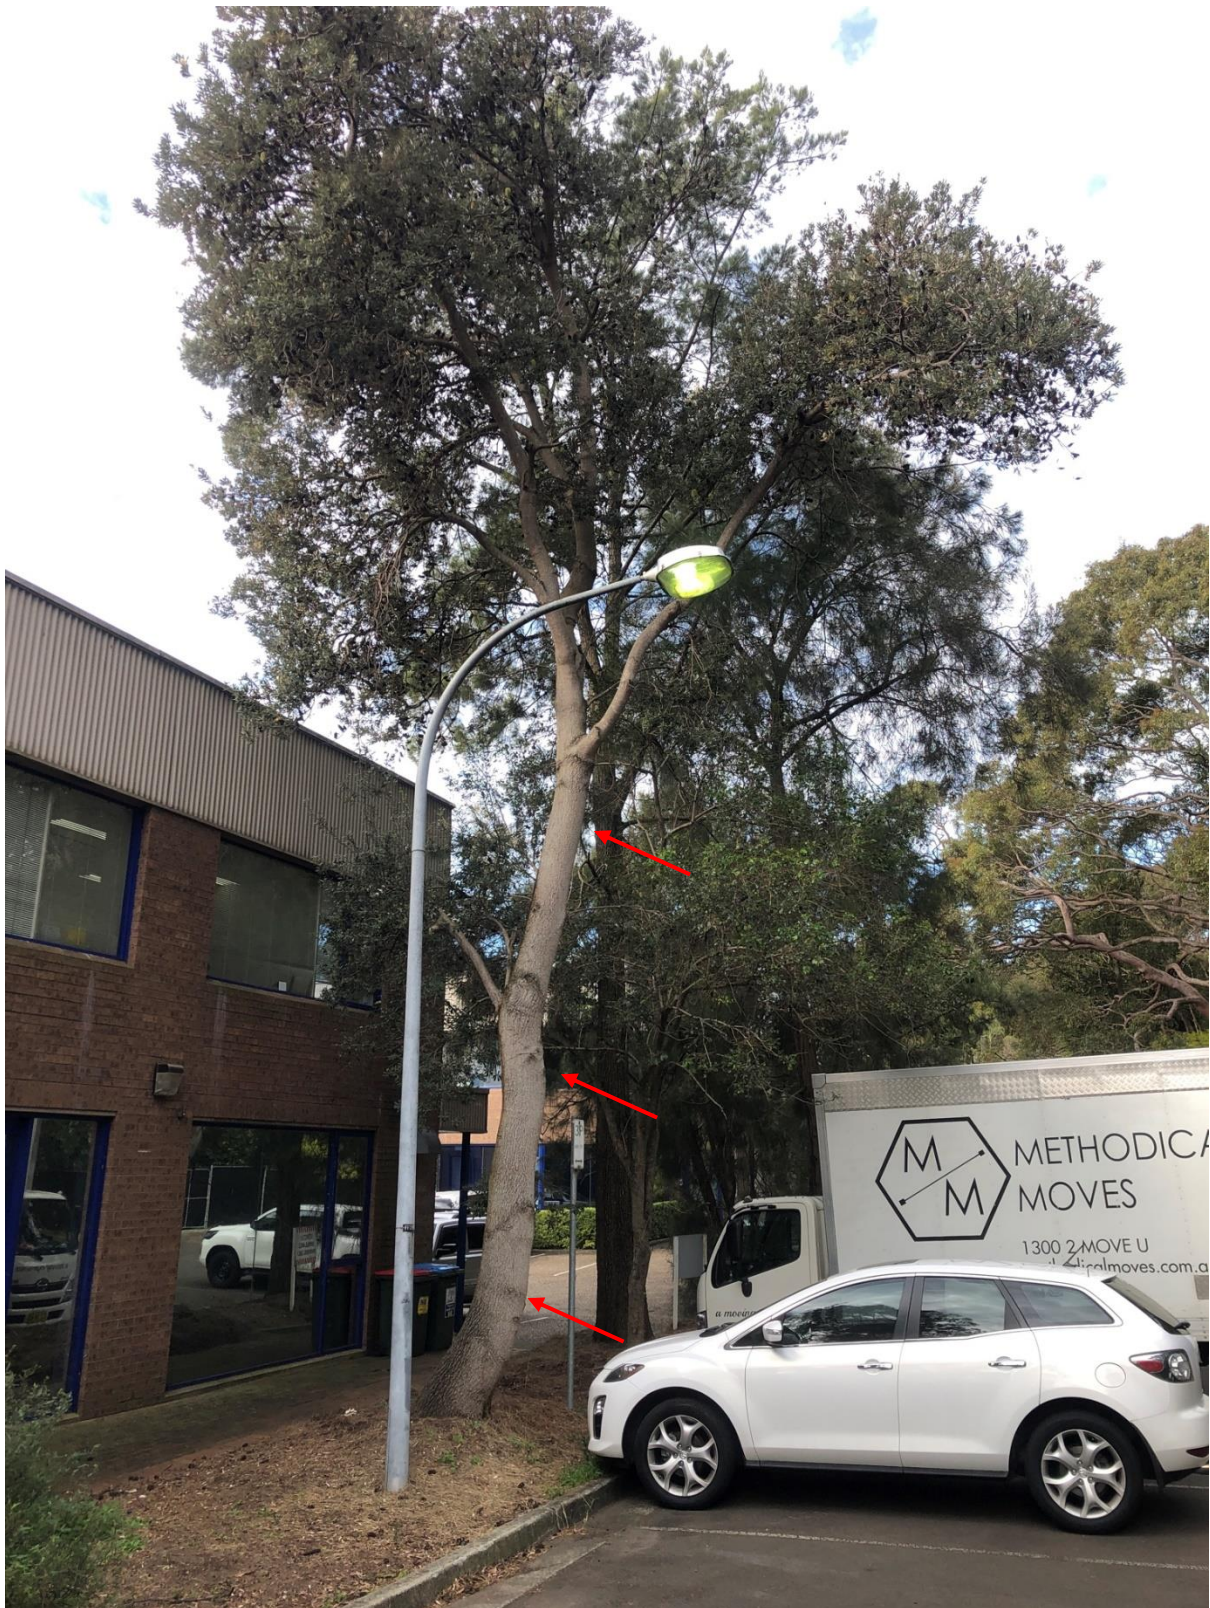
PHOTO 8

Photo 66 – Banksia with limited lower canopy

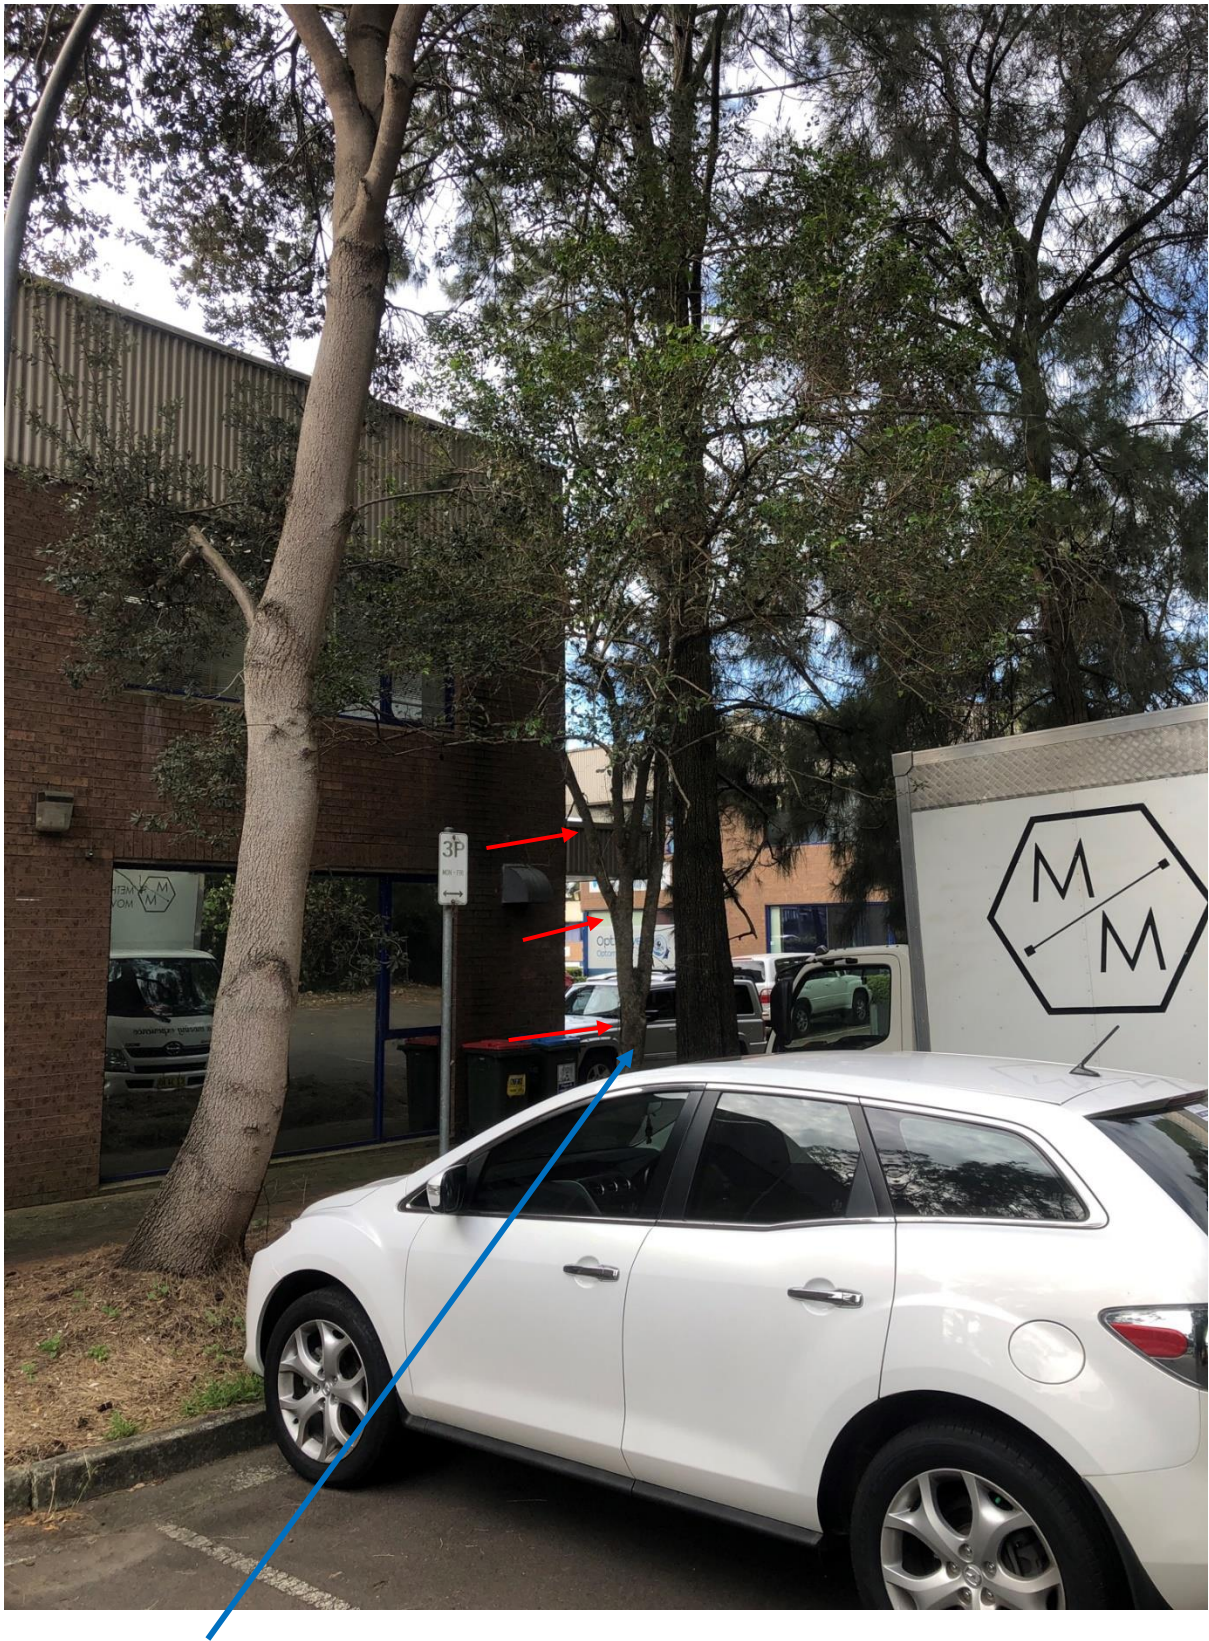
PHOTO 9

Tree 67 – Cheese tree suppressed by surrounding trees .

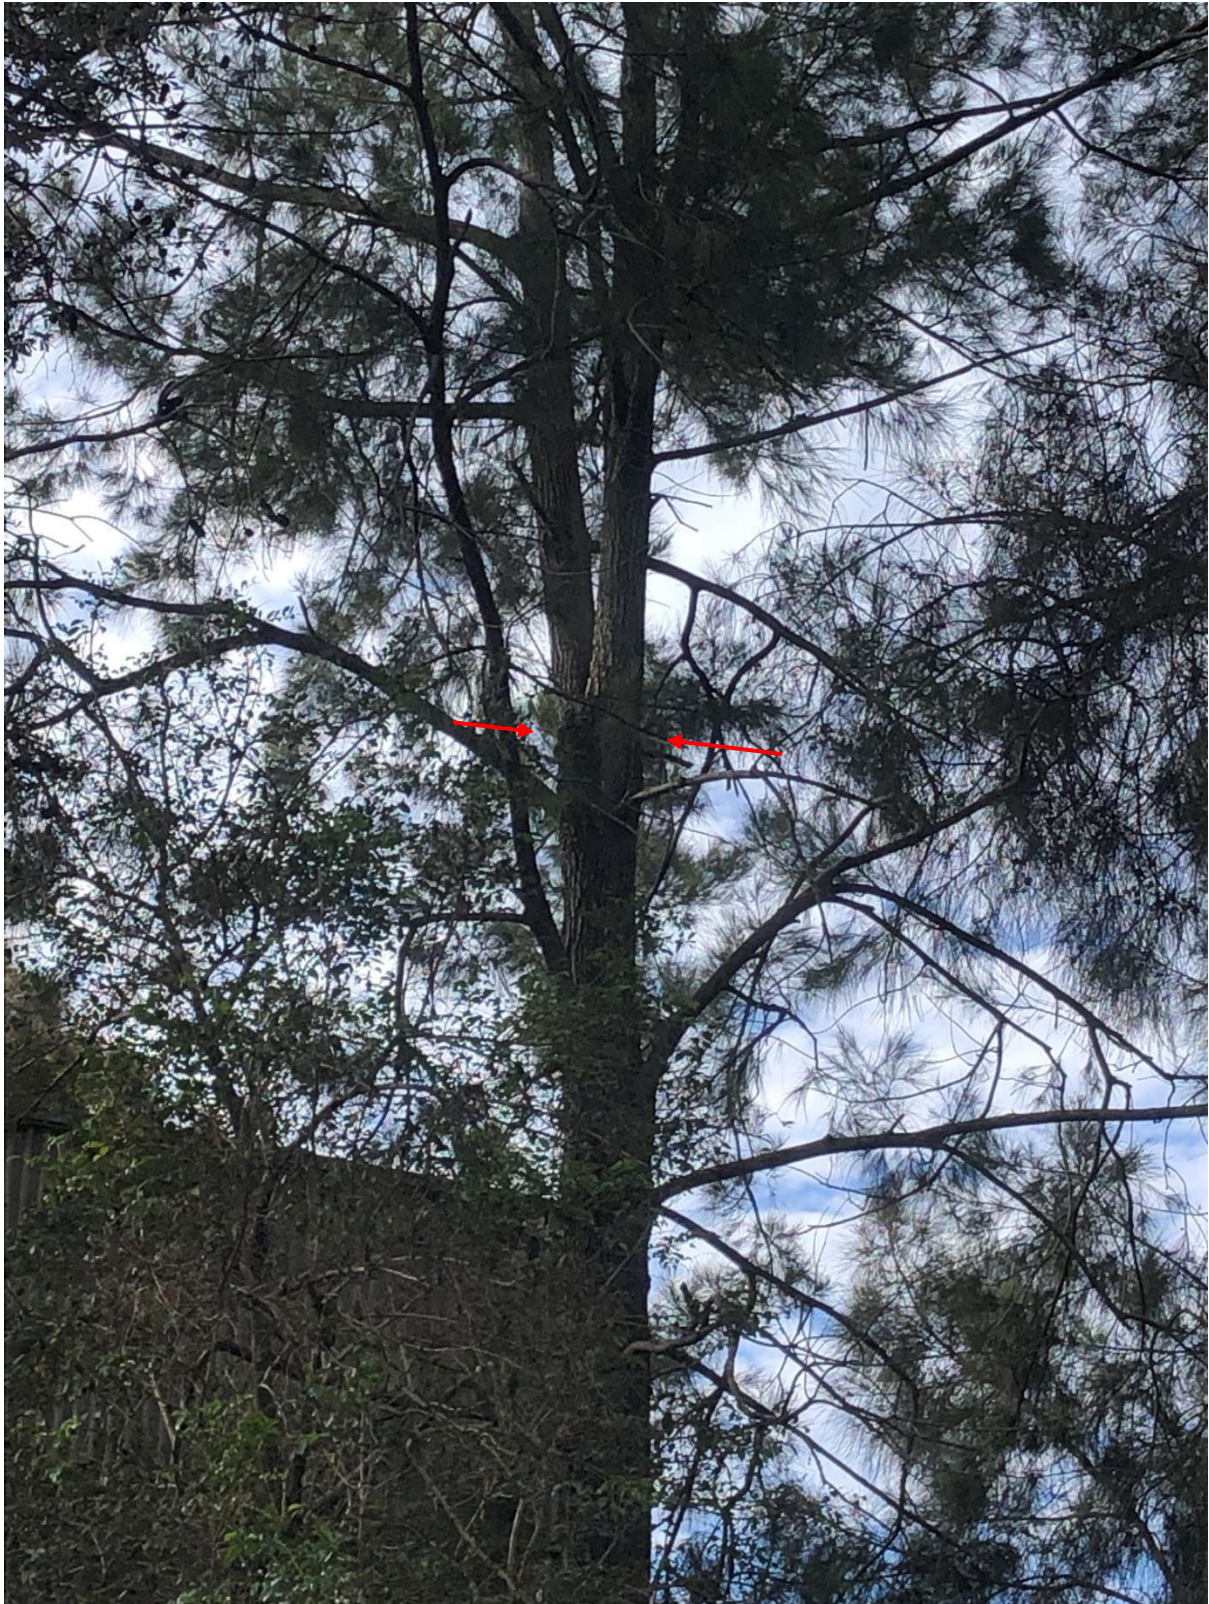
PHOTO 10

Tree 68 – Trunk inclusion at 7 metre mark

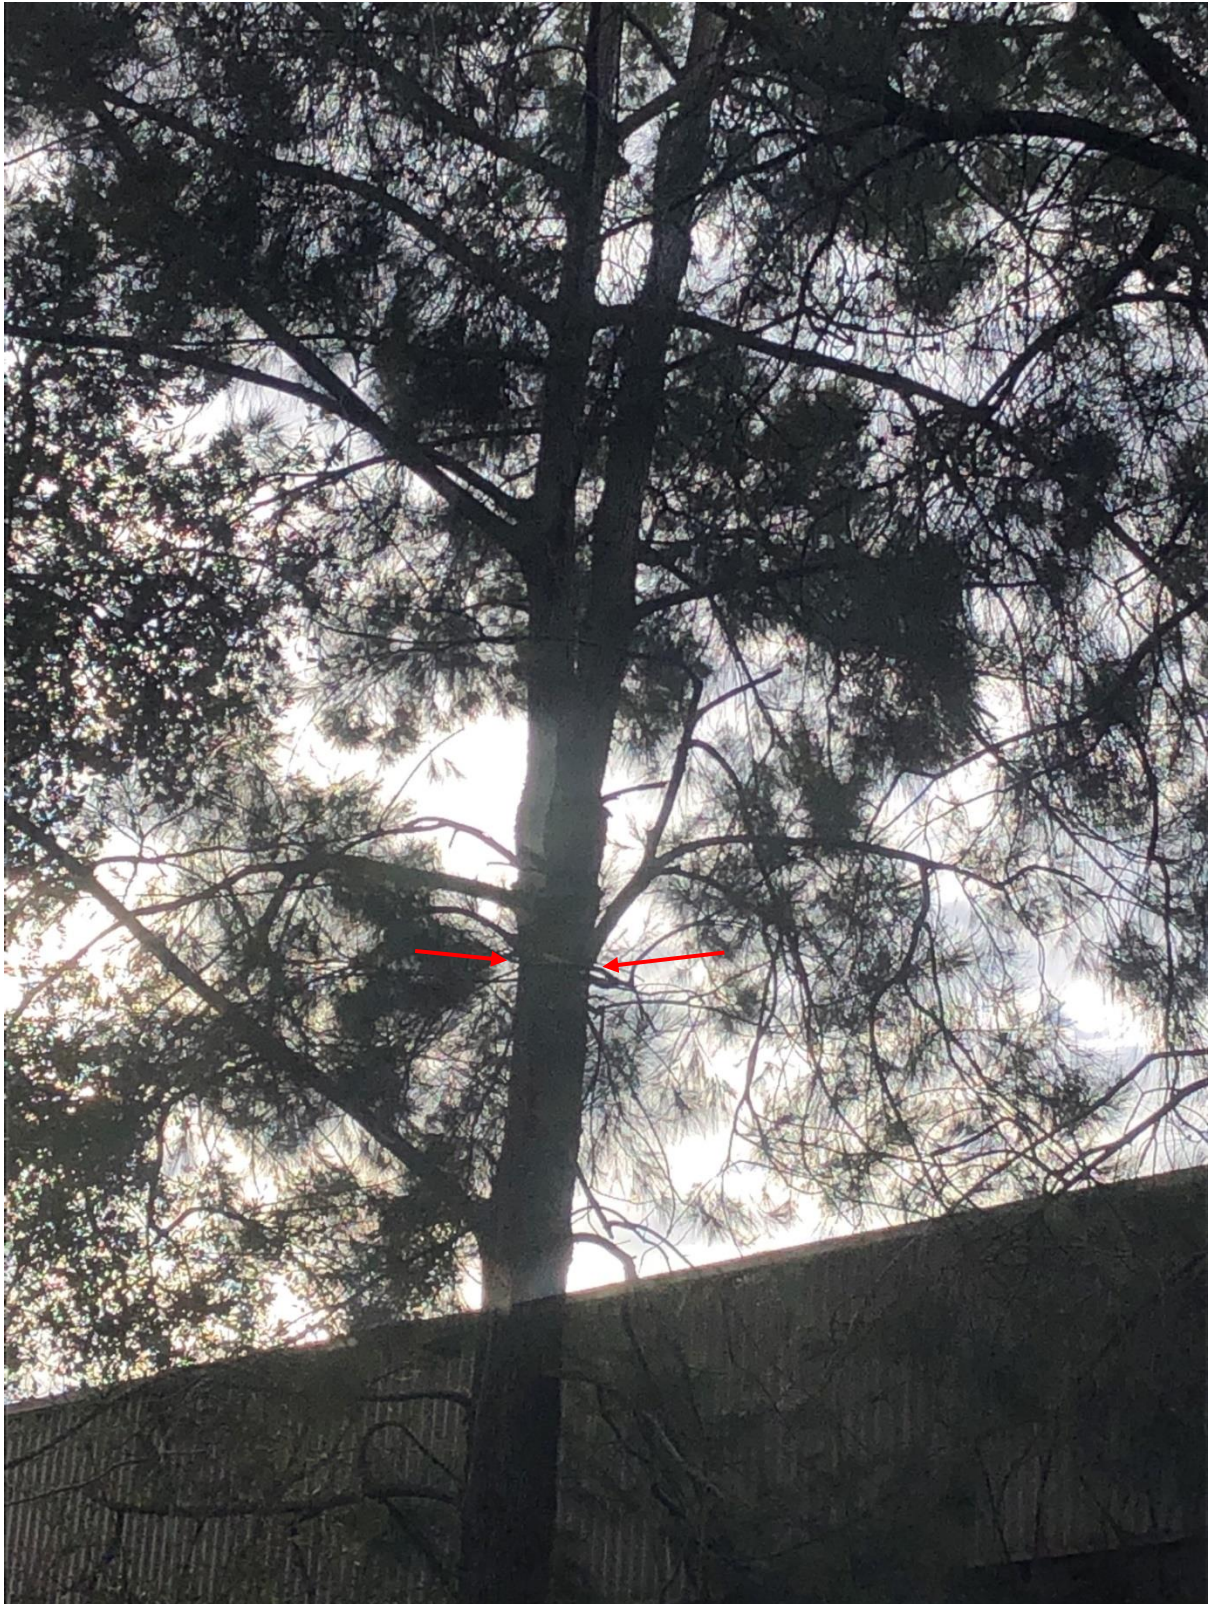
PHOTO 11

Tree 68 – Trunk inclusion at 7 metre mark

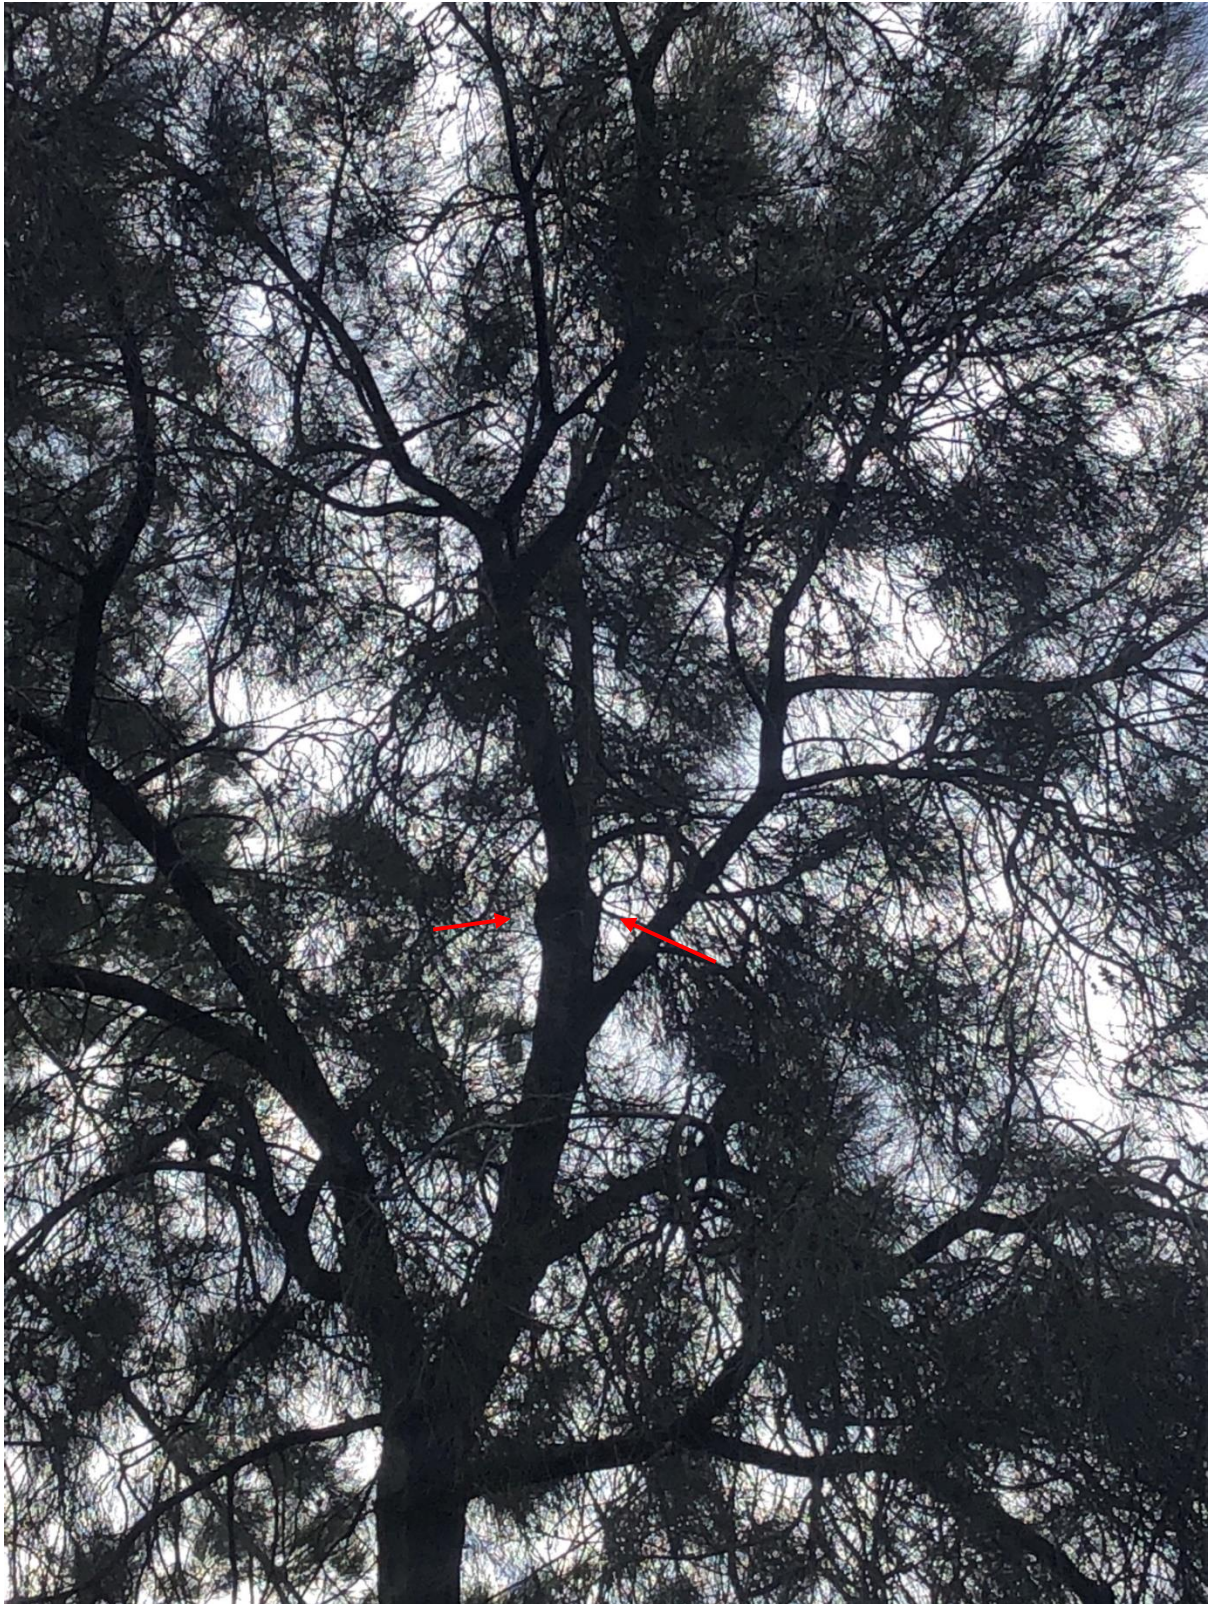
PHOTO 12

- 4.47 Tree 69 - - has a trunk diameter of 50 cm, a height of 12 metres. The tree is mature in age with a health rating of 5 out of 5 and a structure rating of 3 out of 5. It has a dominant crown class with 50% canopy cover. There is storm damage at the 10-metre mark with trunk inclusion and swelling at the eight-metre mark. (See photograph 12).

Tree 69 – Swelling around branch inclusion

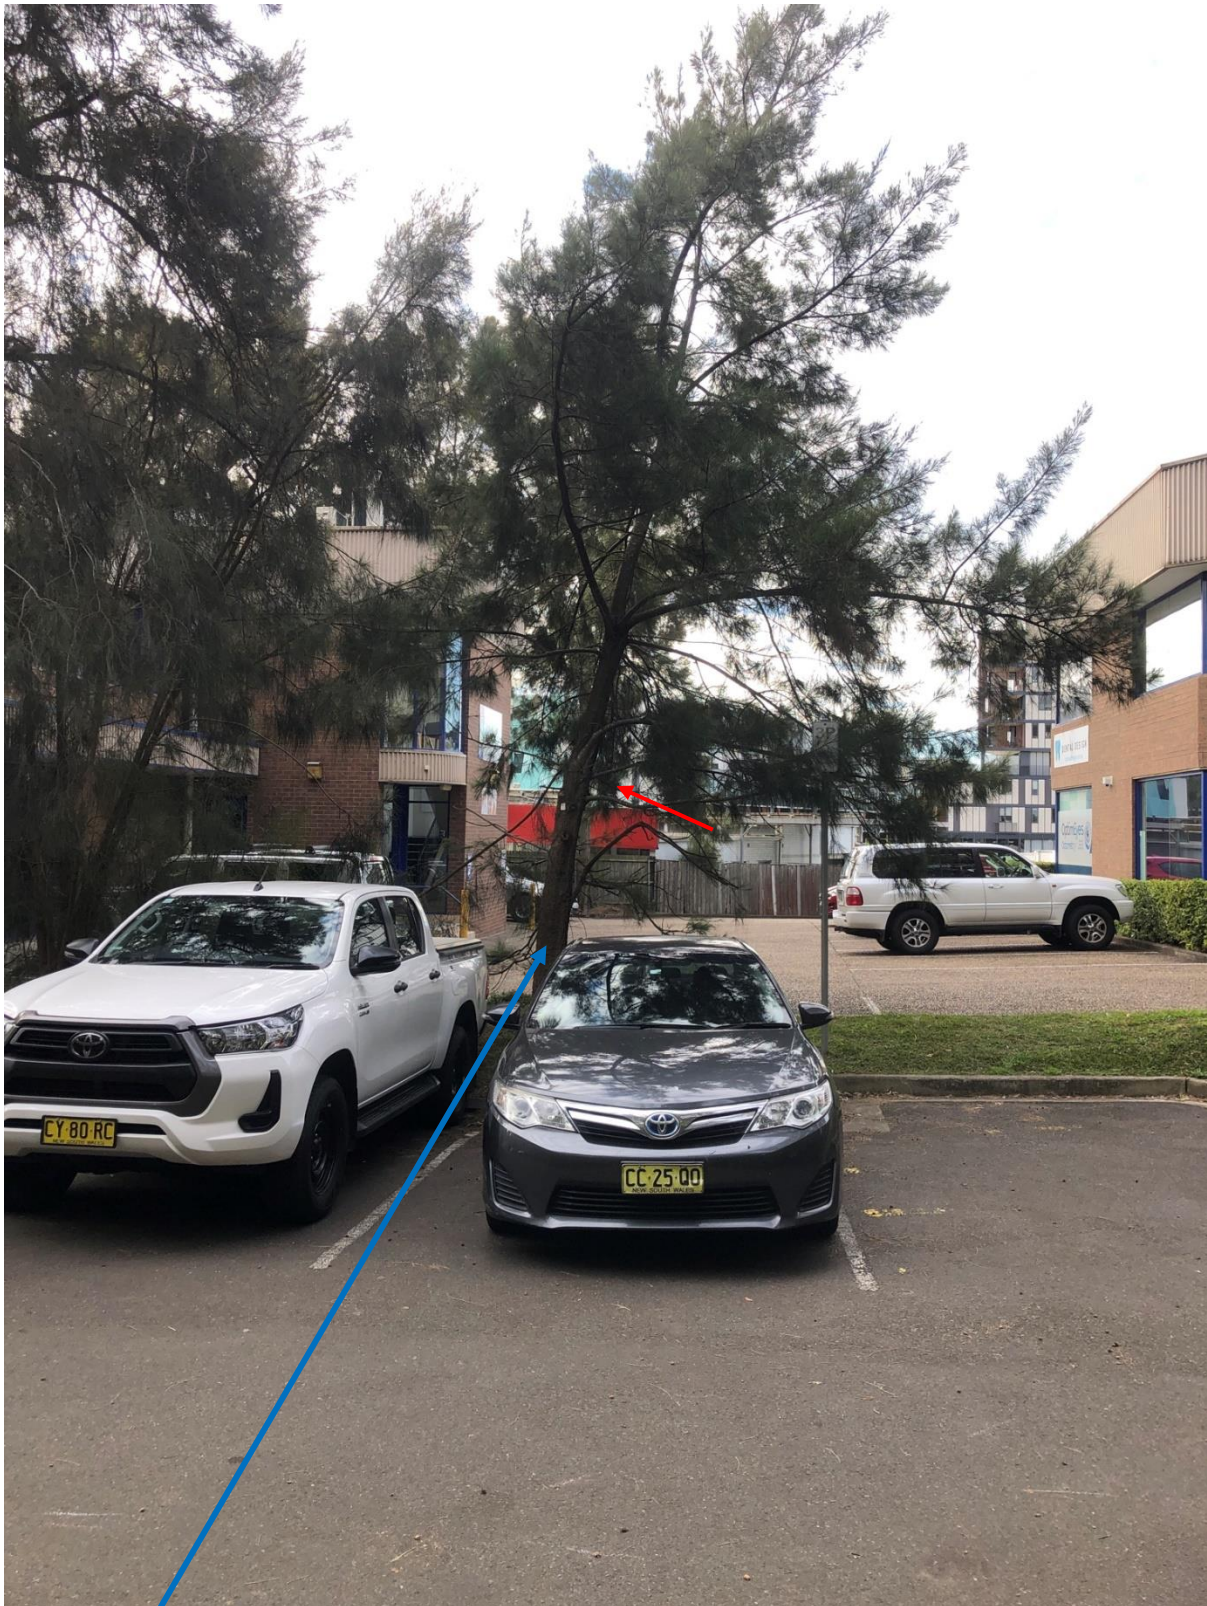
PHOTO 13

Tree 71 – bend in trunk
