Arborist Report

Project **812 Pittwater Road and 4 Delmar Parade**
Dee Why NSW 2099
Ref: 2021-1061
Job: 65488

Client **Dee Why 3 Pty Ltd & Dee Why 4 Pty Ltd**
c/o Willow Frank
Suite 110 , Level 1
13A Montgomery St
Kogarah NSW 2217

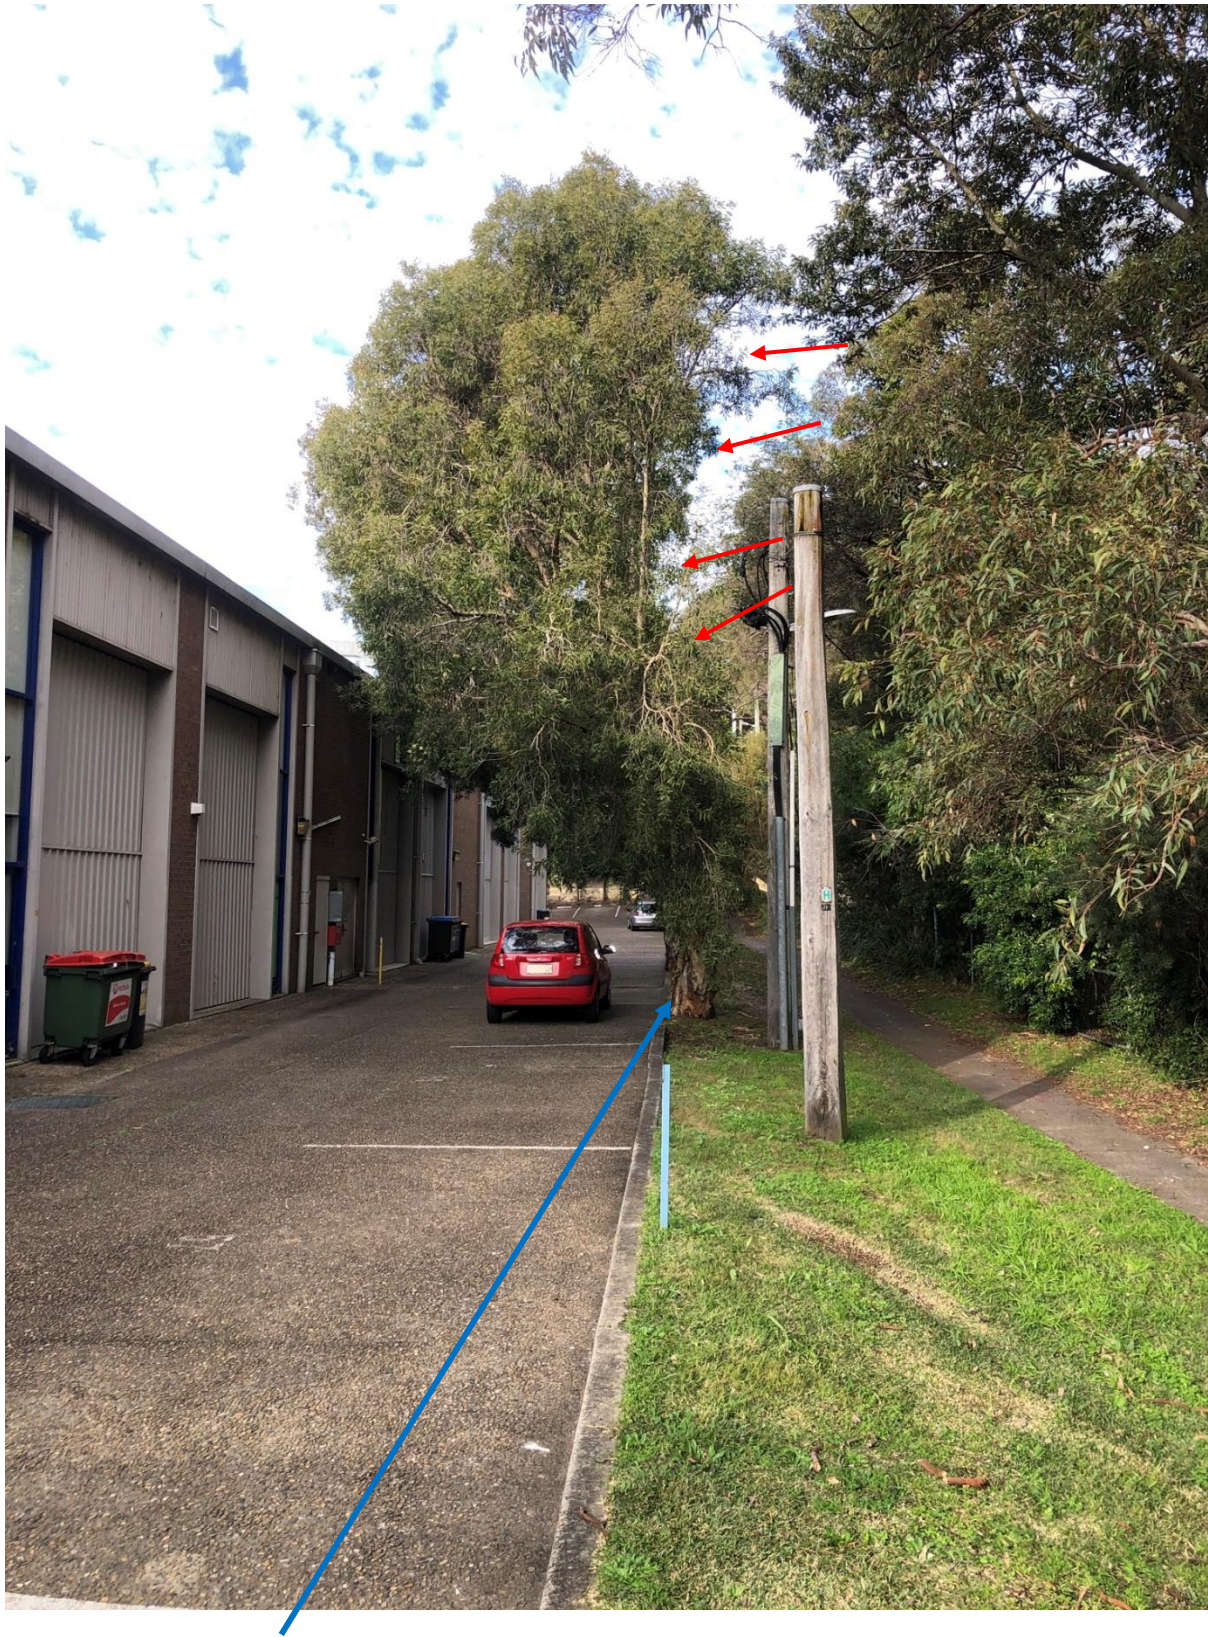
PHOTO 14

Tree 72 – Melaleuca – misshapen canopy

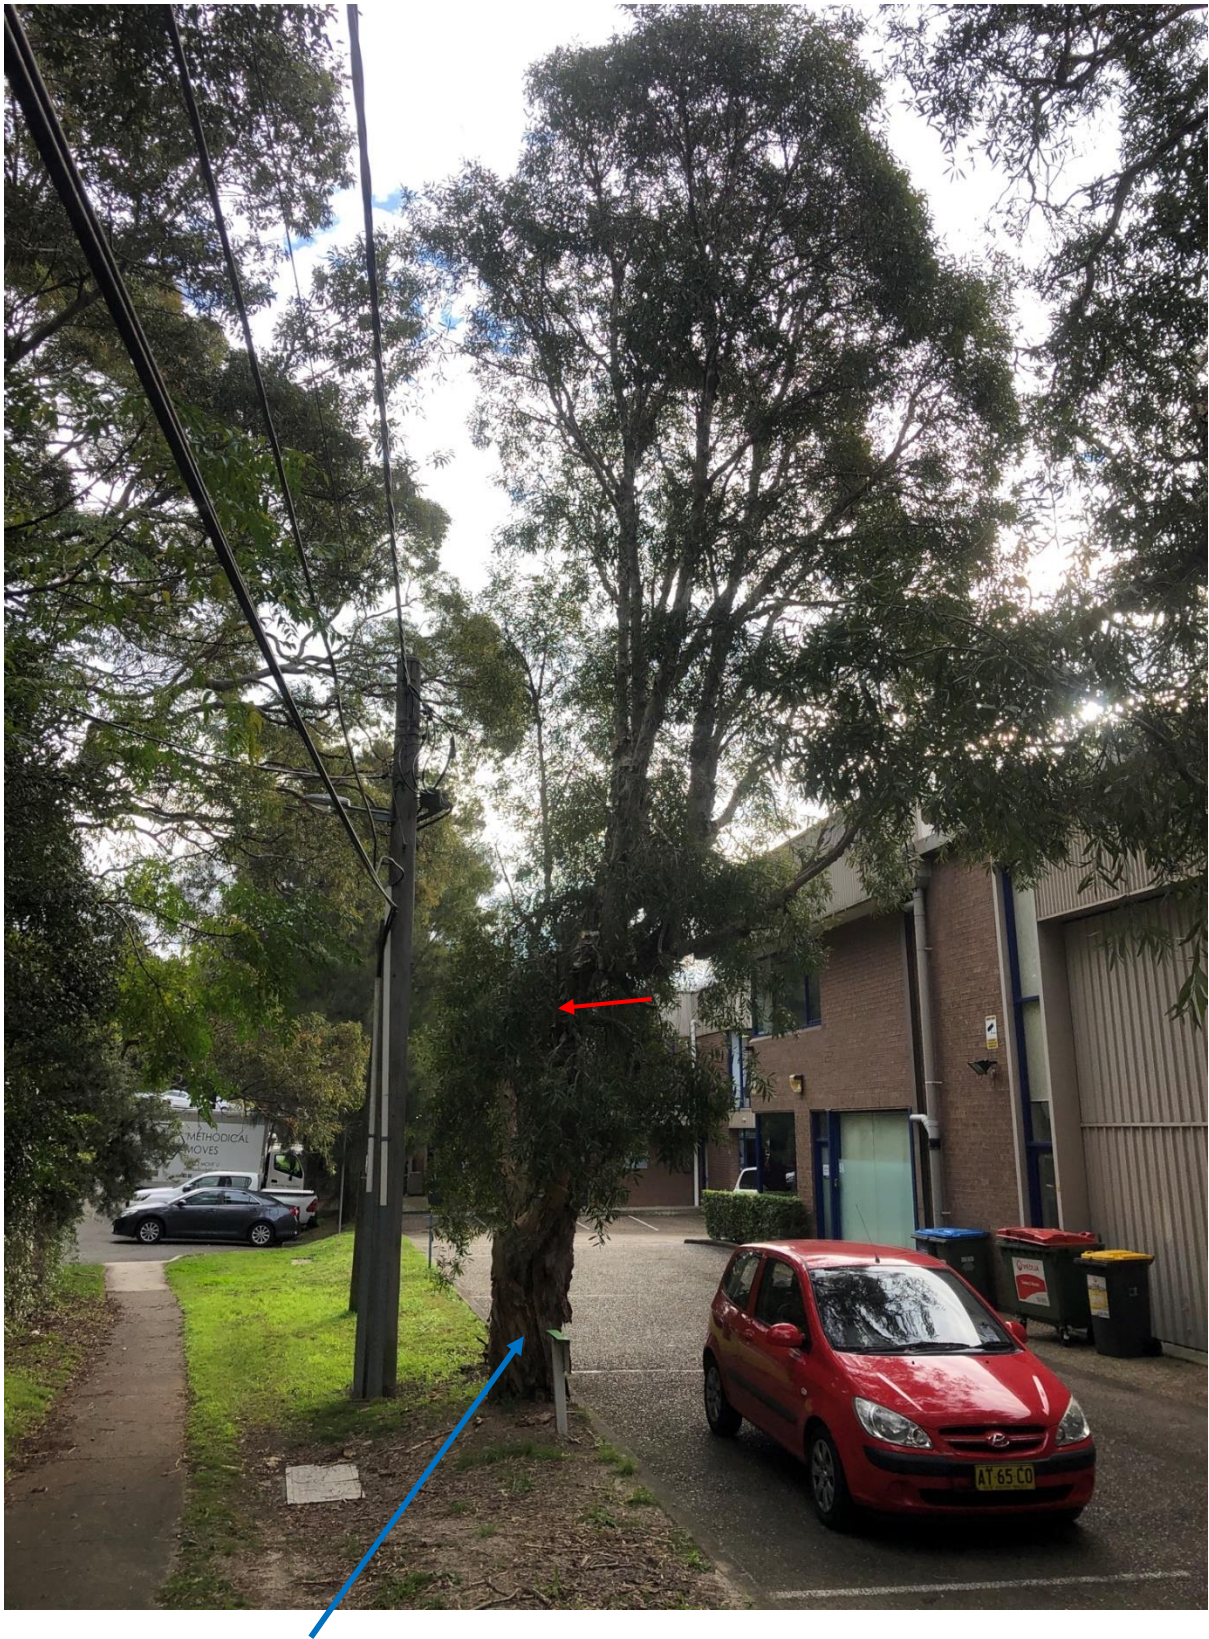
PHOTO 15

Tree 72 – Melaleuca – one-sided canopy

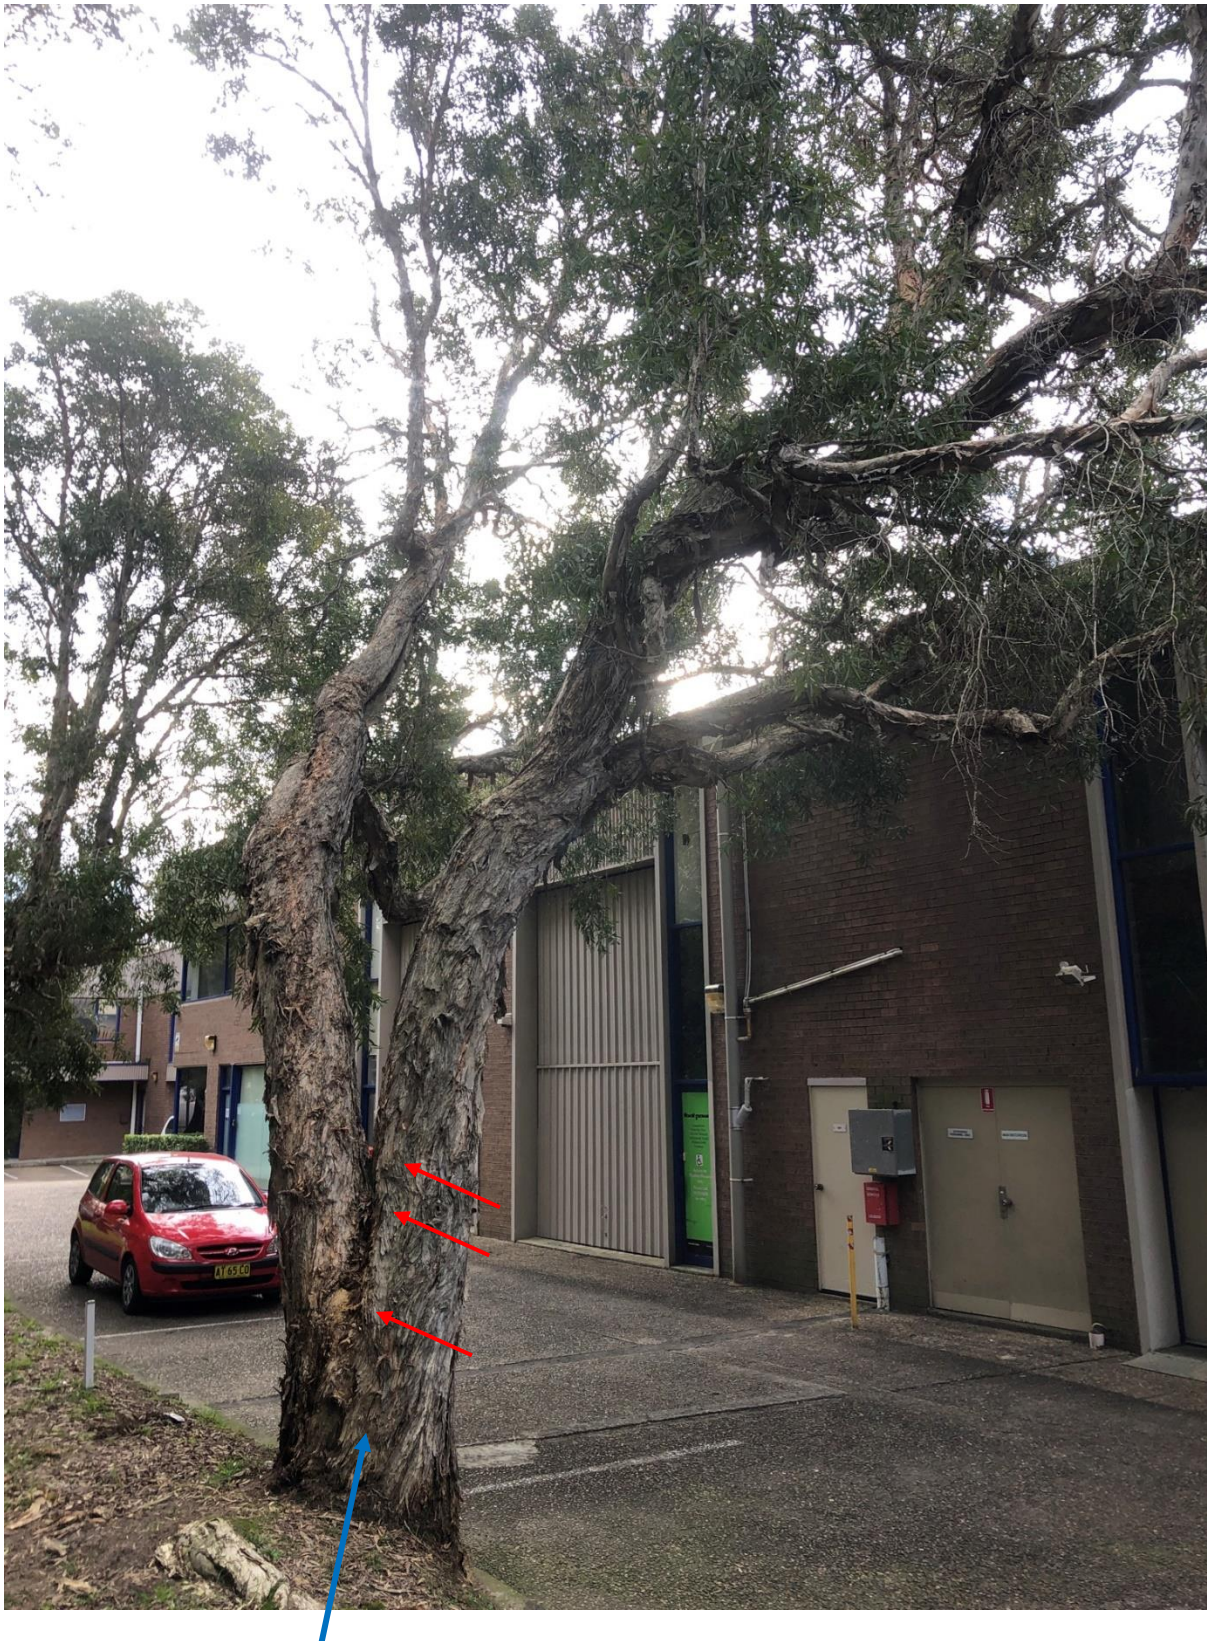
PHOTO 16

Tree 73 – Melaleuca – one-sided canopy which overhangs driveway and building.

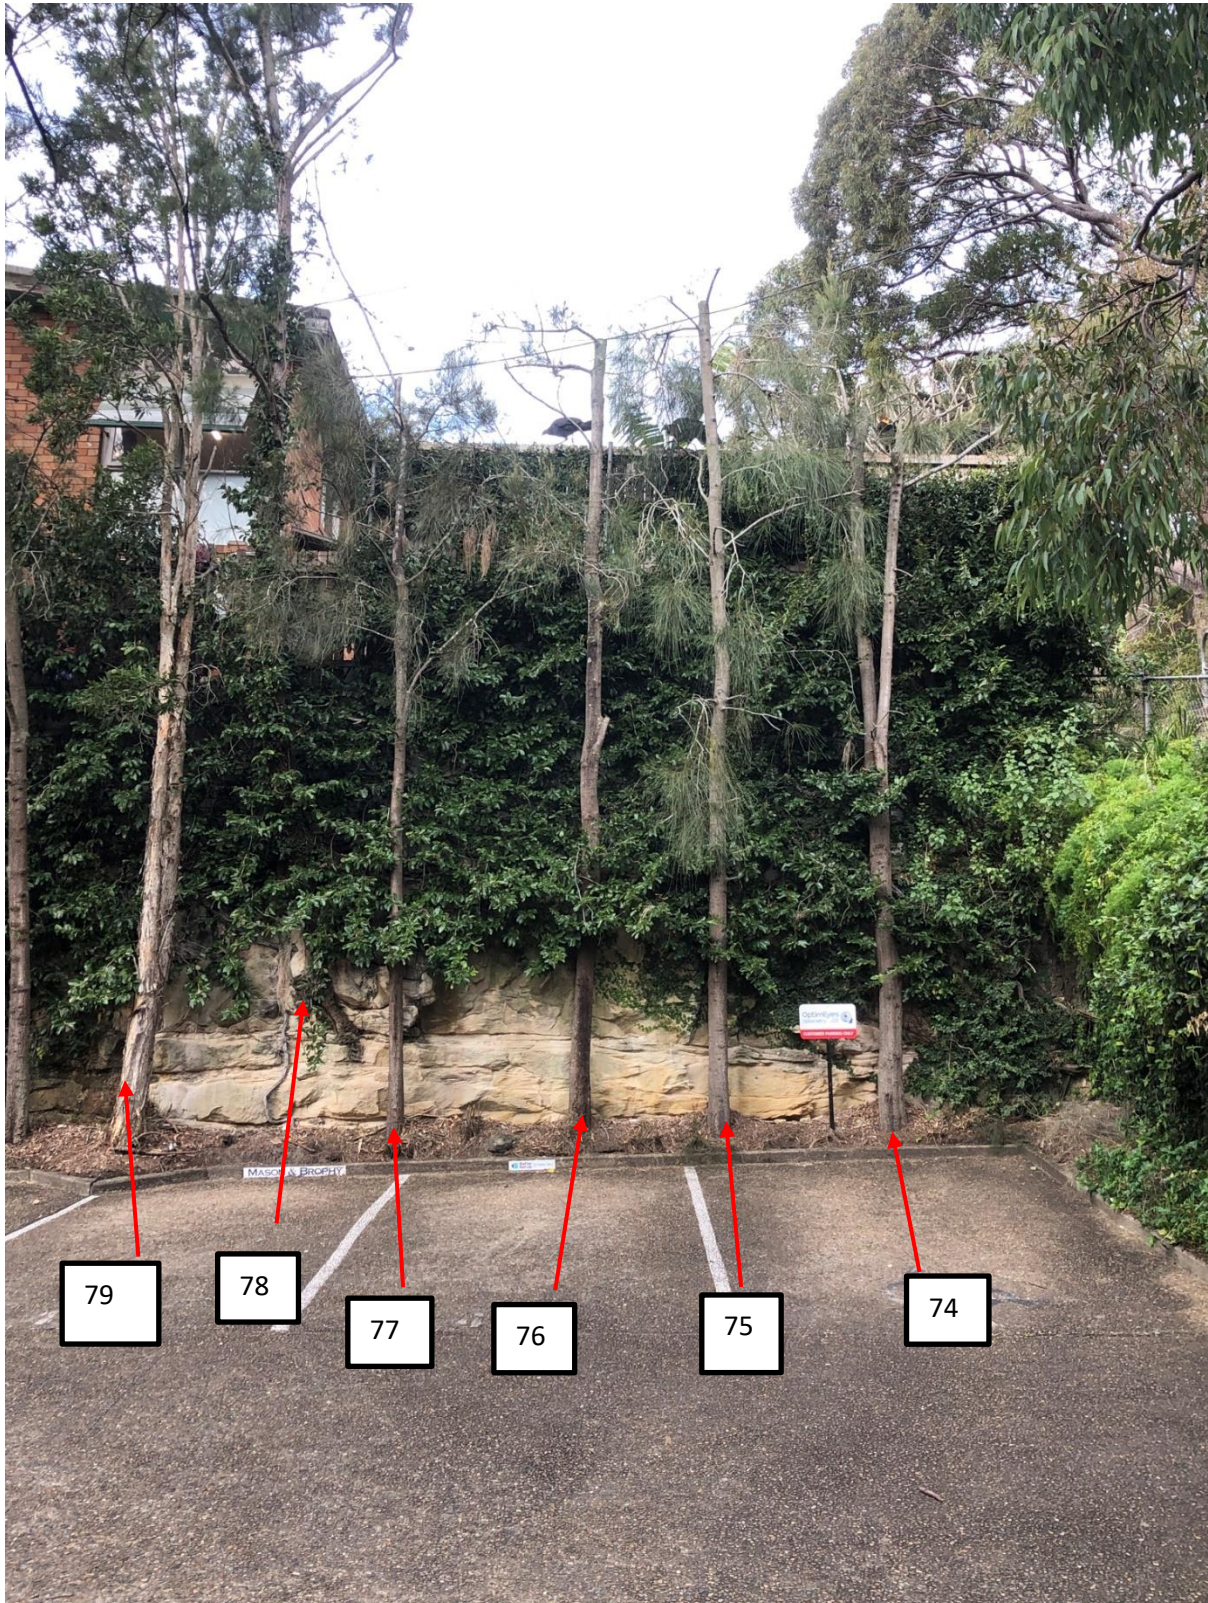
PHOTO 17

Trees 74 to 79 Trees 74, 75 76 77 have been lopped. Tree78 is growing out of rockface

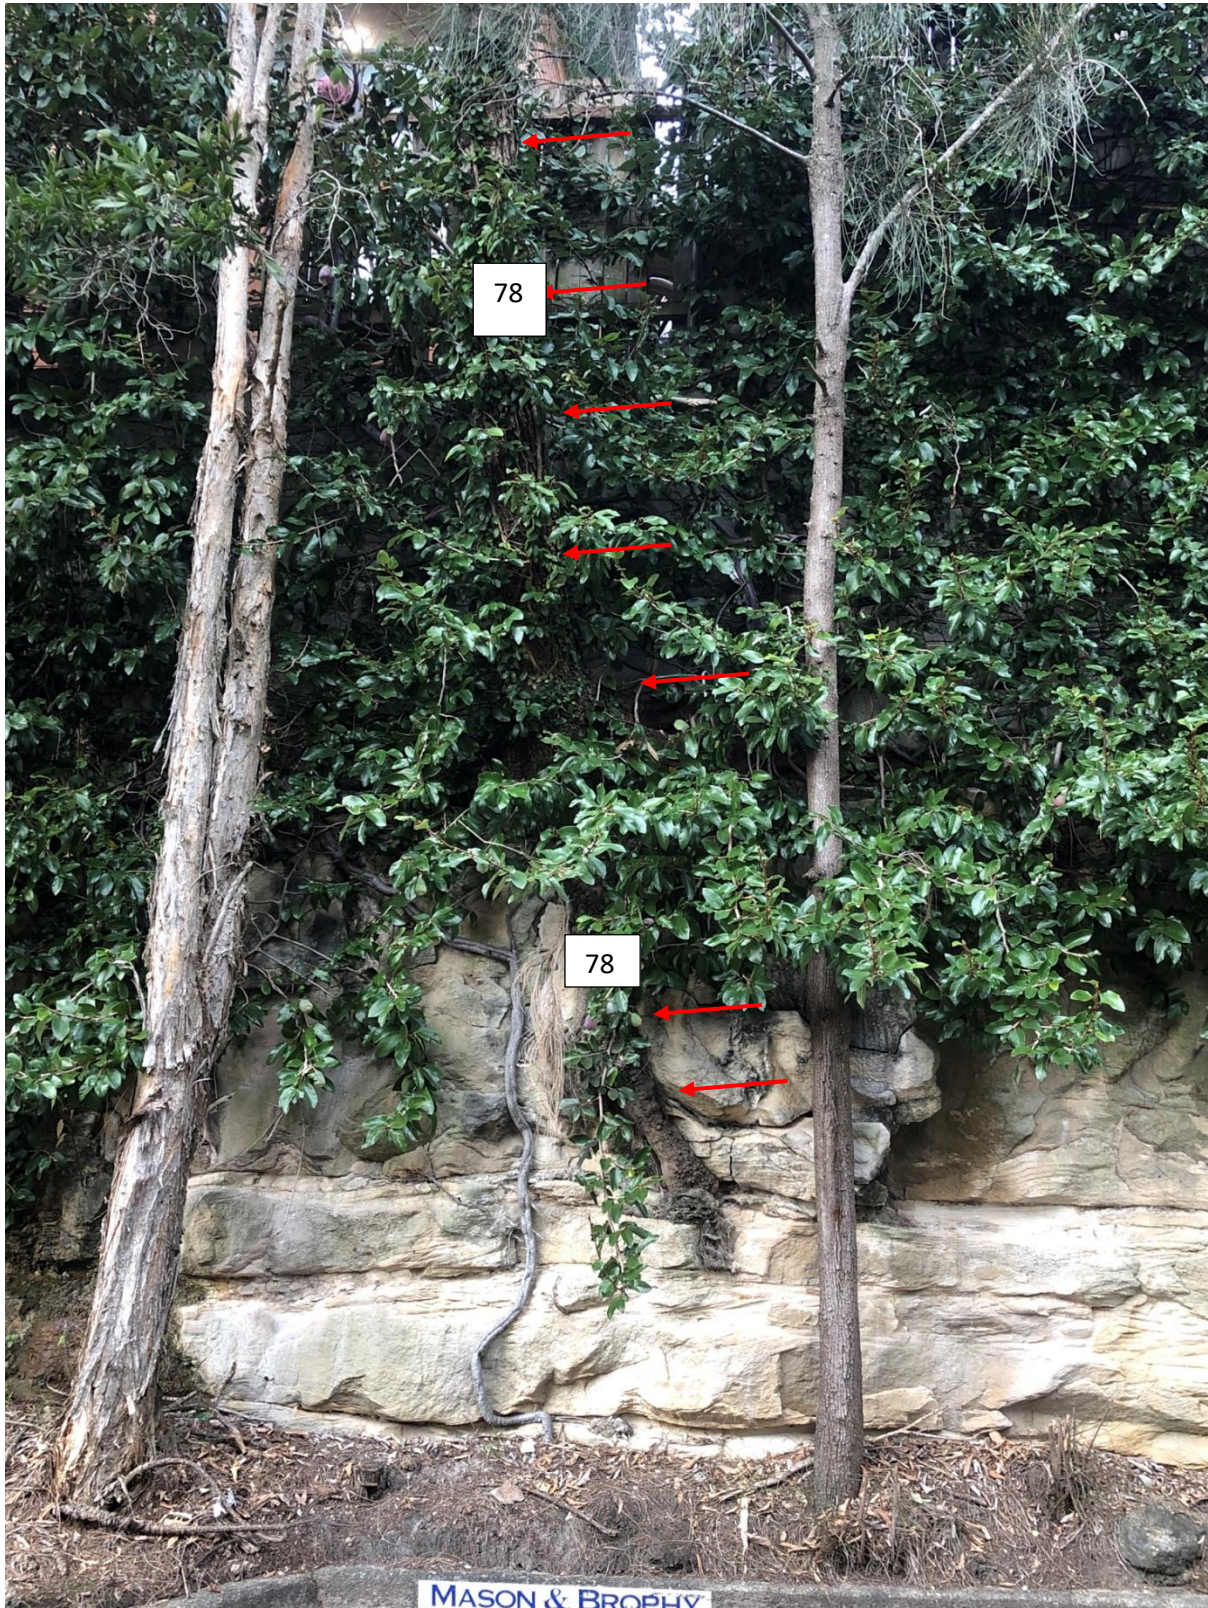
PHOTO 18

Tree 78 Casuarina – growing out of rock face

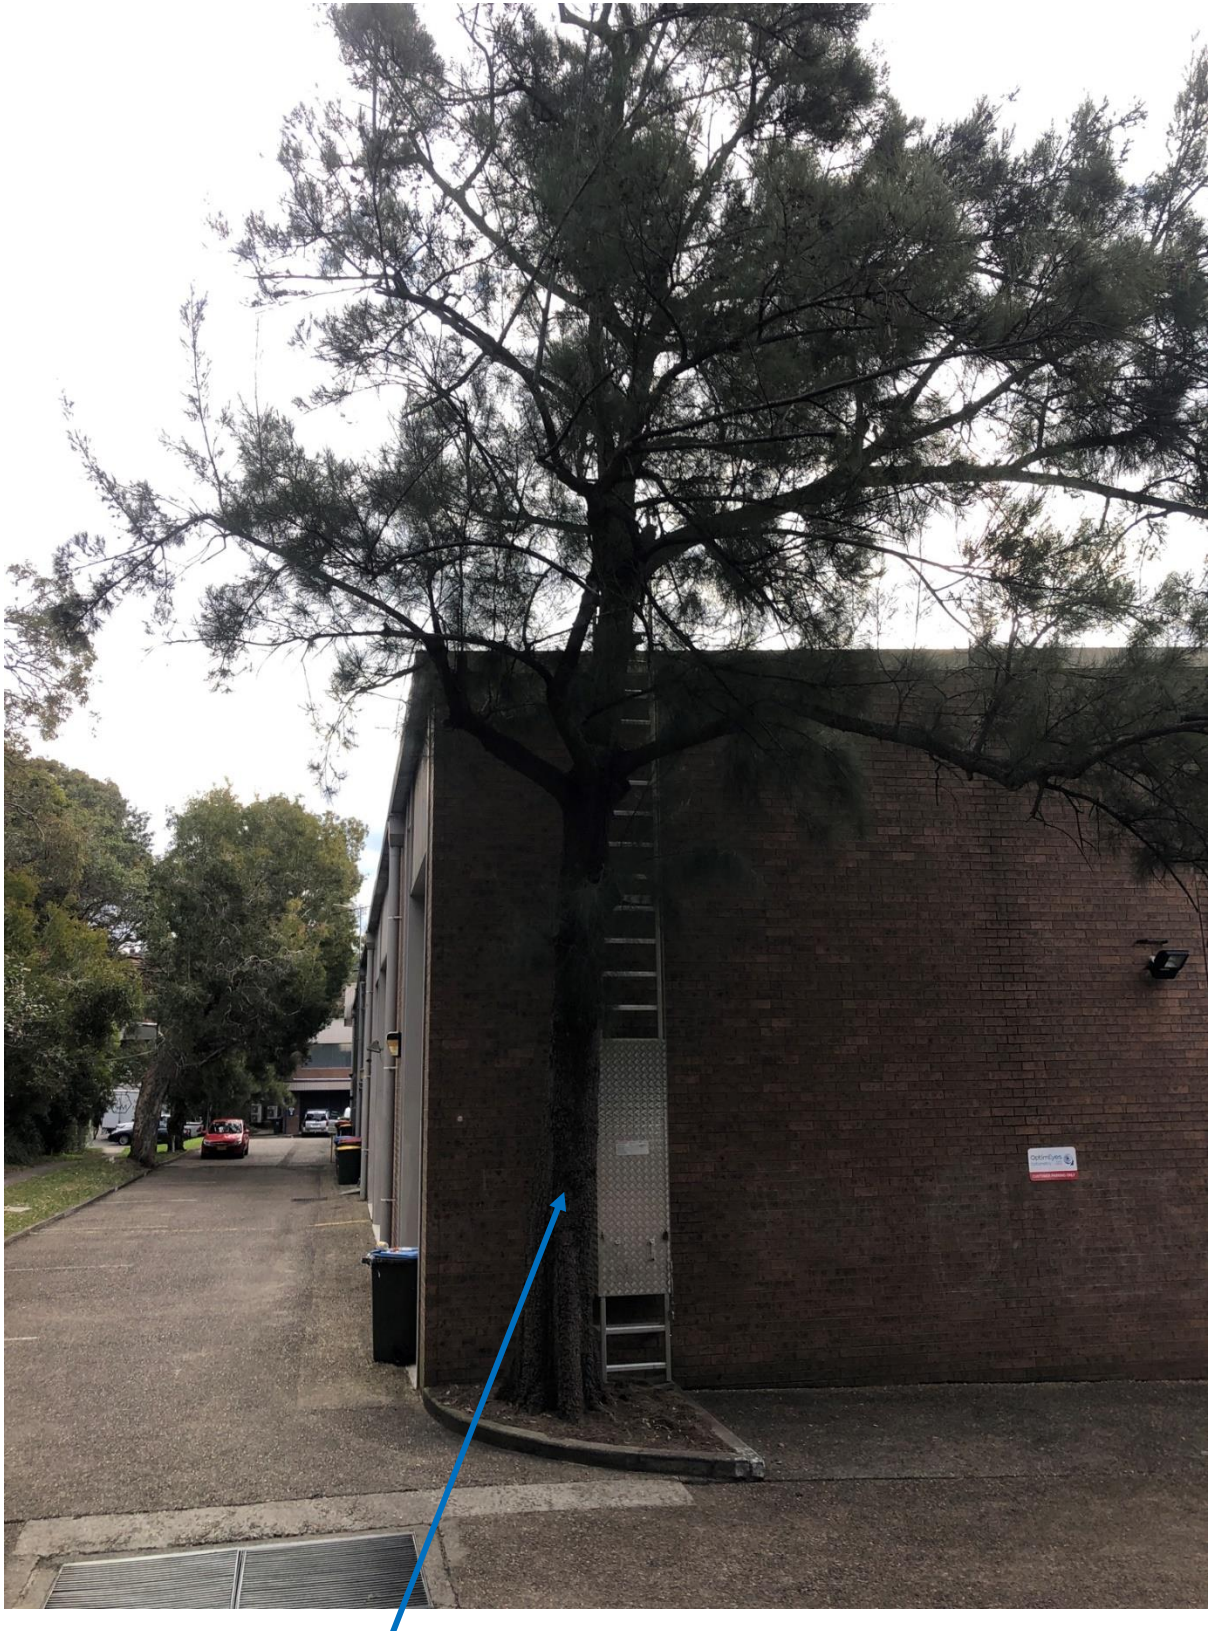
PHOTO 19

Tree 80 - Canopy cover only over car parking on road

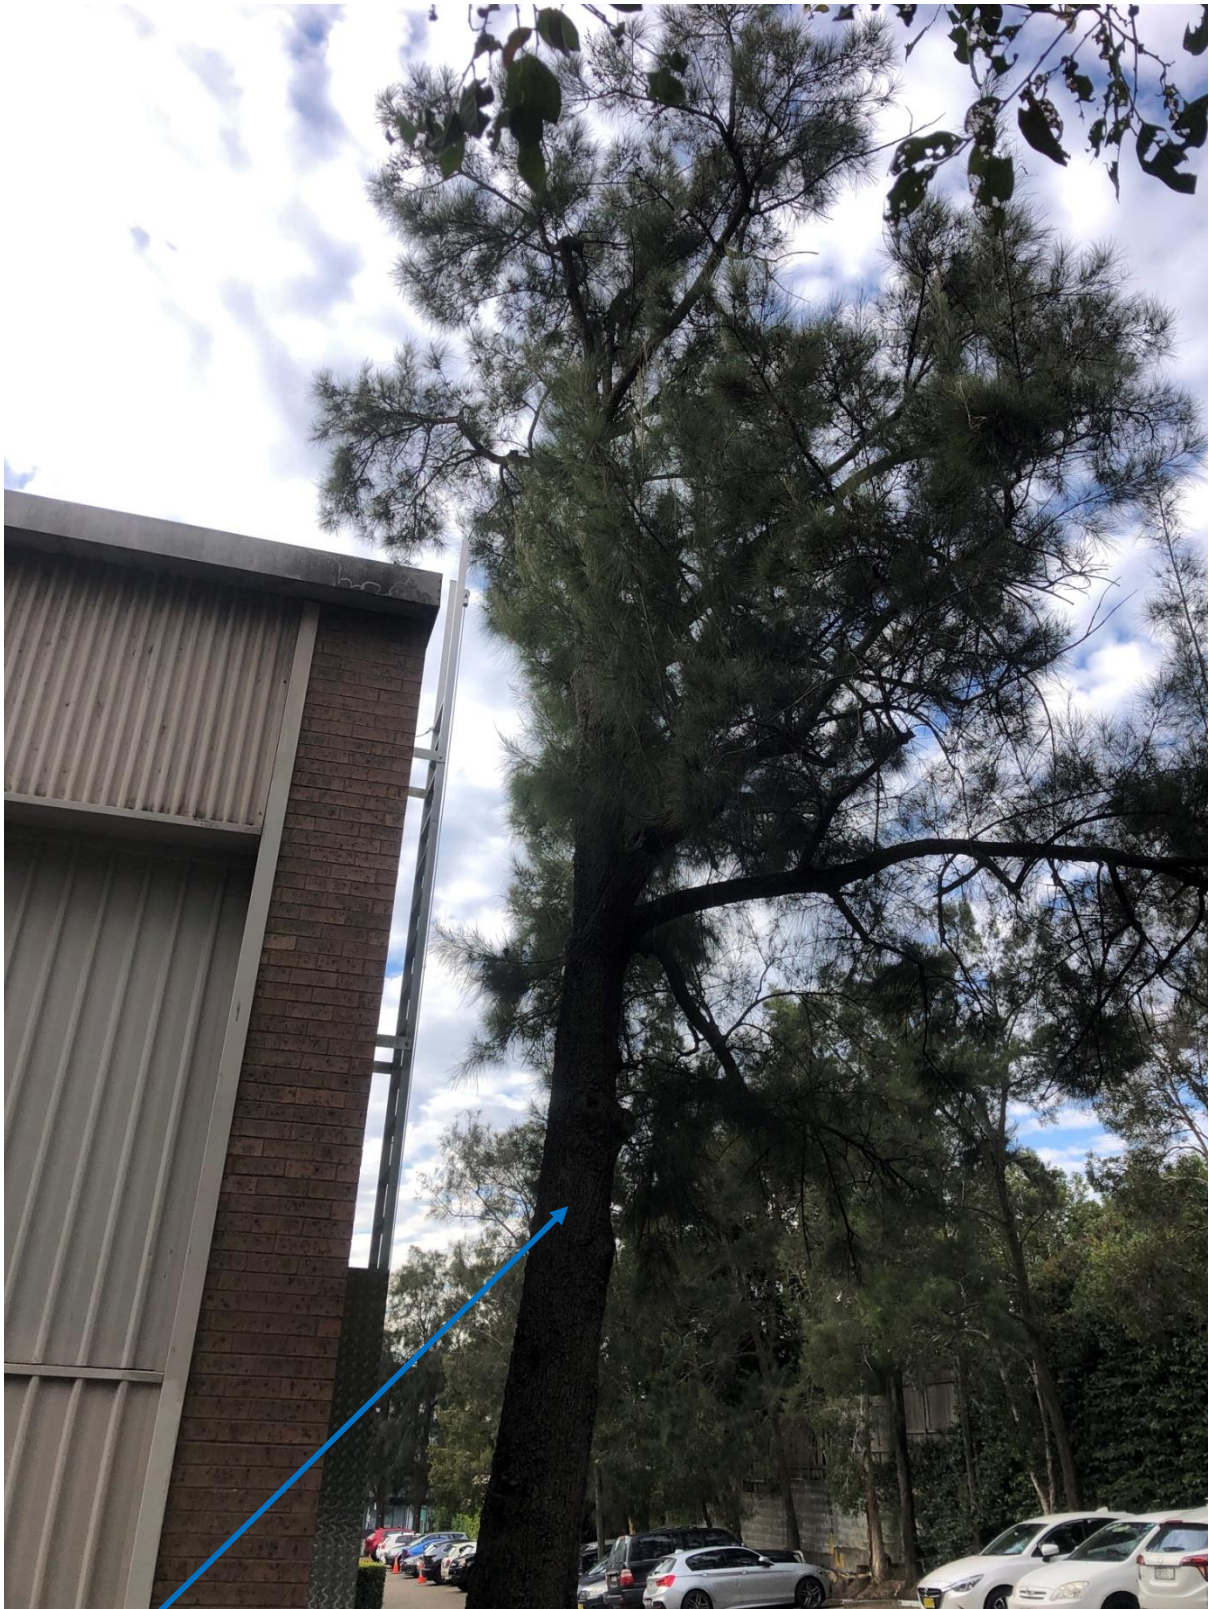
PHOTO 20

Tree 80 – one-sided canopy

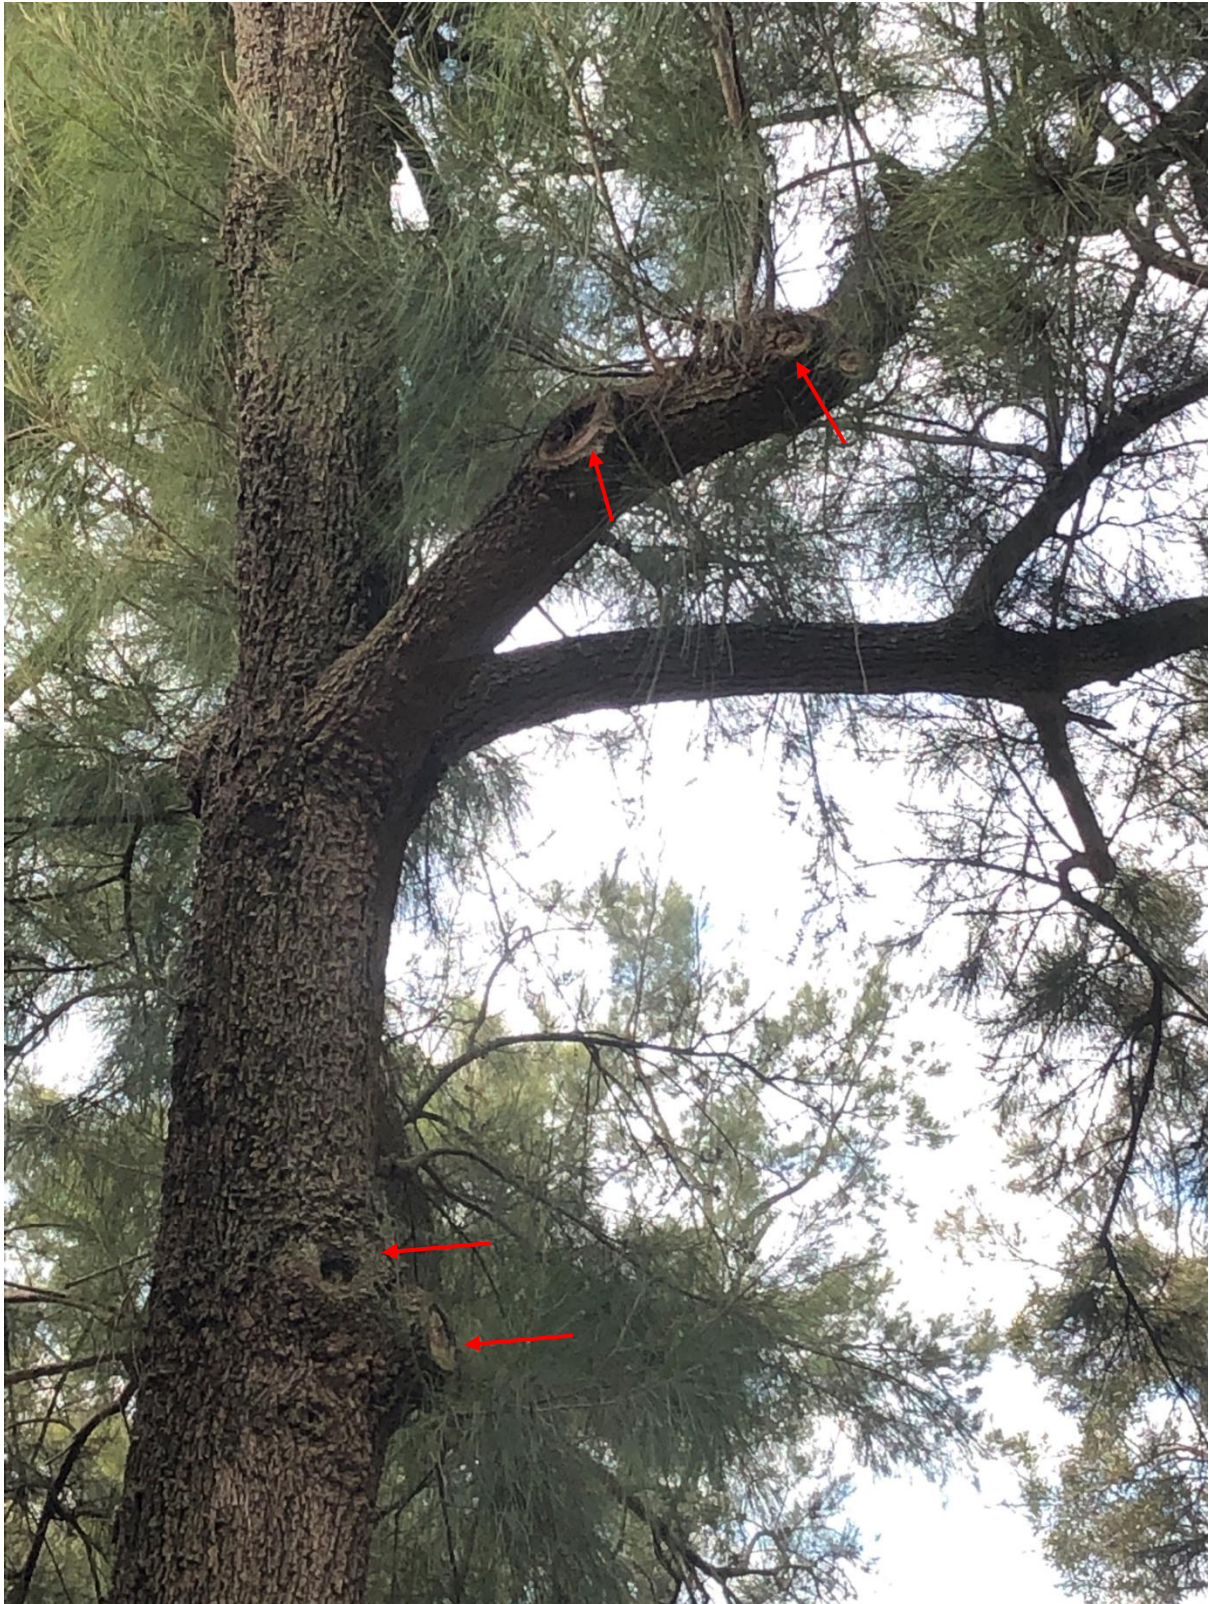
PHOTO 21

Tree 80 – Old wounds with limited closure

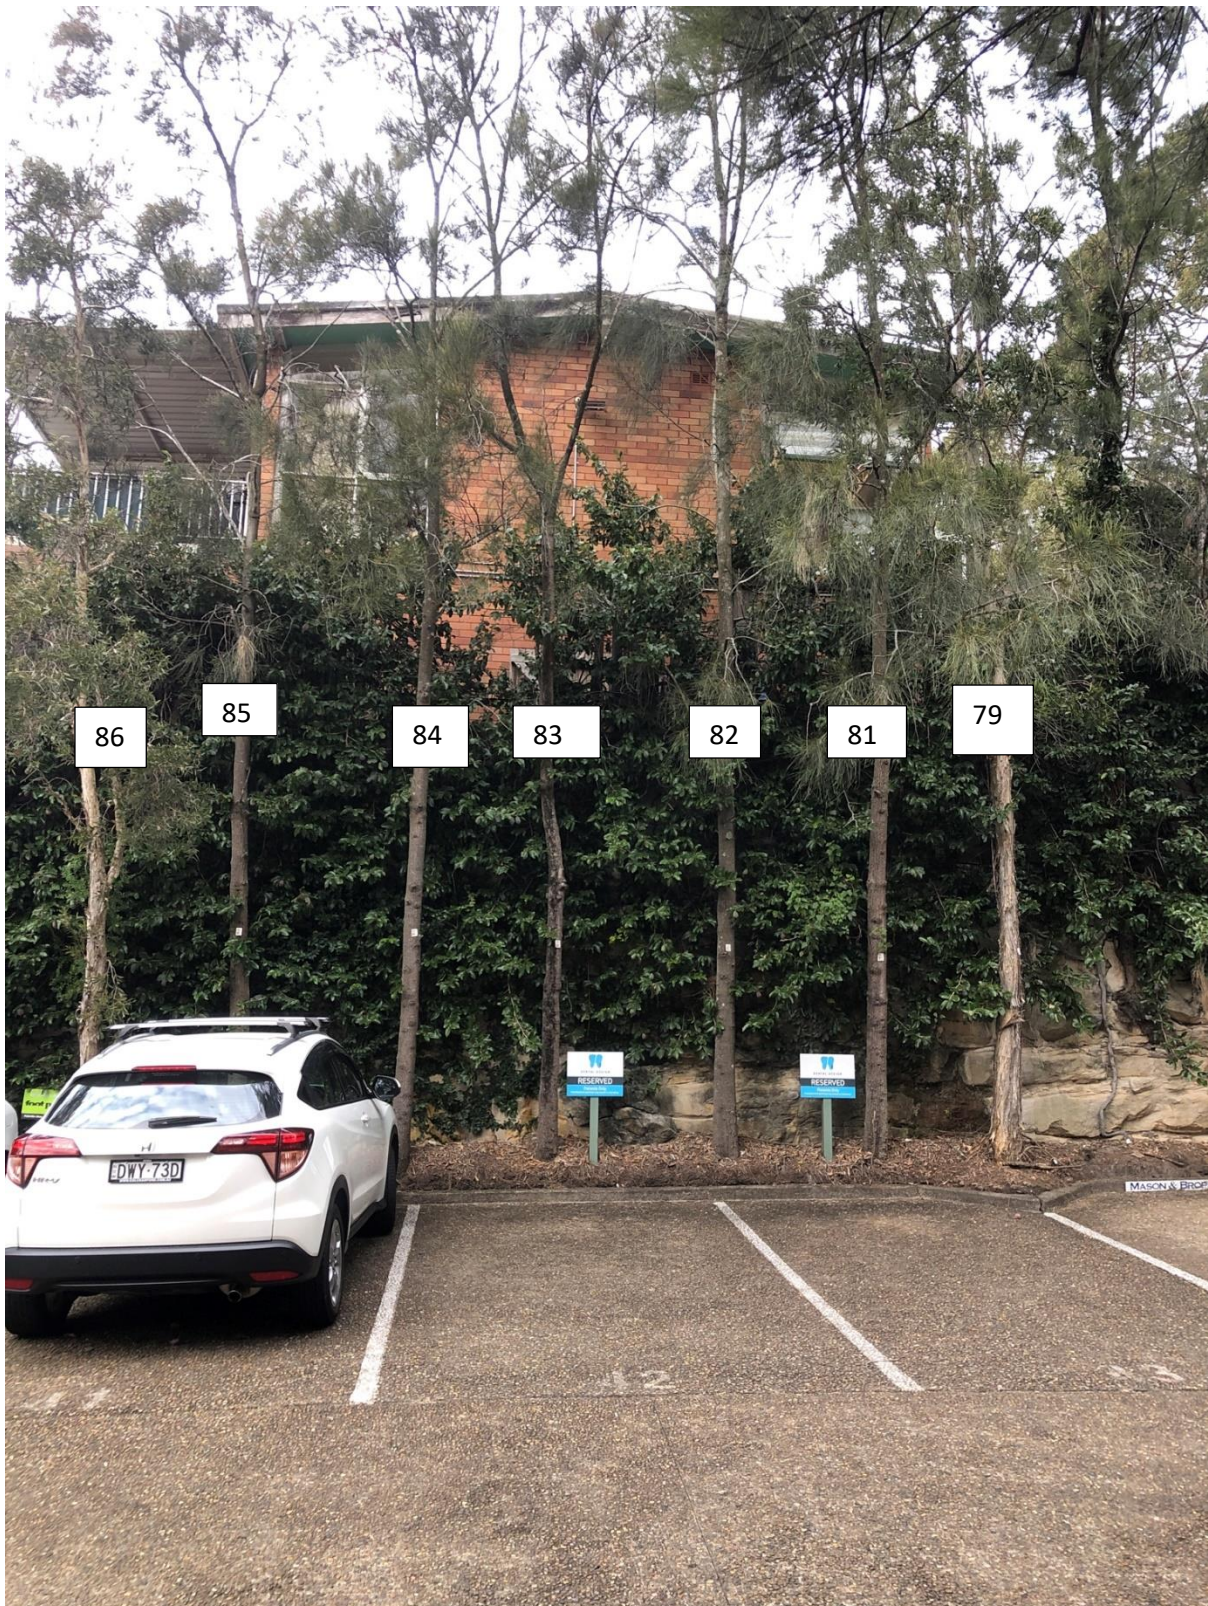
PHOTO 22

Trees 79,81,82,83,84,85,86 – trees growing in narrow garden bed with rock face behind and driveway in front shallow soil .

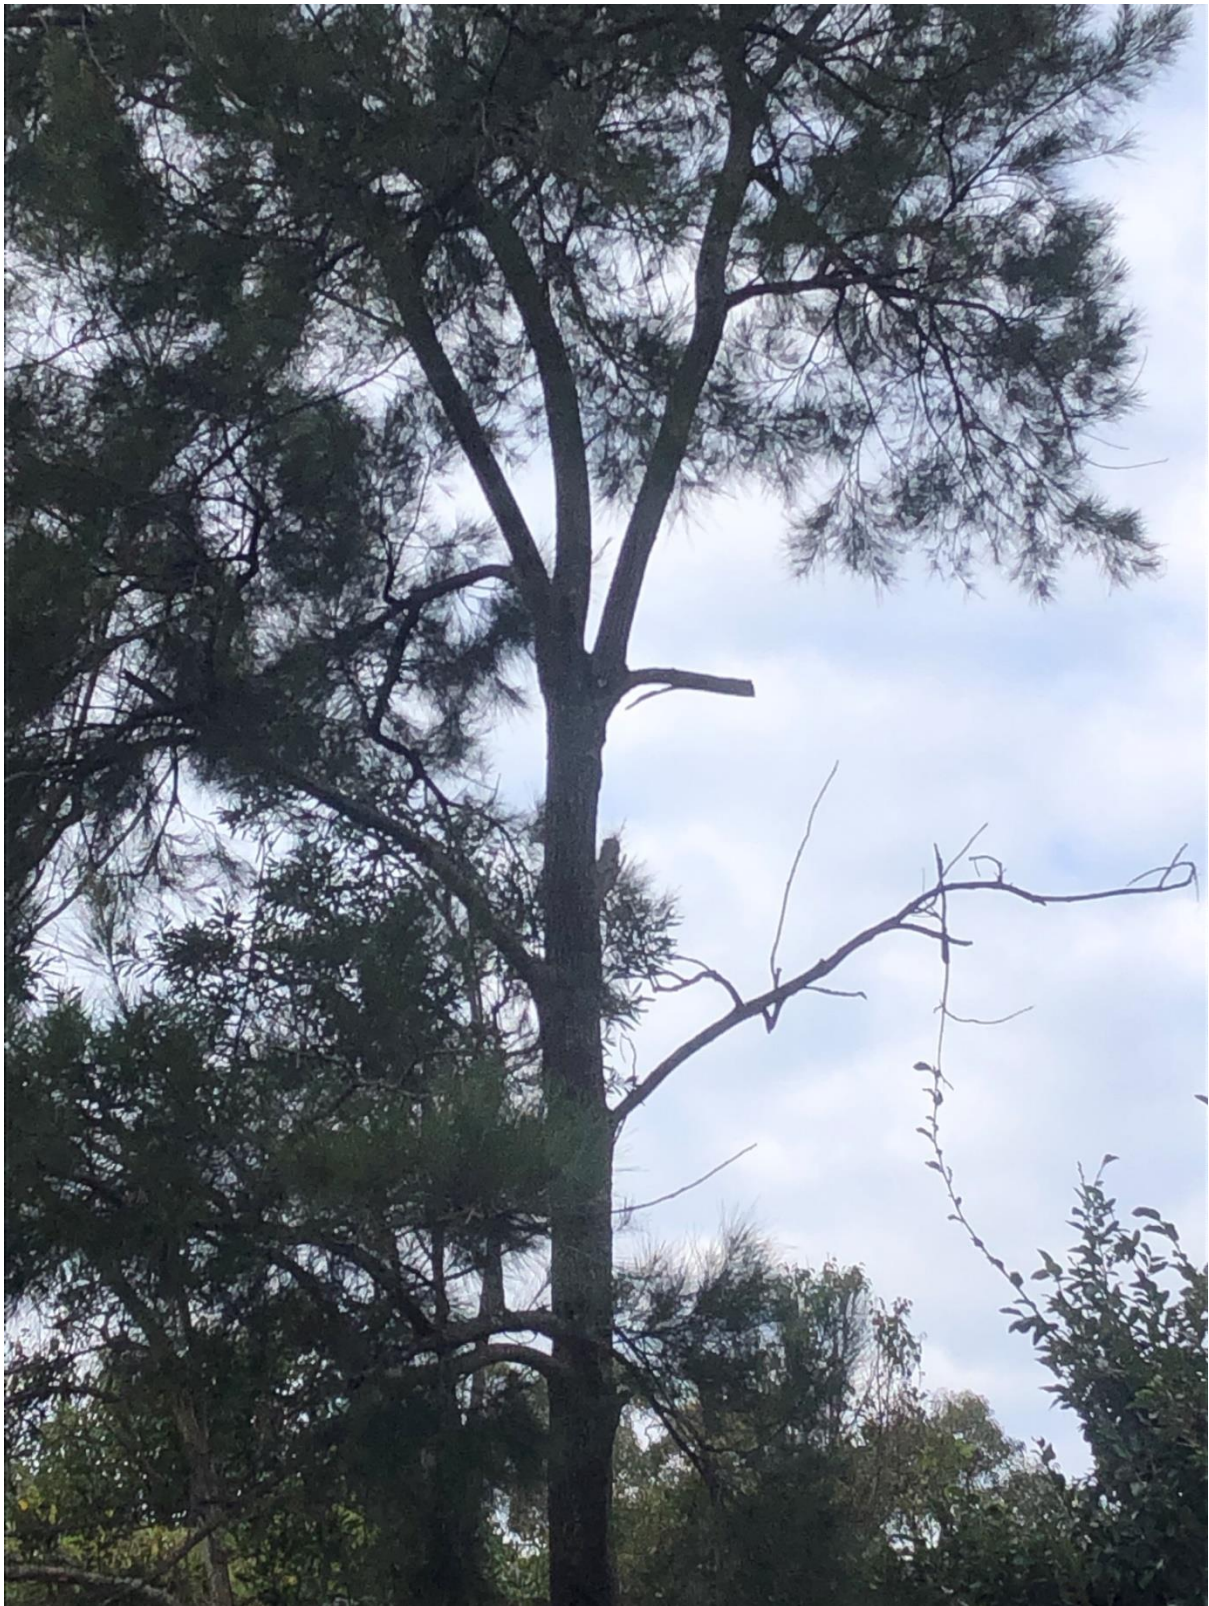
PHOTO 25

Tree 87 – 3-way trunk union at 6 metres

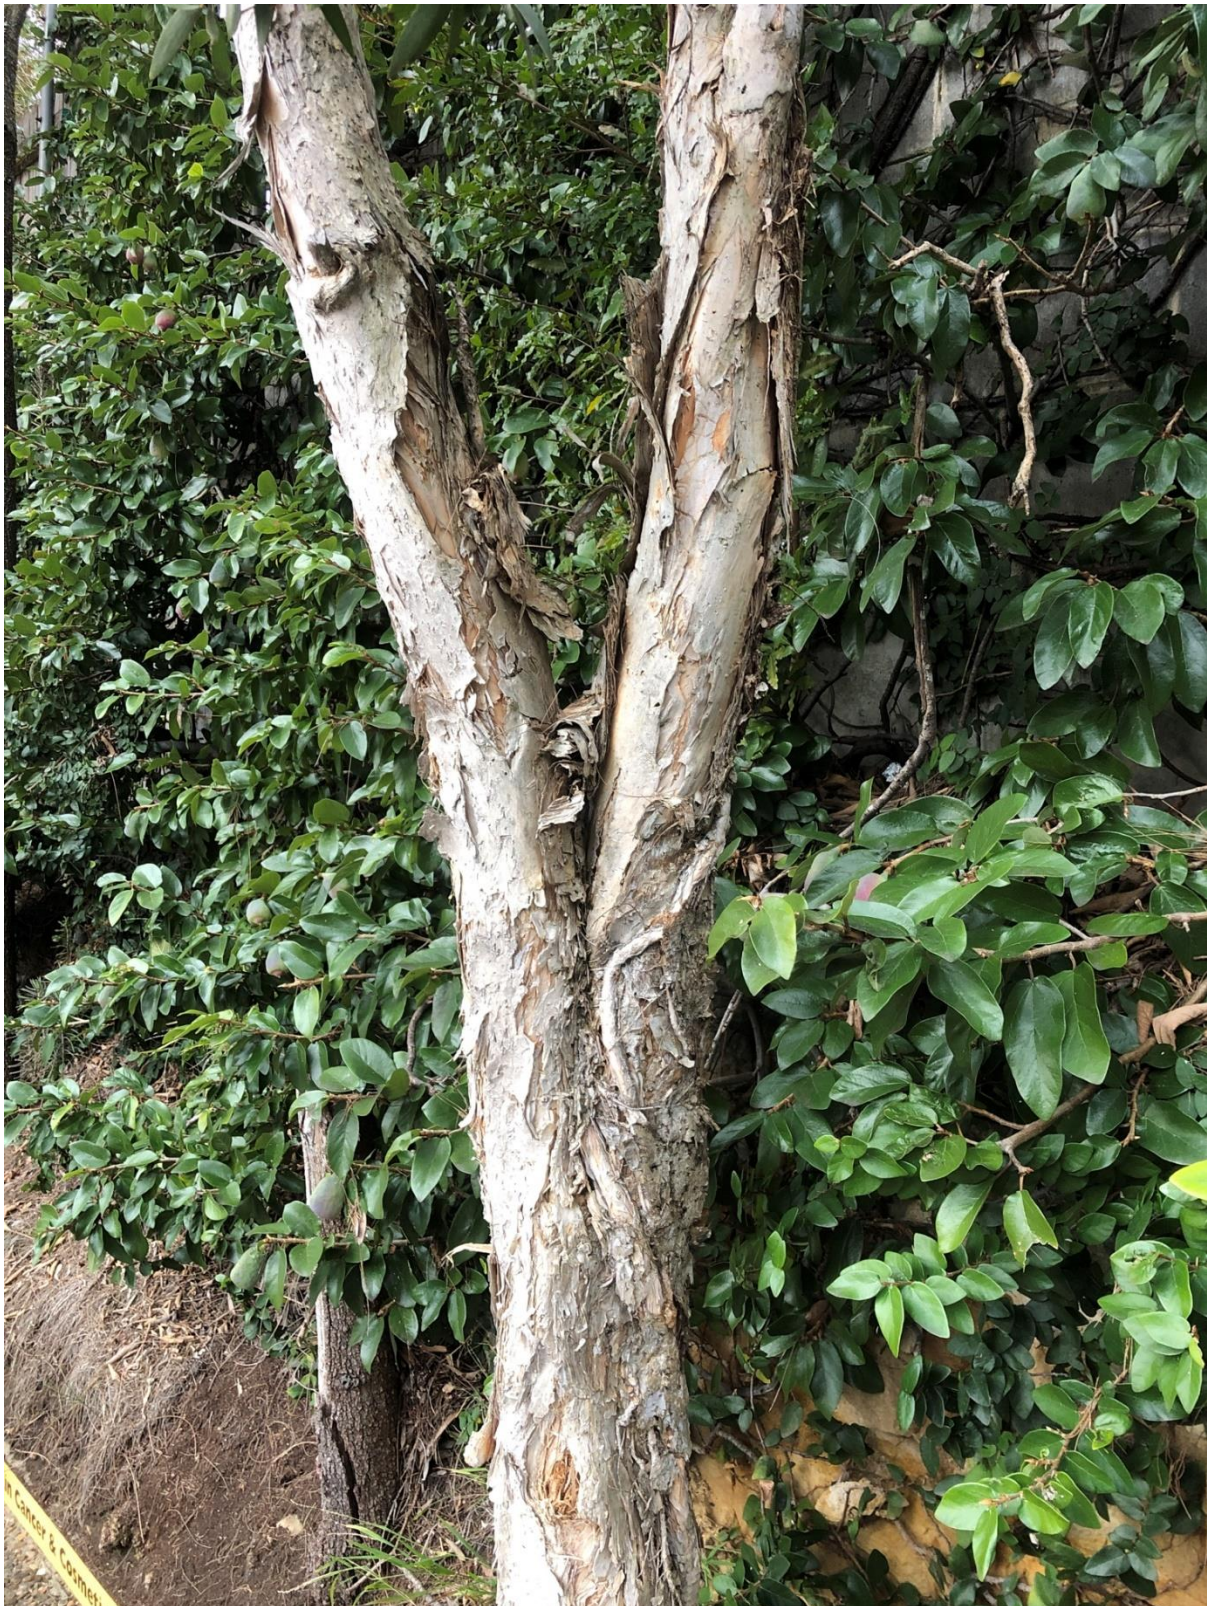
PHOTO 26

Tree 8 – trunk inclusion
