Arborist Report

Project **812 Pittwater Road and 4 Delmar Parade**
Dee Why NSW 2099
Ref: 2021-1061
Job: 65488

Client **Dee Why 3 Pty Ltd & Dee Why 4 Pty Ltd**
c/o Willow Frank
Suite 110 , Level 1
13A Montgomery St
Kogarah NSW 2217

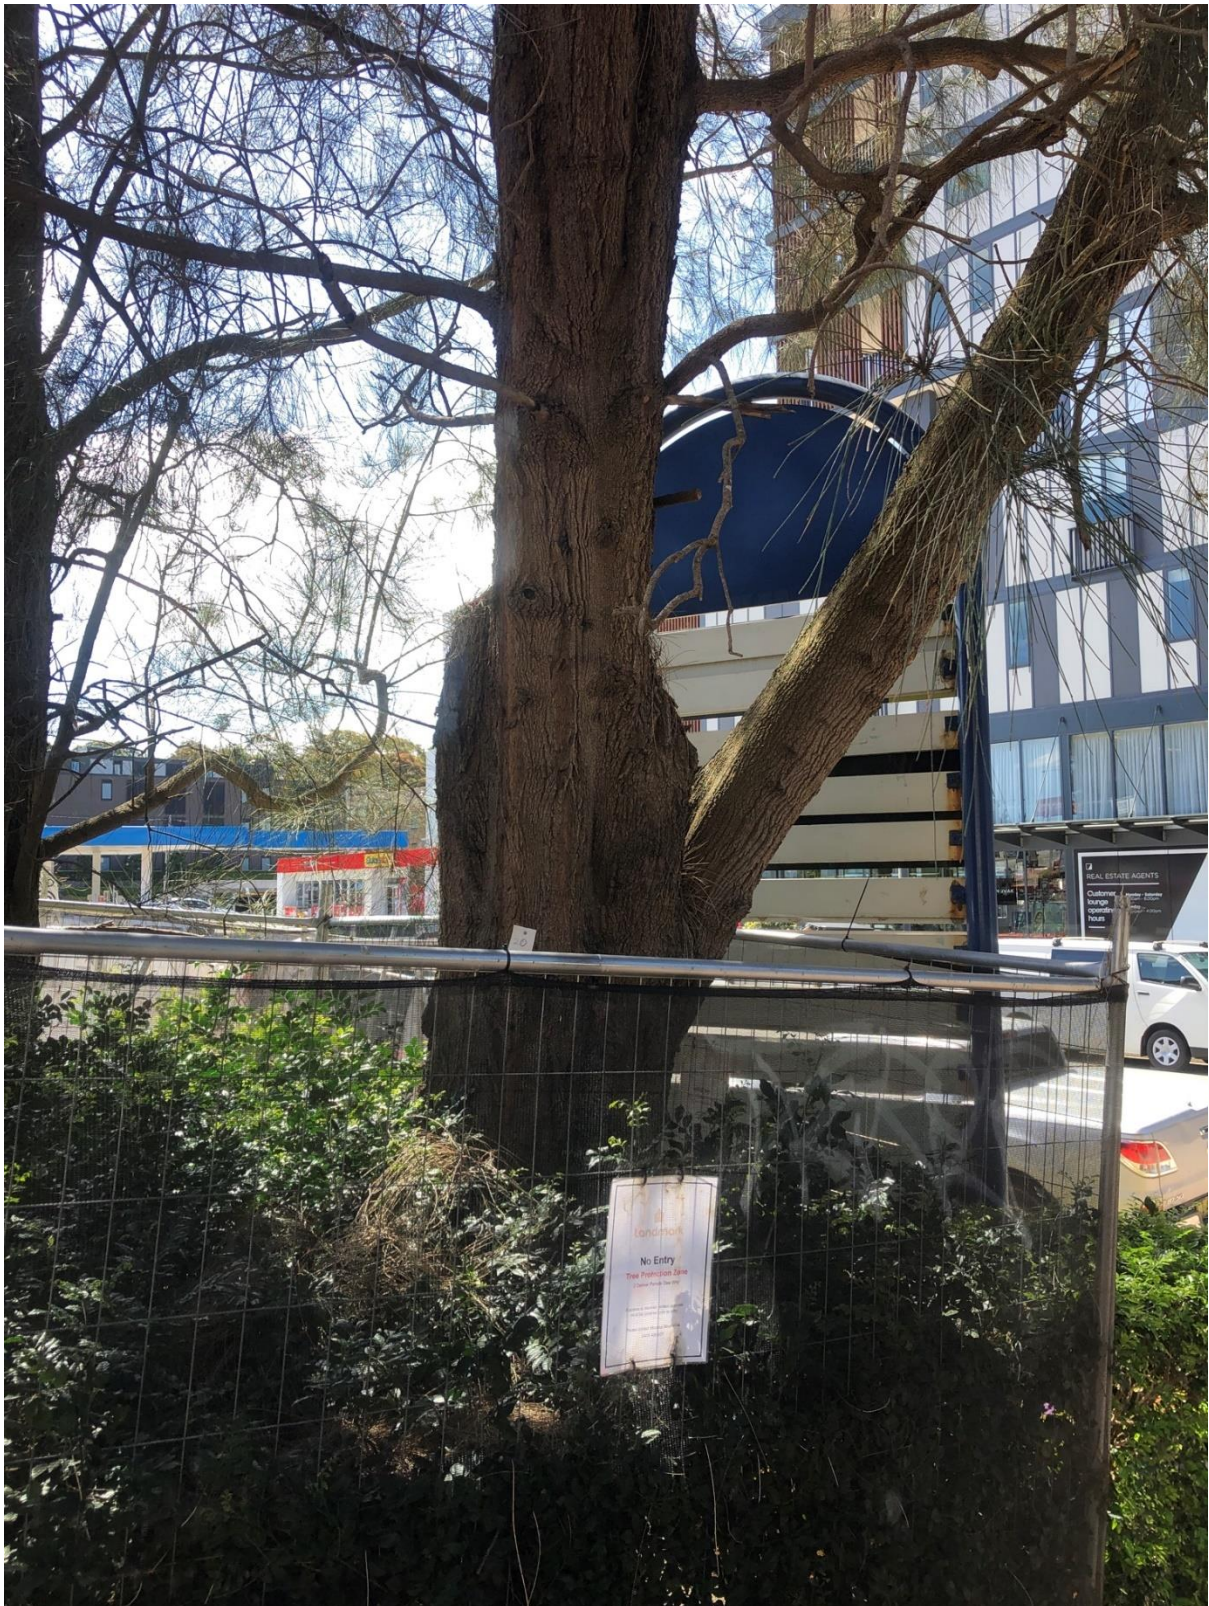
PHOTO 27

Tree 20- Swelling around trunk inclusion

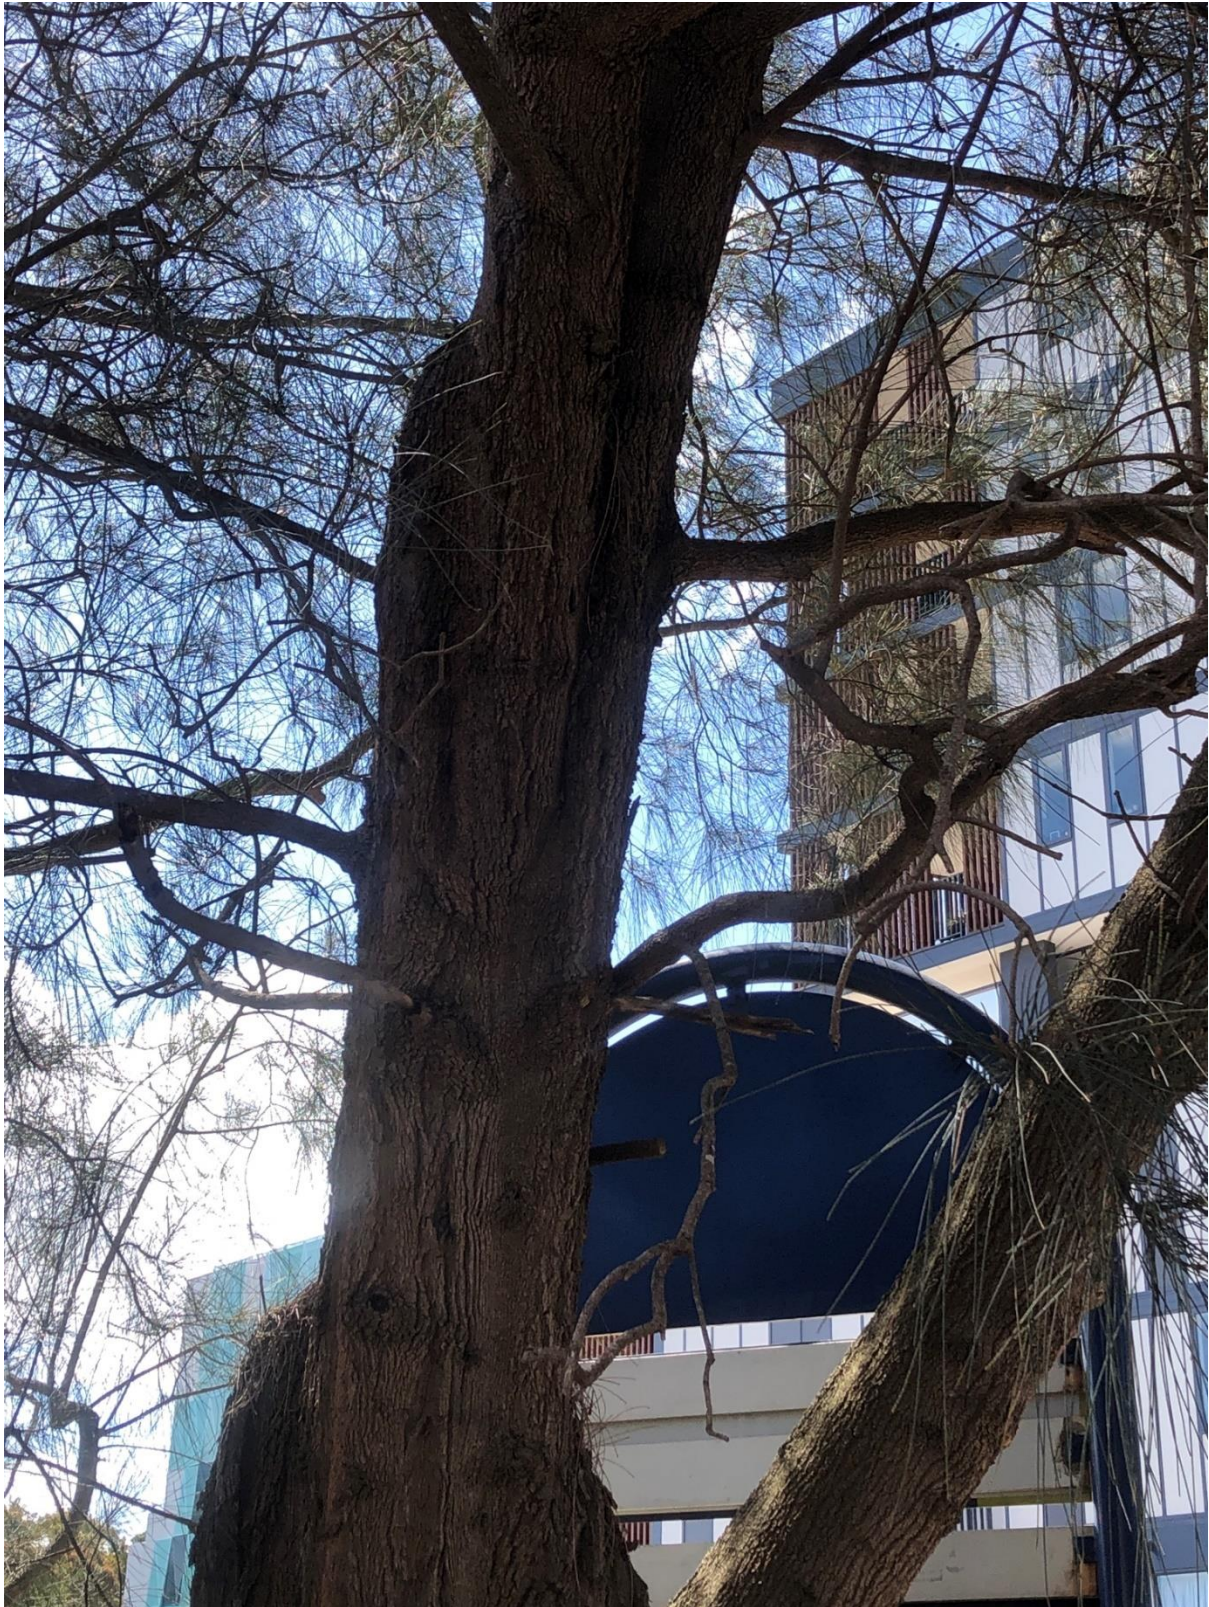
PHOTO 28

Tree 20 – Selling at 4 metres around trunk inclusion
