## **REPORT ON GEOTECHNICAL SITE INVESTIGATION**

### **PROPOSED DEVELOPMENT**

**11 Bruce Street, Mona Vale, NSW**

**Project No.: 2020-129**

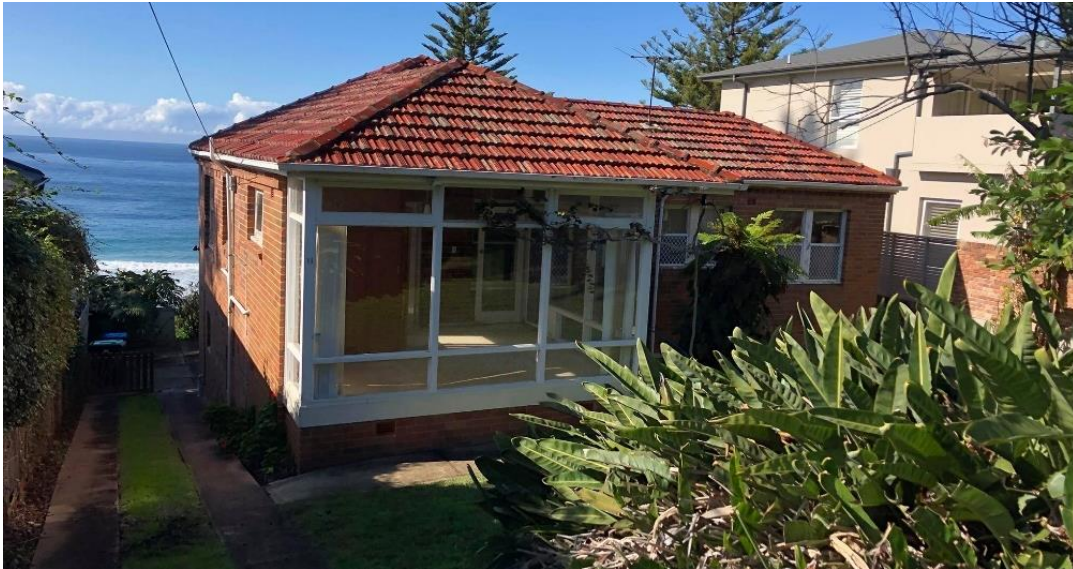
*Photograph 2: View of the front of the site looking north east from Burke Street*

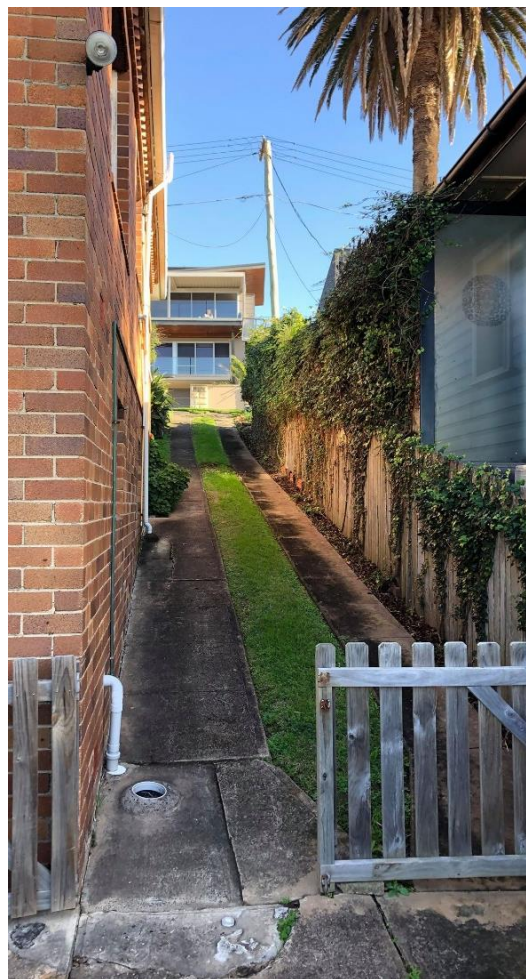
*Photograph 3: View of the driveway along northern side of house, looking west.*

Storm water drainage from the existing structure is largely discharged across the site onto concrete surfaces, this is evident along the northern side (Photograph 3), southern side and rear eastern side of the dwelling. Drainage points are located intermittently throughout the site, downslope to these discharge points. Due to the natural topography of the site, the majority of water discharged which is not intersected by drainage points is expected to flow to the rear of the site, beyond and adjacent to the rear concrete patio.

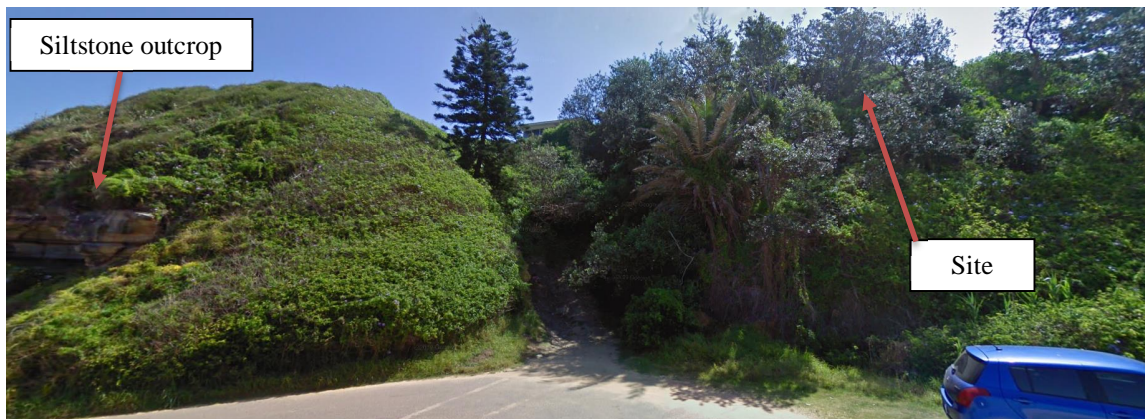
*Photograph 4: View of Warriewood Beach carpark turning circle and above cliff line, looking south west, sourced from Google Maps street view*

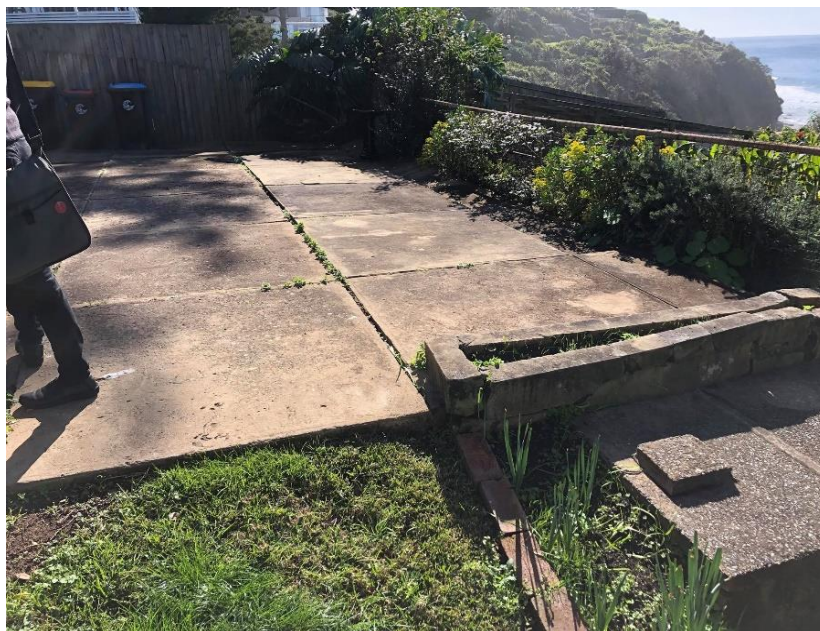
*Photograph 5: Settlement and cracking in rear patio area, looking north*

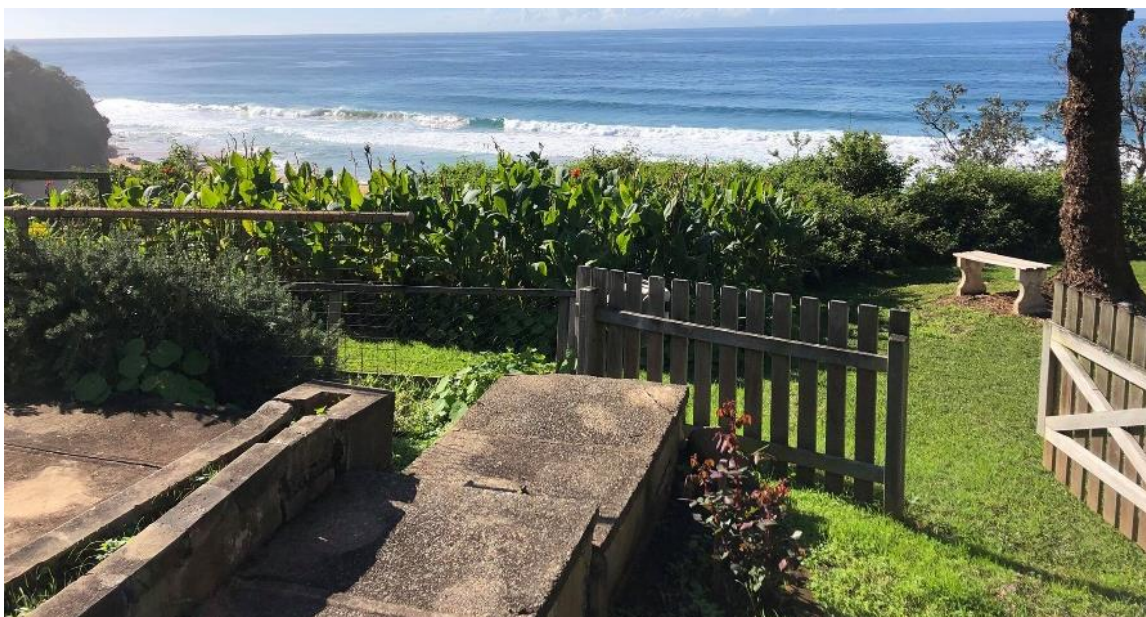
*Photograph 6: View of the rear of the site, looking north east*
