REPORT ON GEOTECHNICAL INVESTIGATION

PROPOSED ALTERATIONS AND ADDITIONS

52A CONSUL ROAD, BROOKVALE, NSW

Project No.: 2023-183

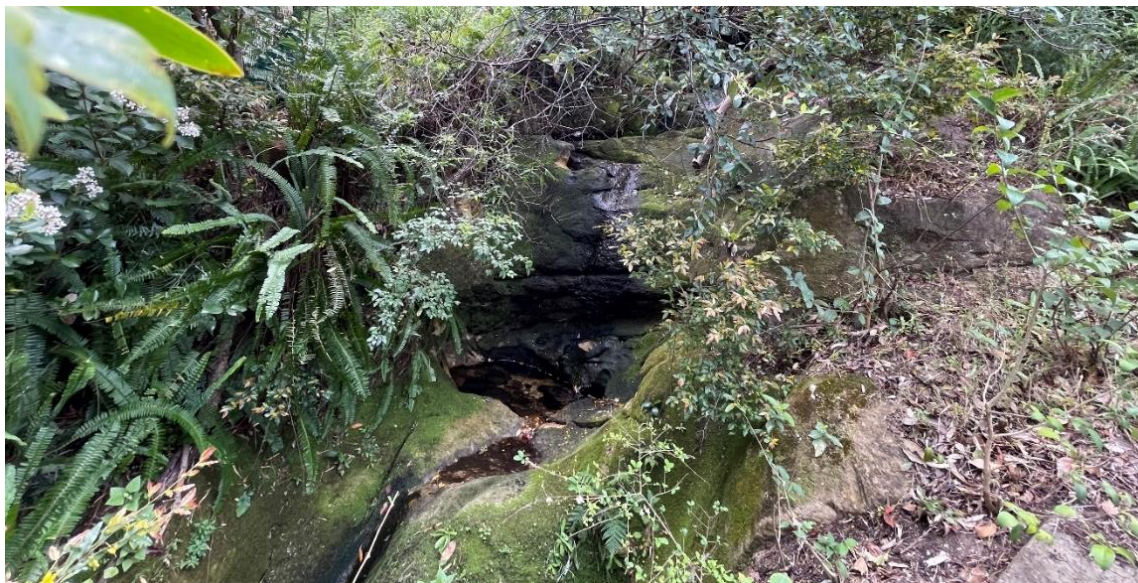
Minor sandstone rock outcrops were observed at the front western side of the grass lawn and were assessed as at least low strength sandstone bedrock without signs of major defects. Similarly, a very steep south dipping natural gully is located adjacent to the sites eastern boundary which consists of sandstone terraces, boulders and dense vegetation as seen in Photograph 2.

Photograph 2: View of the water course adjacent to the site, looking north/northwest

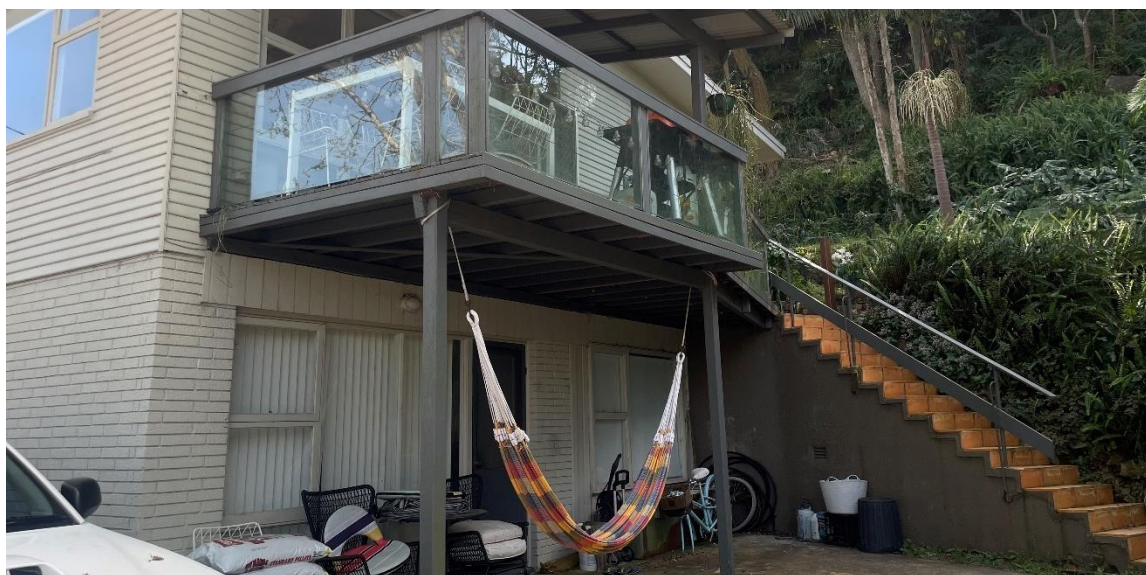
The concrete pavement extends towards the north to a set of concrete steps providing access to the site's one and two storey split level brick and clad dwelling located towards the middle of the site. Concrete steps provide access to the site's rear concrete/tiled path and eastern grass lawn as seen in Photograph 3. The eastern grass lawn is anticipated to have some backfill due to its relatively flat topography. A brick retaining wall (1.0m high) and dry sandstone wall with dense vegetation is situated on the northern side of the stair retaining the eastern grass lawn which can also be seen in Photograph 3. The site dwelling appeared to be in a good condition with no signs of cracks or deformations.

Photograph 3: View of the site dwelling and its surrounds, looking northwest

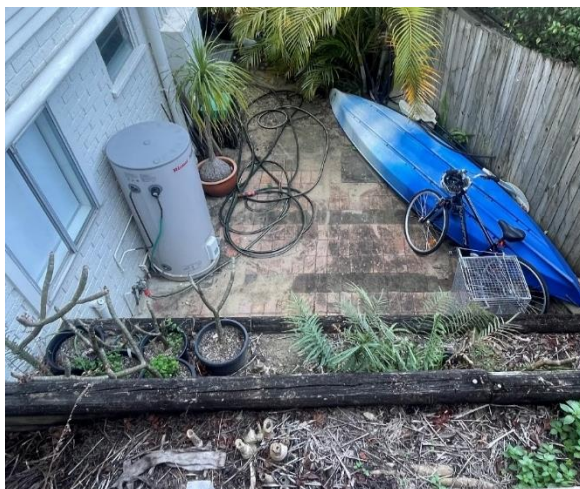
Photograph 4: View of the terraced garden and paved area, looking south

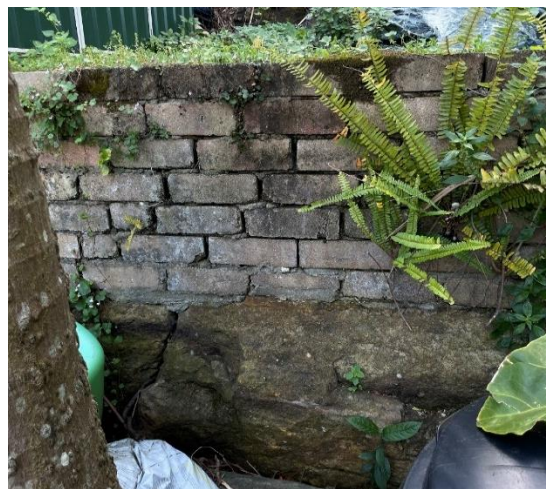
The concrete/tiled path extends towards the western side of the site providing an access to the western grass lawn and garden area. It is understood that fill was placed within the existing lawn/garden area to level out the landscape and provide the existing appearance. The lawn dips south and forms a terraced landscape supported via 1.0m high timber log walls before flattening to a brick paved area as seen in Photograph 4. Furthermore, a terraced landscape with brick retaining wall (0.60m – 0.80m high) is situated towards the northern side of the grass lawn which extends towards the eastern side of the site. The high rear portion of the brick wall was observed to be constructed over a sandstone rock shelf which extends towards the west and into neighbouring property (52 Consul Road), however the shelf disappears as it extends toward the east within the site. The underlying sandstone shelf appeared to be stable with few joint defects, however the brick wall appeared to have been impacted severely due to the lack of drainage and age as seen in Photograph 5.

Photograph 5: View of the Sandstone outcrop and brick retaining wall, looking north

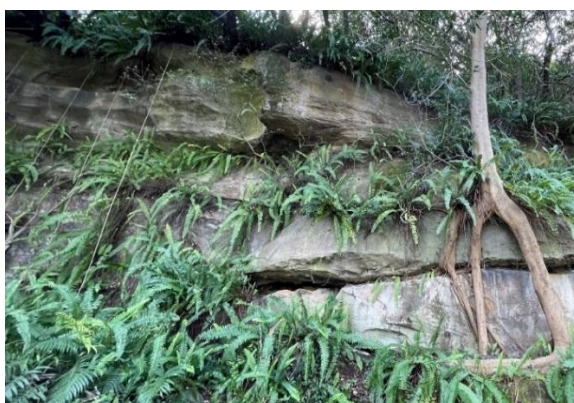
A steep south dipping dense vegetation area extends from the rear brick retaining wall to the northern boundary before a 4.0m high sandstone cliff line extends along the northern boundary and out towards the west as seen in Photograph 6. The cliff consists of sub-horizontal bedding defects and seams with sandy infill at approximately 1.50m intervals, however no geotechnical concern was encountered during our inspection. Sandstone rock shelf/cliff lines up to 1.0m in height (dipping south by 15° - 20°) were observed within the rear dense vegetation area which appeared to be in a good condition and did not exhibit geotechnical concerns. Sandstone boulders varying from 3.0m² to 0.2m² are scattered throughout the rear area as seen in Photograph 7, however all the observed boulders appeared buried beneath the existing ground surface and did not exhibit any geotechnical concerns which could impact the future development within the site. A small scale drainage gully was observed towards the rear eastern side of the site which was observed to be dipping southeast merging with the gully located on the eastern side from the site boundary. The small gully within the site shows signs of only minor seepage and medium to large sandstone boulders.

Photograph 6: View of the rockface, looking north

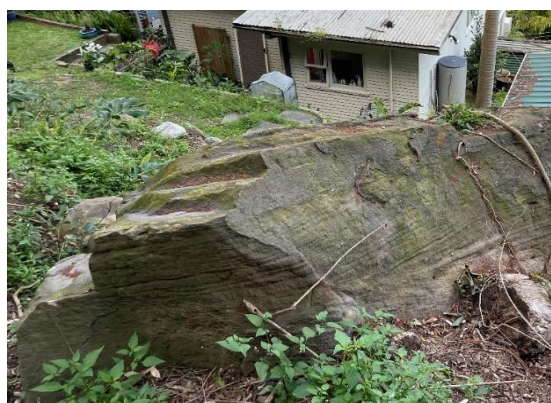
Photograph 7: View of the sandstone boulder, looking south

Large to small sandstone boulders were observed toward the northern side of the site which did not pose an immediate threat to the proposed development work. However, inspection will be required post excavation work to ensure the boulders will remain stable.

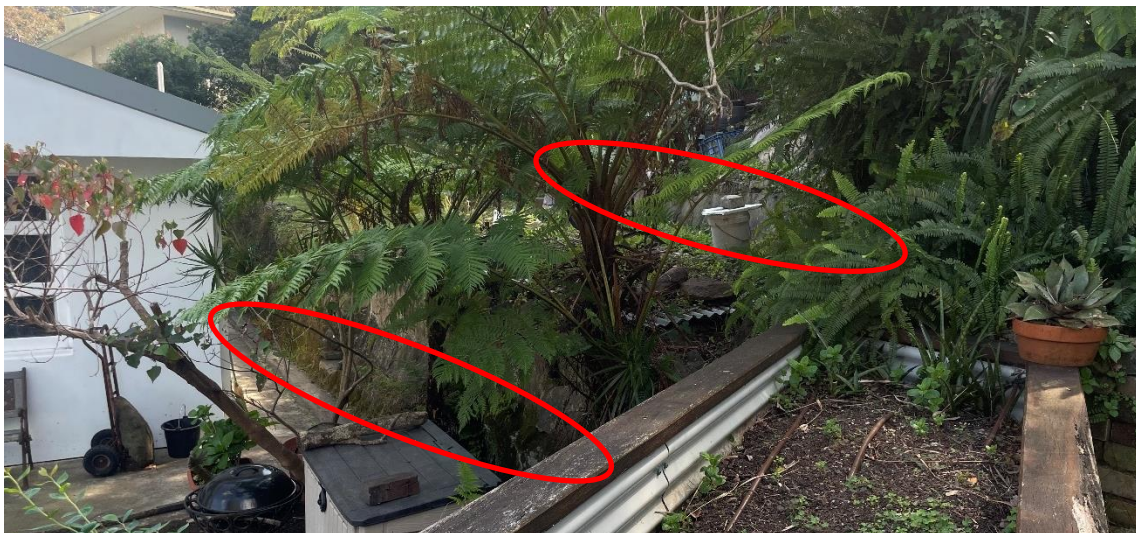
The neighbouring property to the west (52 Consul Road) consists of a two storey rendered brick residence towards the middle of the property with a terraced landscape with dense steep dipping vegetation towards the rear and a concrete driveway and steep south dipping grass lawn towards the front. Sandstone shelves were observed towards the rear of the property's dwelling which extended into the site and can be seen in Photograph 8. The property levels are approximately 1.0m below the site with similar south dipping topography. The property dwelling and surrounding structures appeared to be in a good condition and did not exhibit signs of geotechnical concerns.

Photograph 7: View of the rock shelf (marked) within the neighbouring property (No. 52 Consul Road)

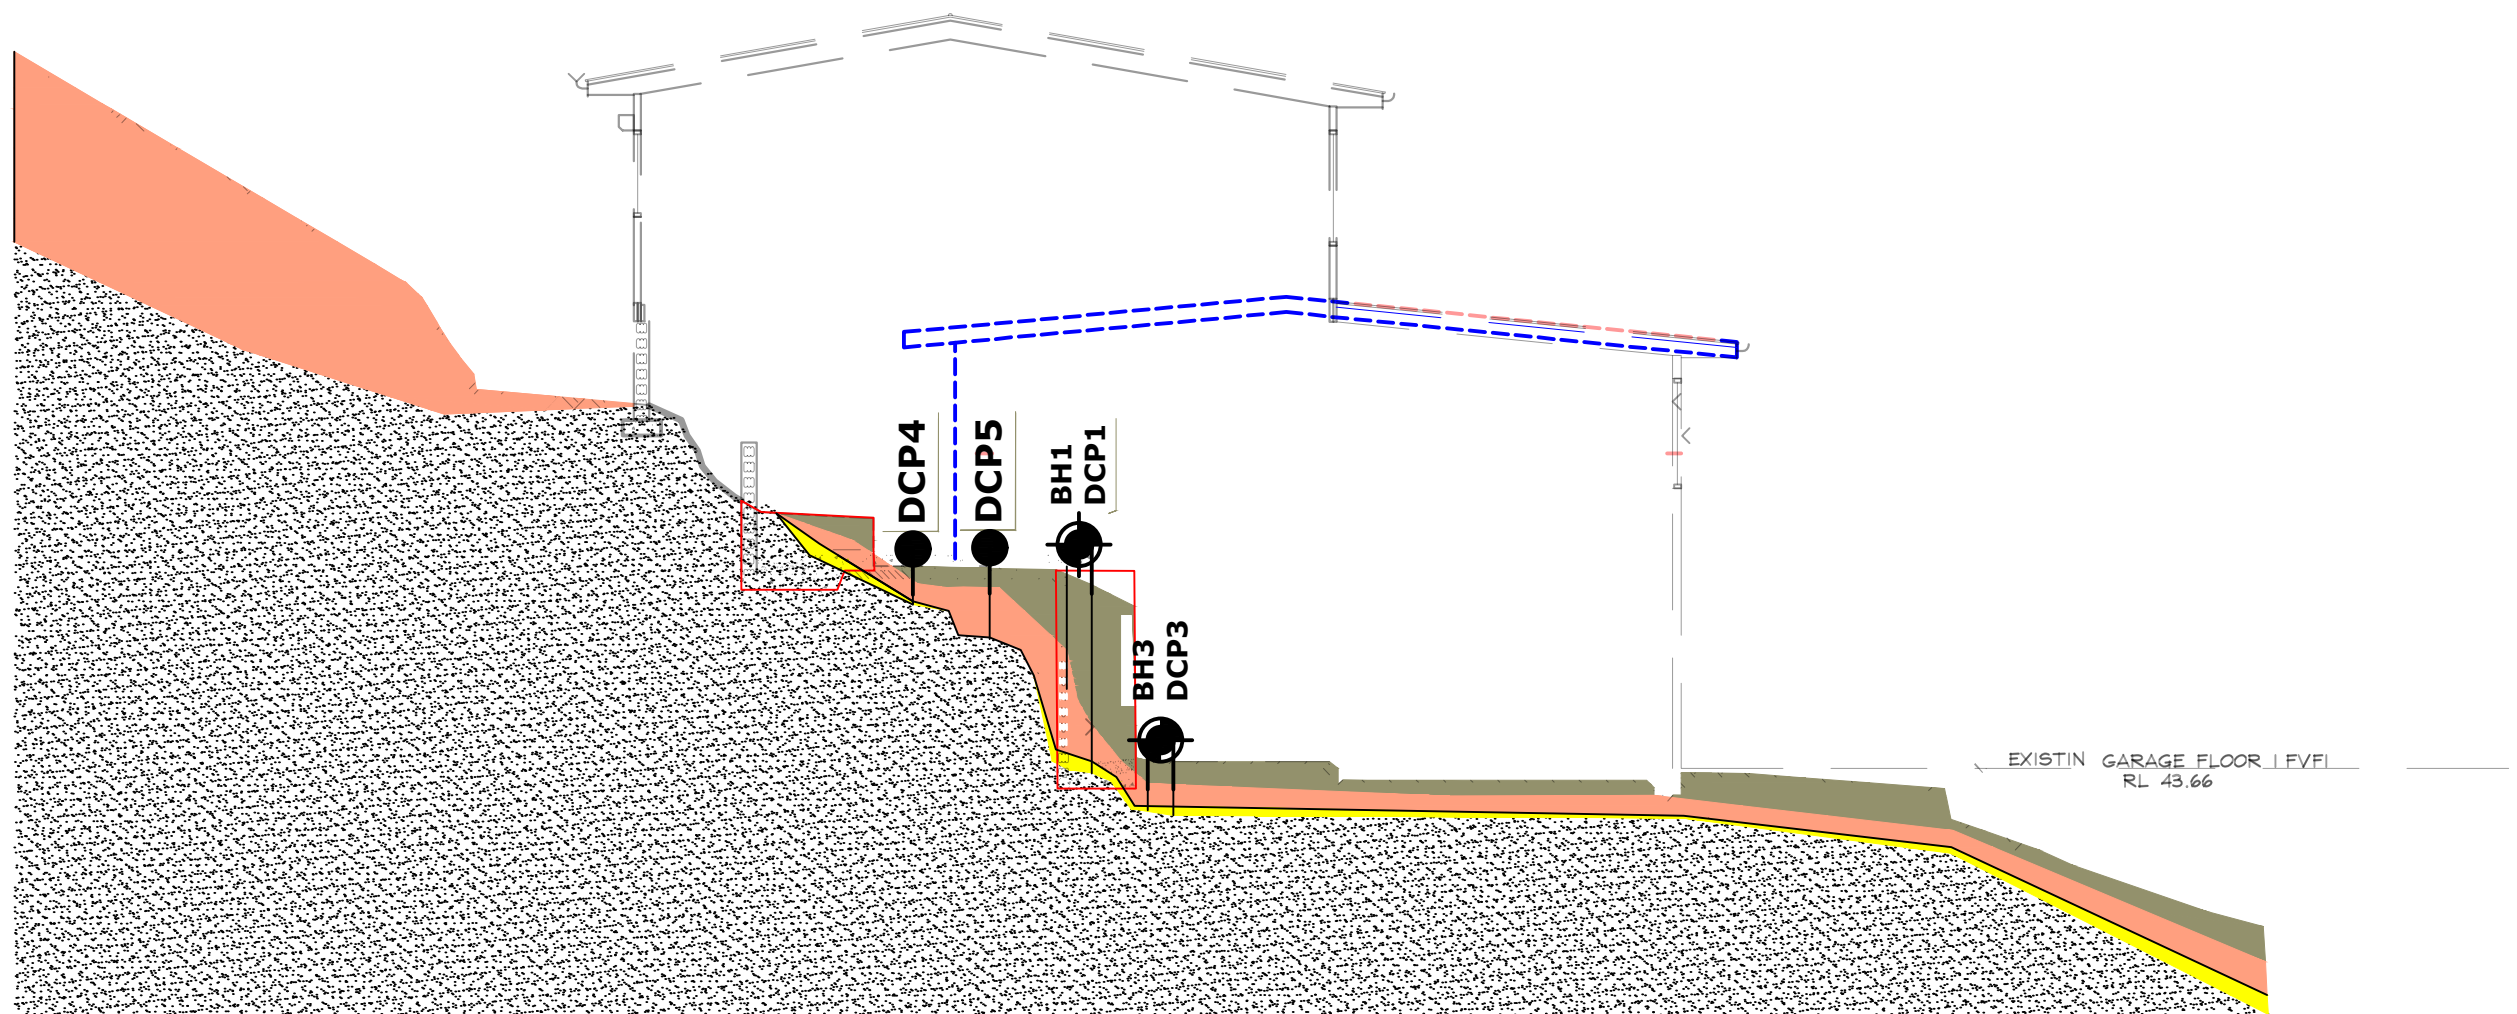
SITE SECTION | FIGURE 2.

Based on the borehole logs and DCP test results, the sub-surface conditions at the project site can be classified as follows:

- **FILL** – This layer was encountered in the boreholes extending from ground surface to a maximum depth of 1.10m(BH1). Where intersected in the borehole it was classified as a loose, dark grey, moist silty sand with sandstone gravels/cobbles.

- **RESIDUAL SOILS** – Natural clayey sand was intersected in all borehole locations from a minimum depth of 0.10m depth (BH2) and a maximum depth of 1.60m depth (BH1). It was identified as very loose gradually transition to medium dense, pale brown to pale grey, moist medium to coarse grained.

- **SANDSTONE BEDROCK** – This unit was encountered within all the boreholes and from a minimum depth of 0.30m depth (BH2) and maximum depth of 1.0m (BH1). Similarly, sandstone shelves and cliff lines were observed predominantly towards the rear side of the site and within the neighbouring property towards the west (52 Consul Road). It consisted of bedding defects dipping towards the south by 15° – 20°. The outcrops were identified as least very low to low strength sandstone with only minor defects within the short cliff line. Overhangs, parting defects and clayey sand seams were observed over the face of the tall cliff line at northern boundary of the site, however the cliff was observed to be stable.
