**REPORT ON GEOTECHNICAL SITE INVESTIGATION**

**PROPOSED NEW DEVELOPMENT**

**70 LAUDERDALE AVENUE, FAIRLIGHT, NSW**

**Project No.: 2019-155**

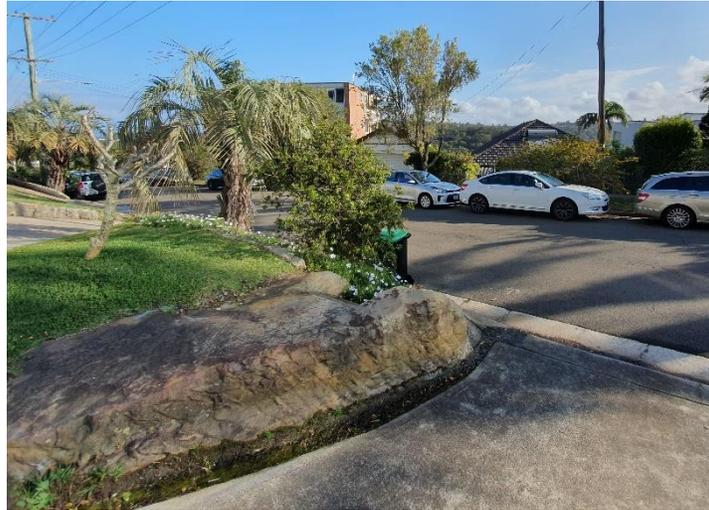
Adjacent to the site's north boundary, the road reserve contains gently dipping lawn and a concrete footpath along the boundary. There were no signs of excessive cracking or deformation within the road pavement or pathway to suggest any movement or underlying geotechnical issues. Minor rock outcrop comprising low to medium strength sandstone is visible, approximately 20.0m north from the north boundary, between the Rosedale Avenue road pavement and No.14 Rosedale Avenue. This sandstone outcrop has been excavated and used as a staircase for the public (Photograph-4).

*Photograph-4: Minor sandstone outcrop observed. View looking south*

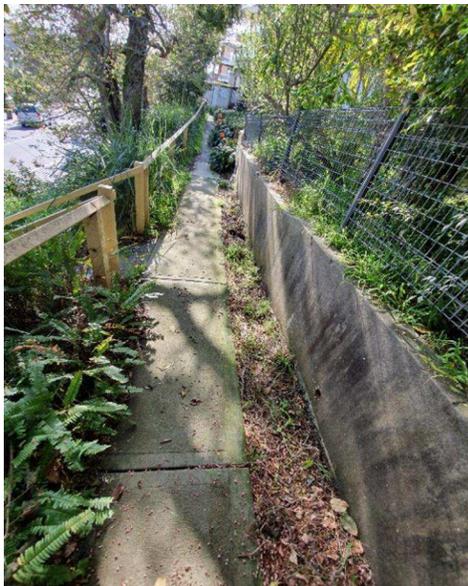
Adjacent to the site's south boundary, the road reserve contains an elevated concrete footpath, approximately 2.5m above the Lauderdale Avenue road pavement with a steep vegetated slope between the road and footpath. This footpath has a low point approximately 5.0m east of the site's west boundary (Photograph-5& Photograph-6) indicating a shallow gully base. Adjacent to this lower point is a sandstone block staircase that leads down to the road pavement. It can be observed within the staircase that the top 6 steps have been pre-worked and brought to the site while the lower 5 steps comprises of insitu low to medium strength sandstone that have been carved into stairs. It can also be seen in Photograph 7 that the top 6 steps are dry and the lower 5 steps are wet, due to water seepage.

*Photograph-5: Footpath. View looking west.*

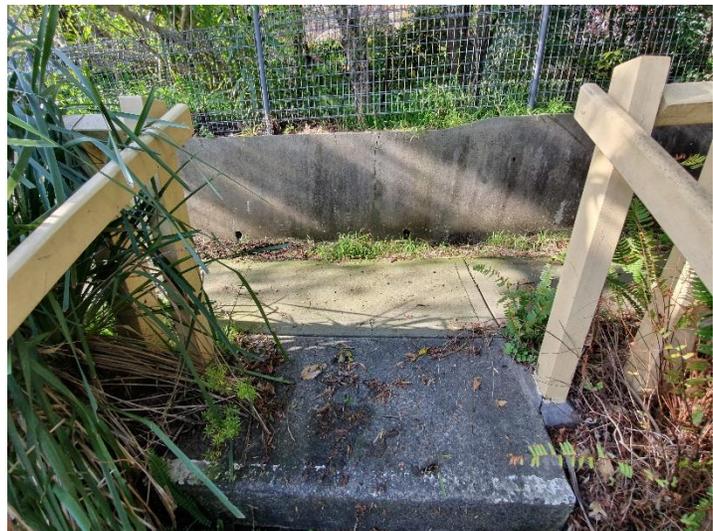
*Photograph-6: Footpath low point. View looking north.*

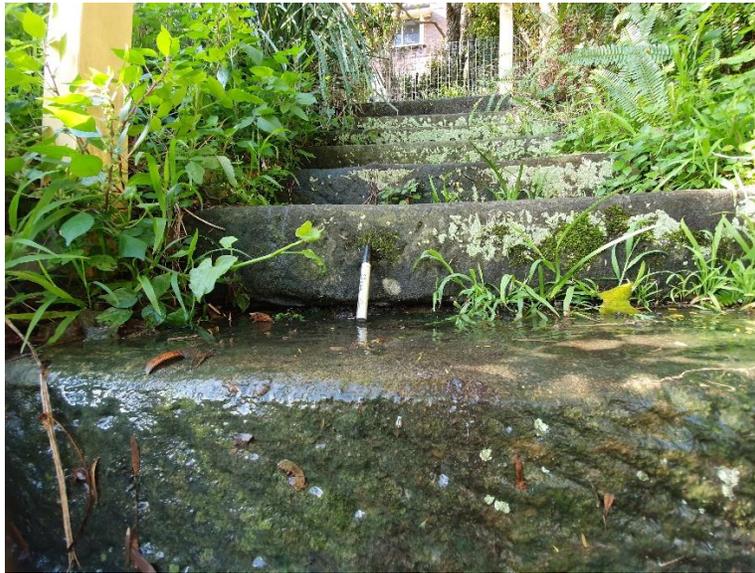
*Photograph-7: Dry and wet staircase. View looking north.*

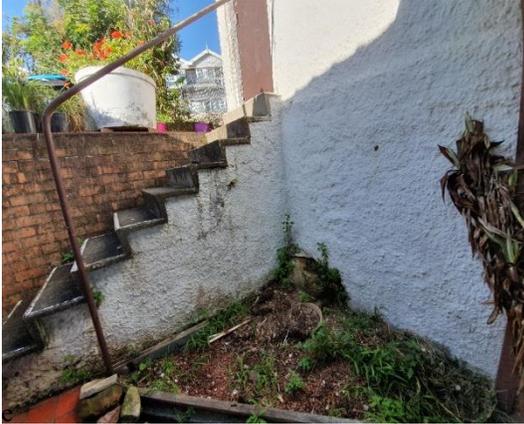
Minor outcrop comprising low to medium strength sandstone was visible (Photograph-8 & Photograph-9) at the base of the garage. The garage external walls appear to be in reasonable condition with no sign of settlement or cracking on its external walls.

*Photograph-8: Staircase. View looking north*

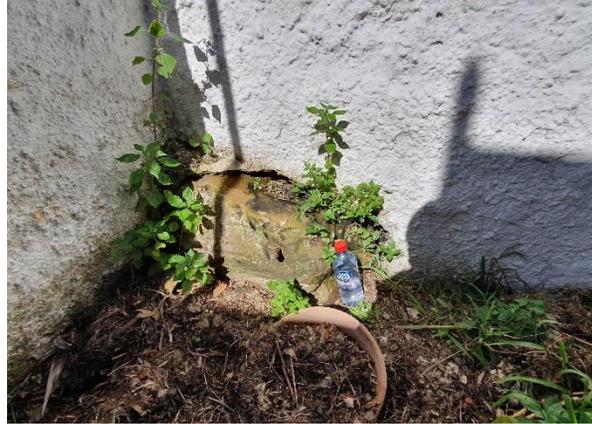
*Photograph-9: Minor outcrop View looking east north*

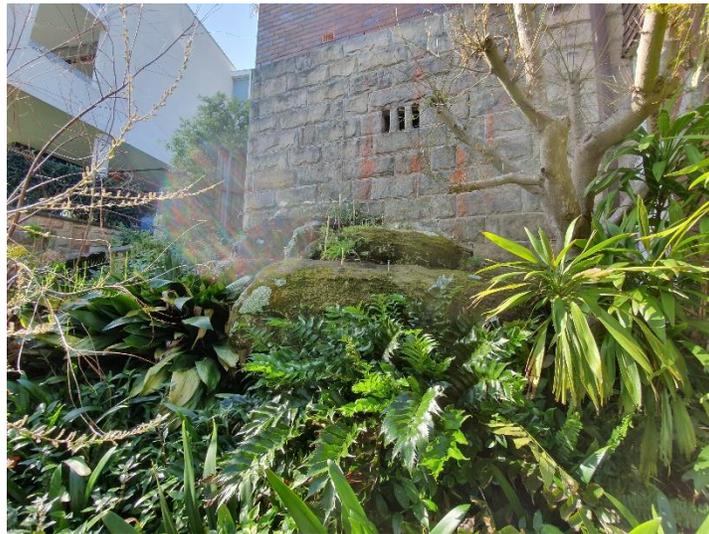
The rear backyard at the south side of the site consists of a gentle ( $<10^\circ$ ) south dipping lawn with several trees along the south boundary. At the south west base of the existing house, rock outcrop (approximately 4.0m wide and R.L. 36.58m.) can be seen, this rock curves underneath the house and contains garden beds downslope (Photograph-10). The external house walls at the south appear to be in reasonable condition with no sign of settlement or cracking.

*Photograph-10: Sandstone rock at rear lawn. View looking north*
