Report Title: Geotechnical Report 25 The Outlook, Bilgola Plateau

GEOTECHNICAL INVESTIGATION:

Alterations and Additions at **25 The Outlook, Bilgola Plateau.**

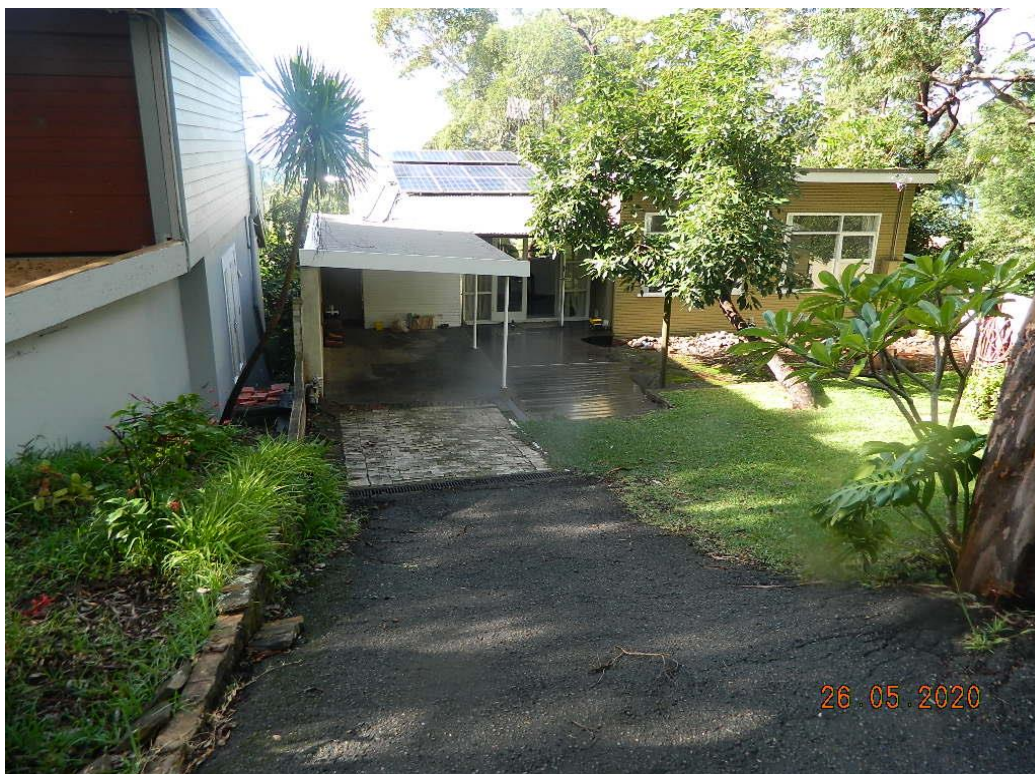
Photo 2

The part two storey brick and timber clad house is supported by brick walls and brick piers (Photos 2 & 6). The supporting walls and piers stand vertical and show no significant signs of movement (Photo 7). Sandstone bedrock is outcropping under the house (Photo 7). A timber deck supported by steel posts extends off the downhill side of the house (Photos 6 & 8). The deck is in good condition.

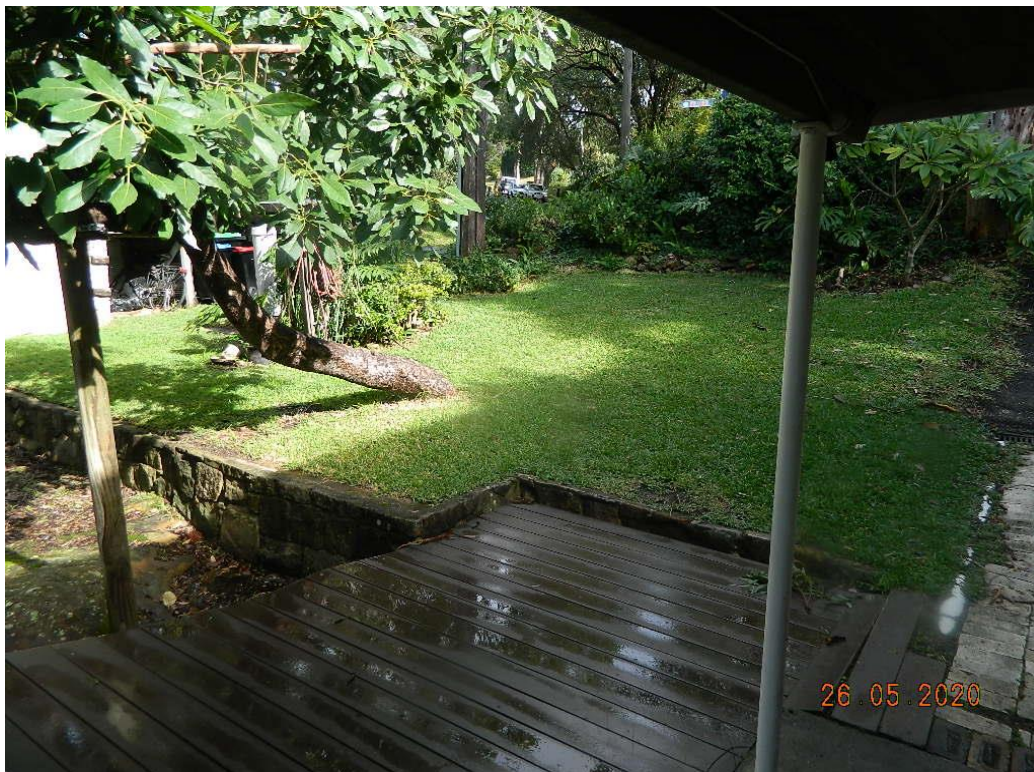
Photo 4

The pier does not appear to have moved since 2004 and is currently considered stable. Between the road and the house is a gently sloping lawn (Photo 4). Fill that levels the lawn is supported by a low sandstone block retaining wall. Medium Strength Sandstone bedrock is exposed at the surface below the retaining wall (Photo 5).

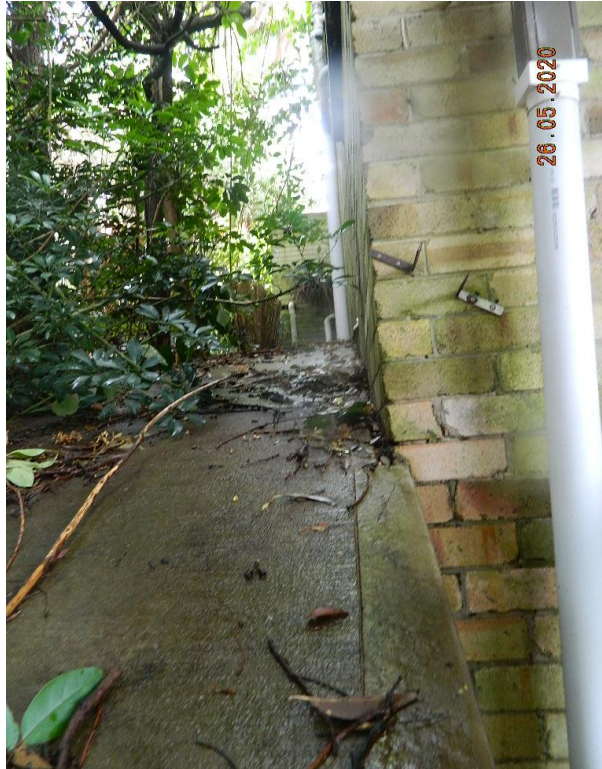
Photo 9

A stormwater pipe from the road above terminates on the S side of the house. Stormwater from the pipe flows into a concrete channel that runs beside the house (Photos 9 & 10). These works appear to have been carried out as remedial measures after the 2004 report noted the sandstone the house was supported on was slightly undercut by the flow. The stormwater from the concrete channel flows into a creek channel immediately below the house and the creek extends to the lower boundary (Photo 11). A moderately sloping lawn extends from below the downhill side of the timber deck (Photo 12). A timber and steel clad studio is located near the downhill boundary of the property (Photo 13). The studio is supported by three rows of timber posts (Photo 14). The upper two rows of posts were tilting from vertical. One of the supporting posts is founded on the edge of the creek (Photo 15). It is recommended that the structure be used for storage only. The studio will be demolished as part of the proposed works. The slope below that extends to the lower boundary falls steeply (Photo 16). No signs of slope instability were observed on the property. The adjoining neighbouring properties were observed to be in good order as seen from the street and subject property.

A stormwater pipe from the road above terminates on the S side of the house. Flows from the pipe run into a concrete channel beside the house and then into an open creek channel below the house (Photos 9 & 10). The creek runs down the property to the lower boundary and beyond (Photo 11). It was flowing during the inspection when it was raining.

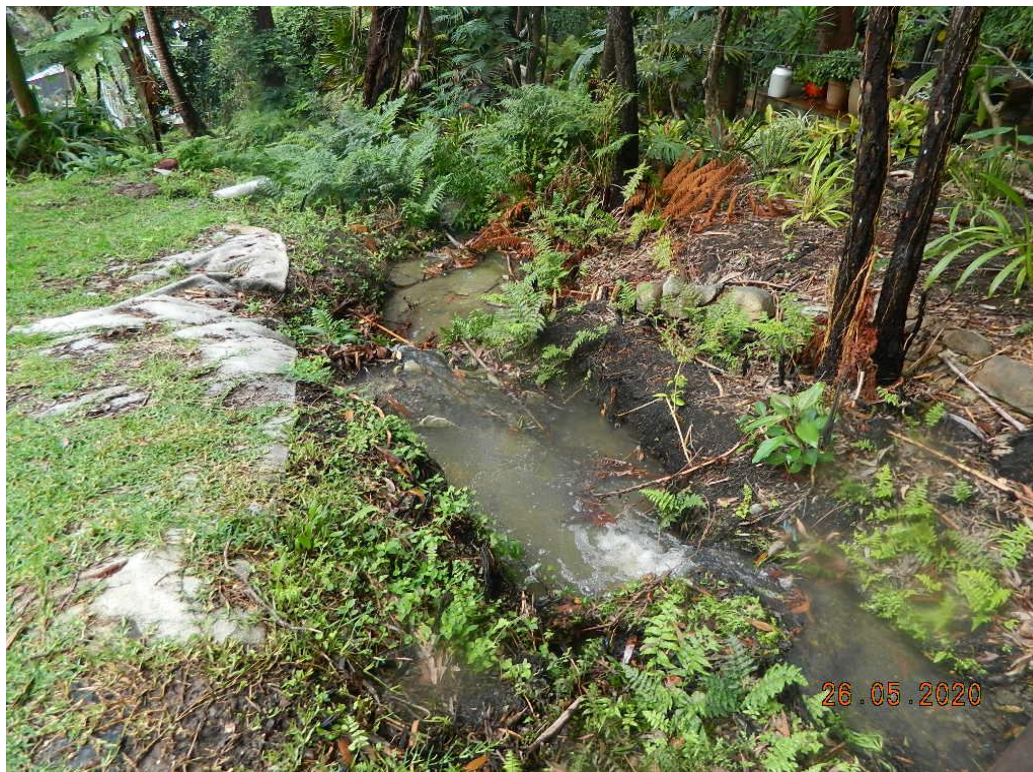
Photo 11

As a watercourse flows across the property (Photo 11), we expect groundwater seepage to be slightly higher across the block as slope seepage will move towards the watercourse.

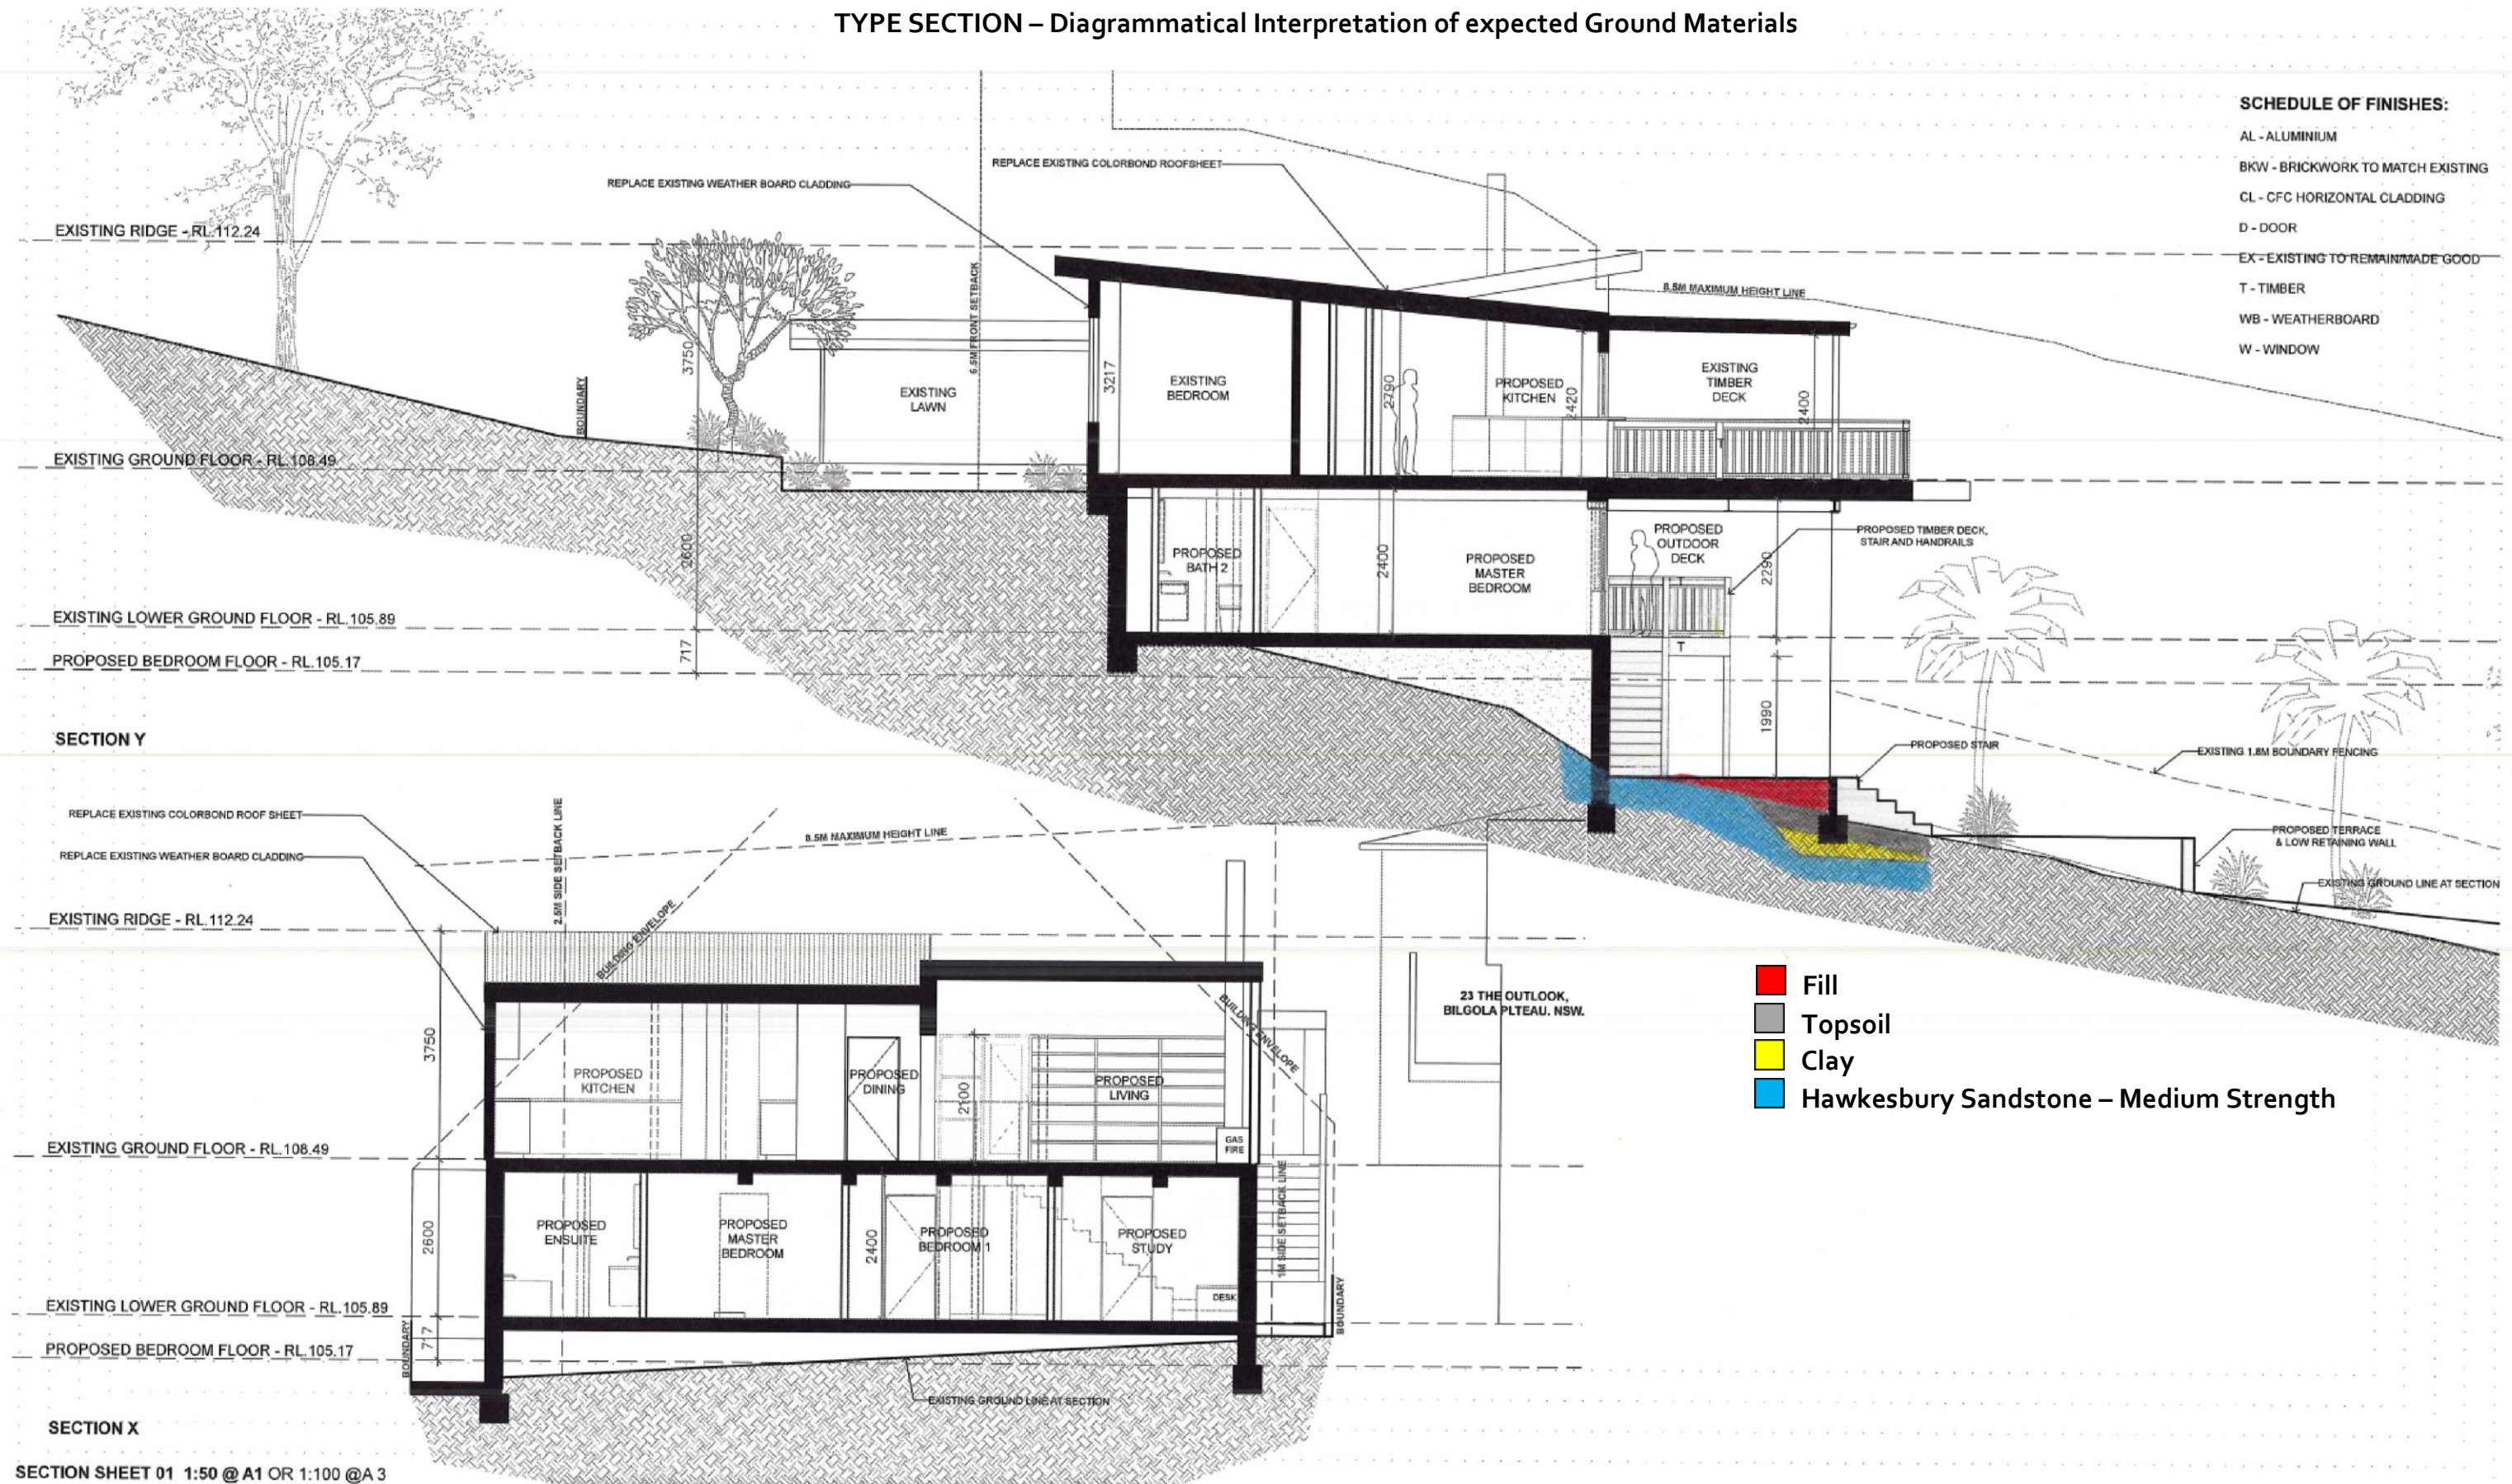
TYPE SECTION – Diagrammatical Interpretation of expected Ground Materials

The surface features of the block are controlled by the underlying sandstone bedrock that steps down the property forming sub-horizontal benches between the steps. Where the grade is steeper, the steps are larger and the benches narrower. Where the slope eases, the opposite is true. The rock is overlain by fill, soil and clay that fills the bench step formation. In the test locations, the depth to rock ranged from the surface to depths of between 0.1 to 0.5m below the current surface. The sandstone underlying the property is estimated to be Medium Strength or better. See Type Section attached for a diagrammatical representation of the expected ground materials.
