Review of Future Maintenance and Upkeep Cost for Brookvale Oval

May 2010

Prepared for the Warringah Council

Prepared By –
Waypoint Pty Ltd
Suite 2, Level 1
197 Bay Street
Brighton Victoria 3186
Phone – 03 9595 6007

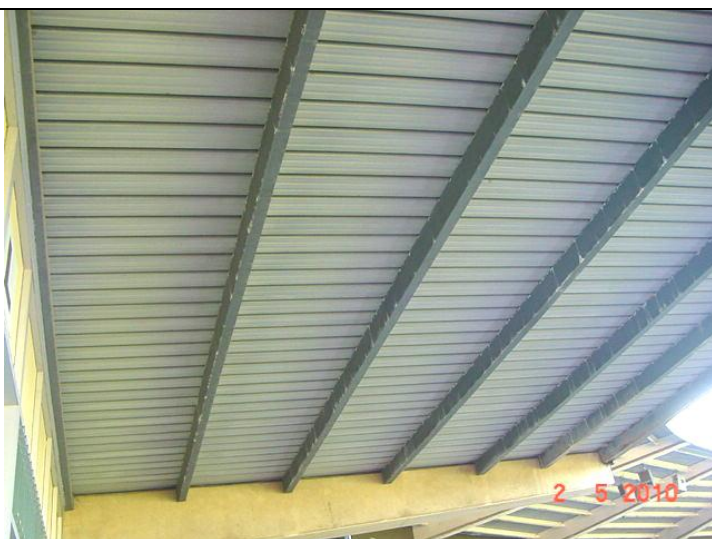
Photo 15

View of roof portals and roof purlins.
Refer structural report

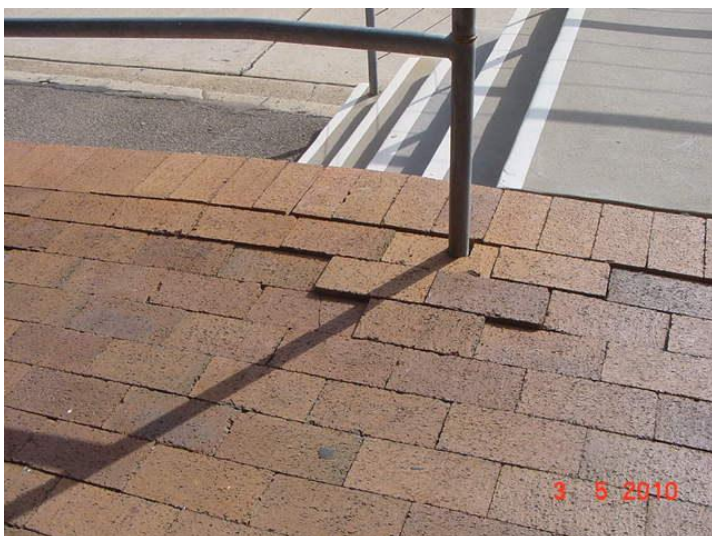
Photo 24

- Sections of the asphalt paving underneath the stand is cracked and damaged in sections and recommended to be re-sheeted. Sections of brick pavers to the exterior of the toilets have subsided adjacent to the female toilet entrance.

View of damaged asphalt paving adjacent to the ground level toilet access path

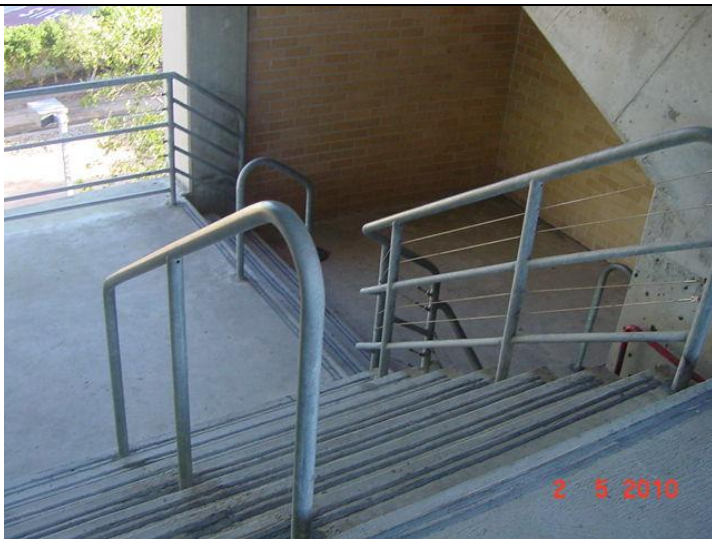
Photo 35

View of exit stairs to the south end below Level 1. The tension wire balustrades and stair handrails do not comply with D2.16h(ii)A of the BCA with openings exceeding 125mm. Installation of additional tensioned wires meeting Table D2.16a requirements to exit stair balustrades where the drop is less than 4 meters is recommended

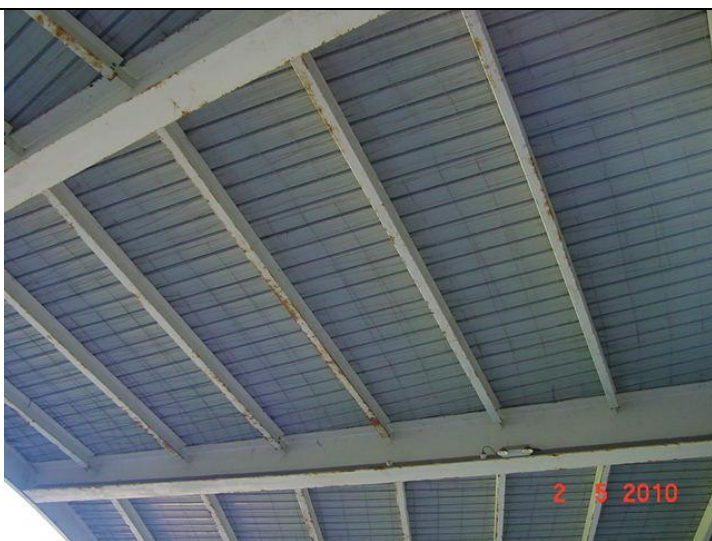
Photo 42

View of corrosion to the roof frames and purlins (south end) which are recommended to be rust treated and a high build epoxy applied. Refer structural report for details

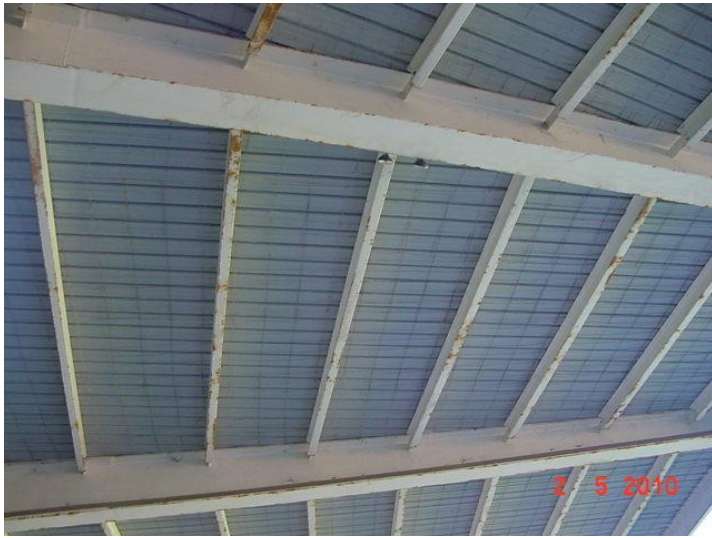
Photo 43

View of corrosion to the roof framing to the centre section

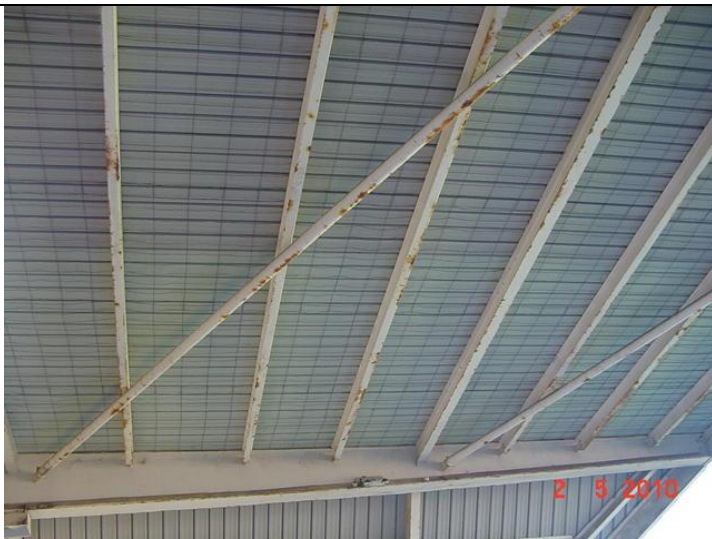
Photo 44

View of corrosion to the roof framing to the centre section

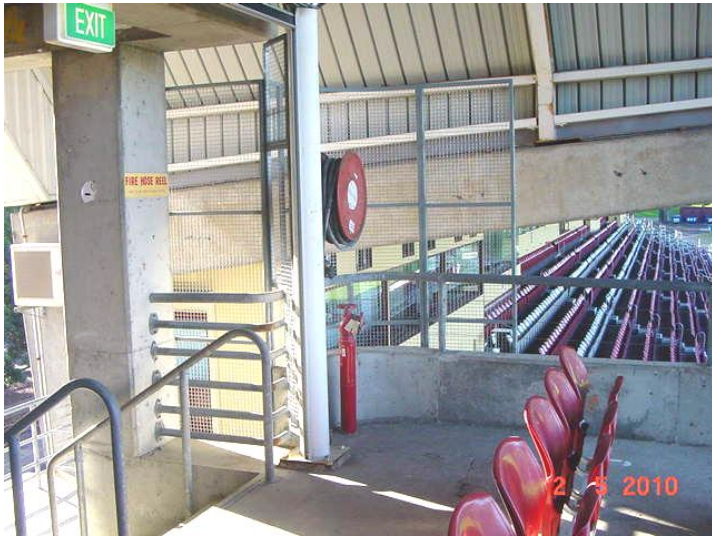
Photo 49

View of exit sign and roller shutter to Level 2 north exit stair. The shutter is recommended to be locked in the open position when Level 2 is in occupation to ensure egress is not blocked

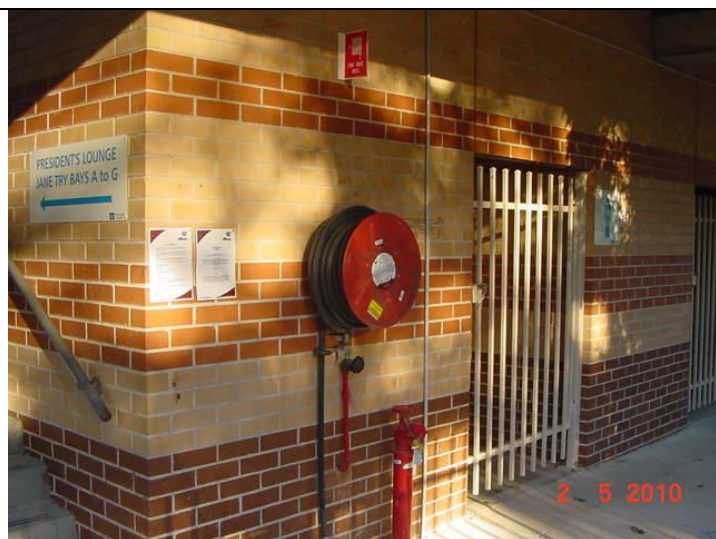
Photo 57

View of fire hose reel to Level 1 north exit stairs. An additional fire hose reel is required to provide coverage to the northern end of the Jane Try stand

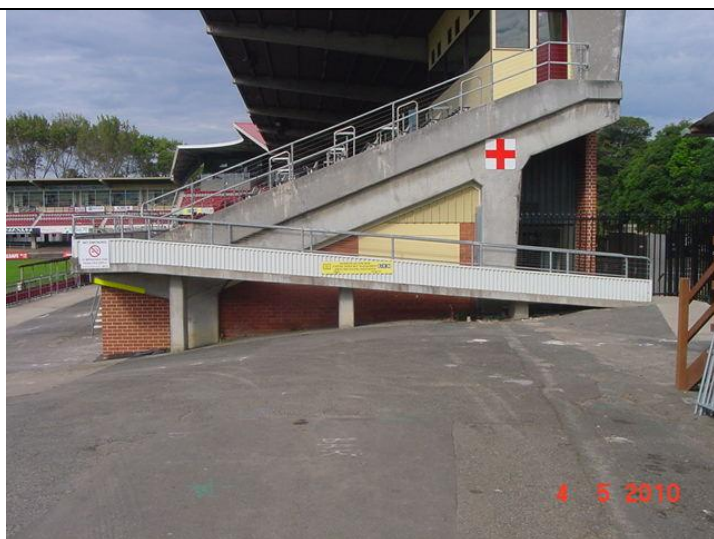
Photo 78

View of the front balustrade to the stand viewed from the north end. Wheel chair access is gained from the northern ramp (shown below). Access to the Arthurson stand is via this front aisle, which does not provide a clear 1000mm width of passage due to the protrusions of the lower steps

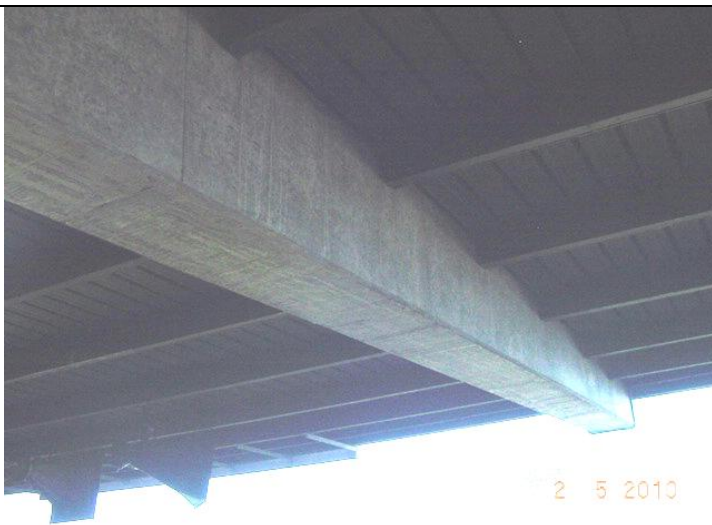
Photo 84

View of concrete portals and steel purlins over the seating area. The roof required replacement and purlins require treatment and repainting (refer structural report)
