## **GROUND TESTING:**

### **Alterations and Additions at 23 Bennett Street, Curl Curl**

#### **1. Scope**

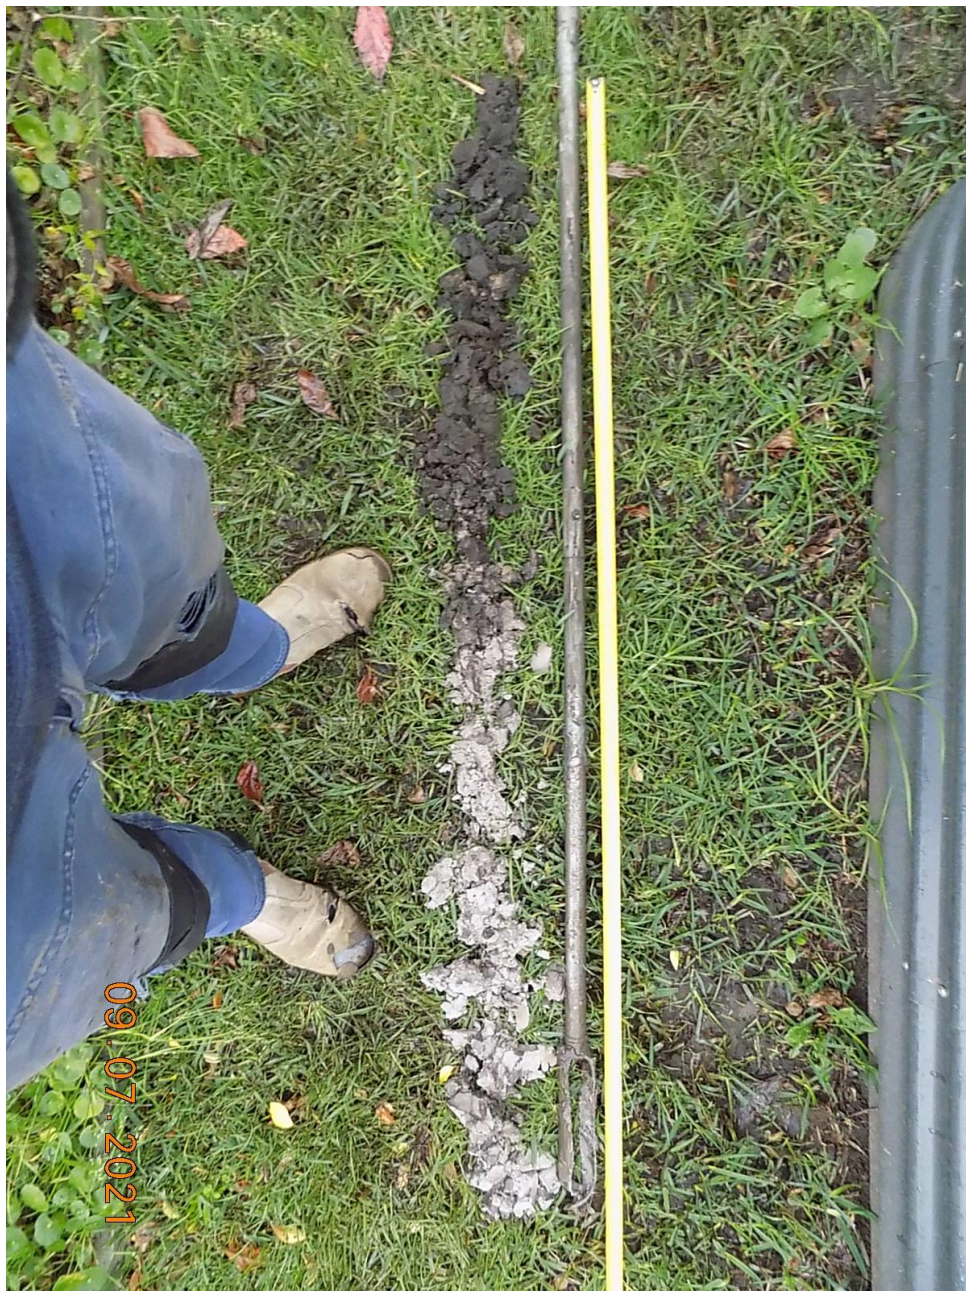
Depth (m)	Material Encountered
0.0 to 0.7	<b>TOPSOIL</b> , clayey soil, dark brown, very loose to medium dense, damp to very wet, fine to coarse grained with fine trace organic matter.
0.7 to 1.5	<b>SANDY CLAY</b> , derived from weathered sandstone, grey, stiff to very stiff, damp, fine to coarse grained.

End of test @ 1.5m in sandy clay derived from weathered sandstone. Groundwater seepage filled hole to ~0.3m below the surface immediately on completion of the Auger Hole.

The sandy clay that was encountered at a depth of ~0.7m below the current surface in AH1 (Photo 1) is acting as a denser more impermeable layer over which the ground water seepage is flowing. As such if this water is intercepted by a subsurface drain the majority of near surface seepage flows will be cut off below the drain.

Photo 1: AH1 – Downhole is from top to bottom

As such a trench drain cut through the dark brown sandy soil and embedded at least 0.4m into the under lying light grey sandy clay is one suitable solution (Photo 1). This is essentially a gravel filled trench with drainage cell running through the base. A detailed drainage plan is beyond the scope of these works but we can provide further details of the drain upon request.
