CUSTOMER JOB NO. 202379 - 2781 - Sean Ramsay Pipe & Cable Locating

Site Details	
Name	2a West Street Balgowlah
Address	2a West Street Balgowlah NSW 2093
Contact	Peter McAuley
Telephone	0411 112 036
Mobile	
Email	weststmacs@optusnet.com.au

Site Report

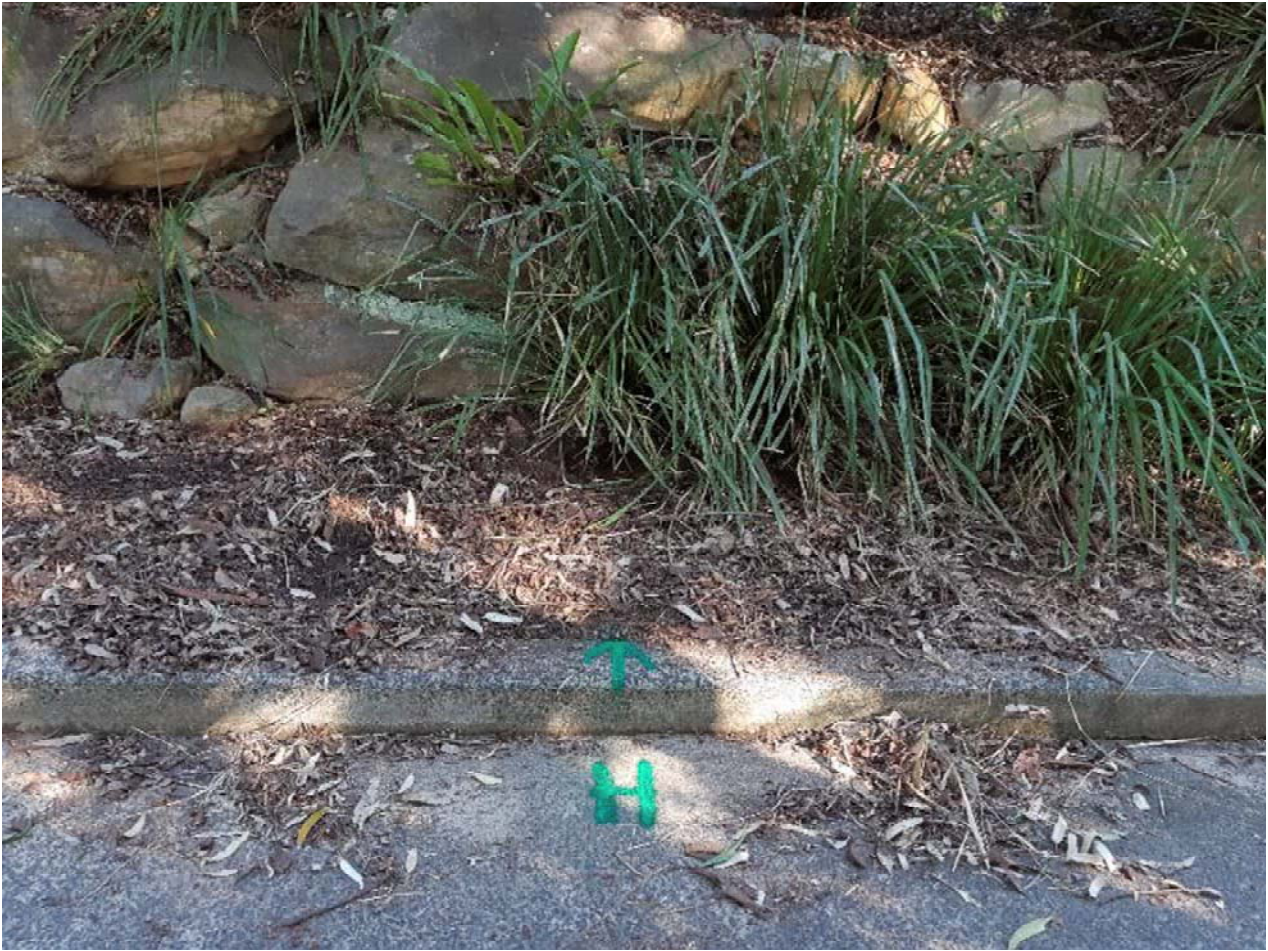
Buried hydrant on end of uPVC water

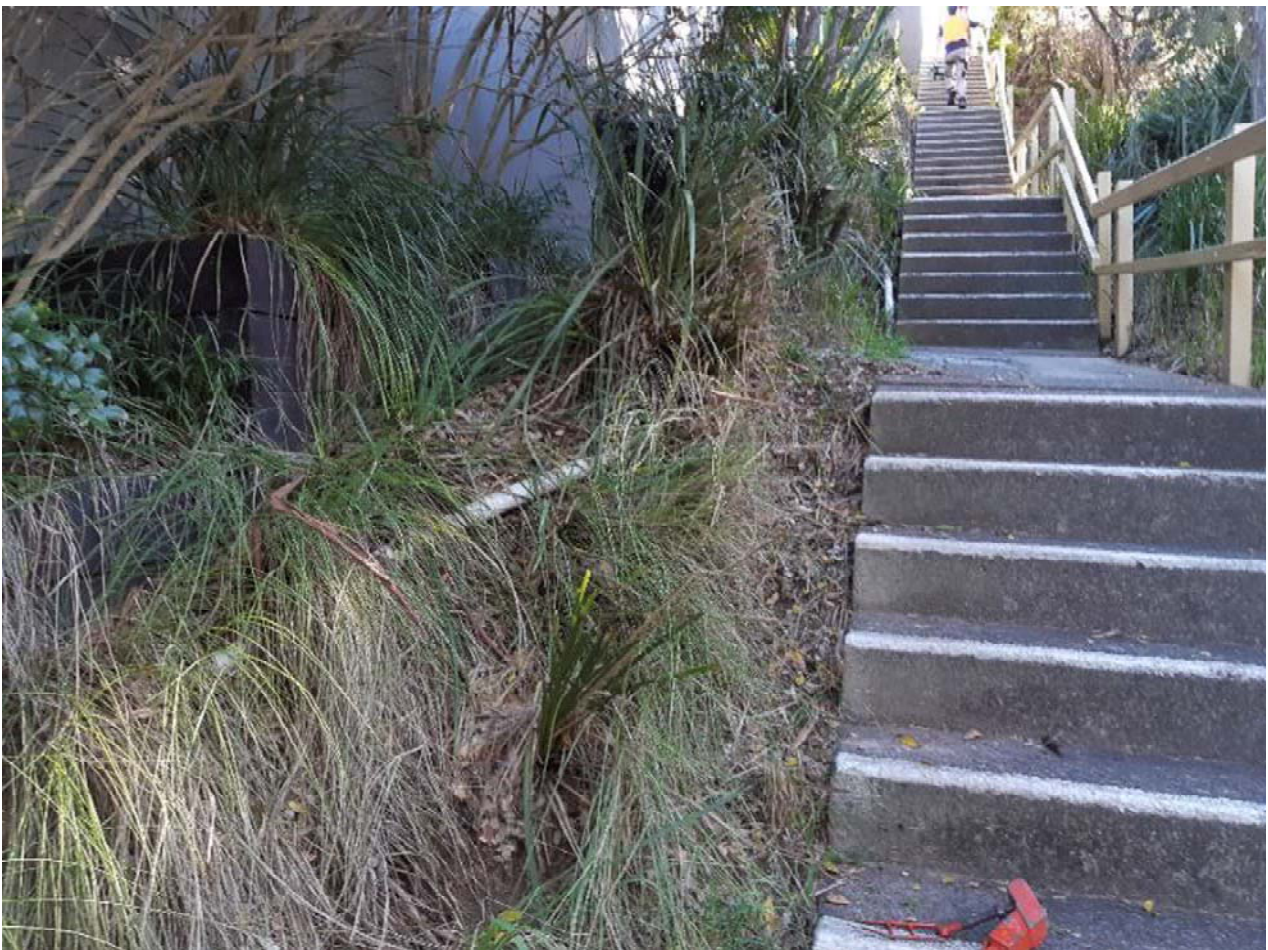
Comms in exposed conduit

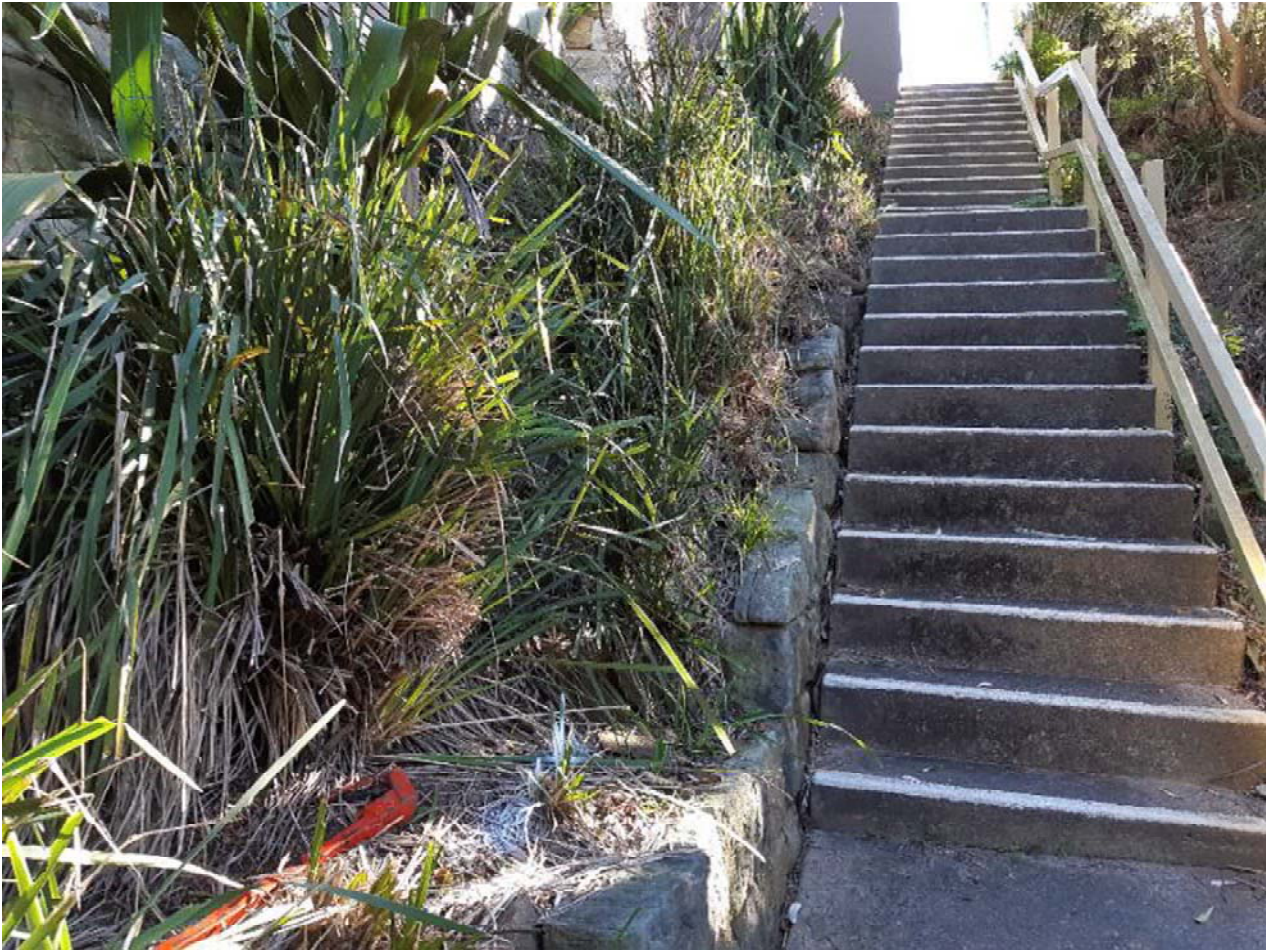
Comms in garden along stairs

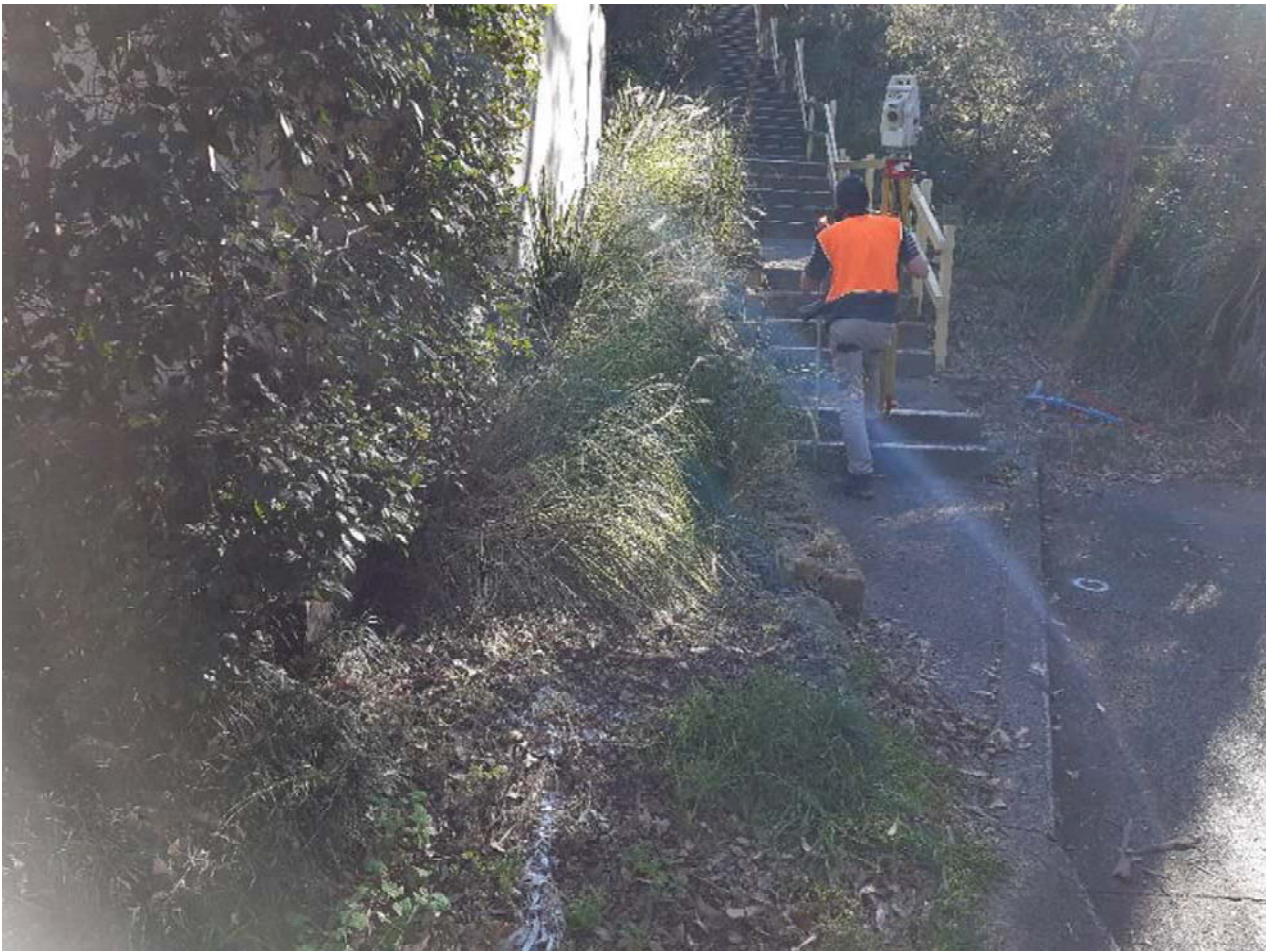
Comms running up garden

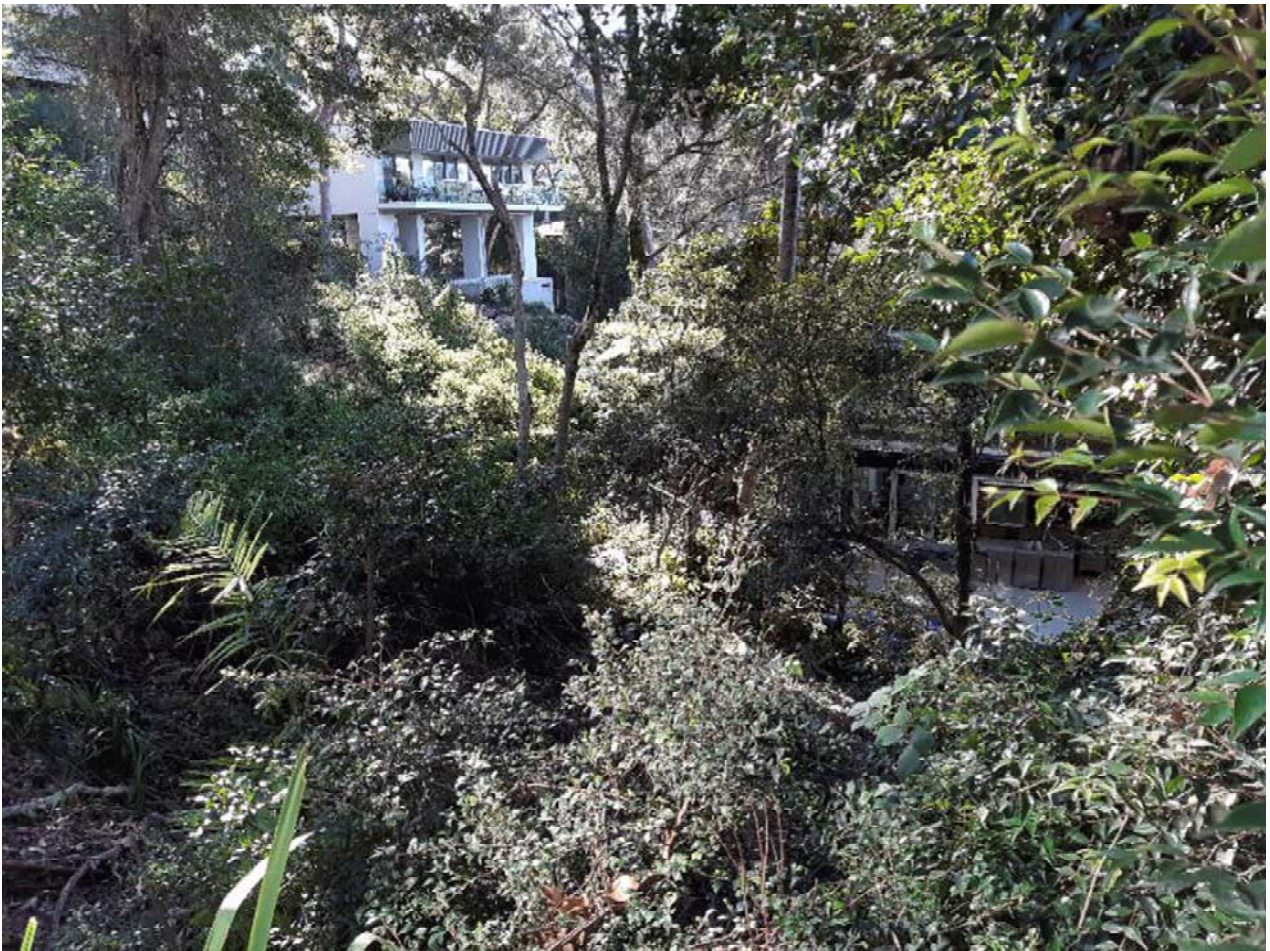
Concrete lid stormwater line from pit outside 37A

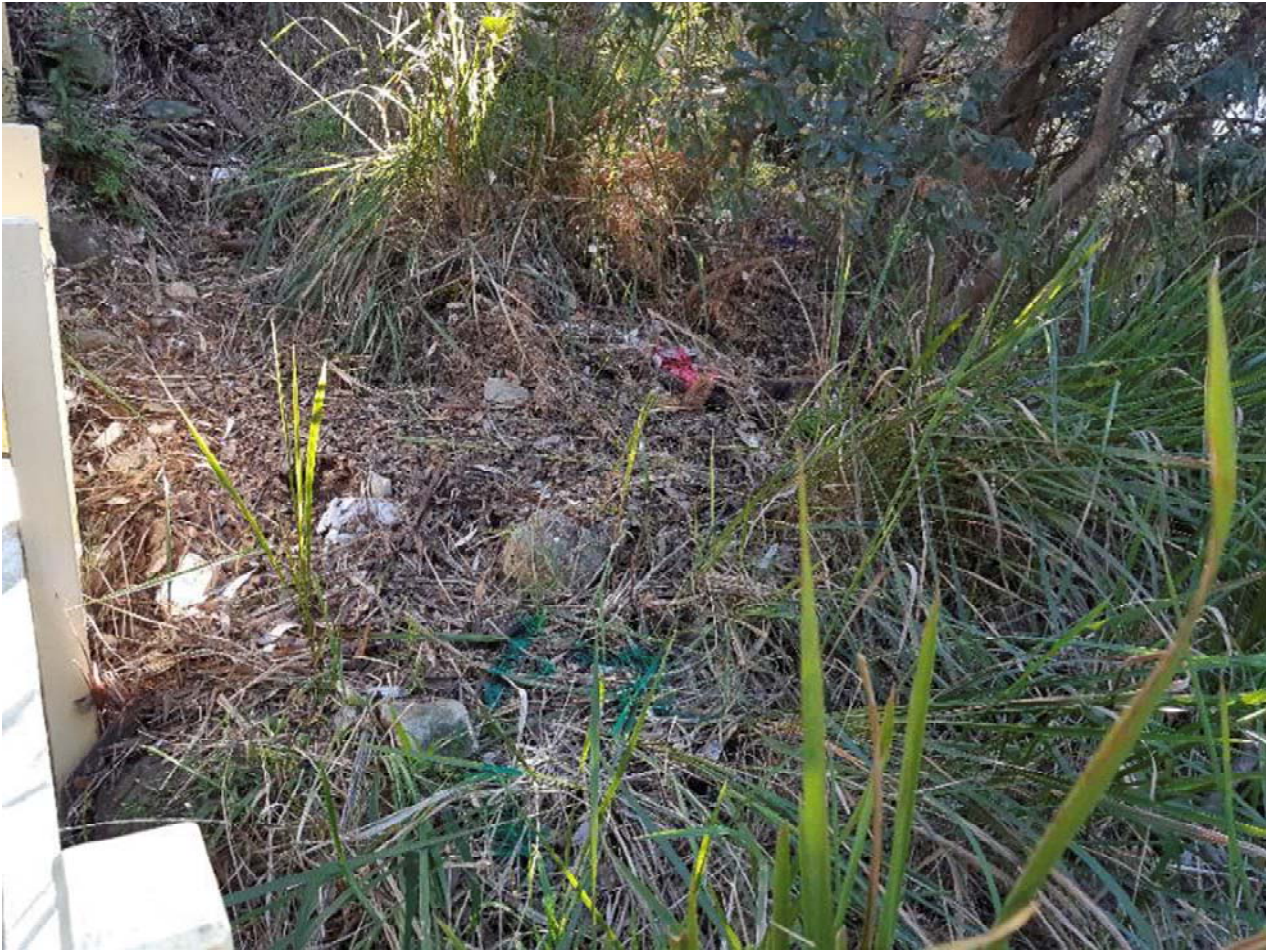
Sewer in green, stormwater in pink

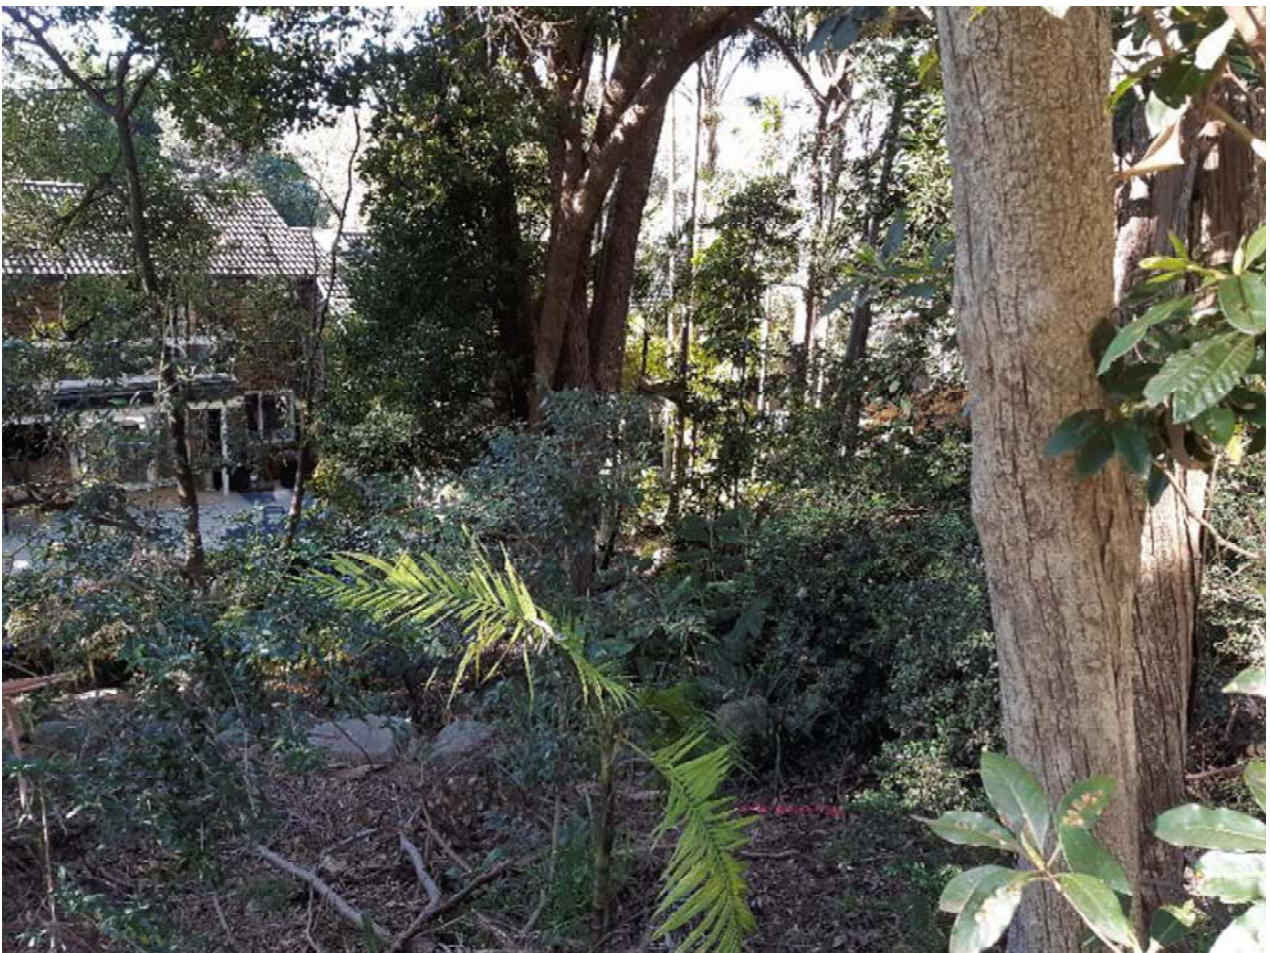
Sewer manhole 3 in bush
