Preliminary Geotechnical Assessment

For Alterations and Additions at
31 Carawa Road, Cromer, NSW

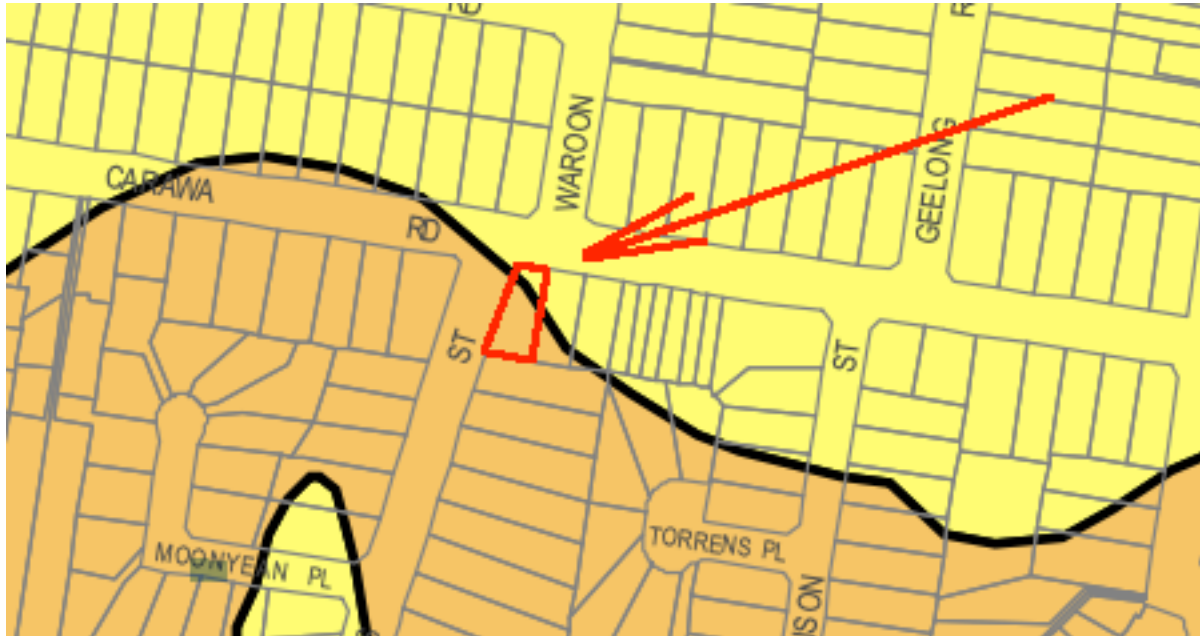
WARRINGAH LANDSLIP RISK MAP

The site is mapped as **Area A & B** on the Landslip Risk Map LSR_009 (**Image 1**, below).
