GEOTECHNICAL INVESTIGATION:

New Spa at **39 Seaforth Crescent, Seaforth**

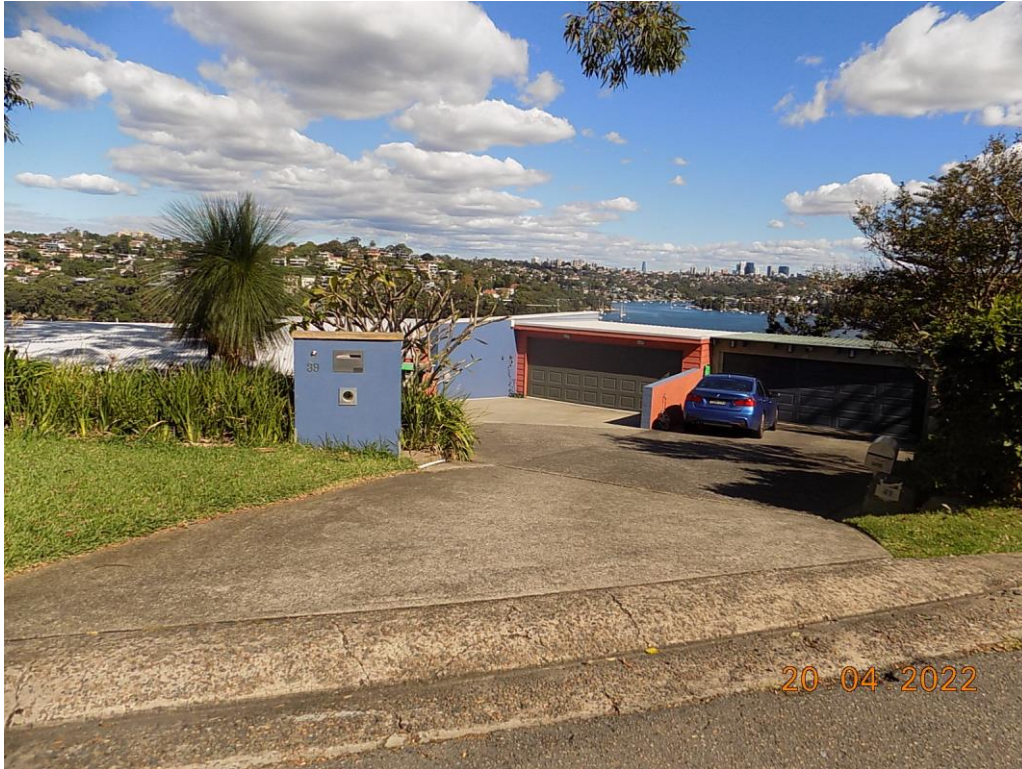
Photo 1

- 2.3** At the road frontage, a shared concrete driveway runs down the slope to a garage on the uphill side of the property (Photo 1). The garage is partially seated on outcropping Medium Strength Rock that is slightly undercut to ~2.0m (Photo 2). The garage extends ~1.0m over the undercut area. Given the thickness of the supporting cantilever arms with no visible defects, the undercut rock is considered to be stable. A series of stable sandstone block retaining walls reaching up to ~1.8m high terrace the slope in between the road frontage and the house (Photo 3). A ~9.0m high cut to create a level platform for the house has been taken entirely through outcropping Competent Medium Strength Sandstone (Photo 4). A portion of the cut face has been protected with sprayed concrete (Photo 5). The three-storey rendered masonry house

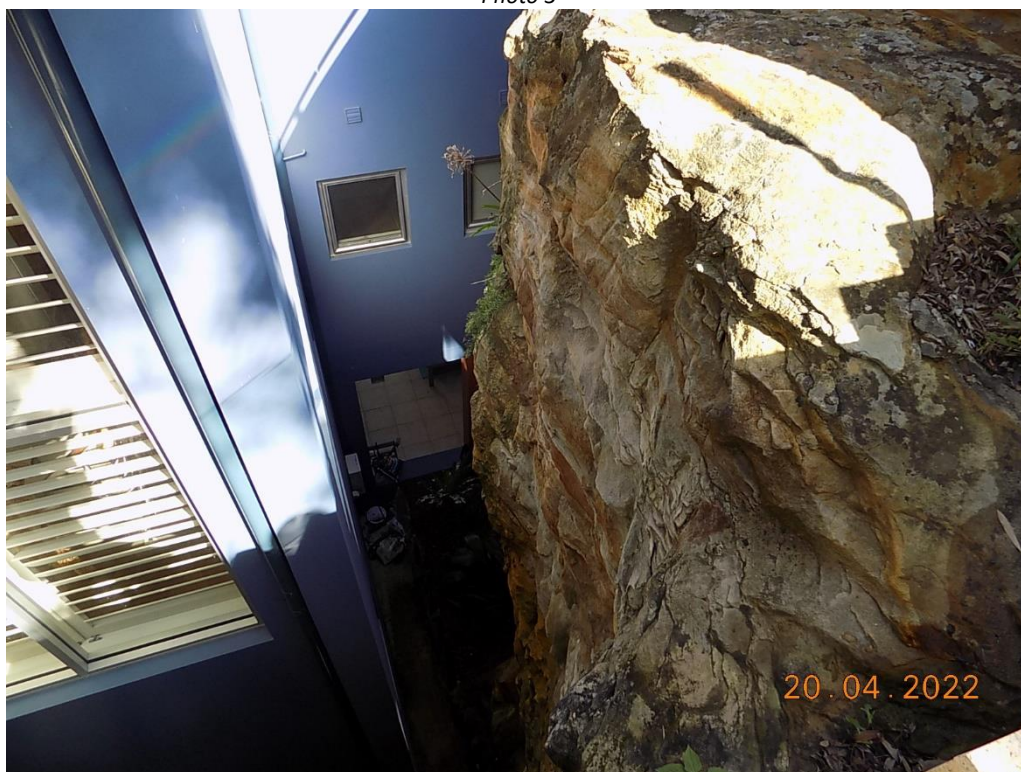
Photo 4

HAZARDS	Hazard One	Hazard Two
TYPE	The steep slope that falls across the property and continues above failing and impacting on the proposed works.	The existing sandstone cut face that steps ~9.0m down the slope failing and impacting on the proposed works (Photo 4).
LIKELIHOOD	'Unlikely' (10^{-4})	'Unlikely' (10^{-4})
CONSEQUENCES TO PROPERTY	'Medium' (15%)	'Medium' (25%)
RISK TO PROPERTY	'Low' (2×10^{-5})	'Low' (2×10^{-5})
RISK TO LIFE	9.1×10^{-7} /annum	2.9×10^{-7} /annum
COMMENTS	This level of risk is 'ACCEPTABLE', provided the recommendations in Section 7 & 16 are followed.	This level of risk is 'ACCEPTABLE'.

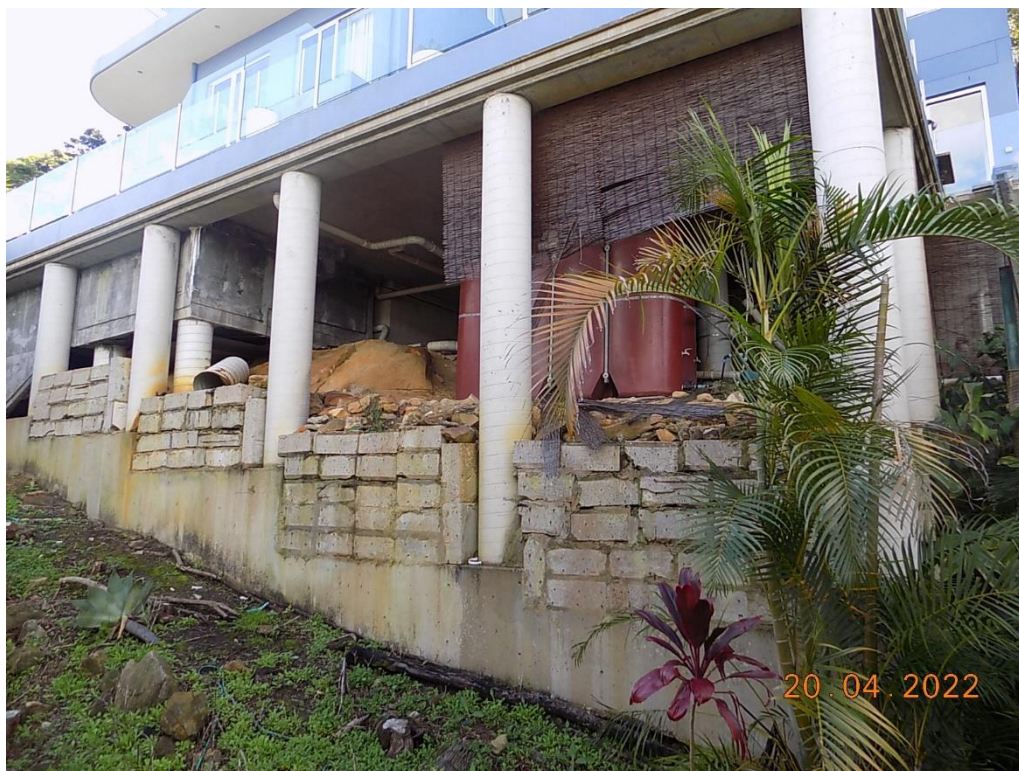
Photo 6

is supported on masonry walls and concrete piers (Photo 6). The masonry walls show no significant signs of movement and the concrete piers stand vertical. A partially suspended pool extends off the downhill side of the house (Photo 7). No significant movement has occurred in the concrete shell of the pool as indicated by the water level against the pool tiles. A series of low sandstone block retaining walls terrace the steep slope that extends to the lower common boundary (Photo 8). A ~1.5m high sandstone block retaining wall supports a fill for a moderately sloping lawn area (Photo 9). The wall is covered in vegetation but from what could be seen, appears to be in good condition. It is supported directly off outcropping Competent Medium Strength Sandstone. Sandstone bedrock outcrops and steps down the property to the waterfront (Photos 10 & 11).
