**RE: ALTERATIONS AND ADDITIONS – S4.55 WORKS
2 TOURMALINE STREET, NARRABEEN**

Site Instruction

To	Micris Design, Bespoke Projects NSW		
Attention	Michael Di Ramio, Hassan Darwiche		
From	Sonia Cunningham, Tadd Walford		
Date	22 nd September 2020	Pages (Inc Header)	Page 1 of 5
Reference	2 Tourmaline Street, Narrabeen	Project No.	2019S0150
Subject	Assessment of existing walls and slabs and construction methodology adjacent to and beneath existing structure

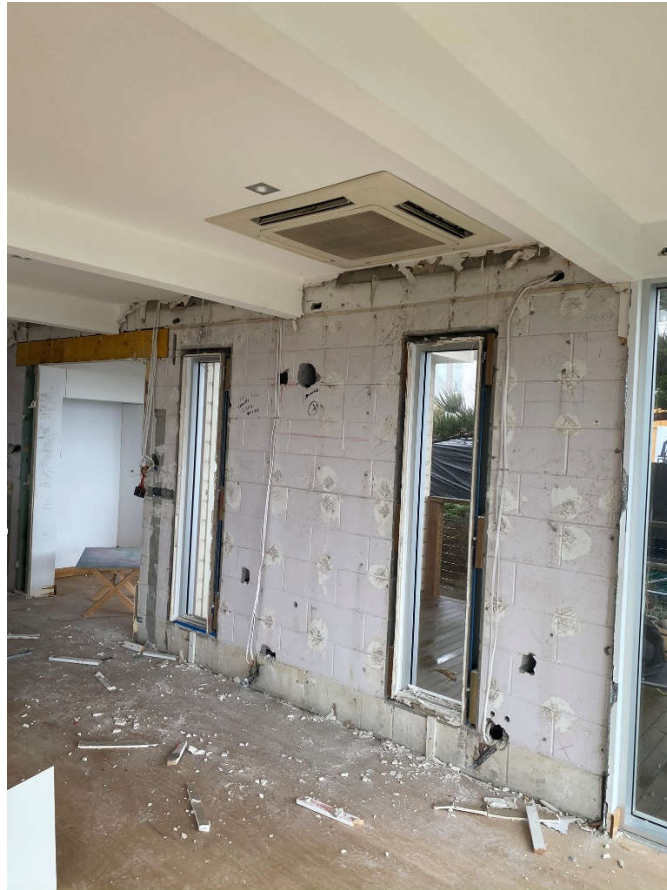
- The ground floor walls are hollow block and so are considered structurally inadequate. The walls are at risk of failure, especially if machinery is proposed to be used in close proximity to the walls, which may cause damage to neighbouring property and/or injury of occupants of the neighbouring property, passers-by on the street, or construction workers.

Photo 1 – Ground floor wall built with hollow blocks

- For these reasons, we believe it would be safer and more efficient to carefully demolish the wall and then rebuild with a structurally adequate wall system in the exact location of the original walls and in accordance with the plans approved by Council.

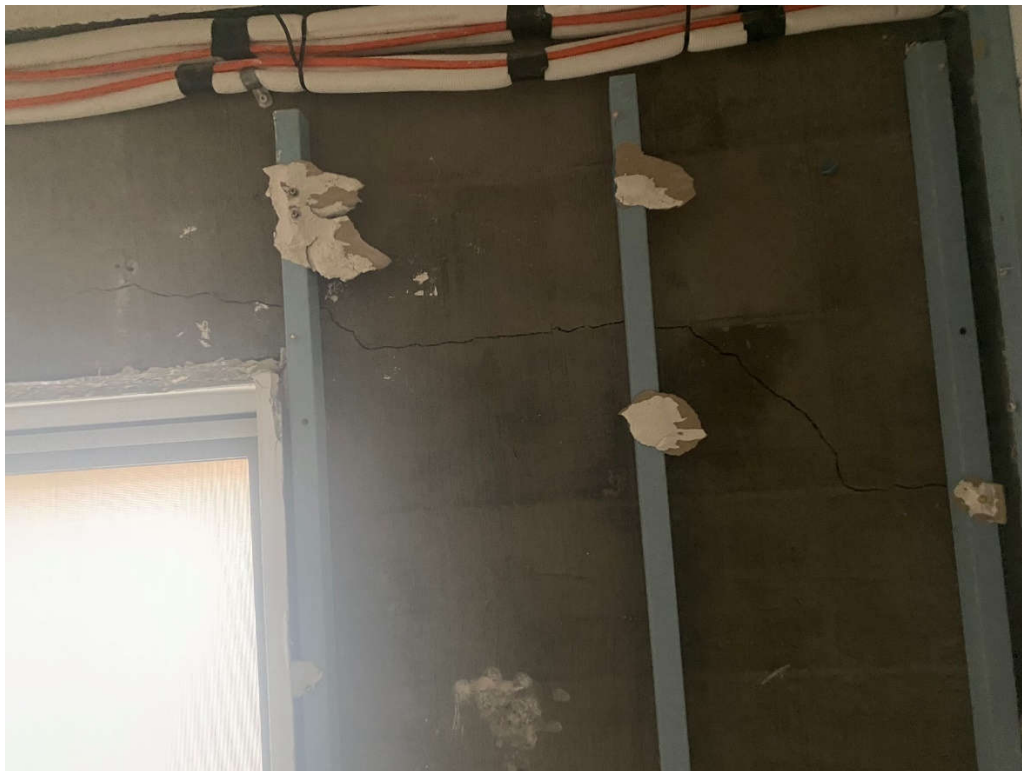
- The existing hollow block walls will need to be strengthened, most likely by core-filling and/or adding reinforcement, in order to support the proposed first floor level and roof and also to be stable under wind. As some areas of the block walls have already cracked, these areas would likely have to be replaced in order to core-fill the wall.

Photo 2 – Cracking observed on the ground floor hollow wall

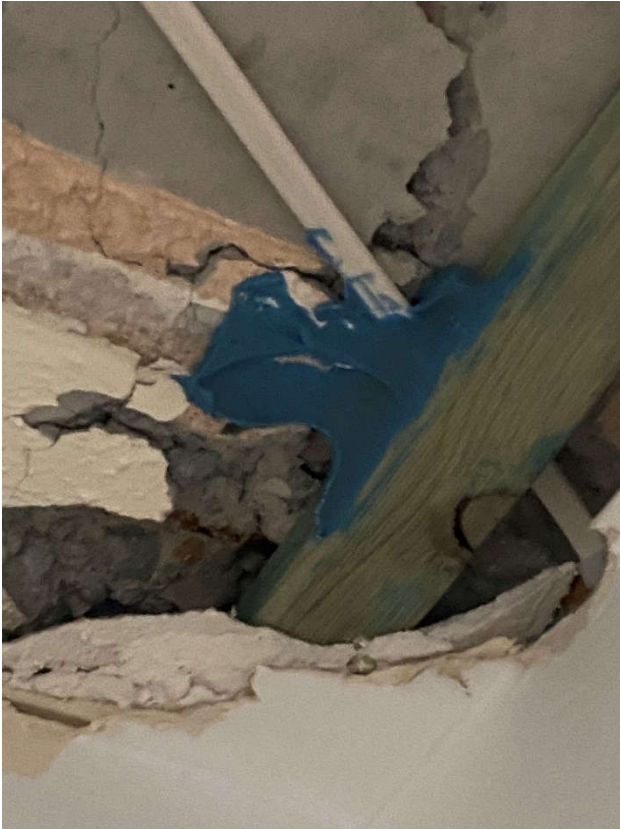
- Repair of the existing concrete slab would require the corroded reinforcement to be cut out and then repaired with new bars. Following this the spalled areas would be patched and repaired. However, we suspect the spalling observed indicates that the existing slab has insufficient concrete cover to the reinforcement, and so there is a high risk of further concrete spalling and corrosion of the reinforcement, especially considering the proximity to the ocean.

Photo 3 – Spalling ground floor slab and exposed corroded reinforcement

- Cutting the penetrations in the slab also exposes the reinforcement bars which creates a risk of further corrosion if not appropriately treated.
- We believe that the existing slab would require extensive repairs in order for us to certify its structural adequacy for the proposed works, and that it would be more prudent and efficient to demolish and rebuild the slab with adequate concrete cover to the reinforcement for the coastal conditions.

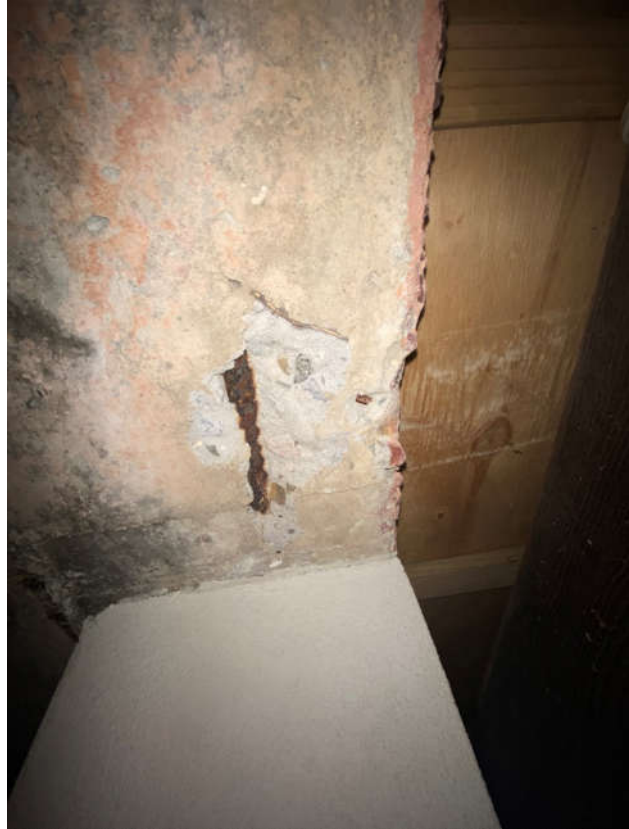
Photo 4 – Spalling ground floor slab and exposed corroded reinforcement

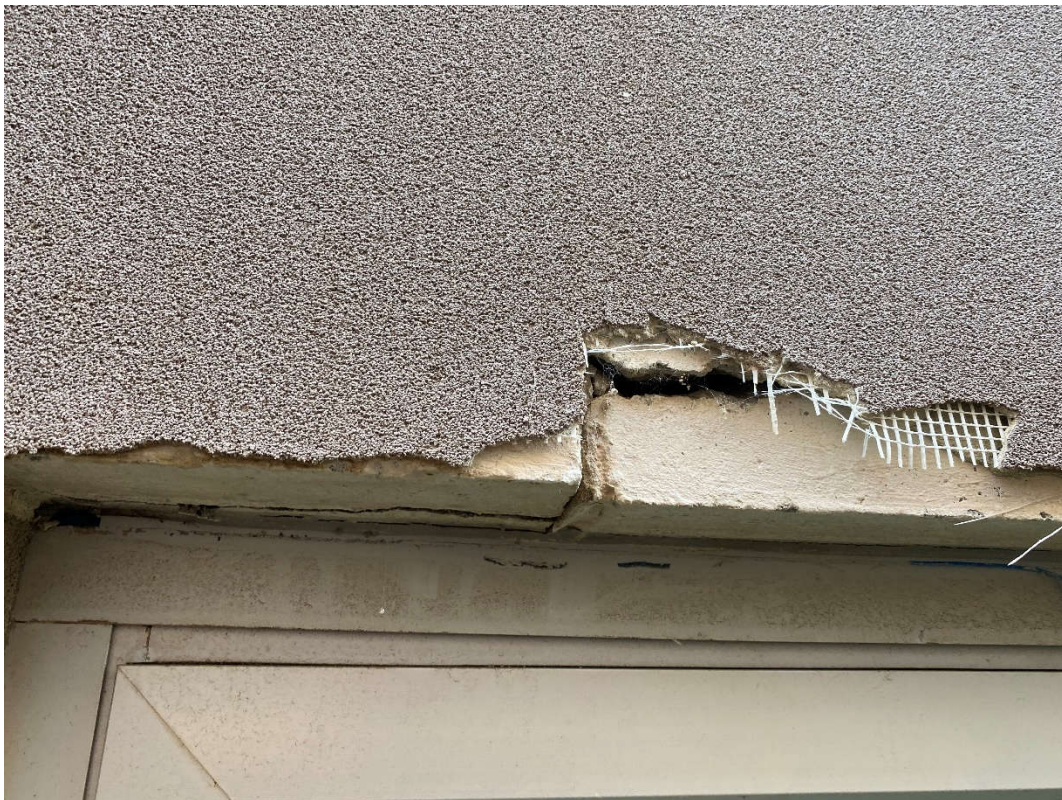
Photo 5 – Cracking in hollow block wall over southern window opening
