Geotechnical Assessment

Project: New Dwelling
5 Graylind Close, Collaroy NSW

Ref: AG 25190
7 May 2025

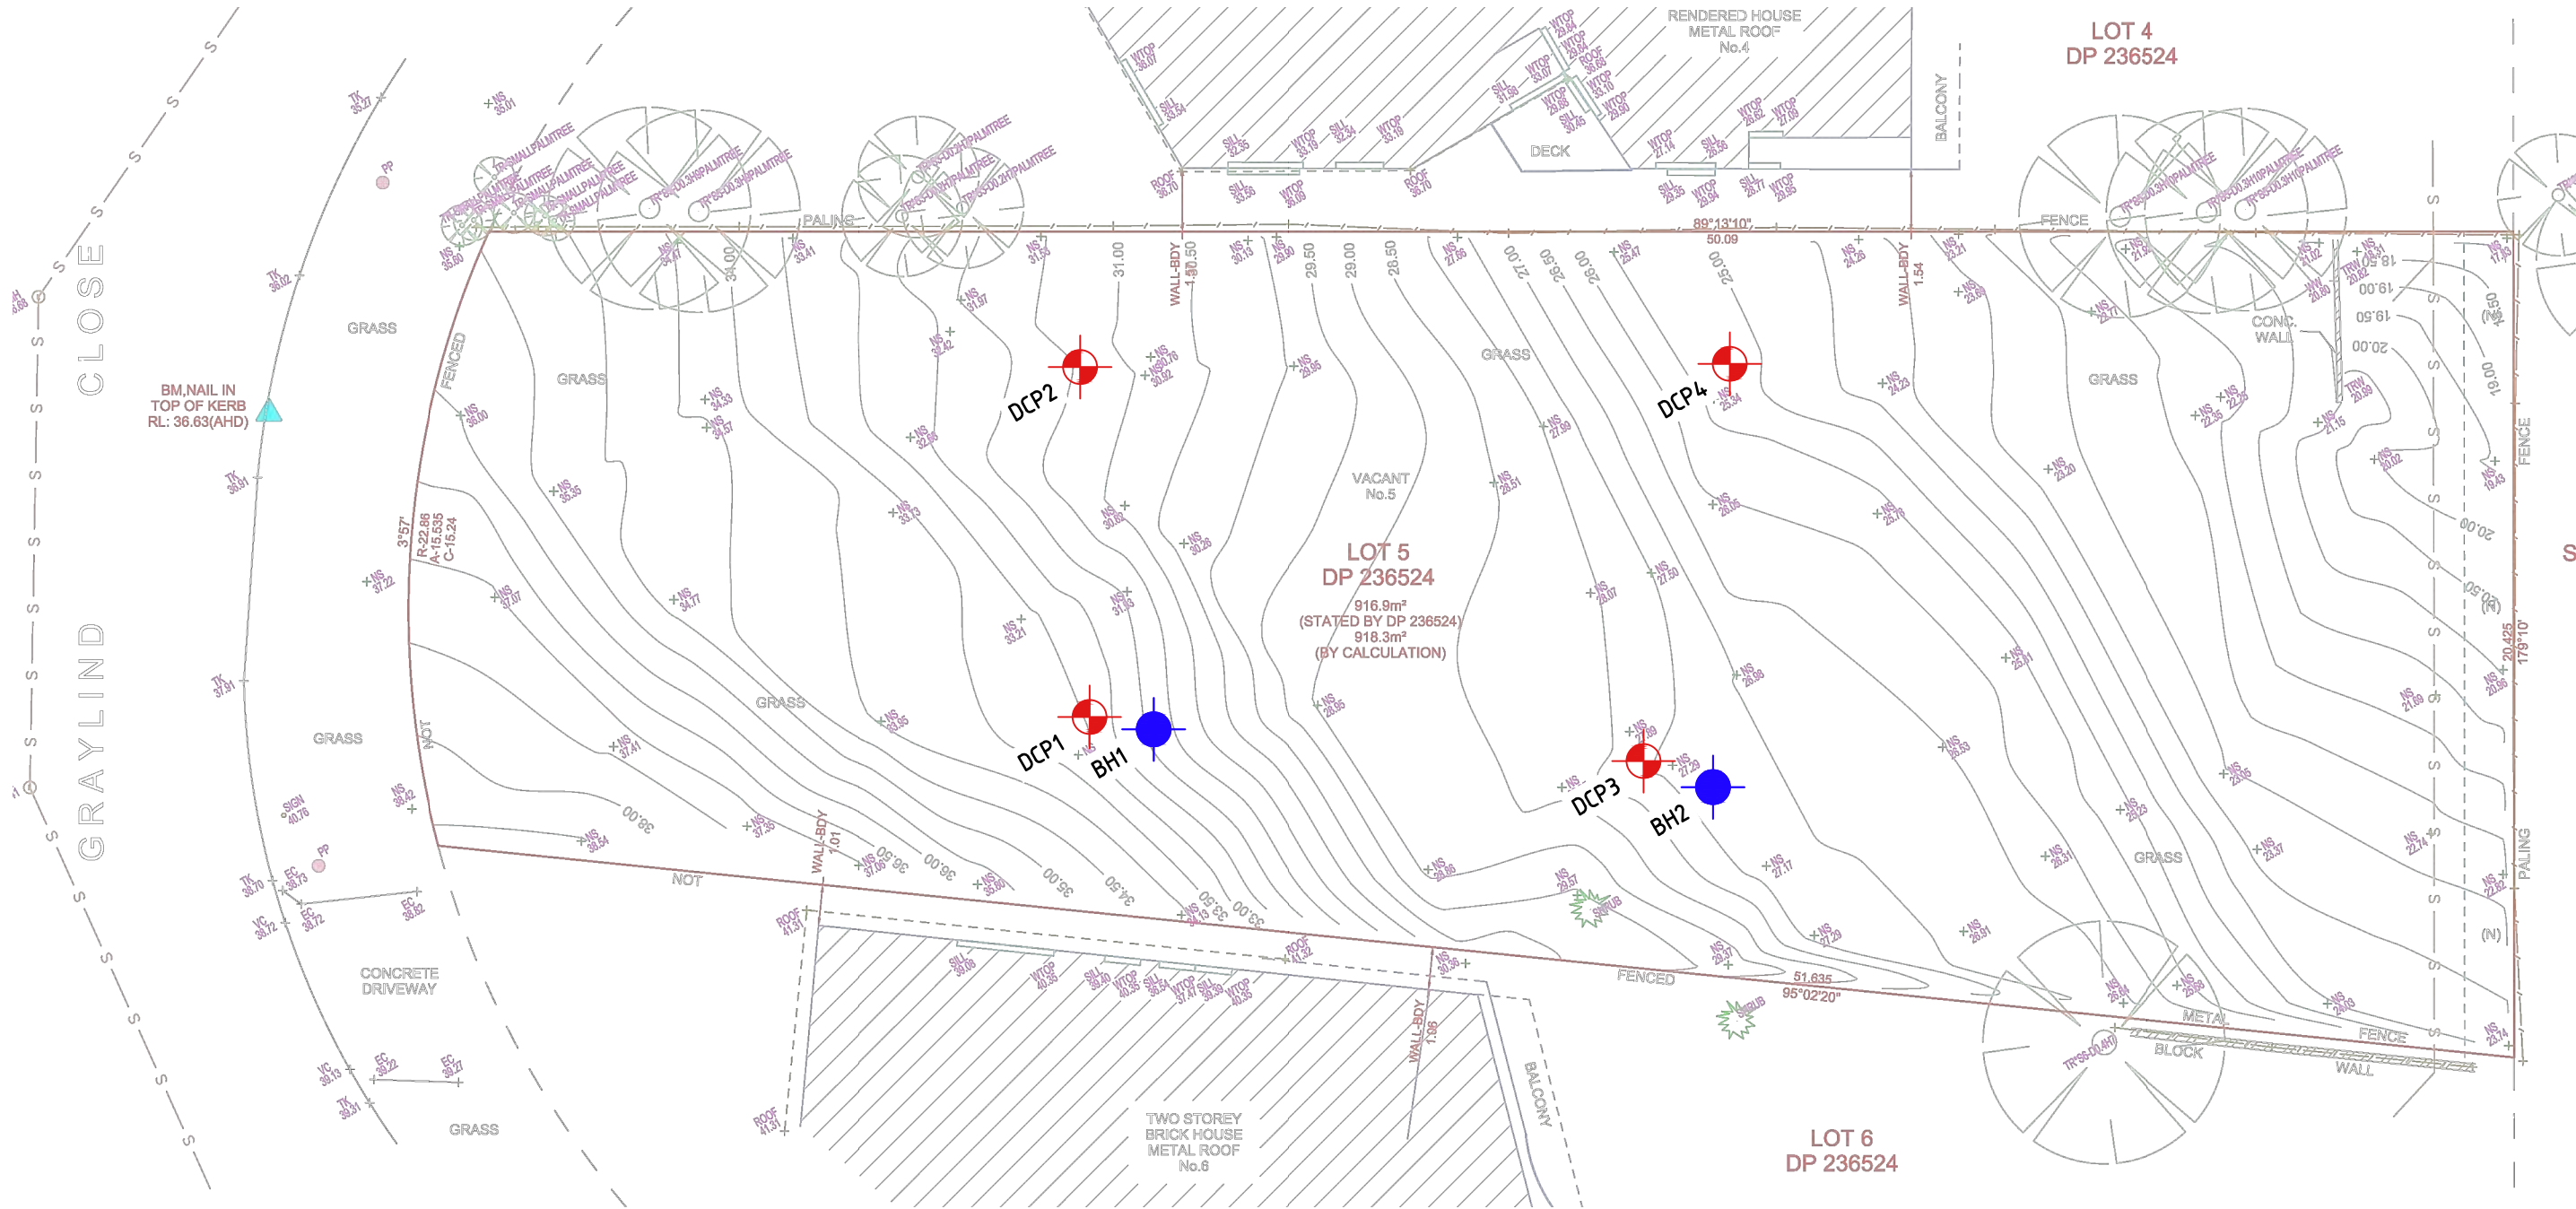
SITE PLAN/GROUND TEST LOCATIONS
SCALE NTS

Test	Summary
DCP 1	Practical refusal @ 2.1m on inferred weathered bedrock. Brown clay on moist tip.
DCP 2	Practical refusal @ 2.1m on inferred weathered bedrock. Brown clay on moist tip.
DCP 3	Practical refusal @ 2.6m on inferred weathered bedrock. Brown clay on moist tip.
DCP 4	Practical refusal @ 1.0 m on inferred weathered bedrock. Light brown clay on moist tip.

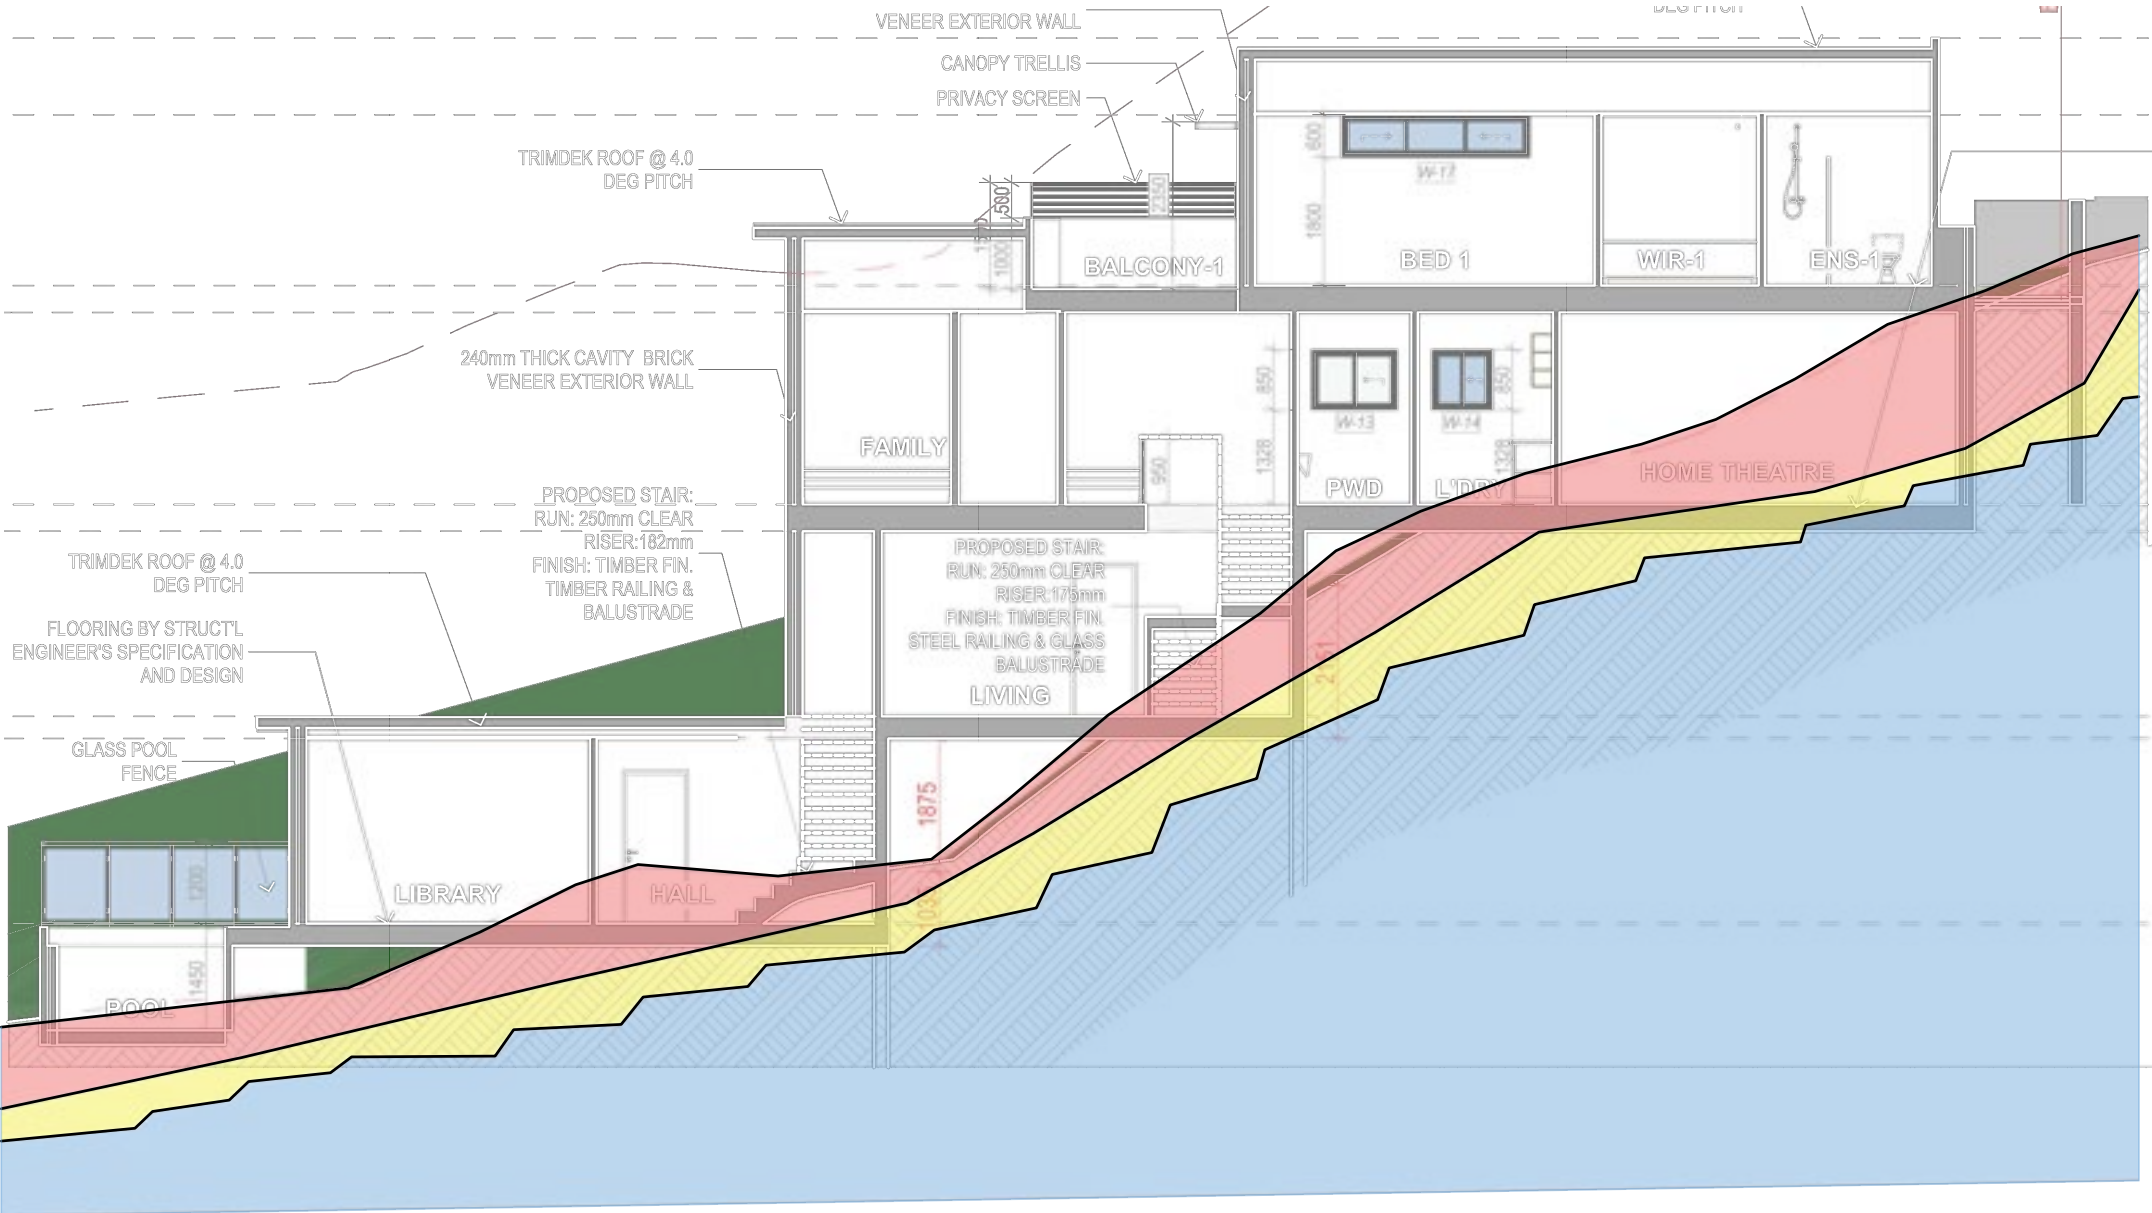
INFERRED GEOLOGICAL SECTION

The soil profile consists of shallow uncontrolled fill and silty topsoil (O & A Horizons), sandy clay (B Horizon) and weathered bedrock (C Horizon), with the potential for large detached sandstone joint blocks or boulders on or withing the slope materials. Based on our observations and the results of testing on site, we expect very low to low strength interbedded sandstone and shale bedrock to be found within 0.9 to 3.0 metres below current surface levels across the area of the proposed works although it may be locally deeper near the inside of rock benches which may exist at this site and along portions of the southern side of the site where fill material / excavation spoil has been placed.

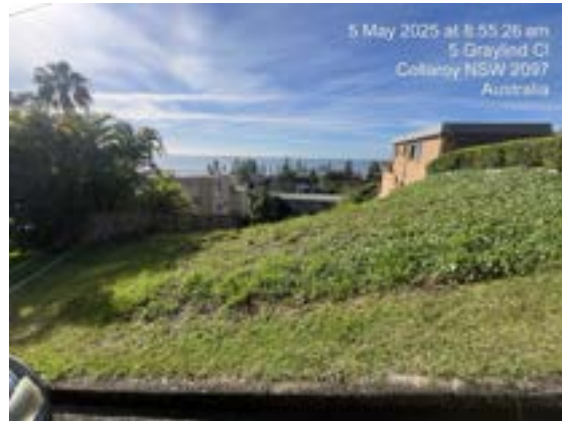
Photo 1: Looking east from site frontage

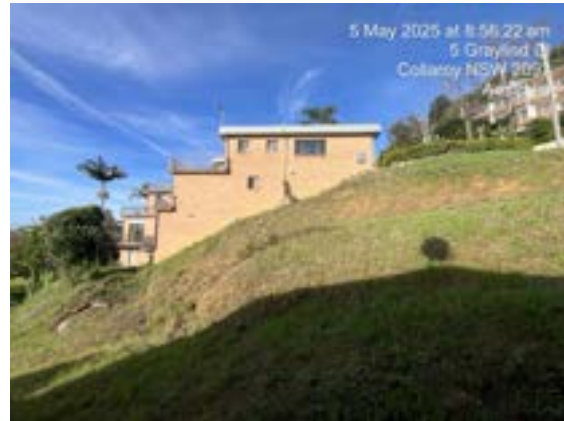
Photo 2: Looking south across the site to adjoining property, 7 Greyland Cl.

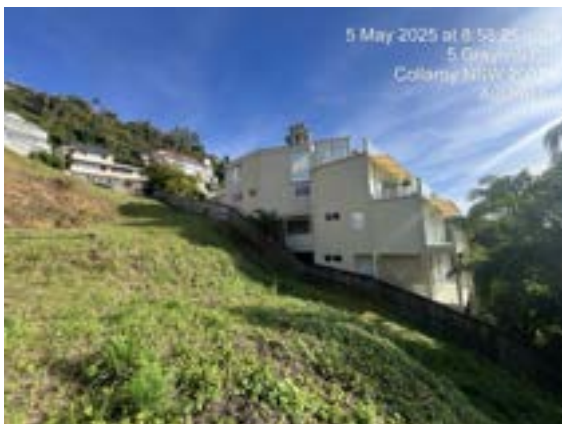
Photo 3: Looking north across the site to adjoining property, 4 Greyland Cl.

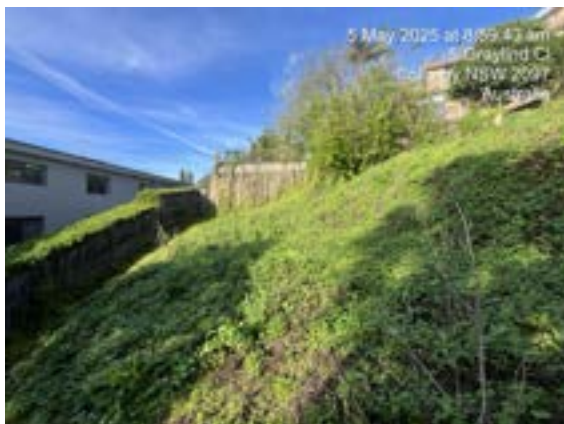
Concrete crib walls at the north-eastern corner at the south-western boundary of the site appear to be in good condition, the site is otherwise vacant. Neighbouring buildings to the north and south are two and three storey dwellings and appear to be in good condition, based on limited visual inspection from within the subject site. Due to limited visual access for inspection from within the subject site, relevant comments on the structures and site to the east of the subject site are not possible.

Photo 4: Looking south towards concrete crib wall at the south-eastern site boundary

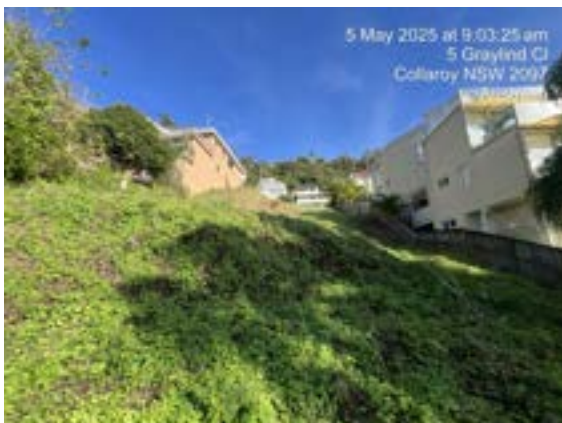
Photo 5: Looking west from the rear boundary

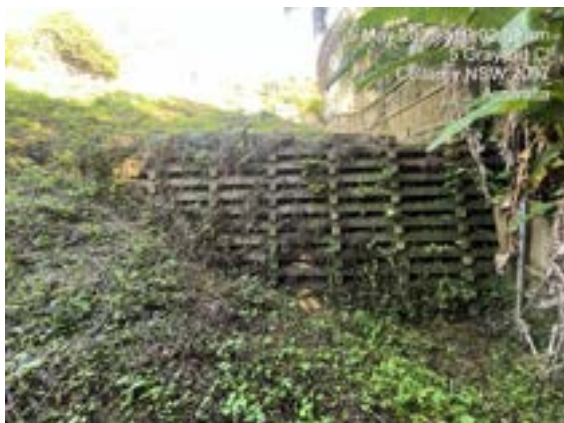
Photo 6: Concrete crib wall in north-eastern corner of the site.
