# Geotechnical Assessment

**Project:** Alterations & Additions  
21 Park Street, Collaroy NSW

**Ref:** AG 24195  
14 January 2025

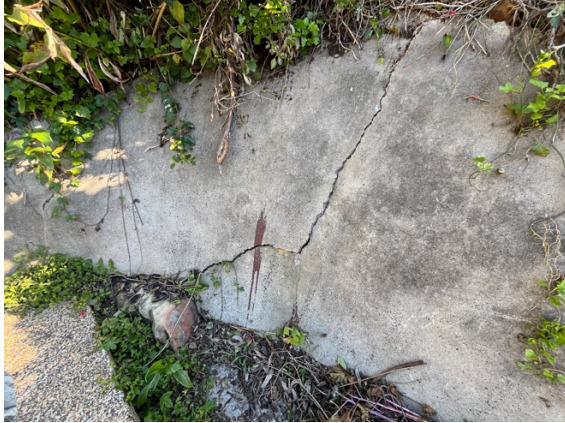
The existing building at the site is a three-storey house which is in dilapidated condition and shows signs of differential settlement, particularly at the southwestern corner where the brickwork has cracked and rotated (Photo 4). The pool and surrounding area is in poor condition, with a significant crack observed in the concrete wall upslope of the western side of the pool (Photo 7).

**Photo 7: Cracking in the concrete wall on the western side of the pool**
