GEOTECHNICAL REPORT

PROPOSED NEW RESIDENTIAL DEVELOPMENT

6 MITCHELL ROAD, PALM BEACH

Project No: 2018-145

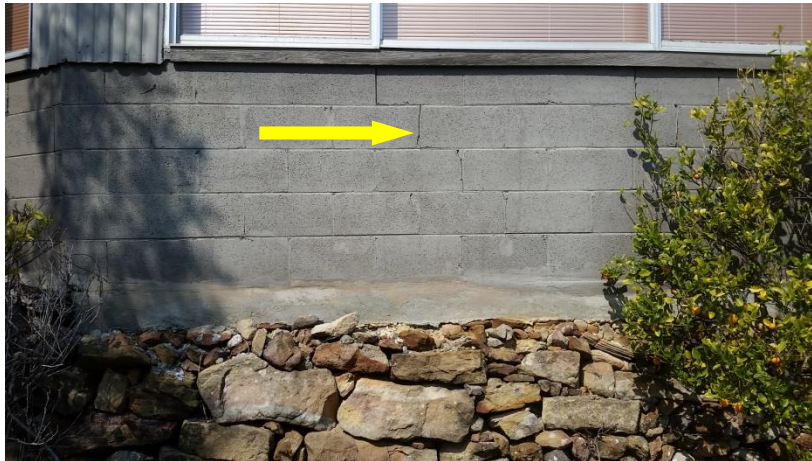
The existing site building comprises a metal and concrete block structure that appears to be in satisfactory condition with some minor cracking observed at the base of the rear wall, see Photograph 4. The cause of the cracking observed is unknown, however it may be due to settlement of the underlying dry stack rock wall.

Photograph 4: Cracking observed in the lower section of the rear wall.

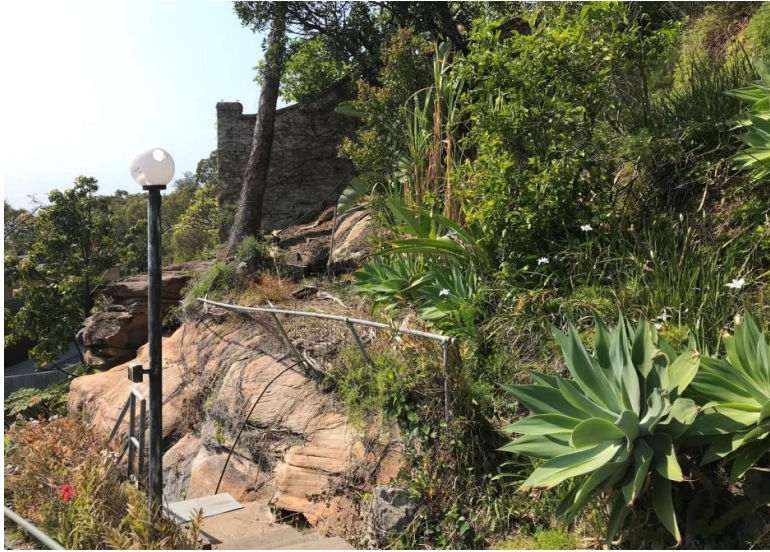
The existing dwelling is accessed via a set of stairs on the south side of the access driveway. A bedrock exposure forms a cliff to the south of the stairs which trends east-west and is formed via a continuous, planar sub-vertical joint defect. The cliff exposes low to medium strength sandstone bedrock and is convex at its crest rising up into the neighbouring properties to the south. Potential signs of previous surface slope movement were observed above the cliff crest including rotating trees and failing fence structures (see Photograph 5) however it was difficult to identify a mechanism for this distress and it may be related to surface creep rather than a deep-seated stability issue.

Photograph 5: View of sandstone outcrops above cliff, looking east.

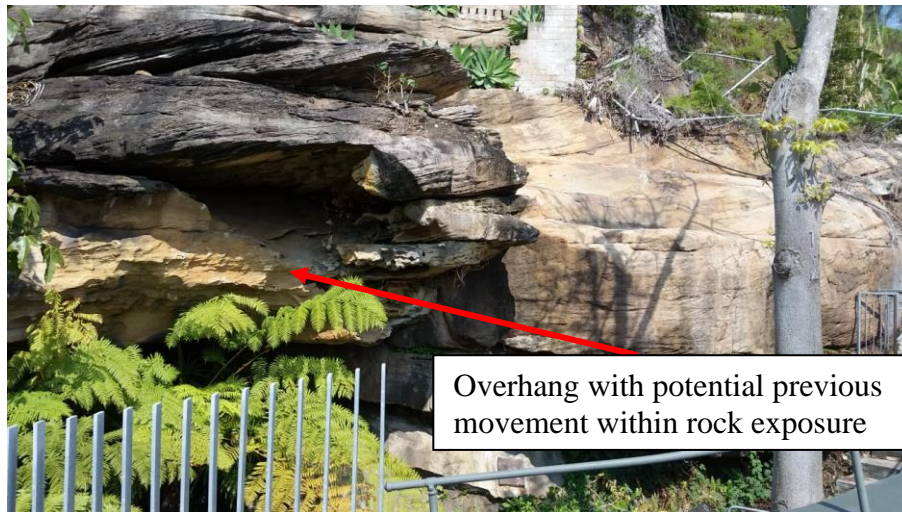
The neighbouring property to the east, No.7 Mitchell Road, comprises a multi-storey rendered residential house that appears less than 20 years old and in good condition. The property is located above the cliff line to the south of the driveway within No.15 Florida Road, with extensive outcrops at its rear extending down to the cliff crest. Within the rear north-west corner of this property the cliff line contains a large overhang structure formed by differential weathering of a lower weaker unit within the cliff geology. This overhang is shown in Photographs 6 and 7.

Photograph 6: View of overhanging sandstone outcrops in No. 7, looking south.

The overhang within No.7 Mitchell Road appears globally stable at present though detailed mapping is not possible without approval of the neighbouring property owner. Based on the location of the overhang and its apparent direction of travel due to failure it is considered a hazard to the site. The scale of the overhang indicates that the risk of instability may need to be mitigated through construction of a support structure, though this would require construction within the neighbouring property. As such discussion with the neighbouring property owner is required.

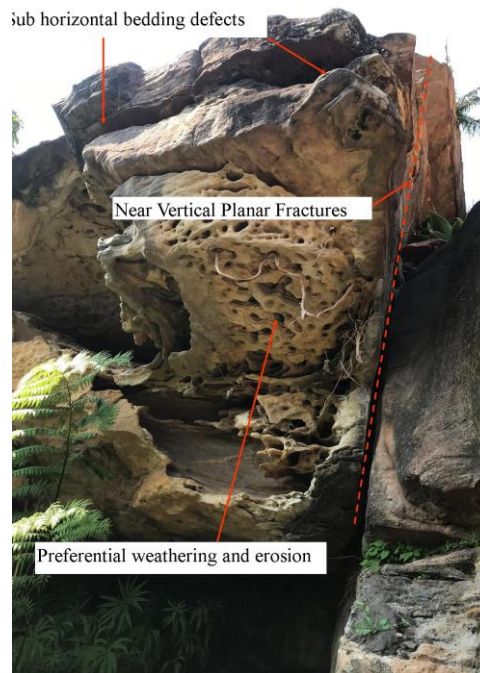
Photograph 7: Horizontal bedding defects, near vertical fractures within the south of the site.

Weathering will continue to increase the overhang dimensions and will result in detachment of the blocks adjacent to the boundary, on the underside of the overhang as shown in Photograph: 7. Whilst relatively small these blocks are expected to create a hazard for the site.

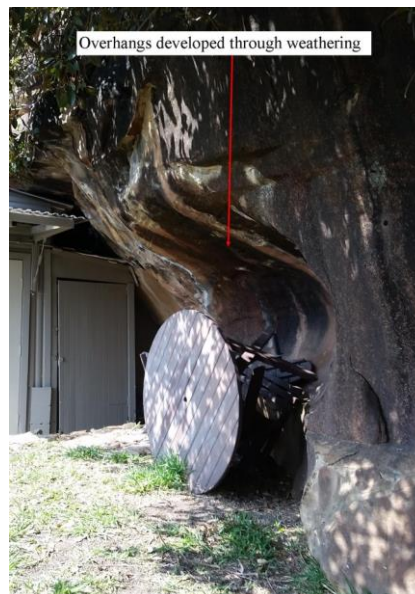
Photograph 8: Overhang/undercutting within the site.

Within the area to the west of the existing site structure, concave undercutting was observed as indicated in Photograph 8. It appears that preferential weathering of the rock mass is occurring and resulting in the concave features indicated in Photograph 8. This has resulted in an overhang in the upper sandstone unit that extends over the existing site house, (Photograph 9).

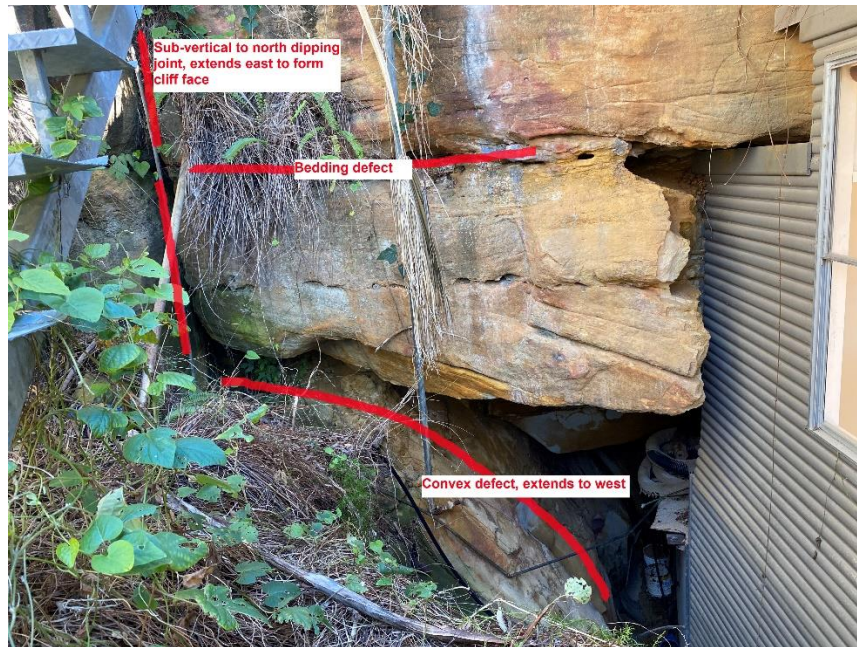
Photograph 9: Defects within bedrock and overhang/undercutting at south-west corner of existing house.

of the cliff whilst sub-parallel defects through the units above have also separated those sections (as per Photograph 9).

The overhang and curved defect adjacent to the west end of the existing site house also requires additional inspection and it appears that it will require stability measures due to the proposed house excavation. The proposed excavation for the new house structure appears to create a potential for undermining of the lower block of sandstone that is supporting the overlying rock units and overhang. This area should be geotechnically re-inspected following demolition of the existing house and prior to any excavation or construction as this will provide for better inspection and support installation.

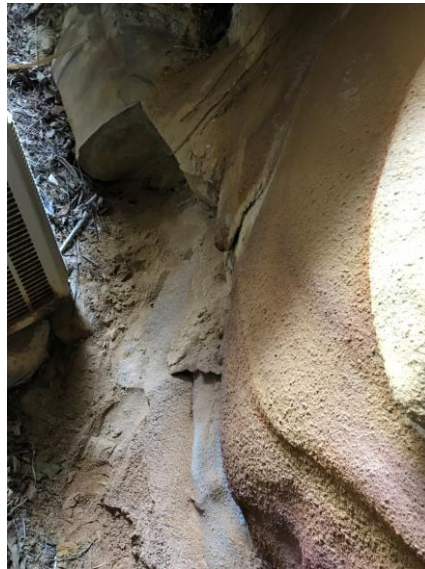
Areas of exposed bedrock which appeared susceptible to erosion were also observed to the south of the site structure and accumulation of eroded sandstone was observed at the toe of the exposure (Photograph 10).

Photograph 10: Accumulation of eroded sandstone to the south of the site structure

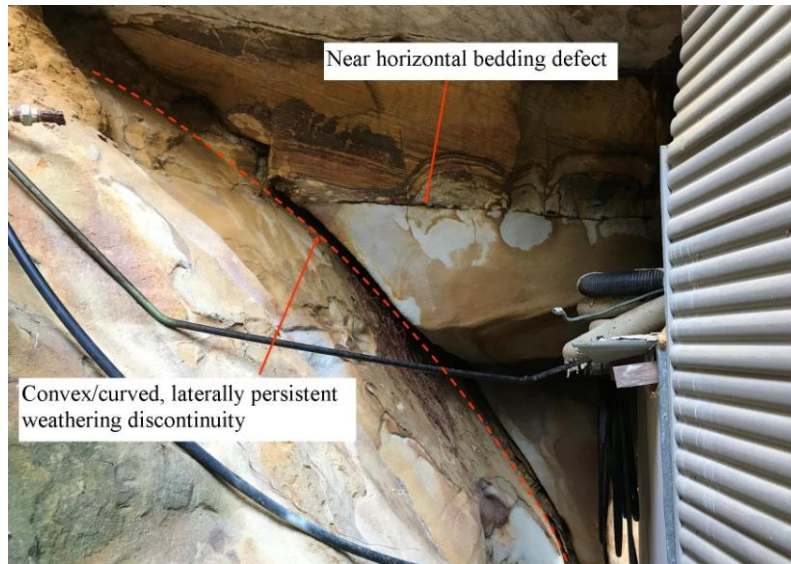
To the south of the site structure, a convex defect was observed in the cliff which appeared to be laterally persistent and trended generally west/east (Photograph 11) through to the sites western side boundary through the lower portion of the cliff exposure. Groundwater was also observed on this defect plane further to the west and within the site. This defect has resulted in separation of the rock to the west of the house at the base

Photograph 11: convex defects to the rear of the existing site structure.

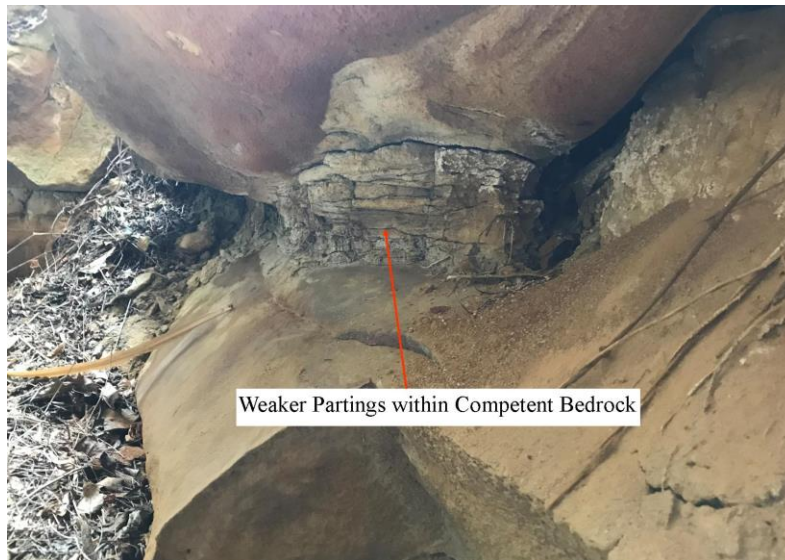
Photograph 12: Weak zones within bedrock

Bedding defects were also observed within otherwise competent sandstone with weaker seams/partings of clay as a result of less competent rock material also encountered, see Photograph: 12.
