MARGOT BLUES
CONSULTING ARBORIST

Arboricultural Impact Assessment (AIA) V3

Prepared for: Erin Isle Investments Pty Ltd
Site Address: 29 Dobroyd Road Balgowlah Heights
Inspection Date: 1 November 2021
Report Revision Date: 15 December 2021

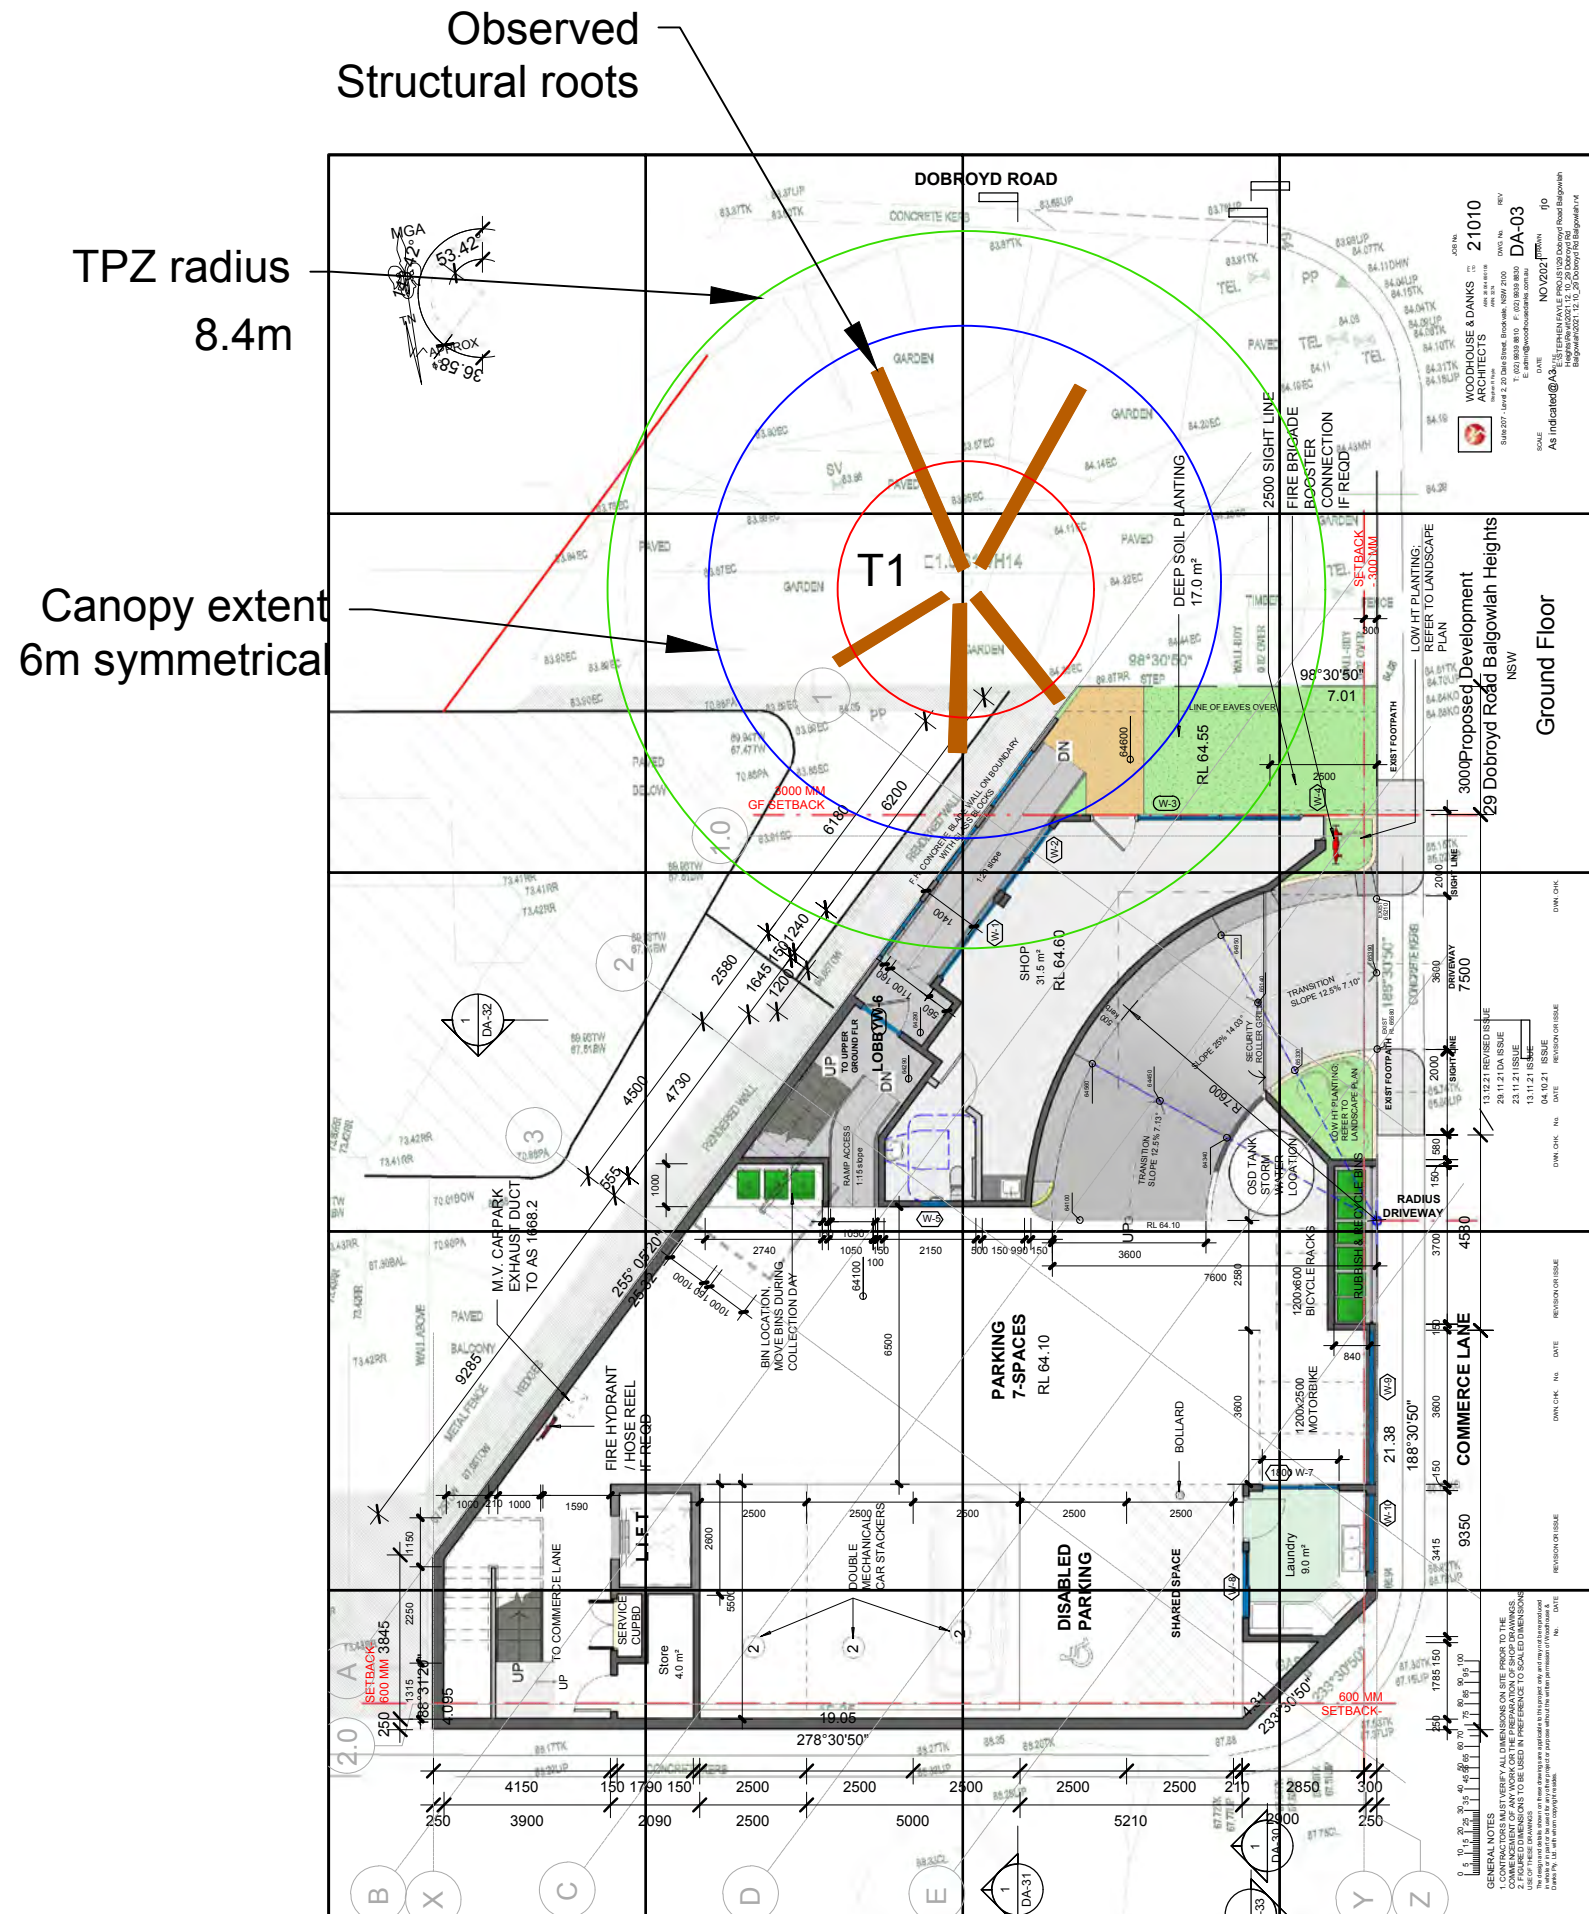
Margot Blues Consulting Arborist
 Title: Tree Identification 29 Dobroyd Rd Balgowlah Hts
 DATE: 15/12/2021
 Project: App 2 Tree Identification And Incursion Potential.dwg
 Scale: Relative to supplied documents

- 3.3.1 No additional excavation will occur within the TPZ or SRZ of the tree. Slight to nil pruning is anticipated as the proposed building is setback from the front boundary line thereby increasing the distance between foliage and building (see appendix 1).

- 4.1.2 Based on the proposal, the calculated incursion into the tree's TPZ was NIL (AS4970-2009). Excavation calculations within the site did not occur as the current building appeared to predate the tree's planting. It is assumed the soil environment beneath the building would not be conducive to root growth.

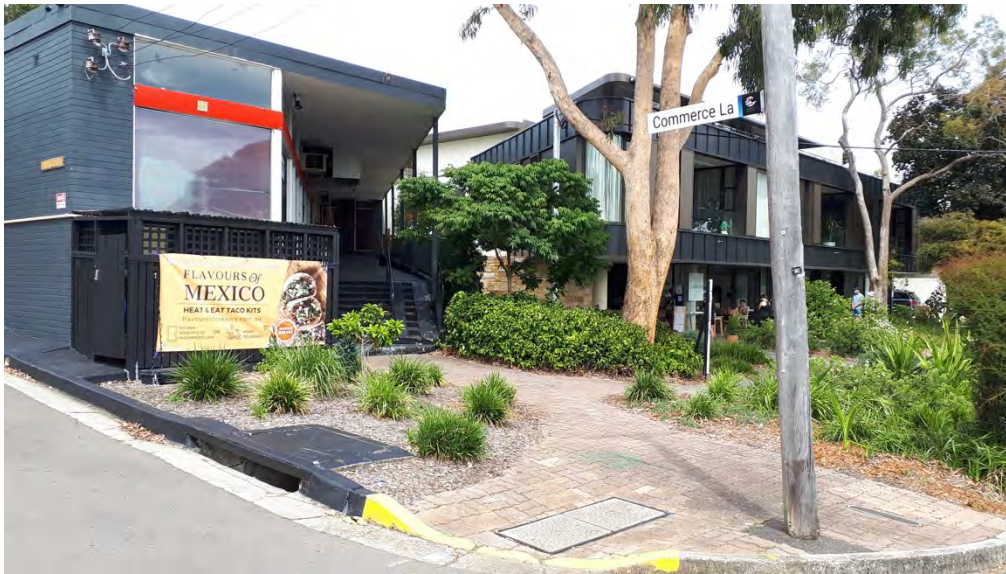
Photo 1: The tree relative to building and infrastructure within the verge.

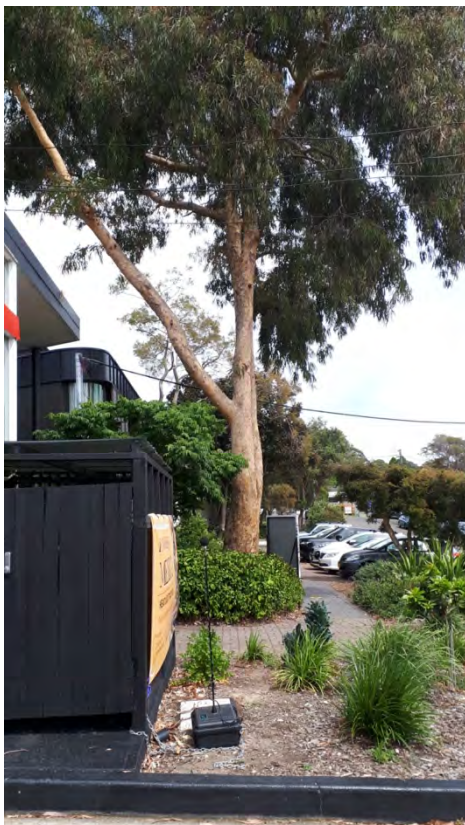
Two branches extend above the front of current building. The lower branch crosses the front boundary and building at an approximate height of 8 metres above ground. The height of the existing building was approximately 5 metres above ground. The branch angles upwards at an approximate 45 degree angle. The second branch is higher above the building.

Photo 2: Looking west. Branching towards existing building.

- 4.1.5 Should pruning occur, it is recommended the lowest branch extending south and above the building is retained as its removal would constitute the loss of approximately 30% of the total live crown. This percentage loss is deemed excessive and damaging for a mature tree (Gilman, 2002)¹.

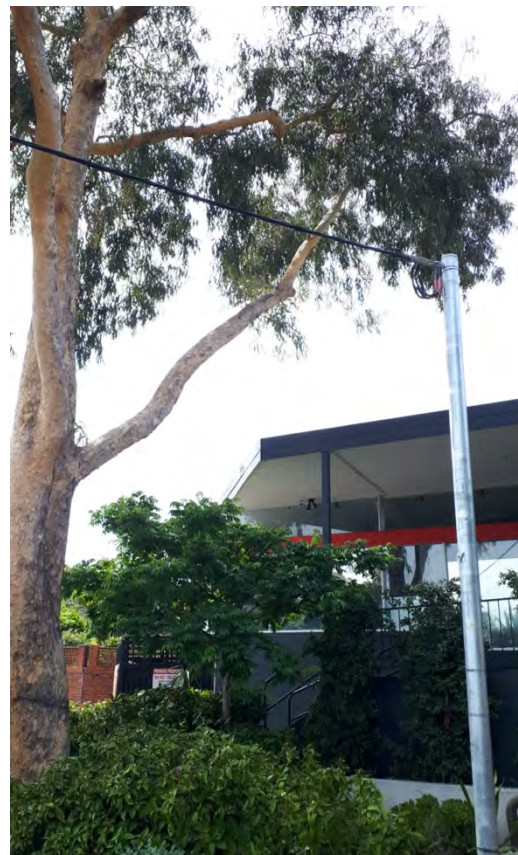
Photo 3: Looking East: Branch positioning above building.

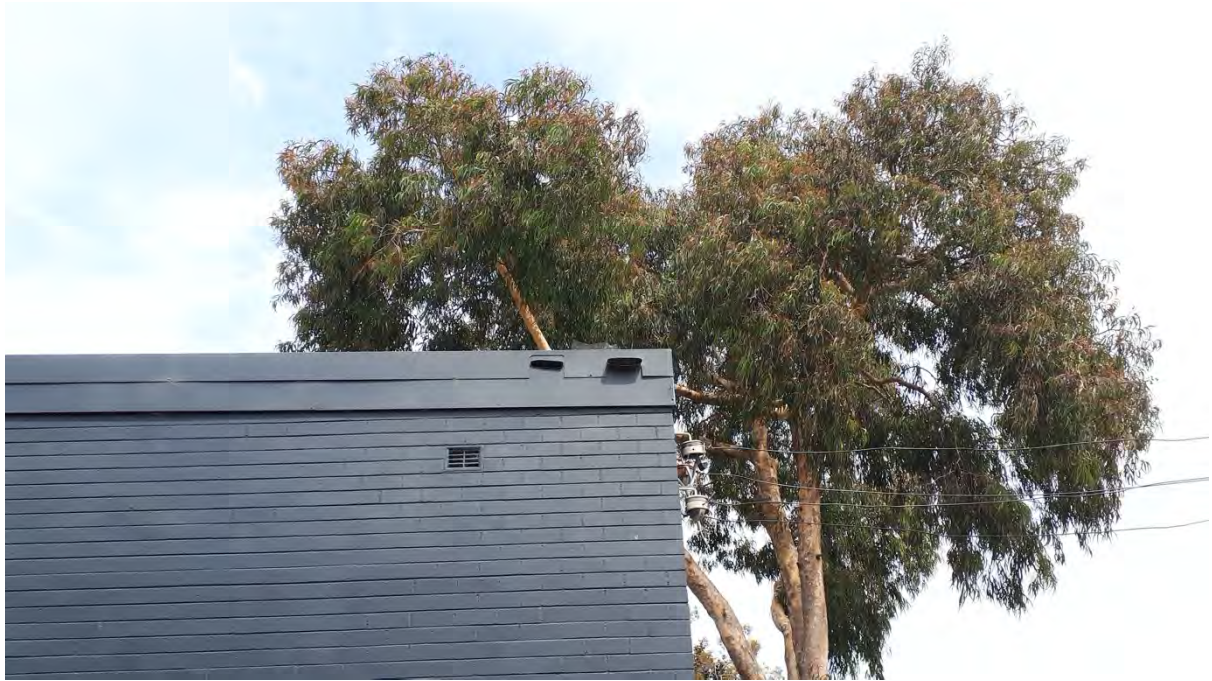
- 3.2.2 Minor pruning of these two limbs is likely particularly if scaffolding is required during construction.
- 3.2.3 No additional excavation within the TPZ will be required based on the supplied information.

Photo 4: Extent of canopy overhanging building.

- 4.1.3 Pruning may be required if scaffolding is required and or for construction access activities.
- 4.1.4 It is recommended any pruning is undertaken by a suitably qualified arborist and performed in accordance with the Pruning Standard AS4373-2007 *Pruning of Amenity Trees*.
