Pittwater Council Final Inspection Request

DA No: N0765/00

Property: 125 RICKARD ROAD NORTH NARRABEEN NSW 2101

PEST REPORT – 125 RICKARD ROAD, NORTH NARRABEEN

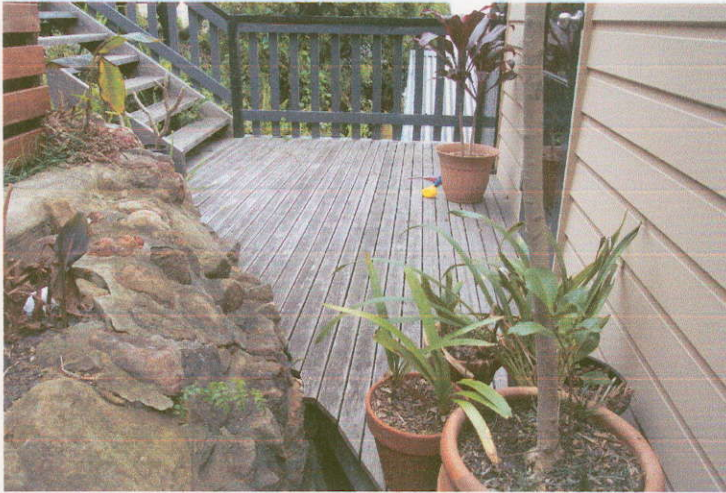
The rear bedroom extension which incorporates a suspended bearer/joist floor is located between the original house and a timber deck and is attached to both.

AS 3660.1 – 2000 requires a separation gap of at least 25mm between attachments and the building (attachments including the likes of steps, decks, verandahs etcetera). The separation gap is to allow clear and uninterrupted visual inspection across the inspection zone. The separation gap is not required if the attachment is fitted with a barrier system. The posts of the attached deck have been fitted with a metal stirrup which is an alternative to shielding (barrier system).

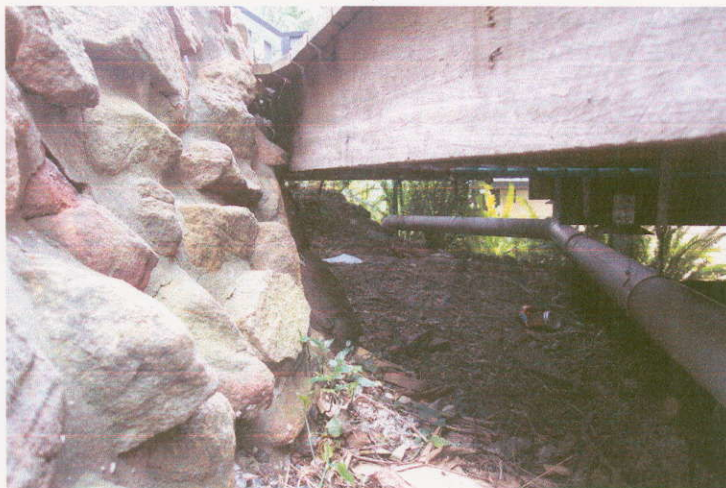
Although the attached deck has been fitted with post shoe supports there are areas where termites could access the deck and enter the extension.

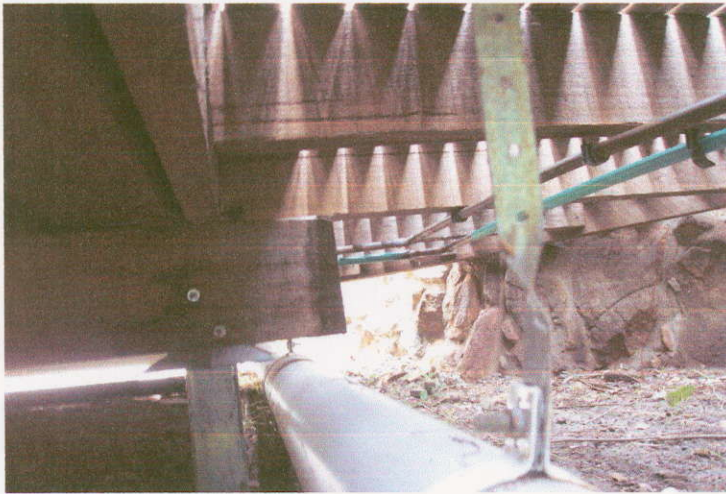
The junction between the extension and the rear deck.

AS 3660.2 – 2000 Termite Management Part 2: In and around existing buildings and structures – Guidelines where attachments to buildings are not fitted with termite barriers, clearance gaps and cannot be easily inspected, then regular inspections should be undertaken to ensure no termite activity. There is however sufficient access to the attachment which allows easy inspection of the adjoining structures and the attachment posts have been fitted with stirrups.

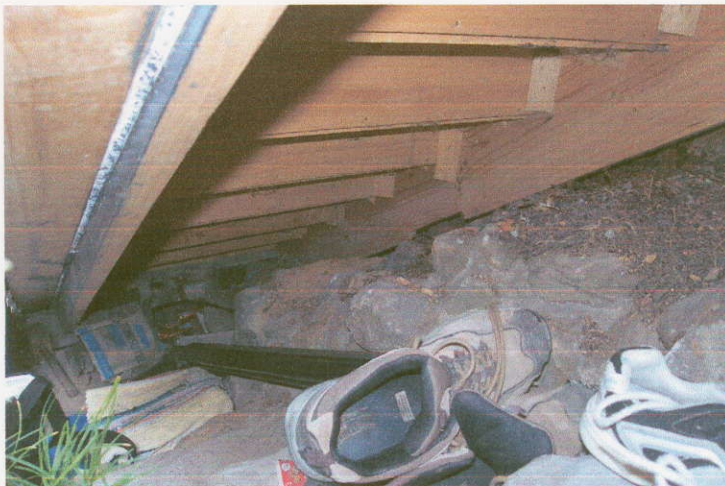
AS 3660.1 – 2000 requires that a barrier be installed at the interface between the new work and the existing building at or below ground floor level to deter concealed entry to the new work. The base of the internal stairs is the only area of the interface work that is in contact with the ground. The stair stringers bear on the house concrete slab and can easily be inspected. It is important that clearance is maintained over the length of the inside stringer where the timber is within close proximity of the ground. The painting of the timber to prevent fungal decay damage to the timber is advisable.

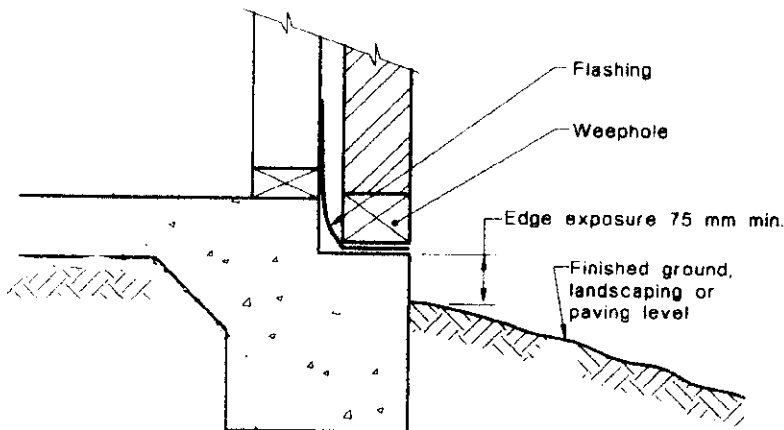
1. Across the concrete slab edge into the external wall cavities.
2. Through cracks between the floor waste pipes and the floor slab due to the shrinkage of the concrete away from the pipes.
3. Through shrinkage/settlement cracks in the concrete slab.

As all slab edges are not exposed, there is a high risk for undetected termite entry into the house.

It is important that all edges are exposed (as illustrated, although diagram for brick veneer construction), however if it is impracticable, and there is no evidence of other suitable termiticide barriers in place, then it is strongly recommended that a suitable termiticide treatment or baiting system be undertaken immediately.
