Email majbruce@hotmail.com ARBORICULTURAL IMPACT ASSESSMENT OF A TREE LOCATED ON 47 ARTHUR STREET, FORESTVILLE

Malcolm Bruce

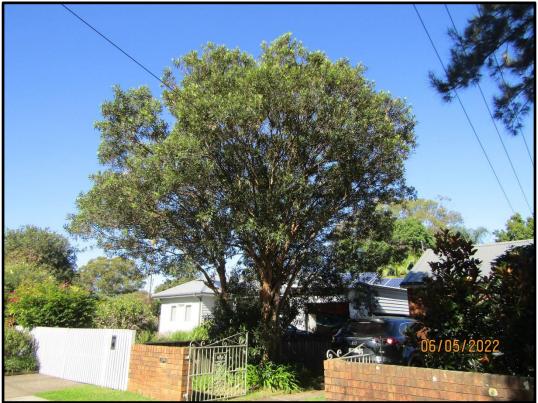
The subject tree is labelled as Trees 5 and 6 in the Landscape Plan (See Figure 3). Trees 5 and 6 are actually a single highly coppiced *Tristaniopsis laurina* (Water Gum). (See Figure 5) The tree has formed as a multi-trunked form as a result of removal of the original stem or damage to the base of the original stem. (See Figure 6) There is some indication of damage to the base of the original stem, resulting in the coppicing as well as signs of decay in the lower trunk. The close growth of the trunks has resulted in the formation of several bark inclusions, which Mattheck (2007) P.131, describes as a "low-level compression fork. (See Figure 7) This formation has a high chance of failure. Several bark inclusions have formed in the crown. Several of these have formed as longitudinal cracks. (See Figure 8 to Figure 10) Formations with bark inclusions and longitudinal cracks have been described by Mattheck as potentially dangerous (Mattheck and

Breloer, 1994, P.60 and Mattheck, 2007, P.21). Lonsdale (2000) P. 20, supports Mattheck stating "unions with included bark are most likely to fail in trees on exposed sites (especially if exposure has increased, as when surrounding trees are removed), or in dominant trees whose height makes them rather exposed. Gusts blowing between the forks are most likely to cause failure ". There is a poorly welded crossover and poorly pruned branch stub, protruding from one of the co-dominant trunks. (See Figure 11 and Figure 12) The Water Gum is in very poor structural condition. Further, the proposed driveway upgrade will encroach on 43% of the tree's Tree Protection Zone (TPZ) with a substantial incursion into the Structural Root Zone (SRZ). (See Figure 3) This is a major encroachment under Point 3.3.3 of Australian Standard 4970 of 2009. This will result in substantial root loss where the loss of structural roots and the subsequent loss of tree stability is emphasised by Mattheck (2007). Ps 34 to 41 and Coder (2000) states "*Reduced rooting volume mechanically destabilizes the whole tree.*" Additionally, Roberts et al (2006) P. 257 state 'If energy reserves have been depleted, a tree faced with stress from disease, drought, or perhaps damage to its roots, may be unable to recover." The tree is so poor structurally, that it should be removed.

Figure 5: Tree 5/6

- 6.1 Trees 5/6 should be removed;
- 6.2 Removed trees must be replaced. The replacement trees should be locally endemic species from the Gymea soil landscape, such as, *Angophora costata* and *Banksia serratifolia*, and grown as specified in AS 2303 of 2015 *Tree stock for landscape use* (Standards Australia, 2015), in 20 litre containers and between 1 and 2 metres in height.

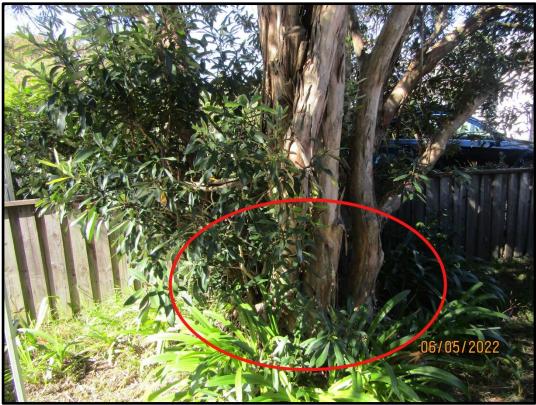
Figure 6: Coppiced base

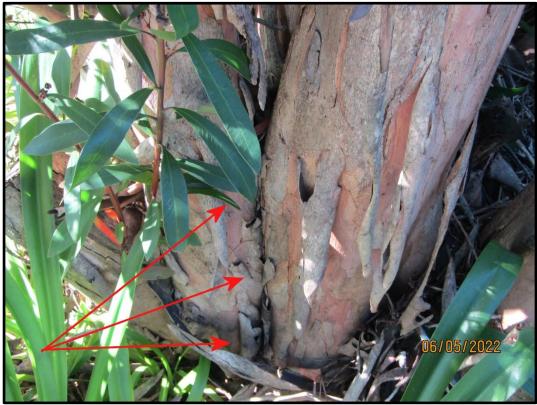
Figure 7: Low-level compression fork with included bark

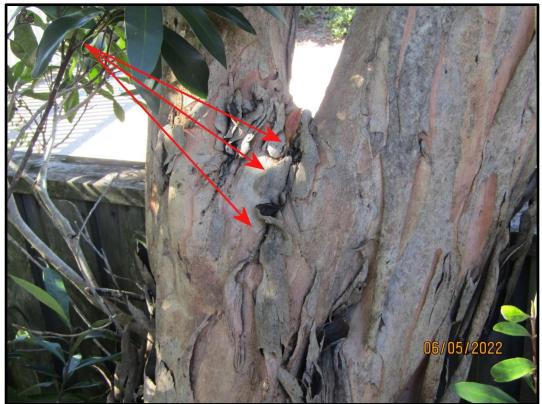
Figure 8: Longitudinal crack with included bark

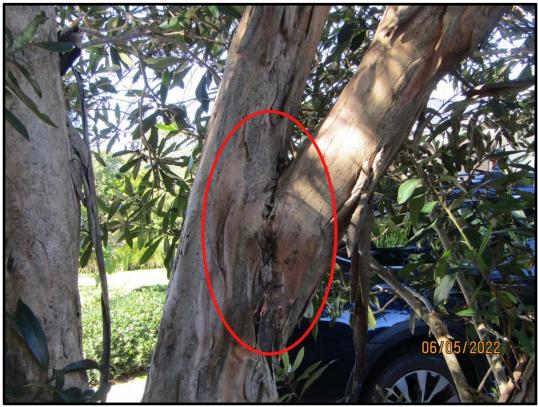
Figure 9: Reverse view of longitudinal crack in Figure 8

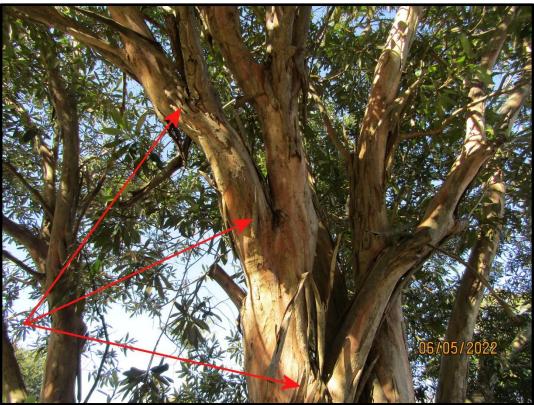
Figure 10: Further bark inclusion in the crown of the tree

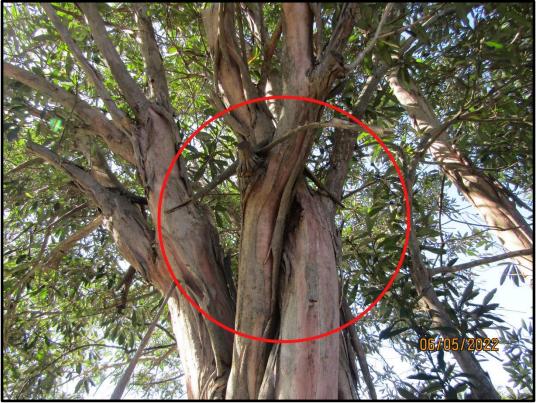
Figure 11: Poorly welded crossover with abrasion wound

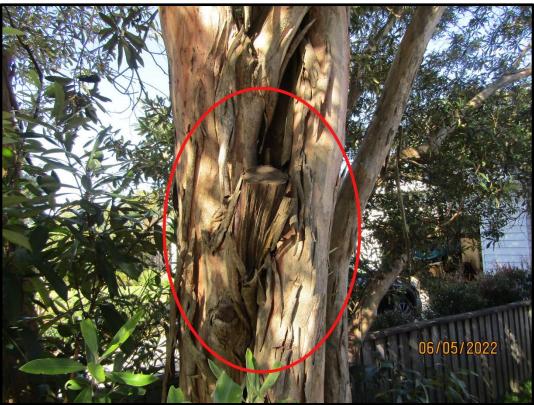
Figure 12: Protruding branch stub
