Interim Occupation Certificate

Certificate No 2007/2412A

FINAL CONDITIONS REPORT

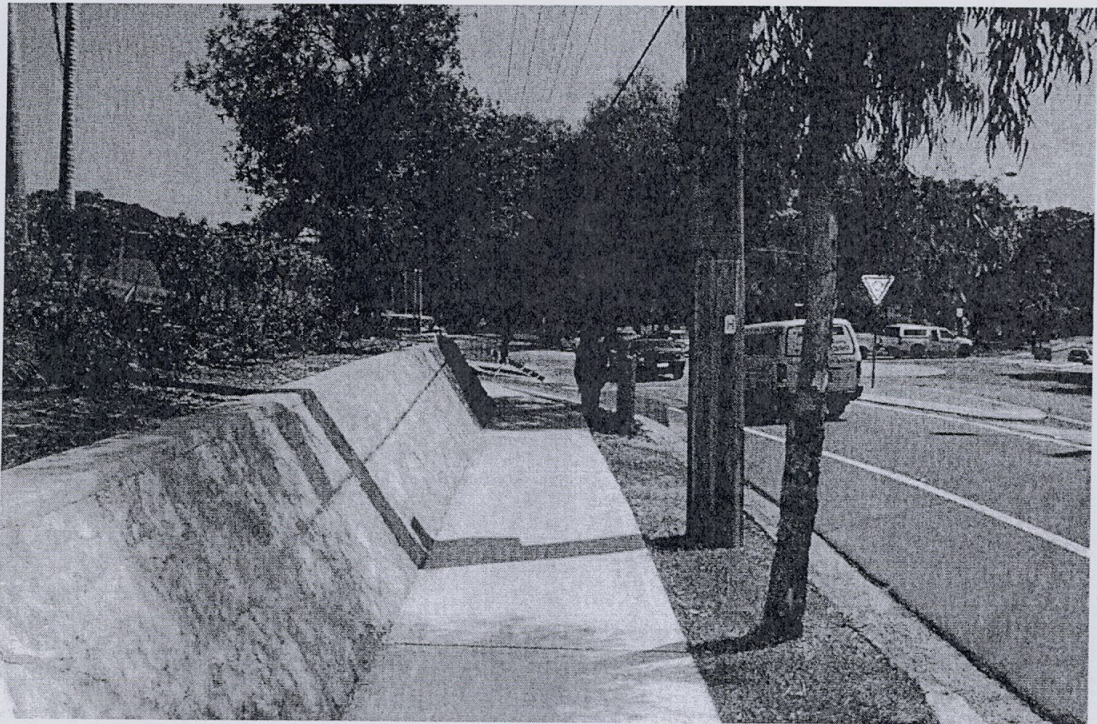
Bayview Golf Club. Adjacent public property. Pittwater Road. Facing north along the western side of Pittwater Road adjacent to power pole no. MV2754. Area compares to photo DSC_0017 from the original report dated 28.11.07. Difference: New concrete paved footpath replacing the full width nature strip.

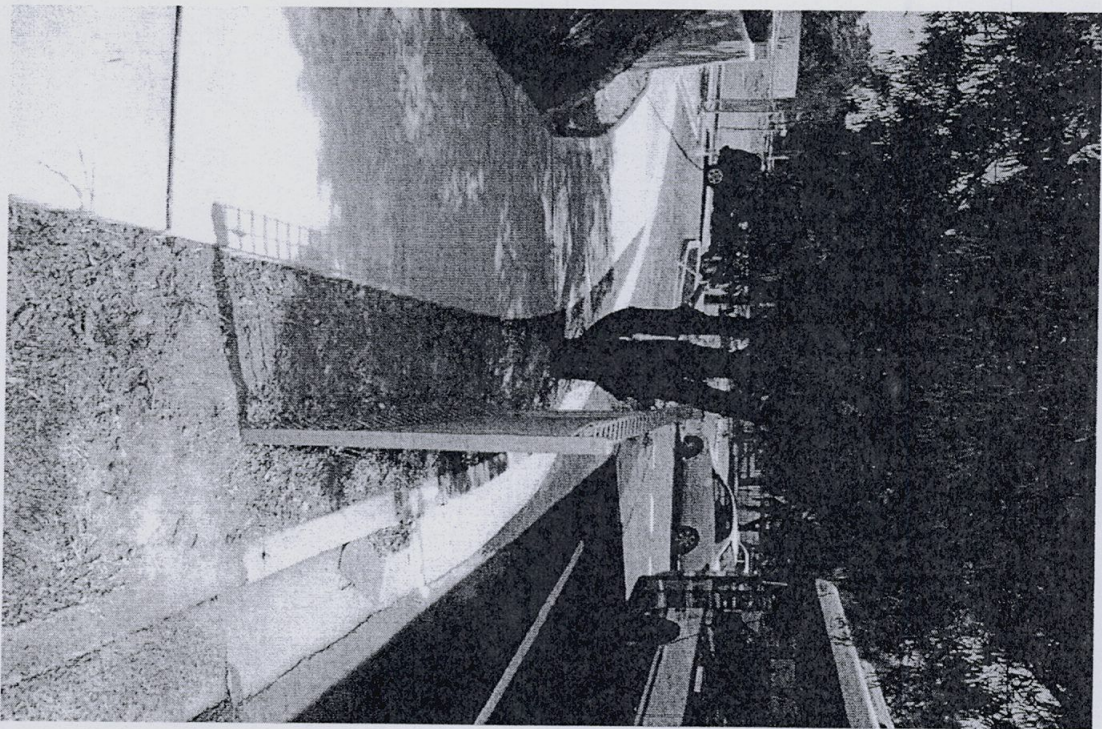
Bayview Golf Club. Adjacent public property. Pittwater Road. Facing north along the western side of Pittwater Road approaching the roundabout at the intersection with Mona Street. Area compares to photo DSC_0019 from the original report dated 28.11.07. Difference: New concrete paved footpath replacing the nature strip. —>

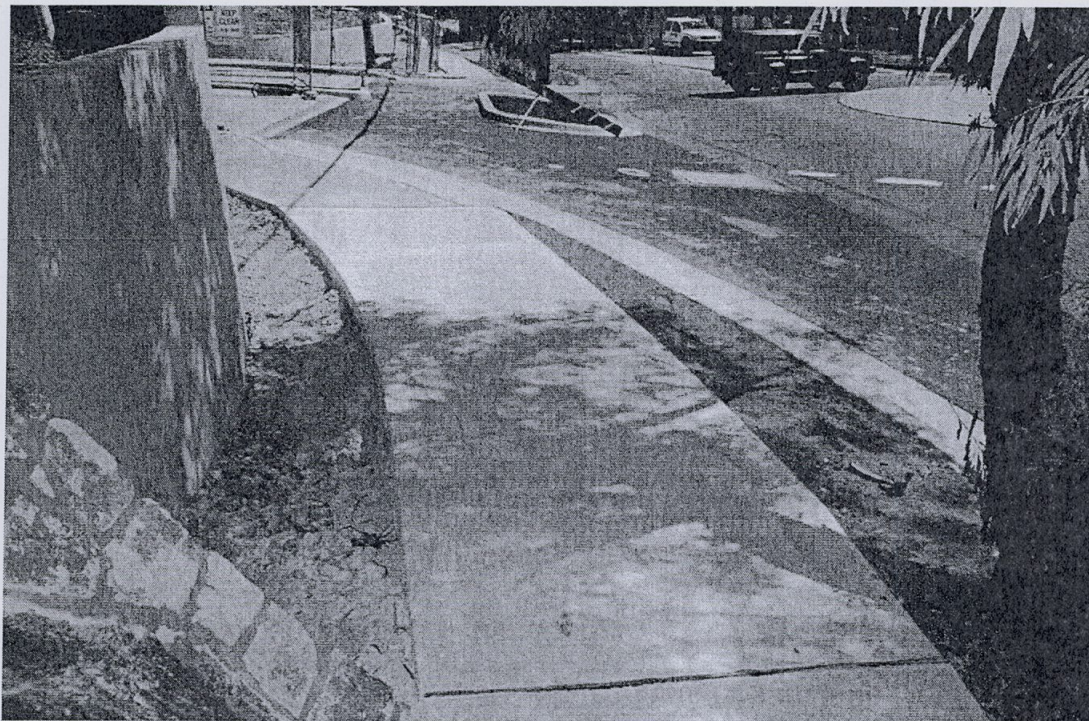
Bayview Golf Club. Adjacent public property. Pittwater Road. Facing north along the western side of Pittwater Road approaching the roundabout at the intersection with Mona Street. Area compares to photo DSC_0020 from the original report dated 28.11.07. Difference: New concrete paved footpath replacing the nature strip.

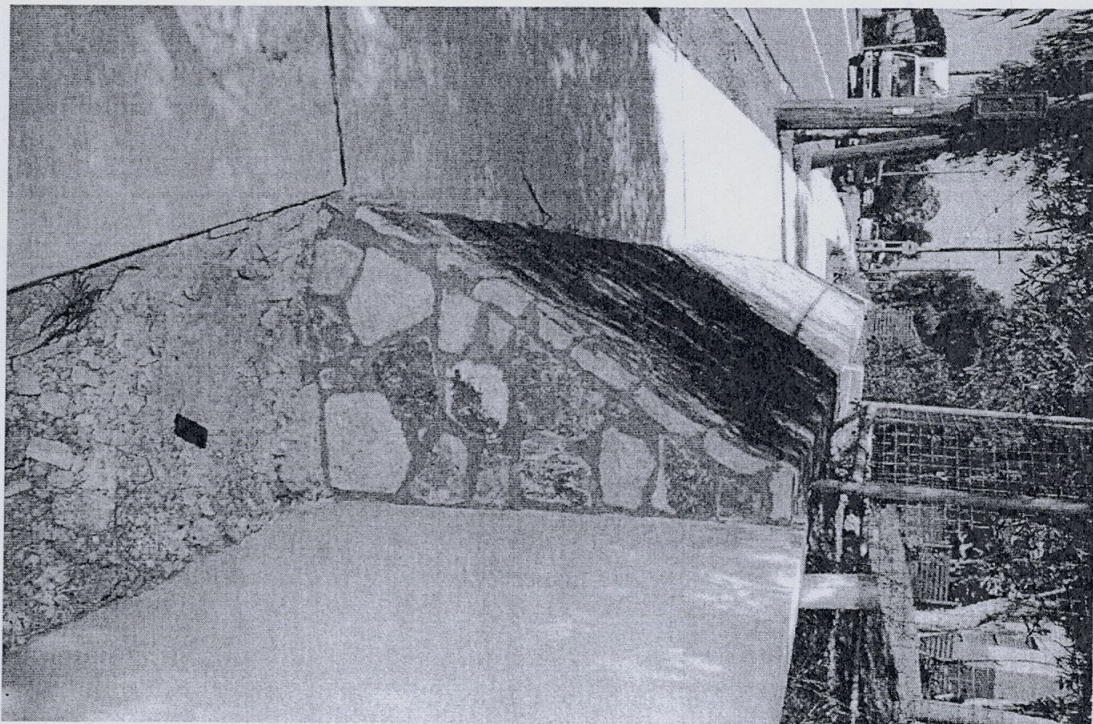
Bayview Golf Club. Adjacent public property. Pittwater Road. Facing south along the western side of Pittwater Road south of the roundabout at the intersection with Mona Street. Junction of the new and previous works. Stone flagged retaining wall returned around the northern end of the wall. —>

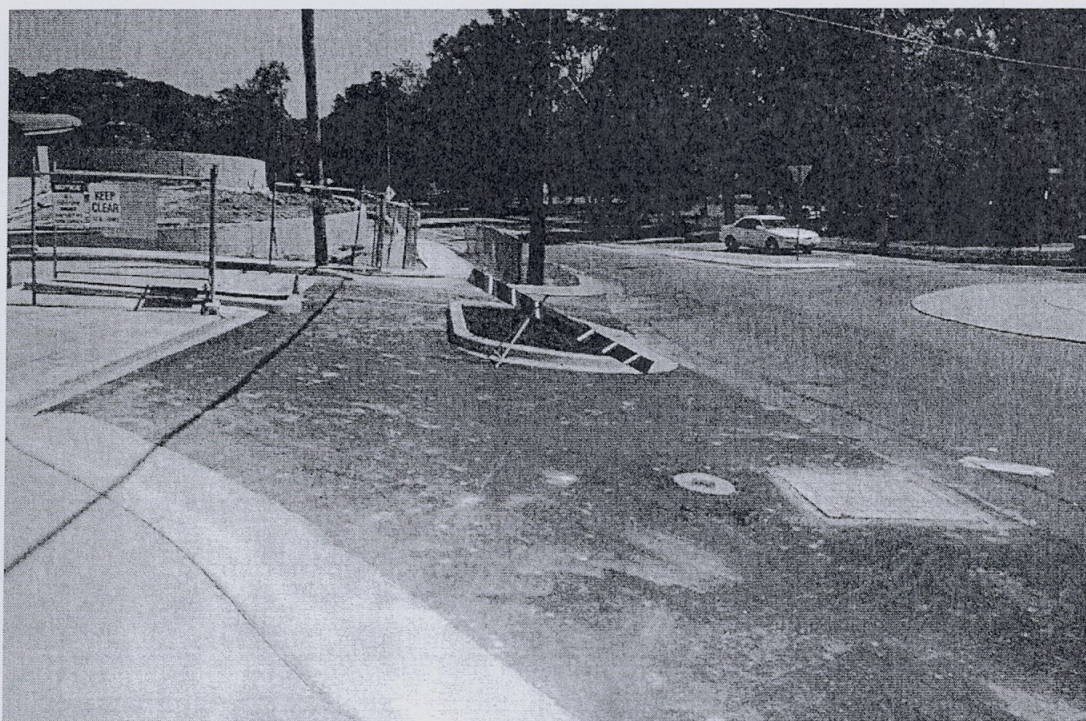
Bayview Golf Club. Adjacent public property. Pittwater Road. Facing north across the new driveway entrance to the development on the western side of Pittwater Road at the roundabout at the intersection with Mona Street. Area compares to photo DSC_0024 from the original report dated 28.11.07.

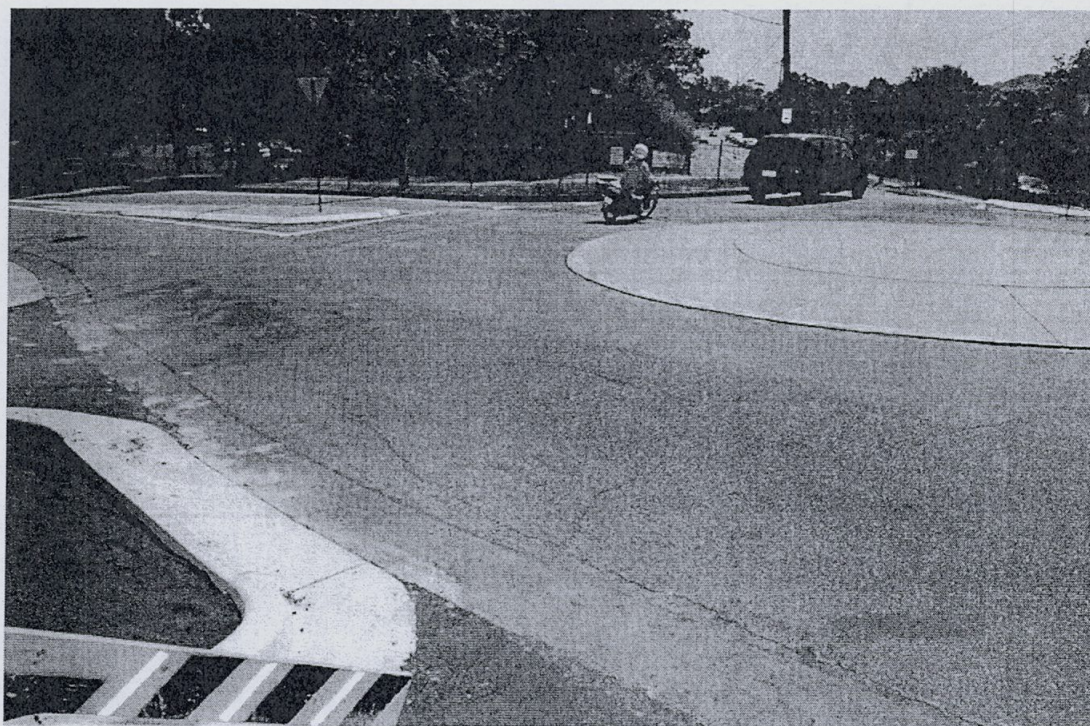
Bayview Golf Club. Adjacent public property. Pittwater Road. Facing north-east from the new driveway entrance to the development on the western side of Pittwater Road at the roundabout at the intersection with Mona Street. Area compares to photo DSC_0035 from the original report dated 28.11.07. Rubber track marks on the road.

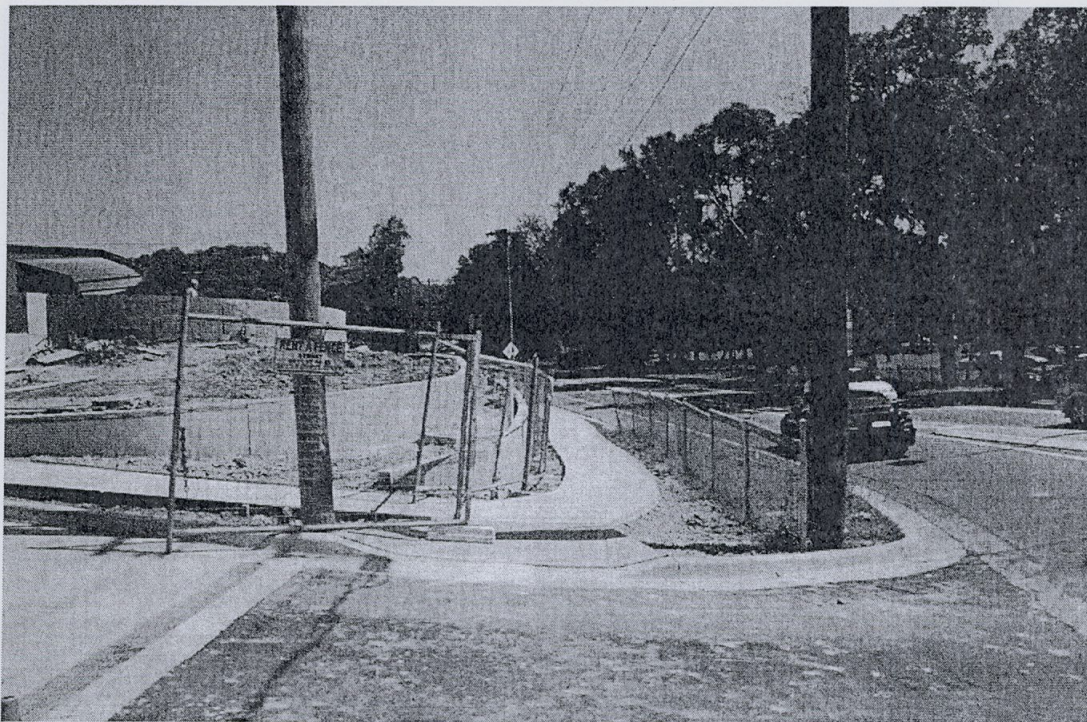
Bayview Golf Club. Adjacent public property. Pittwater Road. Facing north from the new driveway entrance to the development on the western side of Pittwater Road at the roundabout at the intersection with Mona Street. Area compares to photo DSC_0035 from the original report dated 28.11.07. New concrete footpath.

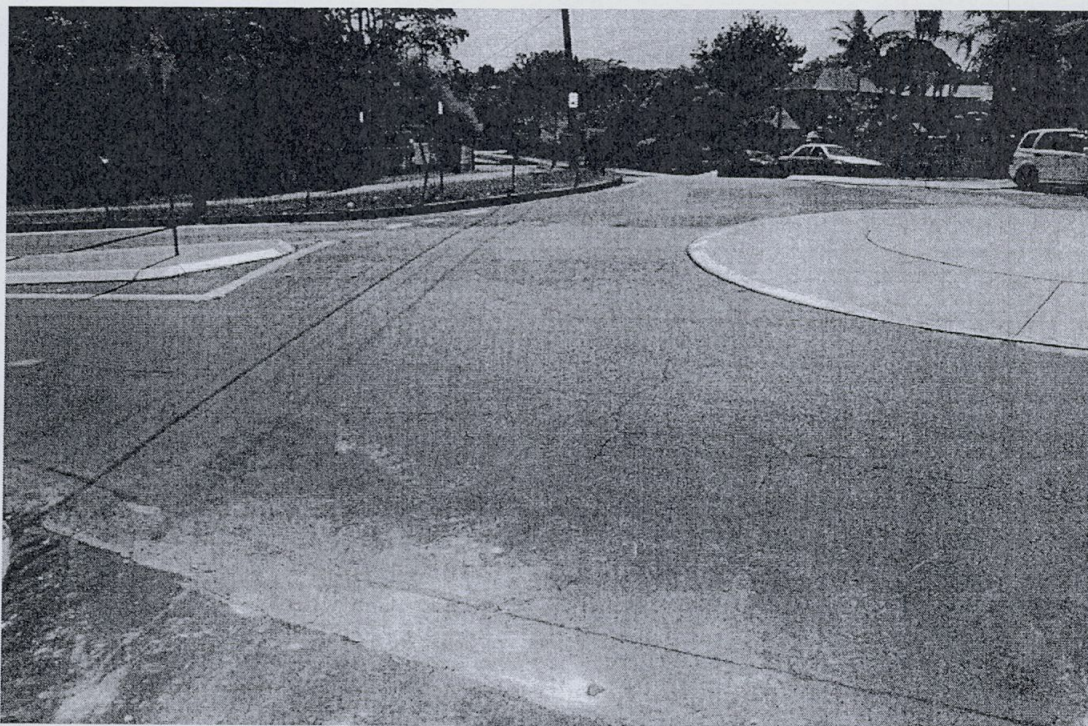
Bayview Golf Club. Adjacent public property. Pittwater Road. Facing east on the northern side of the roundabout at the intersection with Mona Street. Area compares to photo DSC_0036 from the original report dated 28.11.07. Rubber track marks on the road.

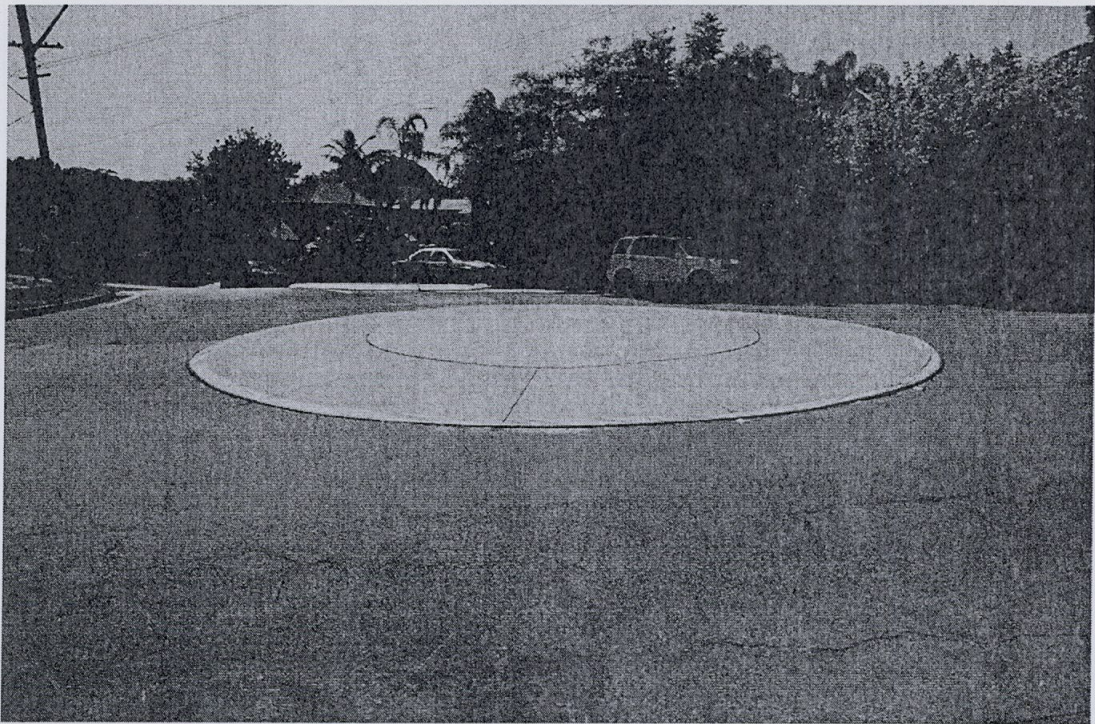
Bayview Golf Club. Adjacent public property. Pittwater Road. Facing east to the roundabout at the intersection with Mona Street. Area compares to photo DSC_0025 from the original report dated 28.11.07. Noting the rubber track marks on the asphalt road surface.

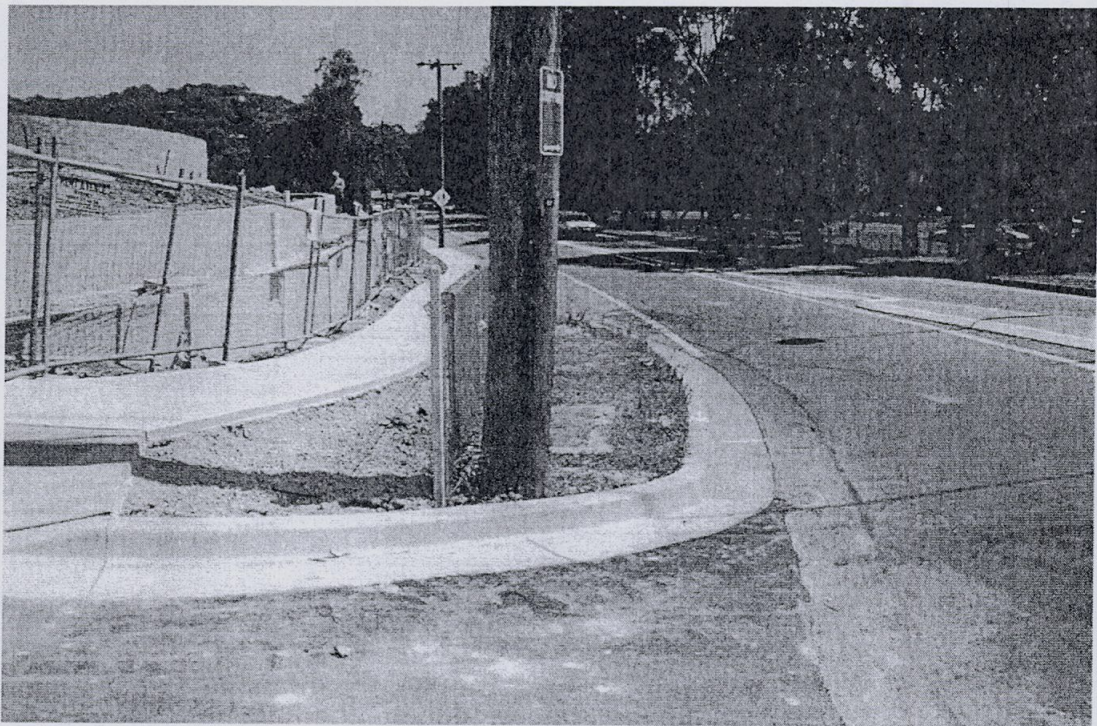
Bayview Golf Club. Adjacent public property. Pittwater Road. Facing north along the western side of Pittwater Road approaching power pole no. MV2751. Area compares to photo DSC_0035 from the original report dated 28.11.07. Noting the lack of landscaping adjacent to the concrete paved footpath.

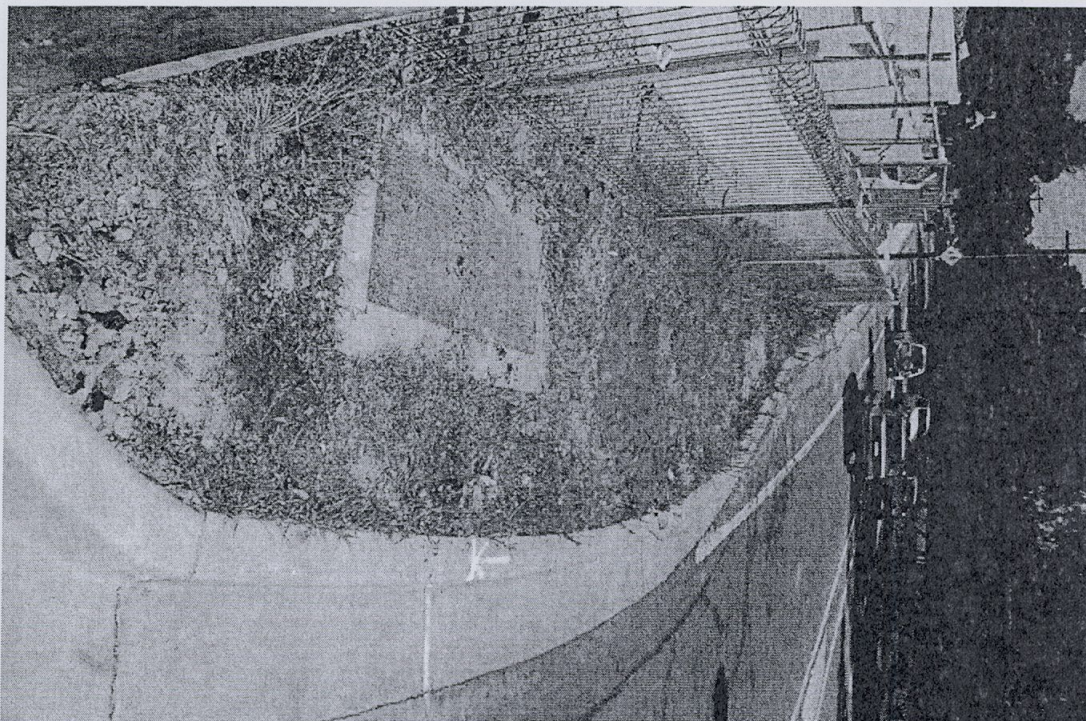
Bayview Golf Club. Adjacent public property. Pittwater Road. Facing north along the western side of Pittwater Road adjacent to power pole no. MV2751. Area compares to photo DSC_0037 from the original report dated 28.11.07. Noting the debris at the base of the power pole. —>

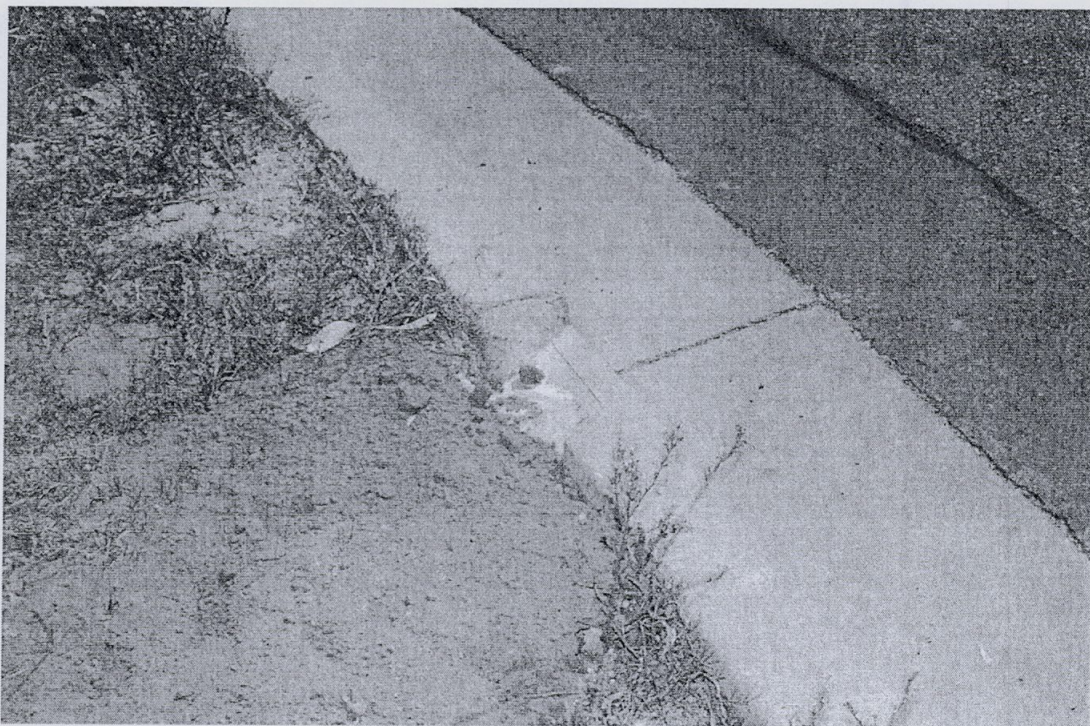
Bayview Golf Club. Adjacent public property. Pittwater Road. Facing north along the western side of Pittwater Road adjacent to power pole no. MV2751. Area compares to photo DSC_0037 from the original report dated 28.11.07. New storm water outlet. Note: no concrete infill above the pipe – check requirements.

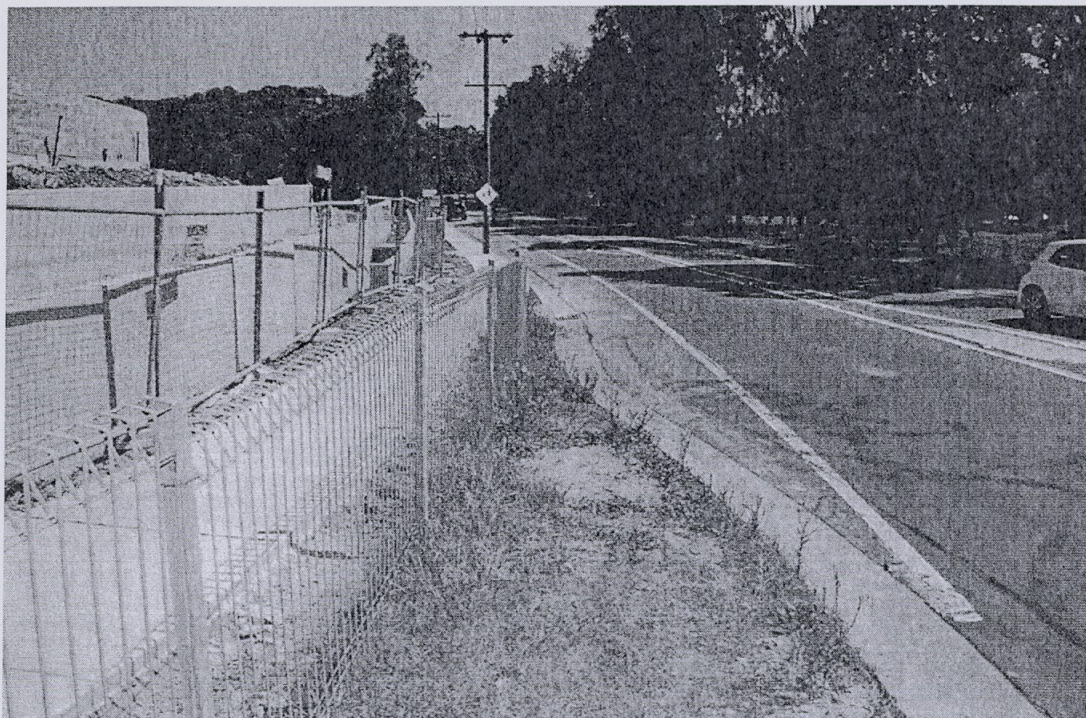
Bayview Golf Club. Adjacent public property. Pittwater Road. Facing north-west along Pittwater Road from the intersection with Mona Street. Area compares to photo DSC_0037 & 40 from the original report dated 28.11.07. New concrete paved footpath replacing the previous nature strip.

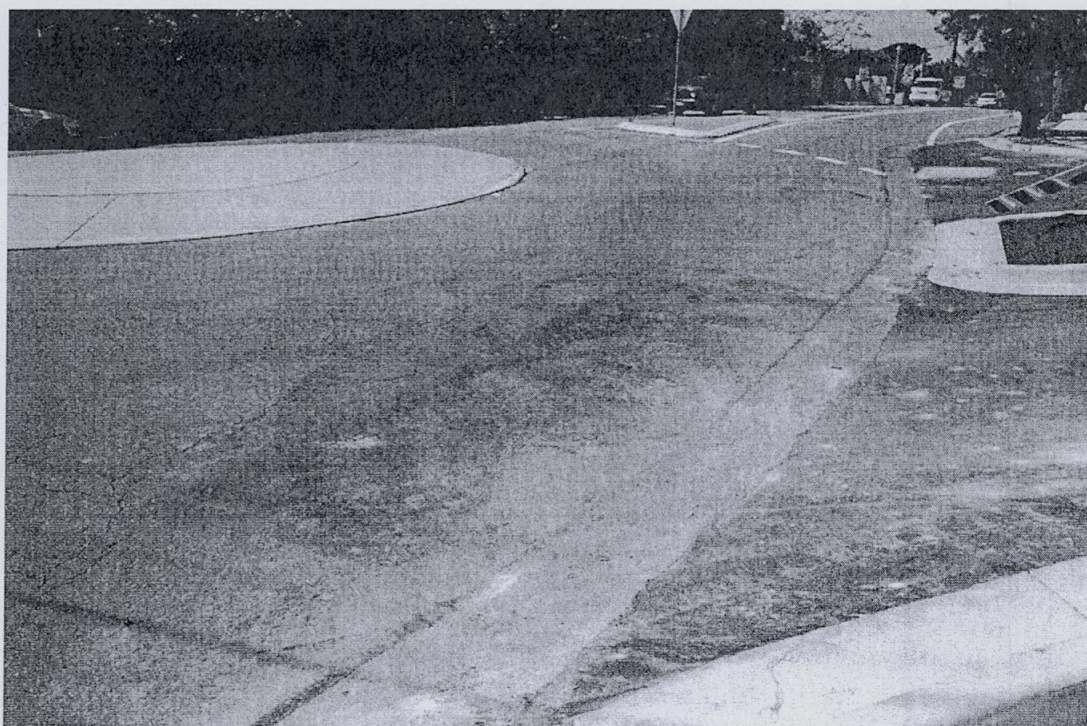
Bayview Golf Club. Adjacent public property. Pittwater Road. Facing south-east along Pittwater Road at the intersection with Mona Street. Area compares to photo DSC_0026 from the original report dated 28.11.07. Noting the rubber track marks on the asphalt road surface.

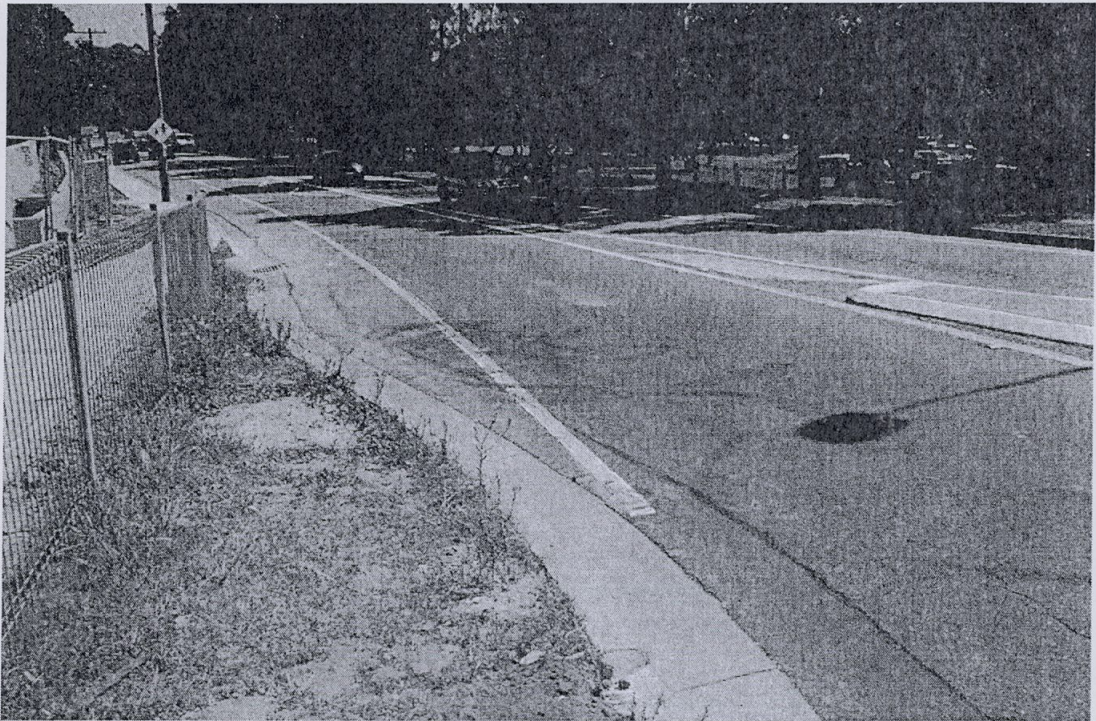
Bayview Golf Club. Adjacent public property. Pittwater Road. Intersection with Mona Street. Facing north along the western side of the intersection. Area adjacent to power pole no. MV2751. Area compared to photo DSC_0037 from the original report dated 28.11.07. Rubber track marks on the asphalted road surface.

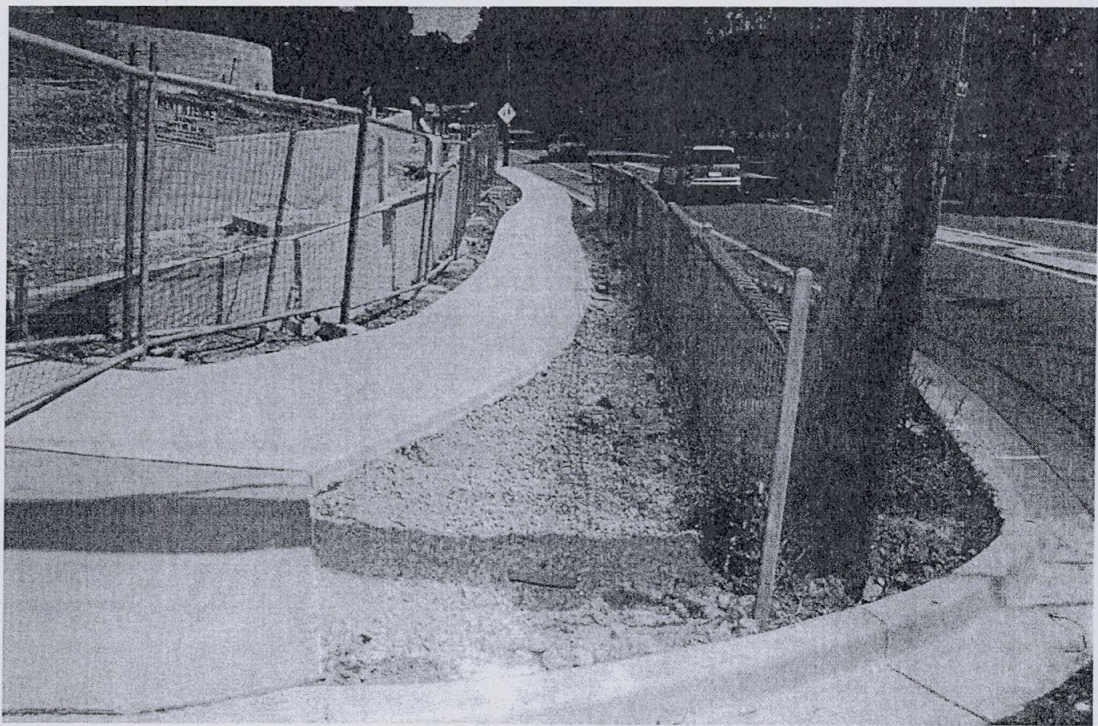
Bayview Golf Club. Adjacent public property. Pittwater Road. Intersection with Mona Street. Facing north along the western side of the intersection. Area adjacent to power pole no. MV2751. Area compared to photo DSC_0035 from the original report dated 28.11.07. Incomplete nature strip.

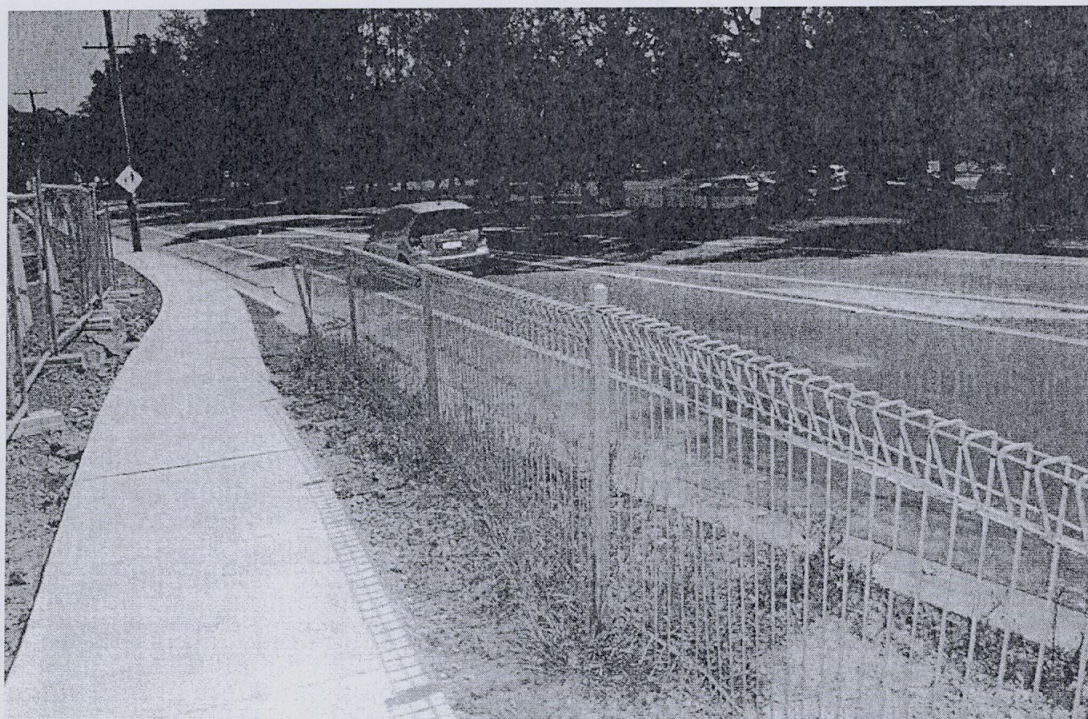
Bayview Golf Club. Adjacent public property. Pittwater Road. Facing north along the western side of Pittwater road. Area to the north of power pole no. MV2751. Area compares to photo DSC_0041 from the original report dated 28.11.07. New concrete paved footpath.

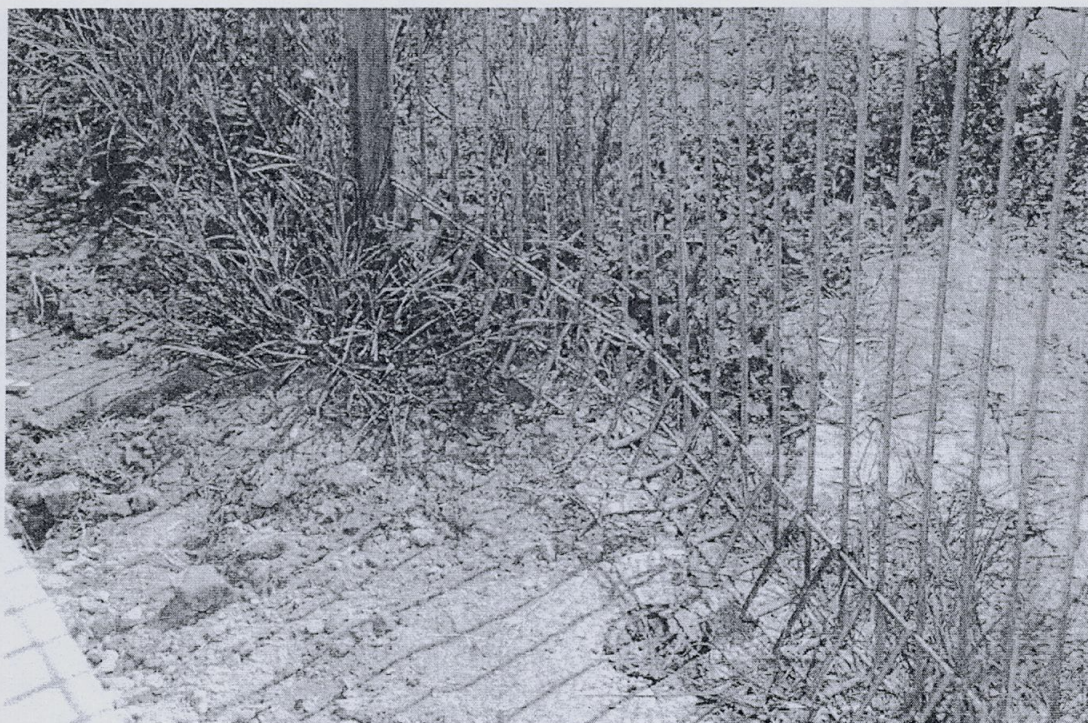
Bayview Golf Club. Adjacent public property. Pittwater Road. Facing north-west along the western side of Pittwater road. Area to the north of power pole no. MV2751. Area compares to photo DSC_0041 from the original report dated 28.11.07. Damage to the fencing / barricade.

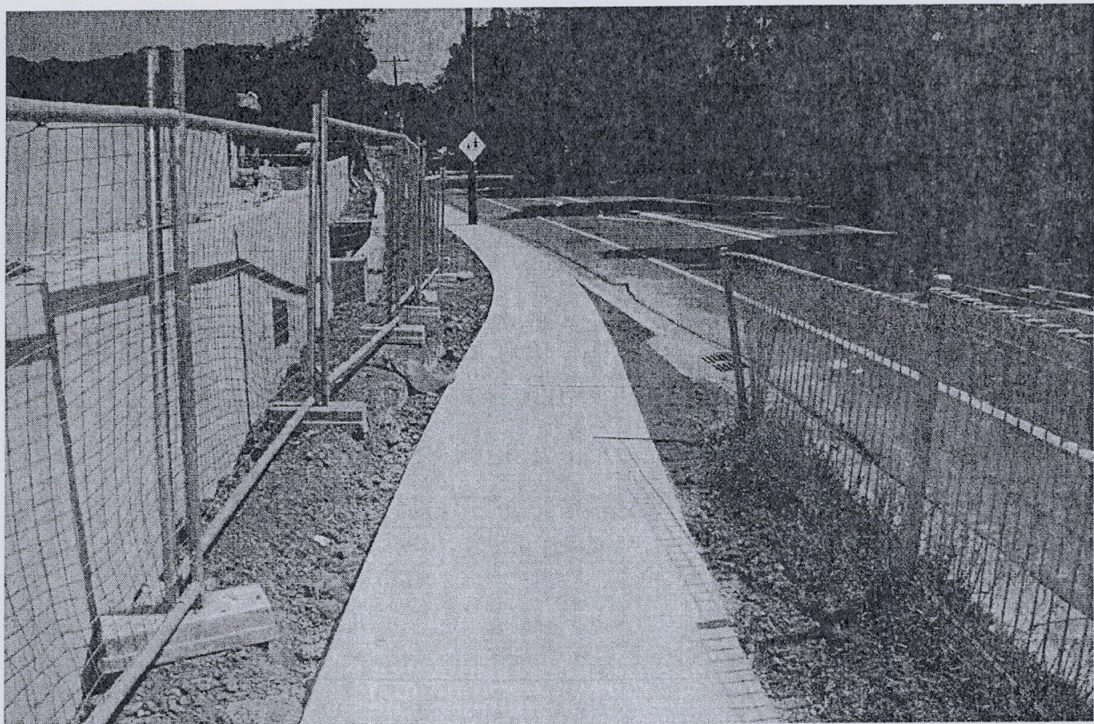
Bayview Golf Club. Adjacent public property. Pittwater Road. Facing north-west along the western side of Pittwater road. Area to the north of power pole no. MV2751. Area compares to photo DSC_0041 from the original report dated 28.11.07. Damage to the fencing / barricade. New concrete paved footpath.

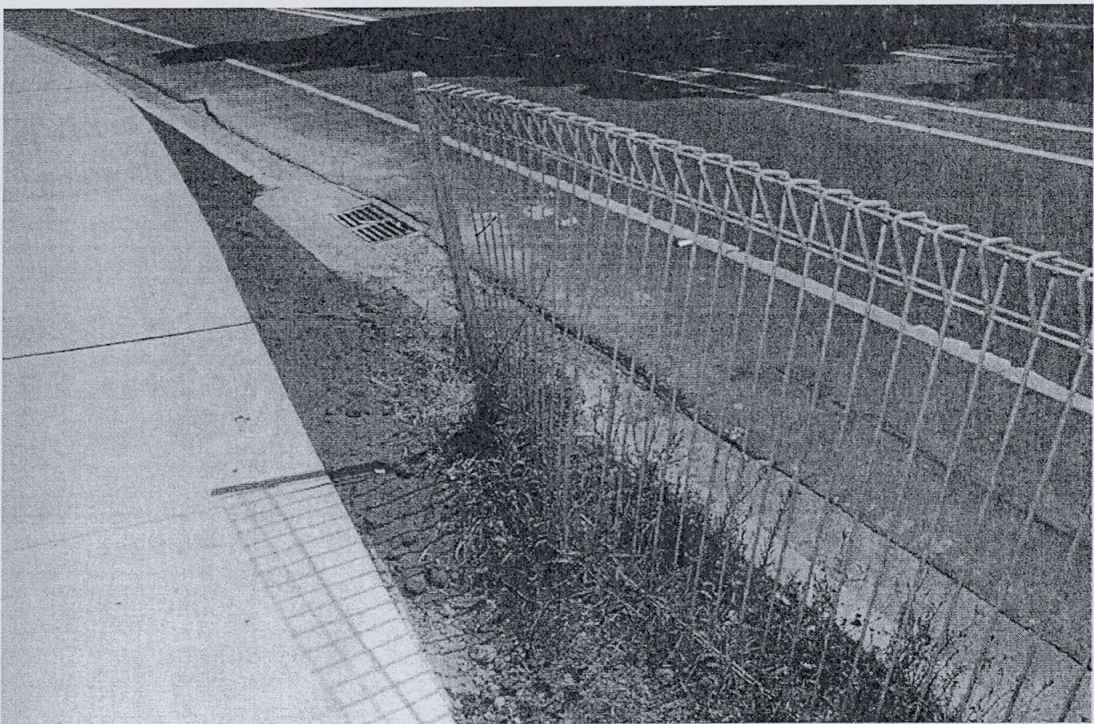
Bayview Golf Club. Adjacent public property. Pittwater Road. Facing north-west along the western side of Pittwater road. Area to the north of power pole no. MV2751. Area compares to photo DSC_0041 from the original report dated 28.11.07. Damage to the fencing / barricade. New concrete paved footpath.

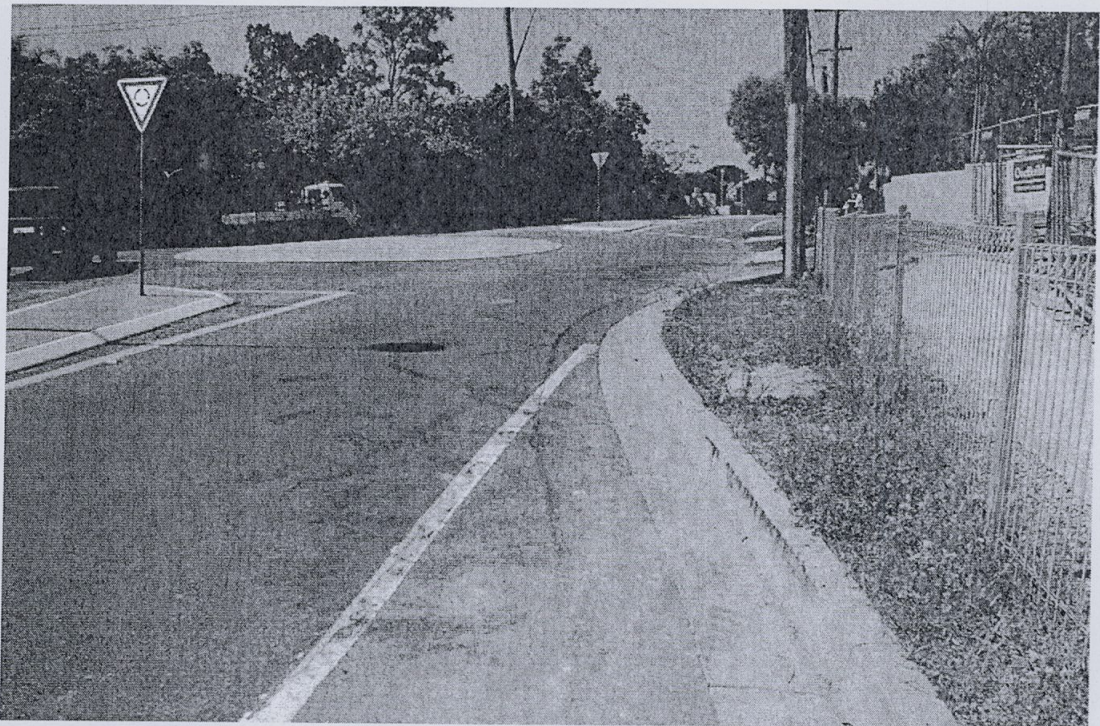
Bayview Golf Club. Adjacent public property. Pittwater Road. Facing south-east along the western side of Pittwater road. Area to the north of power pole no. MV2751. Area compares to photo DSC_0045 from the original report dated 28.11.07. Rubber track marks on the road surface.

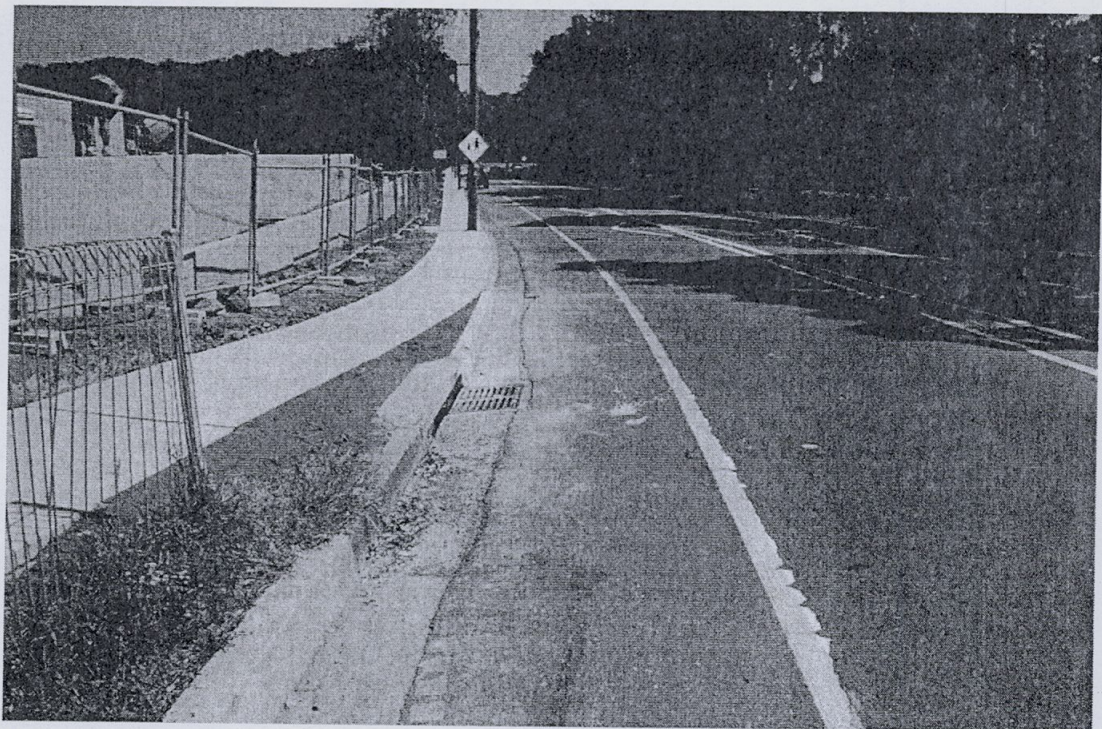
Bayview Golf Club. Adjacent public property. Pittwater Road. Facing north-west along the western side of Pittwater road. Area to the north of power pole no. MV2751. Area compares to photo DSC_0041 from the original report dated 28.11.07. Approaching the storm water drain. Damage to the adjacent fence.

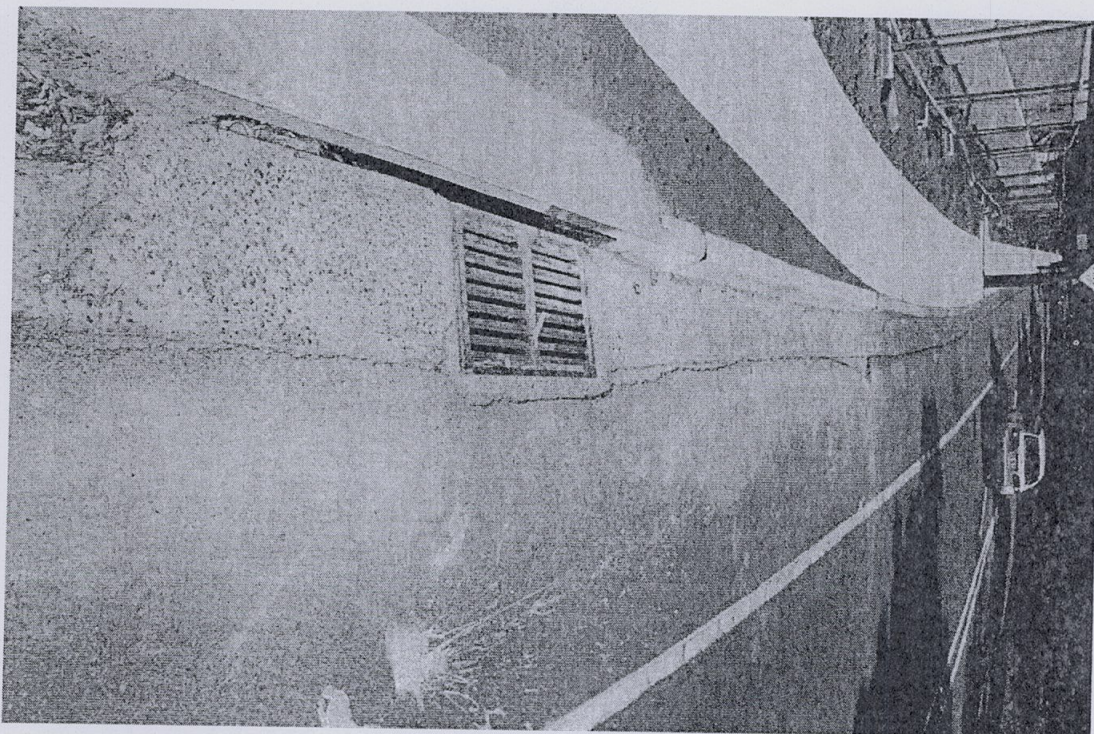
Bayview Golf Club. Adjacent public property. Pittwater Road. Facing north-west along the western side of Pittwater road. Area to the north of power pole no. MV2751. Area compares to photo DSC_0042 from the original report dated 28.11.07. Area of the storm water drain. —>

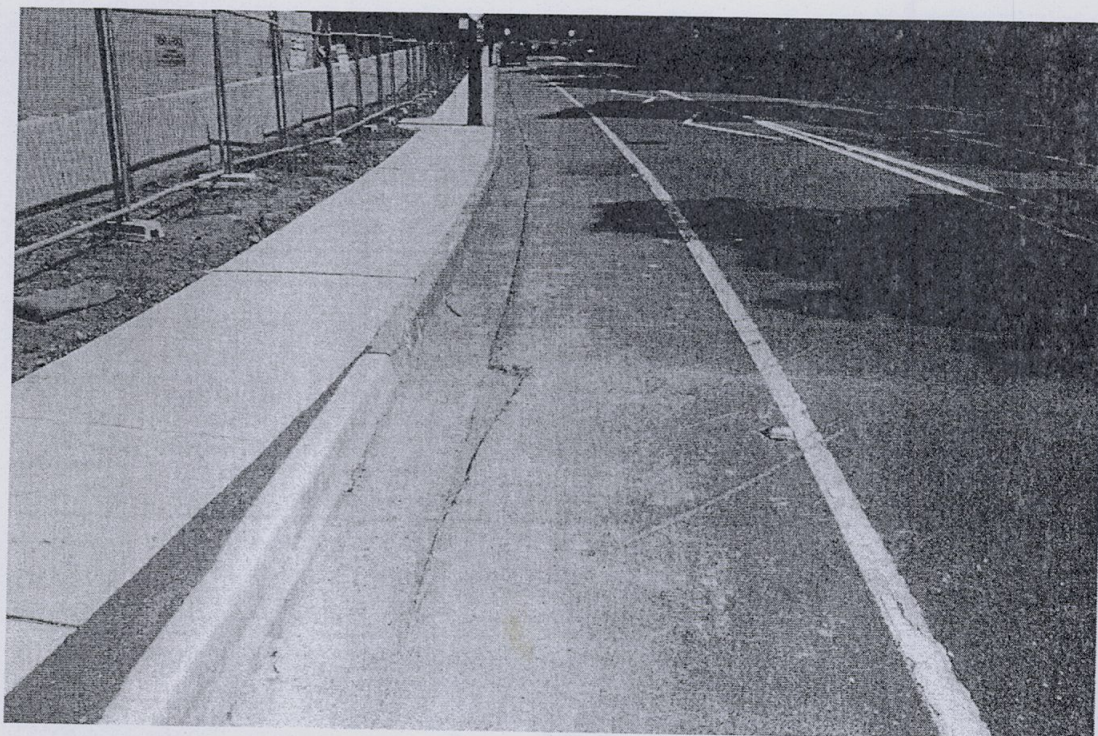
Bayview Golf Club. Adjacent public property. Pittwater Road. Facing north-west along the western side of Pittwater road. Area to the north of power pole no. MV2751. Area compares to photo DSC_0042 & 43 from the original report dated 28.11.07. Section of asphalt missing adjacent to the gutter – area of the previous layback.

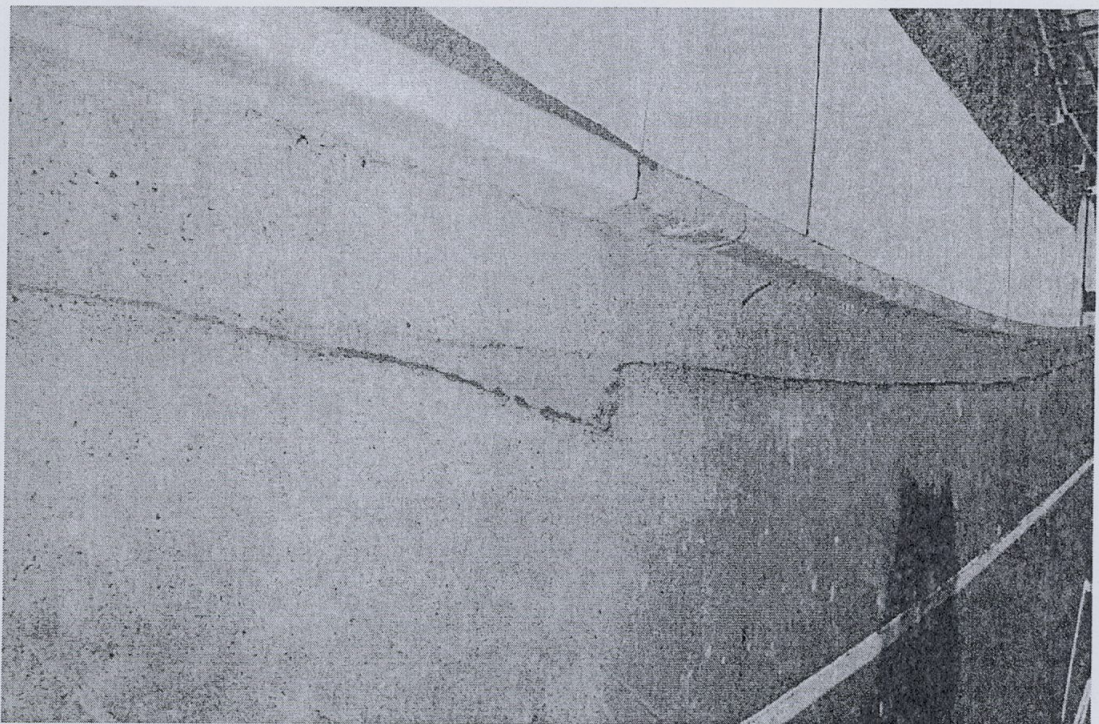
Bayview Golf Club. Adjacent public property. Pittwater Road. Facing north-west along the western side of Pittwater road. Area to the north of power pole no. MV2751. Area compares to photo DSC_0042 & 43 from the original report dated 28.11.07. Section of asphalt missing adjacent to the gutter – area of the previous layback. —>

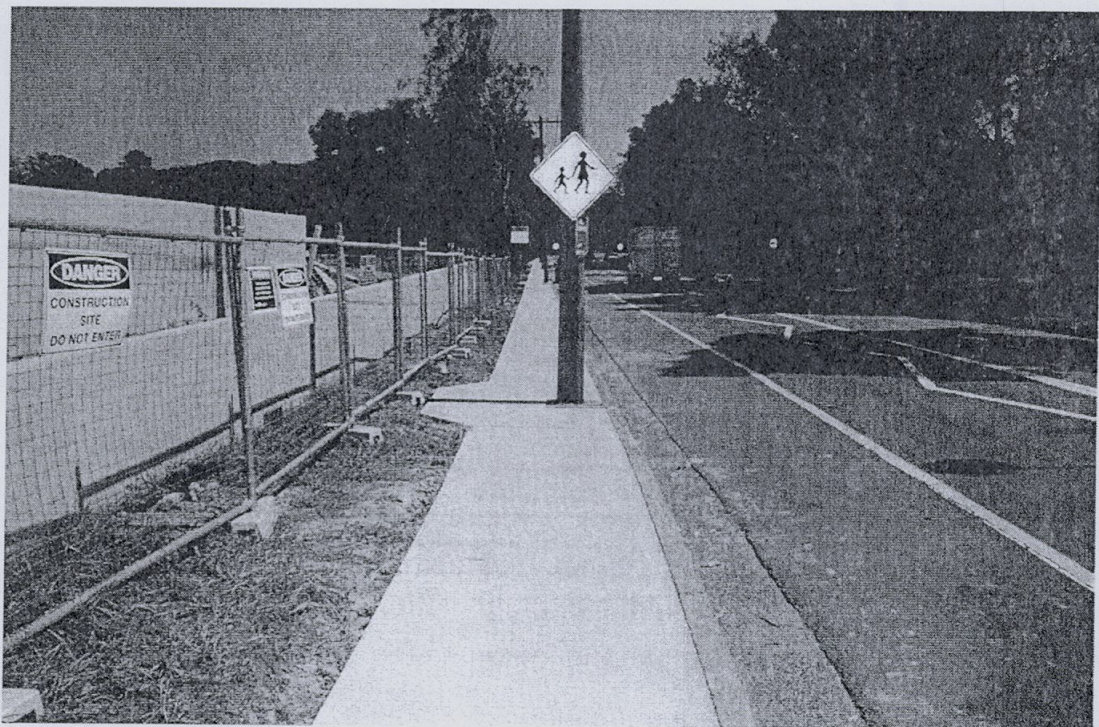
Bayview Golf Club. Adjacent public property. Pittwater Road. Facing north-west along Pittwater Road approaching power pole no. MV2748 seen in the photo. Area compares to photo DSC_0044 from the original report dated 28.11.07. New concrete paved footpath replaces the nature strip.
