Interim Occupation Certificate

Certificate No 2007/2412A

FINAL CONDITIONS REPORT

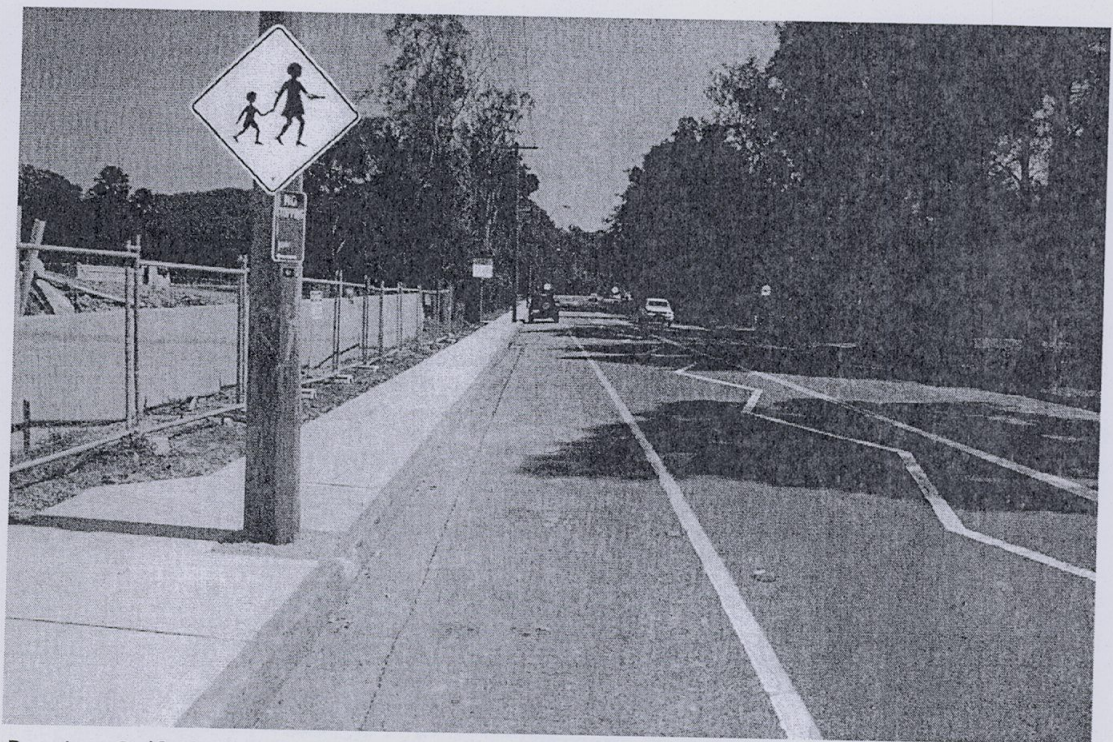
Bayview Golf Club. Adjacent public property. Pittwater Road. Facing north-west along Pittwater Road approaching power pole no. MV2748 (seen in the photo). Record of the western half of the road. Area compares to photo DSC_0046 from the original report dated 28.11.07. New concrete paved footpath replaces the nature strip.

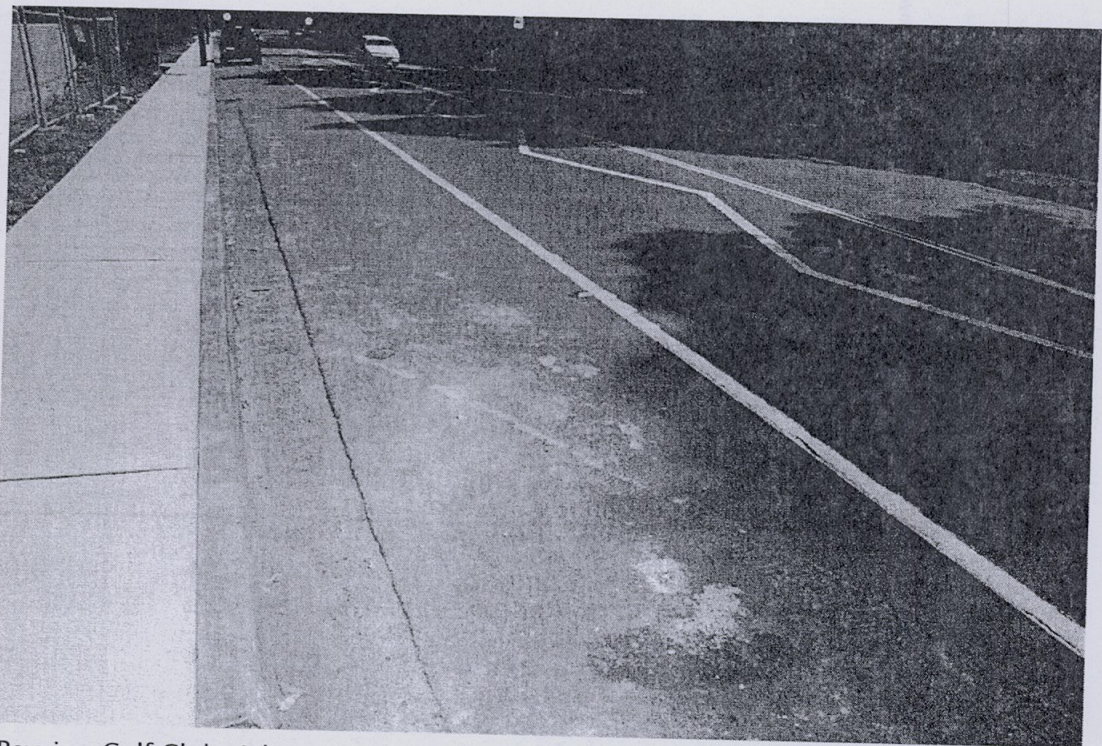
Bayview Golf Club. Adjacent public property. Pittwater Road. Facing north-west along Pittwater Road between power poles no. MV2748 & MV2747. Record of the asphalt road surface to the western half of the road. Area compares to photo DSC_0047 from the original report dated 28.11.07. Stained condition of the asphalted road surface.

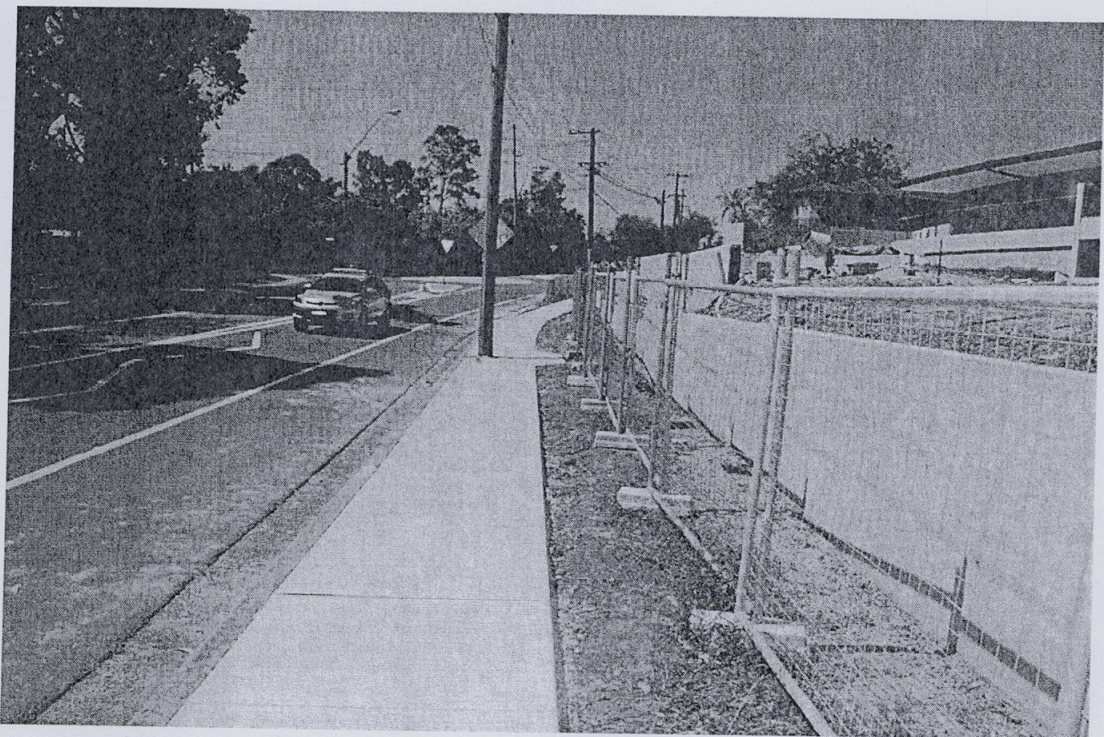
Bayview Golf Club. Adjacent public property. Pittwater Road. Facing south-east along Pittwater Road between power poles no. MV2748 & MV2747. Concrete paved footpath replaces the nature strip. Noting the incomplete landscaping adjacent to the footpath.

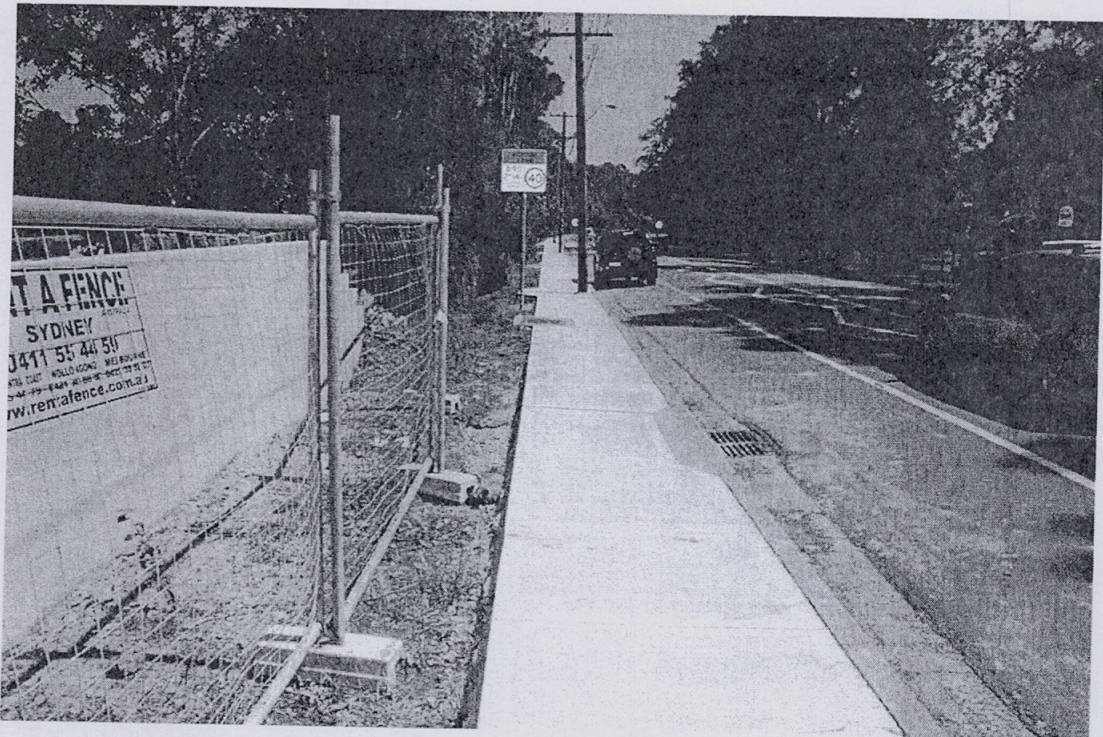
Bayview Golf Club. Adjacent public property. Pittwater Road. Facing north-west along Pittwater Road between power poles no. MV2748 & MV2747. Concrete paved footpath replaces the nature strip. Noting the incomplete landscaping adjacent to the footpath.

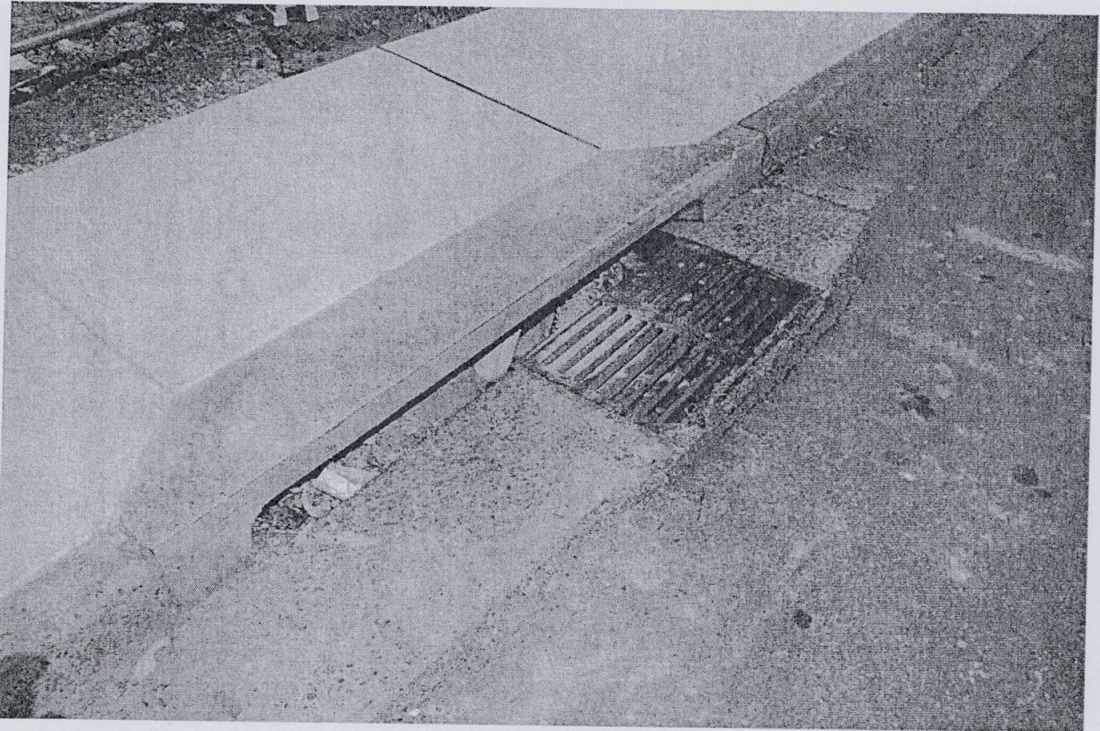
Bayview Golf Club. Adjacent public property. Pittwater Road. Facing north-west along Pittwater Road between power poles no. MV2748 & MV2747. Detail of the area seen in photo DSC_0048. Record of the storm water drain. Area compares to photo DSC_0049 from the original report.

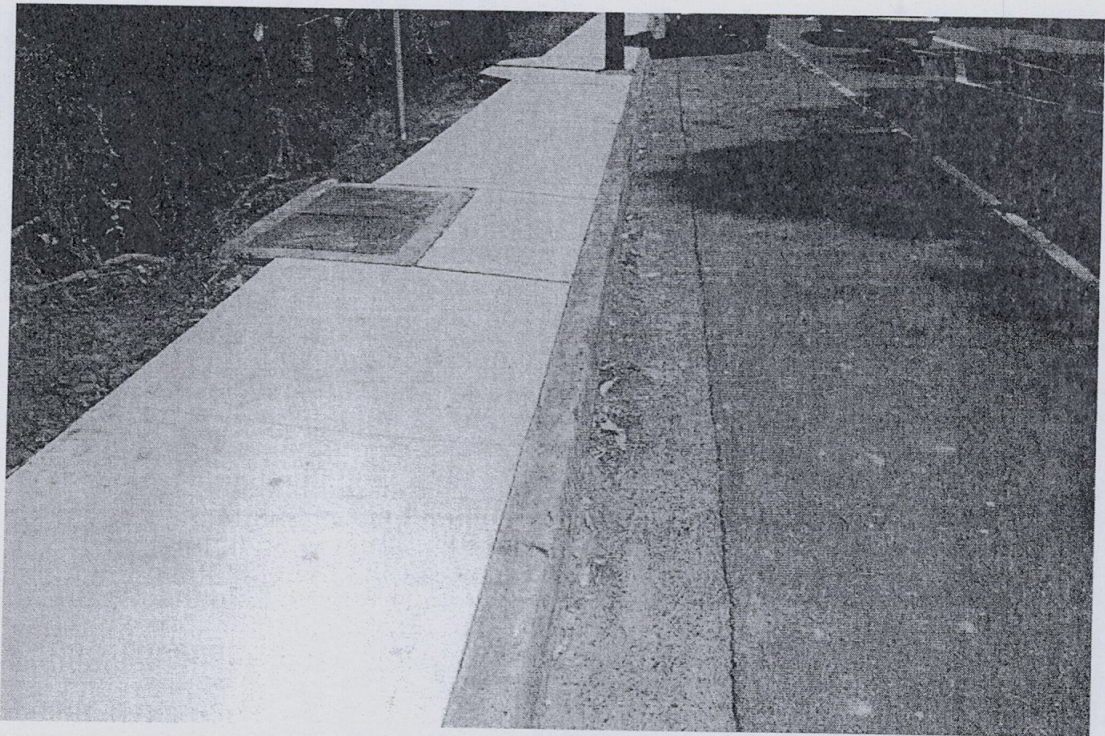
Bayview Golf Club. Adjacent public property. Pittwater Road. Facing north-west along Pittwater Road approaching power pole no. MV2747. Noting the Telstra access pit in the nature strip. Area compares to photo DSC_0050 from the original report dated 28.11.07.

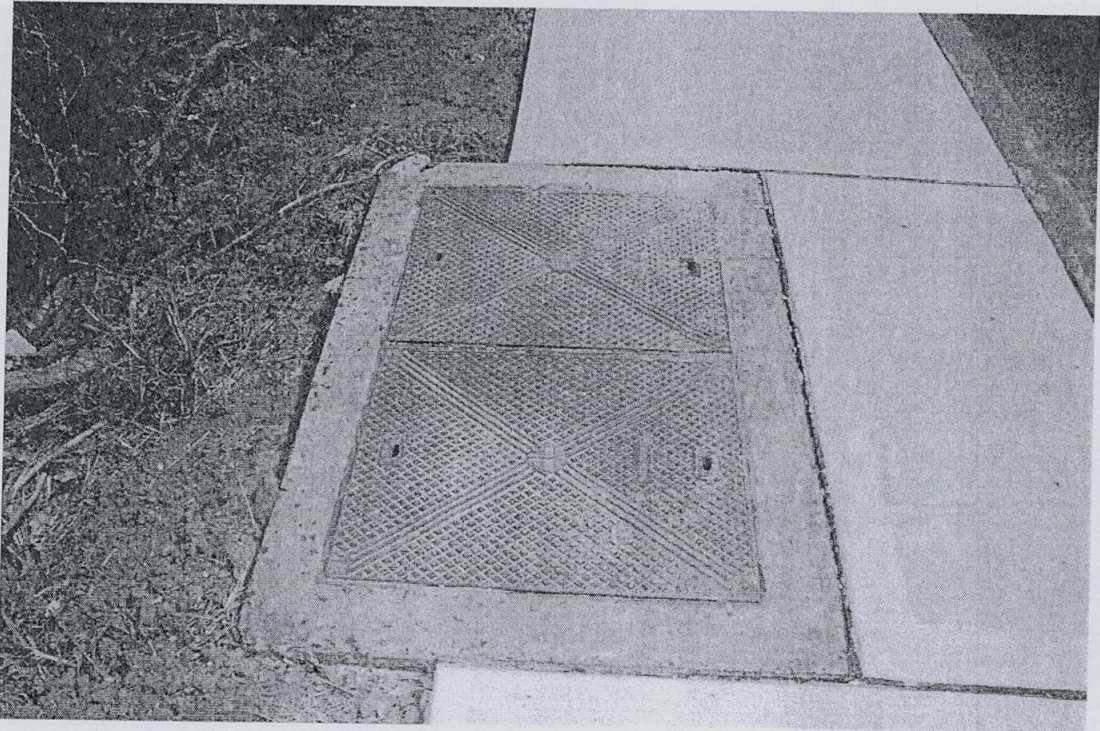
Bayview Golf Club. Adjacent public property. Pittwater Road. Facing north-west along Pittwater Road approaching power pole no. MV2747. Area compares to photo DSC_0051 from the original report dated 28.11.07. Noting the new concrete paved footpath around the Telstra pit.

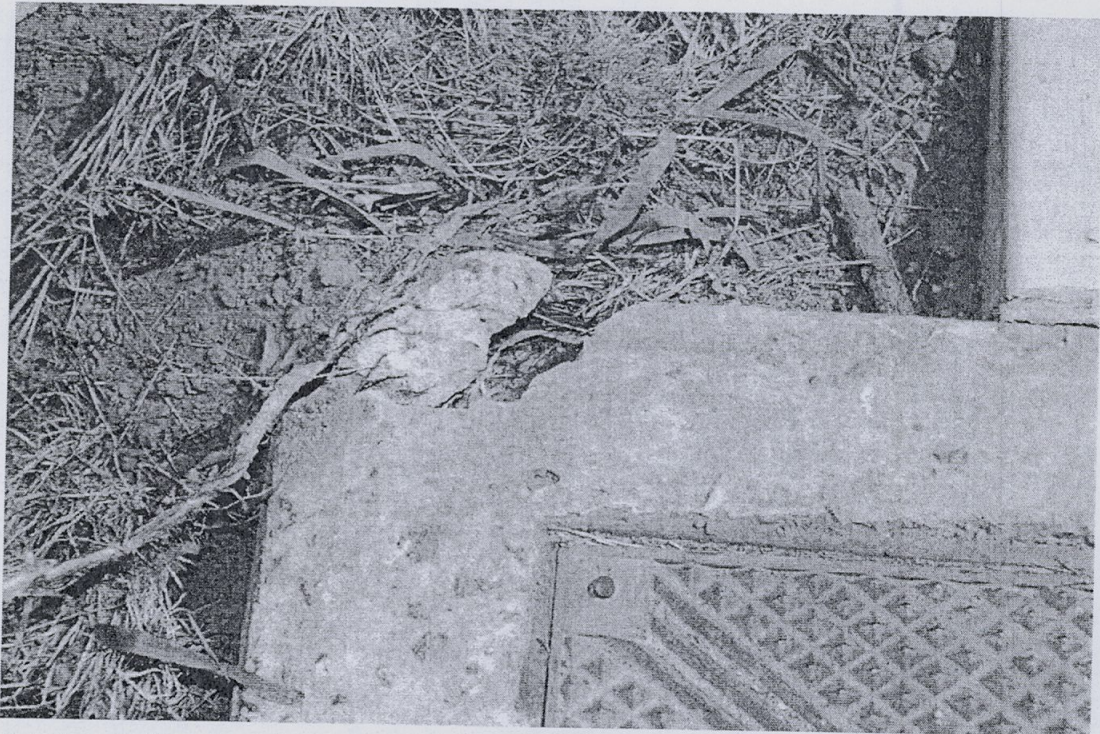
10	DSC_0033 / 34	Telstra access pit approaching power pole MV2747	Chipped NW corner of the concrete surround
11	DSC_0035	Road surface adjacent to power pole MV2747	Building dust / debris on the road surface
12	DSC_0038	Temporary site egress	Temporary layback to be removed?
13	DSC_0038	Temporary site egress	Stains on the footpath from the temporary crossover
14	DSC_0040	Area between the site boundary and footpath	Incomplete landscaping- possible trip hazard for pedestrians
15	DSC_0042 / 43	Refuge island at the pedestrian crossing	Chip to the northern end of the refuge island
16	DSC_0046 / 47	Hydrant valve in footpath between power poles MV2746 & MV2745	Concrete has sealed the valve lid closed

Bayview Golf Club. Adjacent public property. Pittwater Road. Facing north-west along Pittwater Road approaching power pole no. MV2747. Area compares to photo DSC_0051 from the original report dated 28.11.07. Detail of the area seen in the previous photo. Noting the chipped concrete surround to the pit.

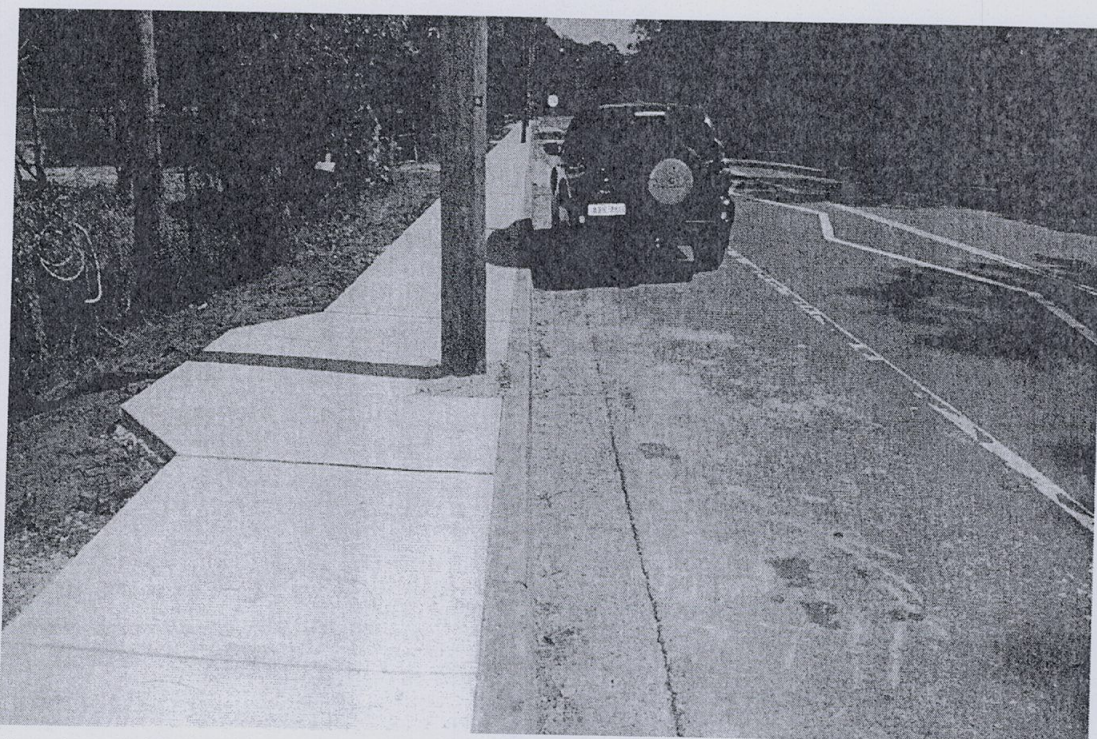
Bayview Golf Club. Adjacent public property. Pittwater Road. Facing north-west along Pittwater Road approaching power pole no. MV2747. Area compares to photo DSC_0052 & 55 from the original report dated 28.11.07. New concrete paved footpath replaces the nature strip. Also noting the debris / dirt on the road surface.

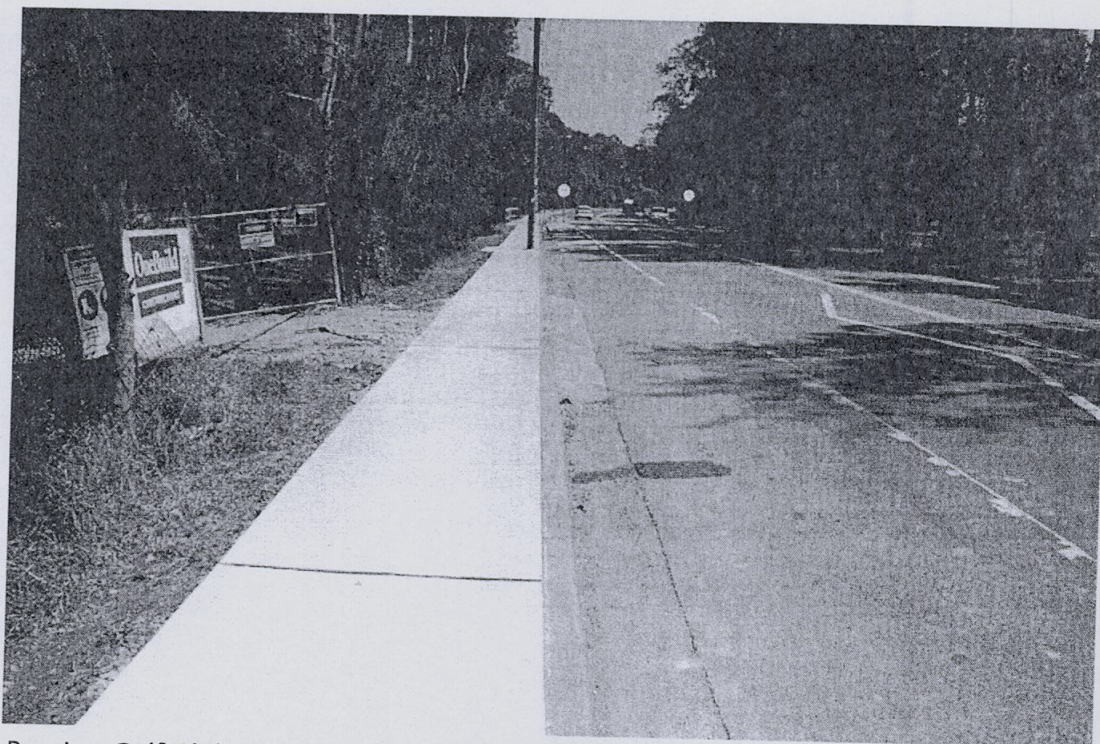
Bayview Golf Club. Adjacent public property. Pittwater Road. Facing north-west along Pittwater Road between power poles no. MV2747 and MV2746 (seen in the photo). Area compares to photo DSC_0058 from the original report dated 28.11.07. New concrete paved footpath replaces the nature strip.

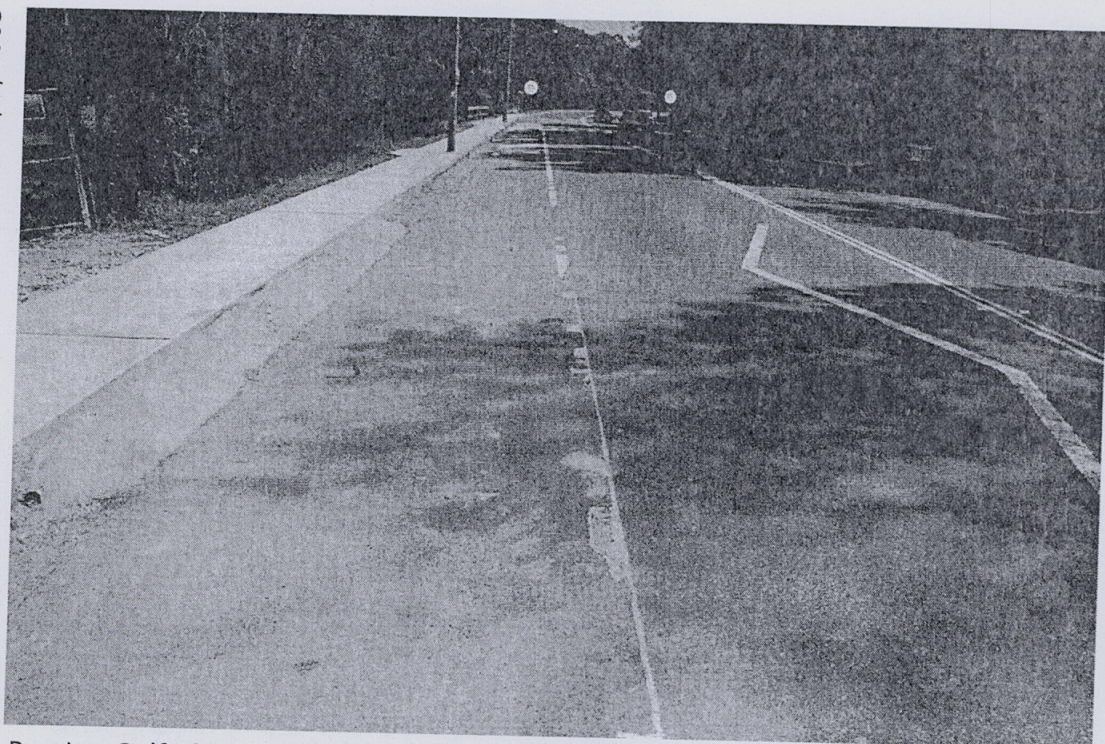
Bayview Golf Club. Adjacent public property. Pittwater Road. Facing north-west along Pittwater Road between power poles no. MV2747 and MV2746 (seen in the photo). Area of the temporary site egress gates. Noting the ramped concrete in the gutter to the footpath crossover.

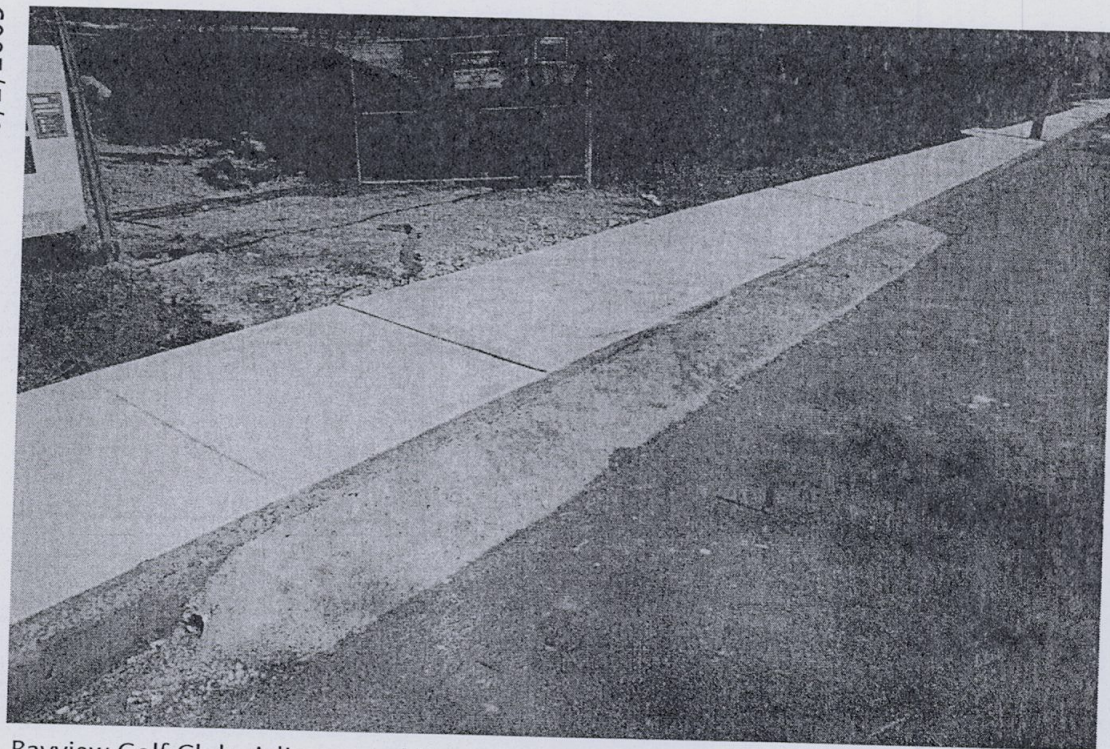
Bayview Golf Club. Adjacent public property. Pittwater Road. Facing north-west along Pittwater Road between power poles no. MV2747 and MV2746 (seen in the photo). Area of the temporary site egress gates. Noting the ramped concrete in the gutter and the track marks on the footpath crossover.

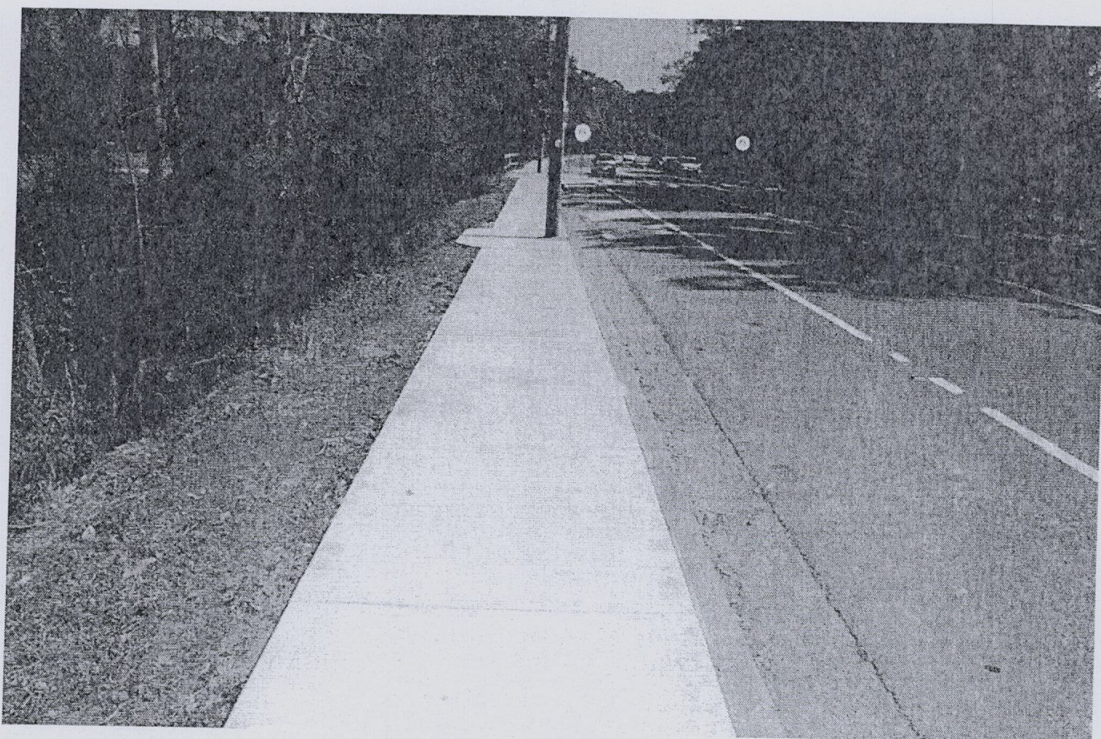
Bayview Golf Club. Adjacent public property. Pittwater Road. Facing north-west along Pittwater Road approaching power pole no. MV2746 (seen in the photo). New concrete paved concrete path replace the previous nature strip.

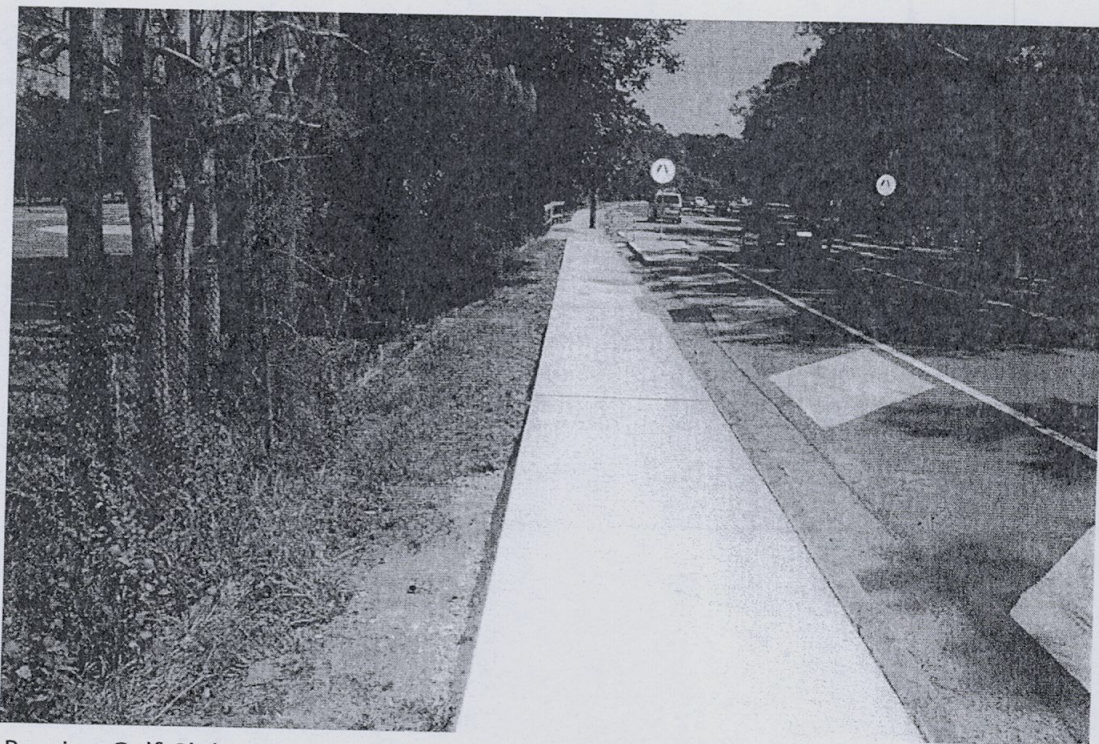
Bayview Golf Club. Adjacent public property. Pittwater Road. Facing north-west along Pittwater Road adjacent to power pole no. MV2746. New concrete paved concrete path replace the previous nature strip. Noting the height difference between the footpath and nature strip.

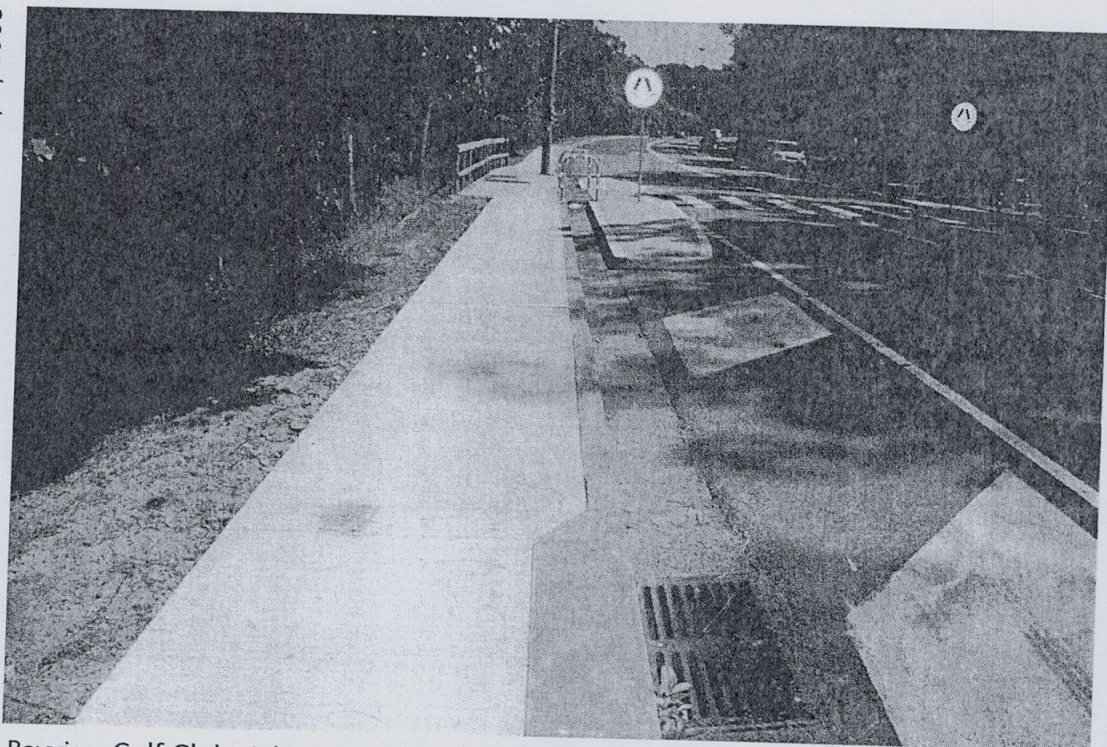
Bayview Golf Club. Adjacent public property. Pittwater Road. Facing north-west along Pittwater Road between power poles no. MV2746 & MV2745 (seen in the photo). New concrete paved concrete path replace the previous nature strip. Area compares to photo DSC_0063 from the original report dated 28.11.07.

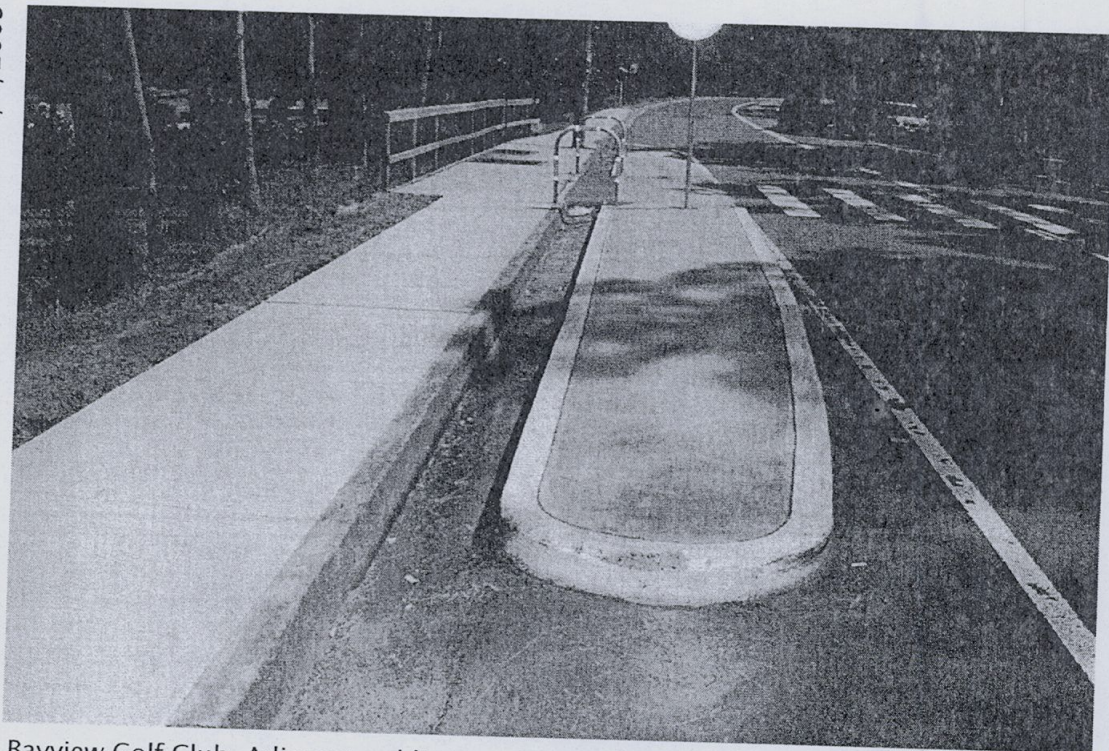
Bayview Golf Club. Adjacent public property. Pittwater Road. Facing north-west along Pittwater Road between power poles no. MV2746 & MV2745 (seen in the photo). Area approaching the pedestrian crossing. Area compares to photo DSC_0064 from the original report. Noting the chip to the refuge island.

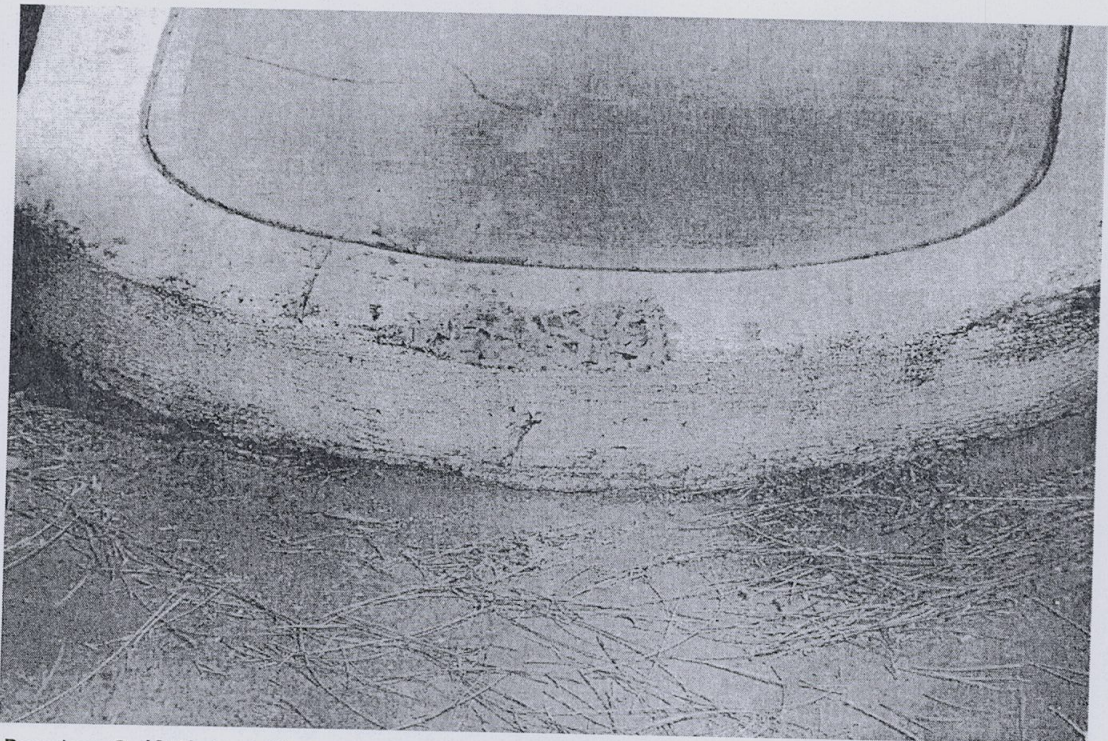
Bayview Golf Club. Adjacent public property. Pittwater Road. Facing north-west along Pittwater Road between power poles no. MV2746 & MV2745 (seen in the photo). Area approaching the pedestrian crossing. Area compares to photo DSC_0064 from the original report. Noting the chip to the refuge island.

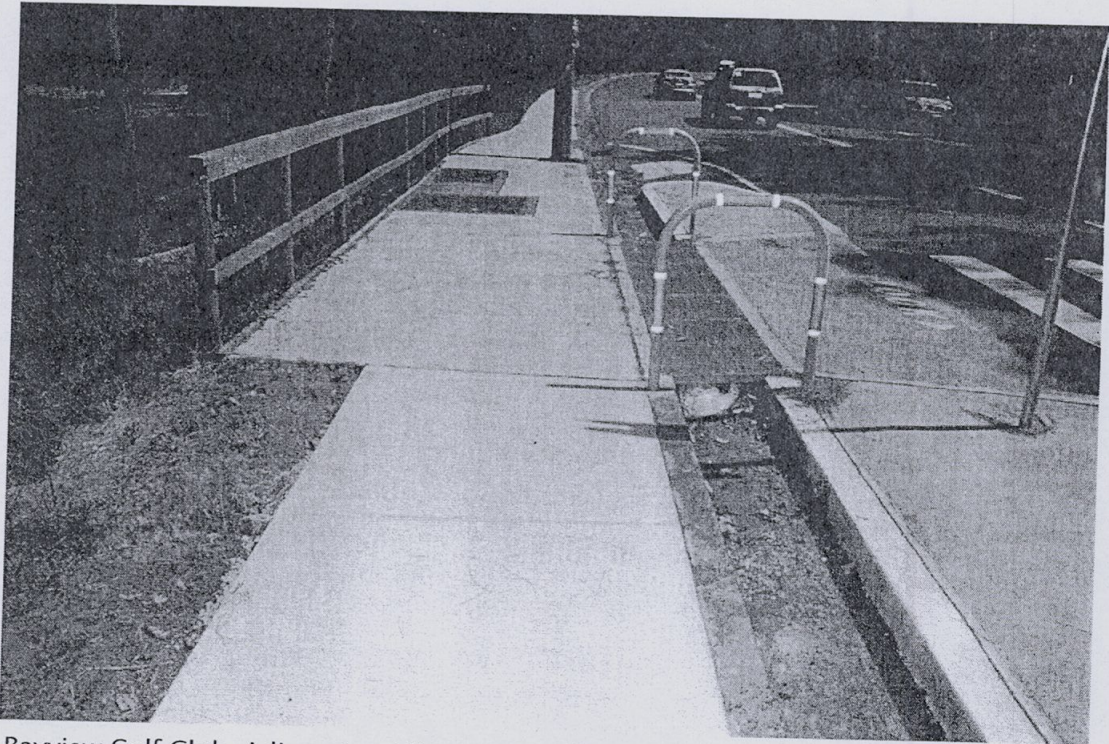
Bayview Golf Club. Adjacent public property. Pittwater Road. Facing north-west along Pittwater Road approaching power pole no. MV2745 (seen in the photo). Record of the footpath approaching the pedestrian crossing. Area compares to photo DSC_0064 from the original report. Noting the new concrete paved footpath.

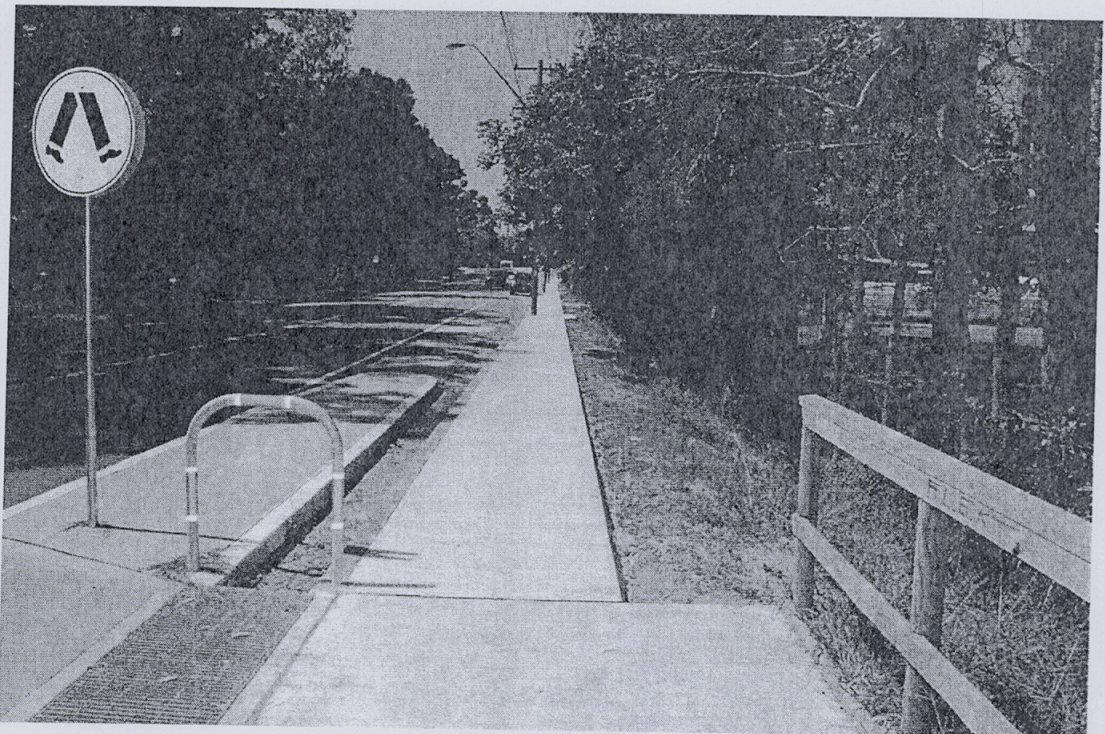
Bayview Golf Club. Adjacent public property. Pittwater Road. Facing south-east along Pittwater Road from the pedestrian crossing on Pittwater Road adjacent to power pole no. MV2745. Area compares to photo DSC_0069 from the original report. Noting the new concrete paved footpath.

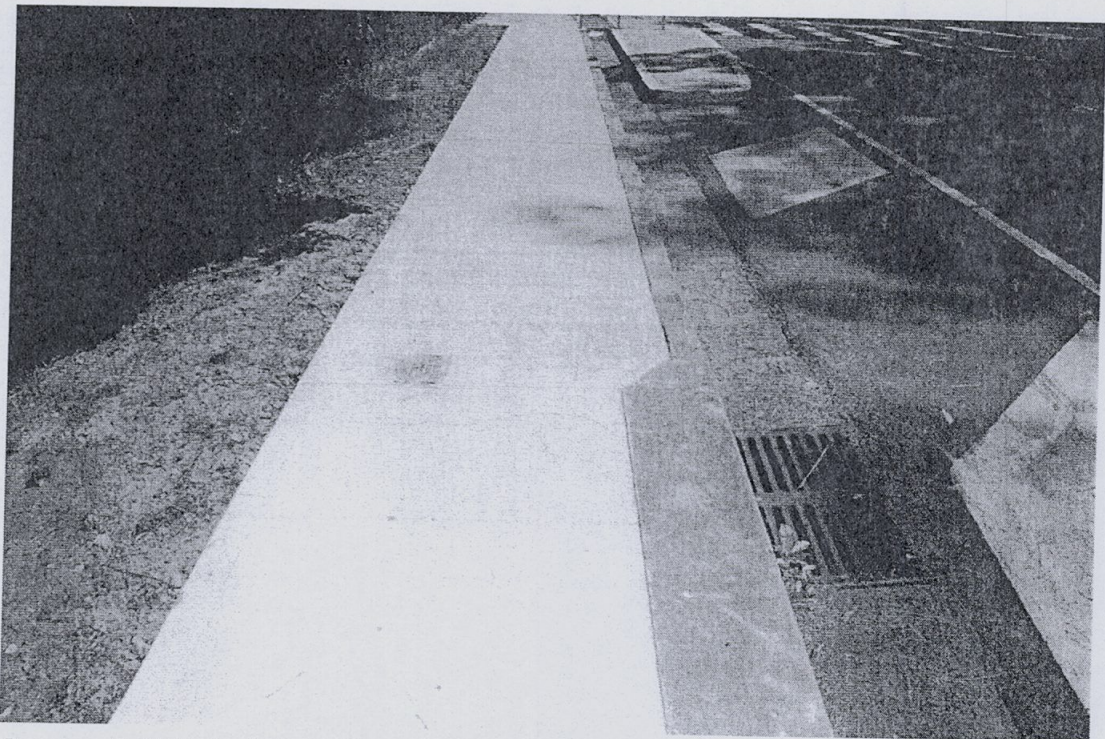
Bayview Golf Club. Adjacent public property. Pittwater Road. Facing north-west along Pittwater Road between power poles no. MV2746 & MV2745. Area compares to photo DSC_0062 from the original report. Noting the previous hydrant valve in the new concrete paved footpath.

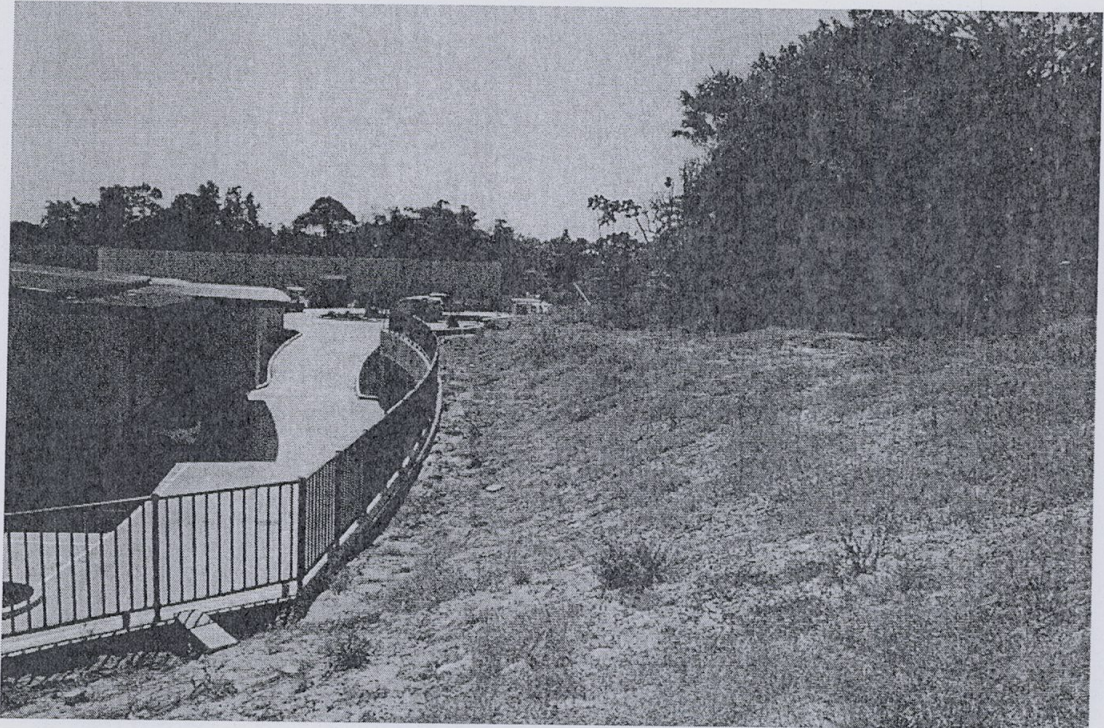
Bayview Golf Club. Facing east along the bank to the south of the new club house.

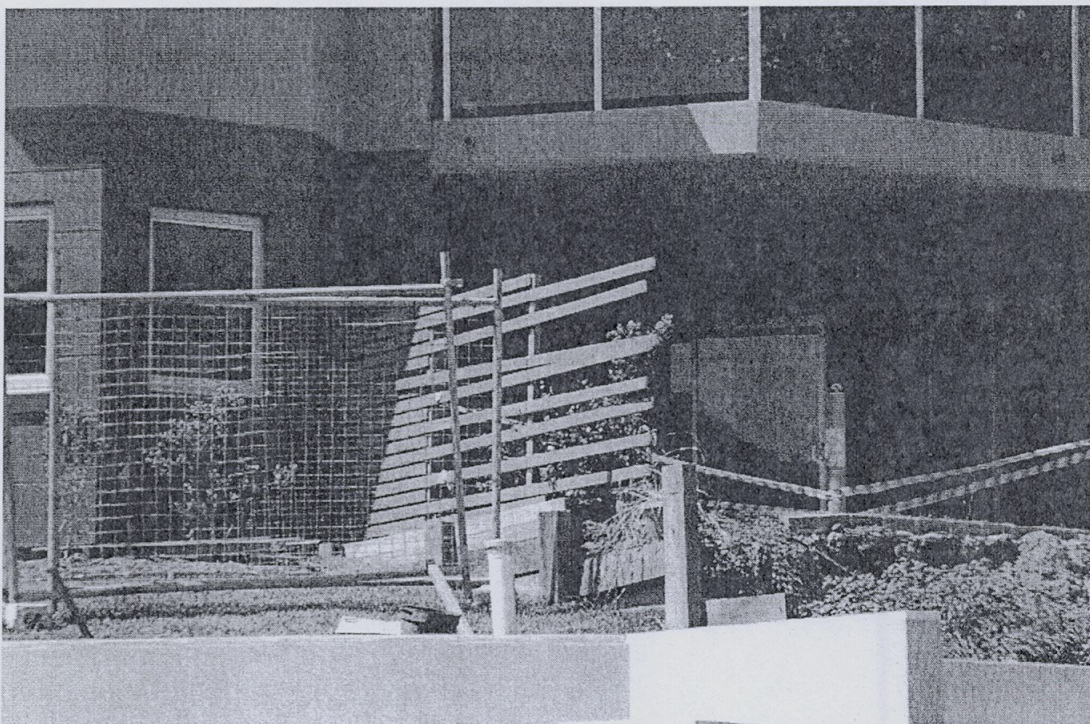
Bayview Golf Club. Facing south from the site of the new golf club to the north-western elevation of the newly completed development to the south of the site. Noting the damaged timber slatted fence.
