Our Ref AWG48504
Your Ref -

Site Classification as per AS2870-2011

No. 32 Parr Avenue, North Curl Curl

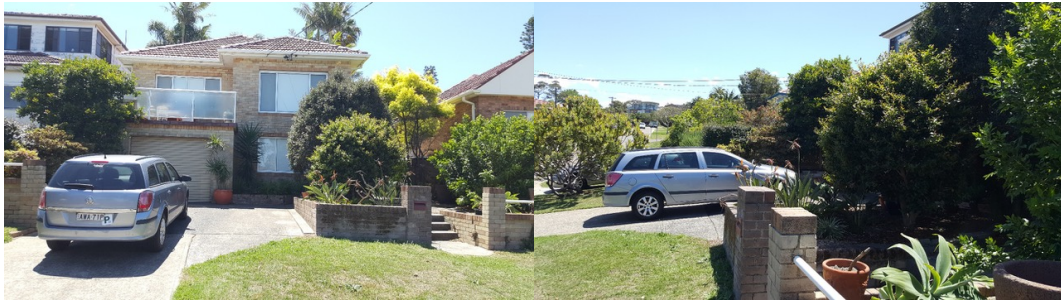
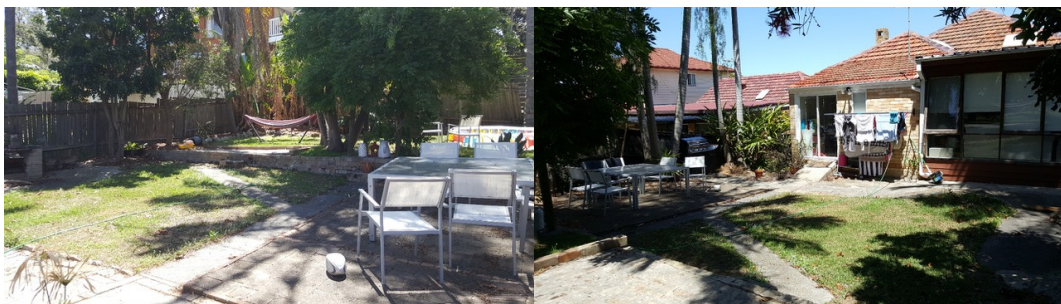
Site Photographs

Site Classification	CLASS P
Site Features	Existing dwelling with grasses and trees
Ground Slope	Gentle/ Moderate
Proposed Earthworks	Unknown (refer "about your report")
Ys Range (normal)	10-20 mm (Hs = 1800 mm)
Ips Value	Too sandy to test
Water Table	Not present

There is an existing dwelling on this site which, when removed, will cause some disturbance to the strata down to depths equal to the depth of the footing.
