**Date:** 25<sup>th</sup> October 2022

**Project No.:** 2022-243

Kathie Pisto  
3 Elizabeth Place  
Brookvale NSW 2100

### **Preliminary Landslip Assessment for 3 Elizabeth Place, Brookvale, NSW.**

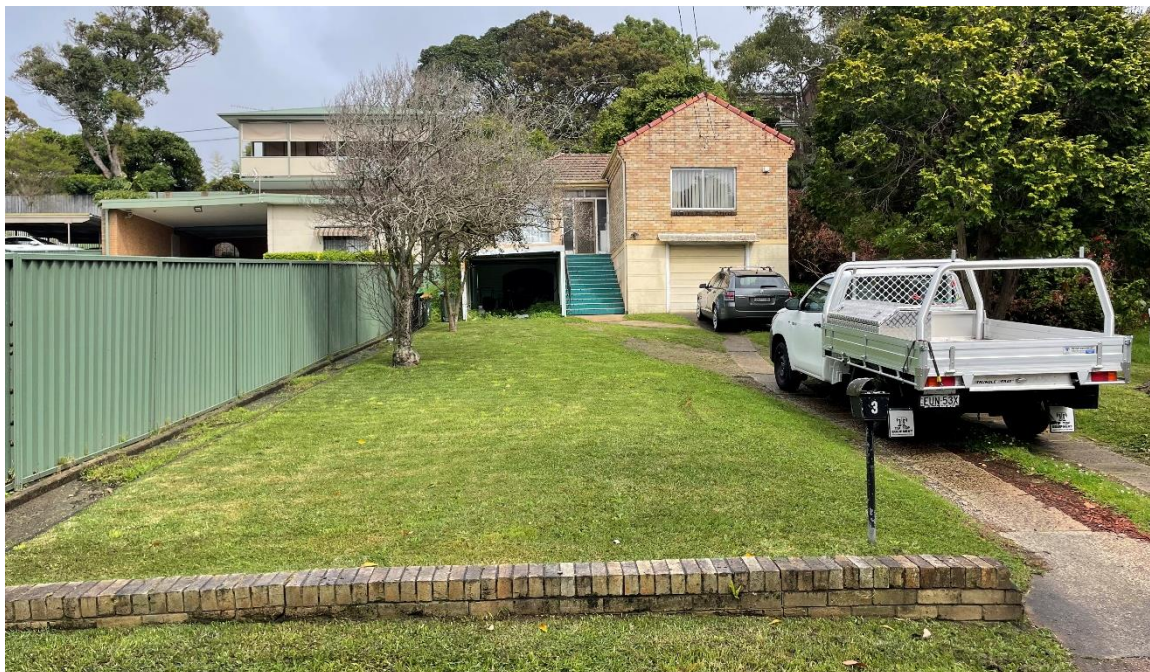
*Photograph 1: View of the front of site, looking broadly west from the roadway*

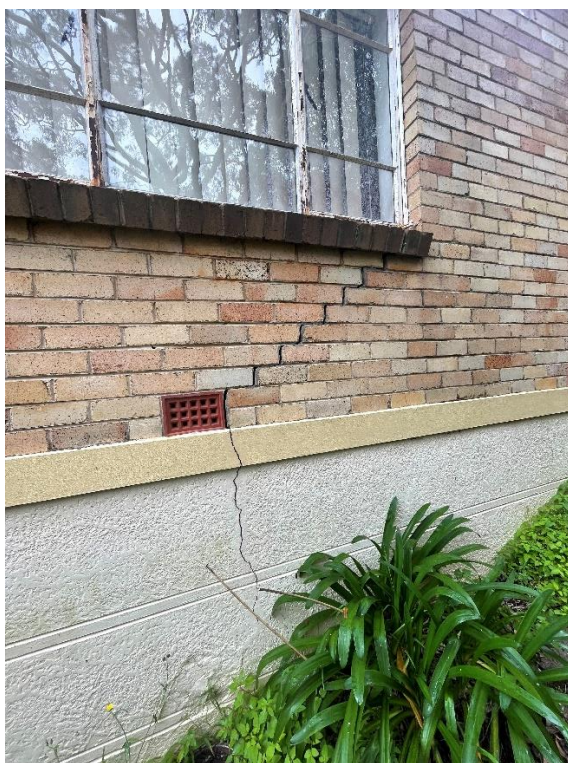
The front of the site comprises a gently east dipping lawn with a concrete strip driveway extending from the roadway to the front edge of the dwelling. The dwelling comprises a one and two storey masonry structure with the lower level partially excavated below pre-development levels. The structure is anticipated to be of >40 years construction age and exhibits signs of deterioration. A relatively large crack was observed on the

northern side of the structure propagating through render and the mortar lines from the base of the structure to the roof. This crack is interpreted as a result of differential settlement of the front and rear portion of the dwelling with the latter likely founded atop/closer to materials of greater strength due to its extension into the slope. Photographs 1 and 2 below provide views of the front of site and the dwelling.

*Photograph 2: View of the cracking on the northern dwelling wall (lower portion)*

It is considered that a detailed Landslip Risk Assessment is not required for this Development Application., Based on the observed cracking within the existing dwelling, structures have an inherent risk of differential settlement within the site. Therefore, care must be taken to ensure that all new footings are founded within material of similar strength.

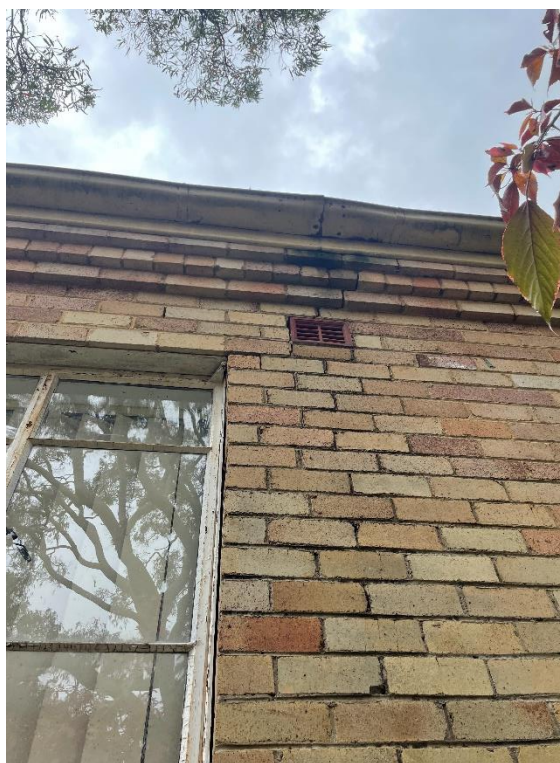
*Photograph 3: View of the cracking on the northern dwelling wall (upper portion)*

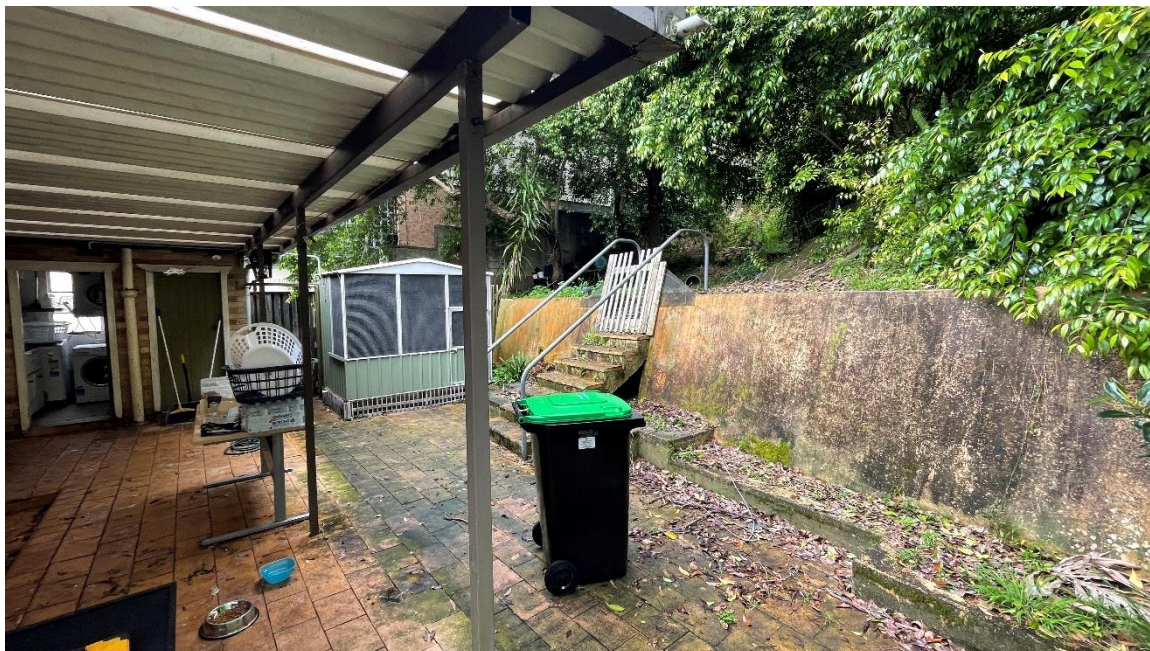
Access to the rear of the site was gained via a gently east dipping concrete pathway which extends around the northern edge of the dwelling. A tiled courtyard area is situated directly adjacent to the dwelling and is bounded to the west by a concrete wall retaining approximately 1.50m of soils upslope. No cracking or rotation was observed within the retaining wall to indicate any impending geotechnical concern.

*Photograph 4: View of the rear courtyard of site, looking broadly south west from the northern boundary*

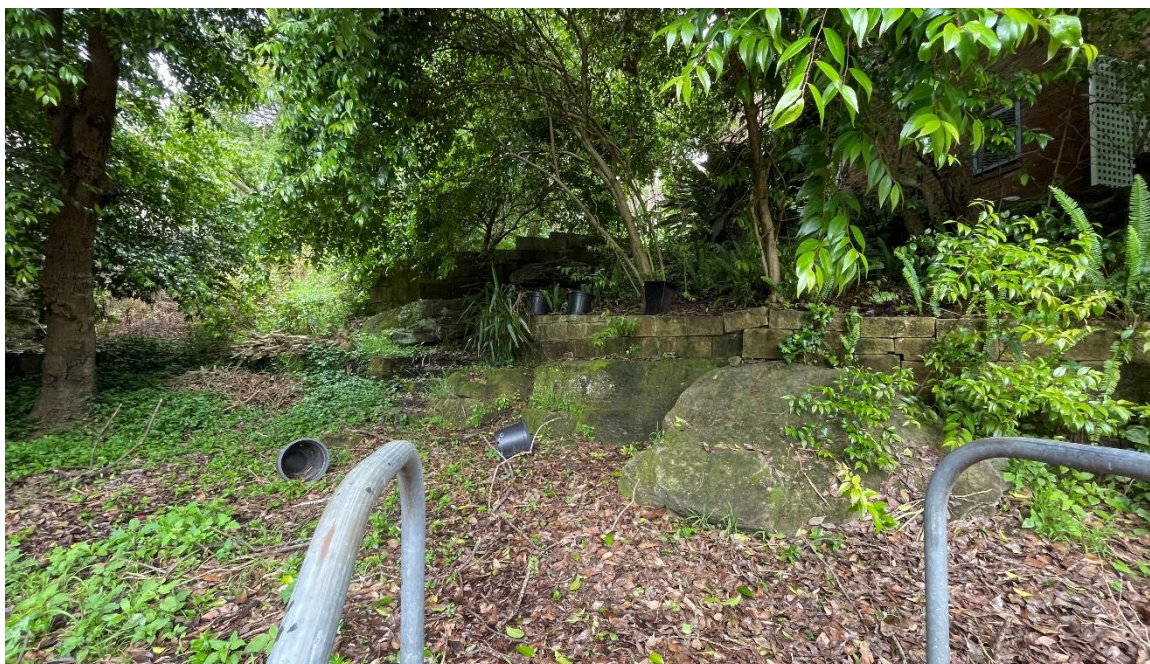
Further upslope of the wall, the rear of site comprises a moderately east dipping vegetated garden area with some sandstone block retaining walls forming level terraces. Sandstone was observed outcropping in multiple locations throughout the rear garden where it was interpreted as both bedrock and as boulders. Photograph 4 and Photograph 5 below provide views of the rear portion of site.

*Photograph 5: View of the rear garden of site, looking broadly west from the top of the retaining wall*
