Arboricultural Impact Assessment Report

Client Name: D&V Horsfall

Site Address: 2097 Pittwater Road Church Point NSW

Date Prepared: 9th December 2022

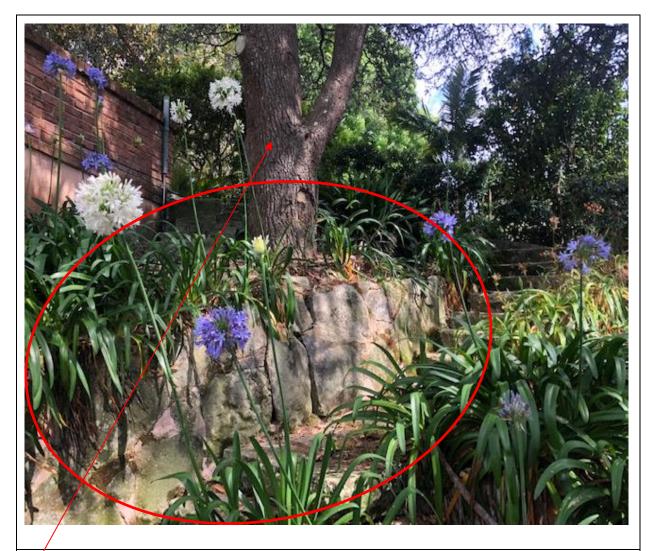
Photo A: The proposed extension to the terrace should not disturb the existing structures around tree

- 10.5 No in ground structures are to be installed within the existing garden bed which contains the trees base and much of the trees root system. Any extension to the terrace will be required to be constructed using lightweight materials such as timber and bridge over the soil area containing the tree. The structure should be supported from the existing driveway level across to the existing lawn area below the wall containing the tree. Proposed footings are unlikely to significantly impact the tree on the provision the existing retaining walls are retained, the structure bridges over the soil area containing the tree base and SRZ area and no footings are installed within the Structural Root Zone of the tree. If the works cannot be carried out in accordance with these specifications the tree may not be viable for retention.
