Report Title: Geotechnical Report 20 Sunrise Road, Palm Beach
Report Date: 15/03/21

GEOTECHNICAL INVESTIGATION:

New Lift at 20 Sunrise Road, Palm Beach

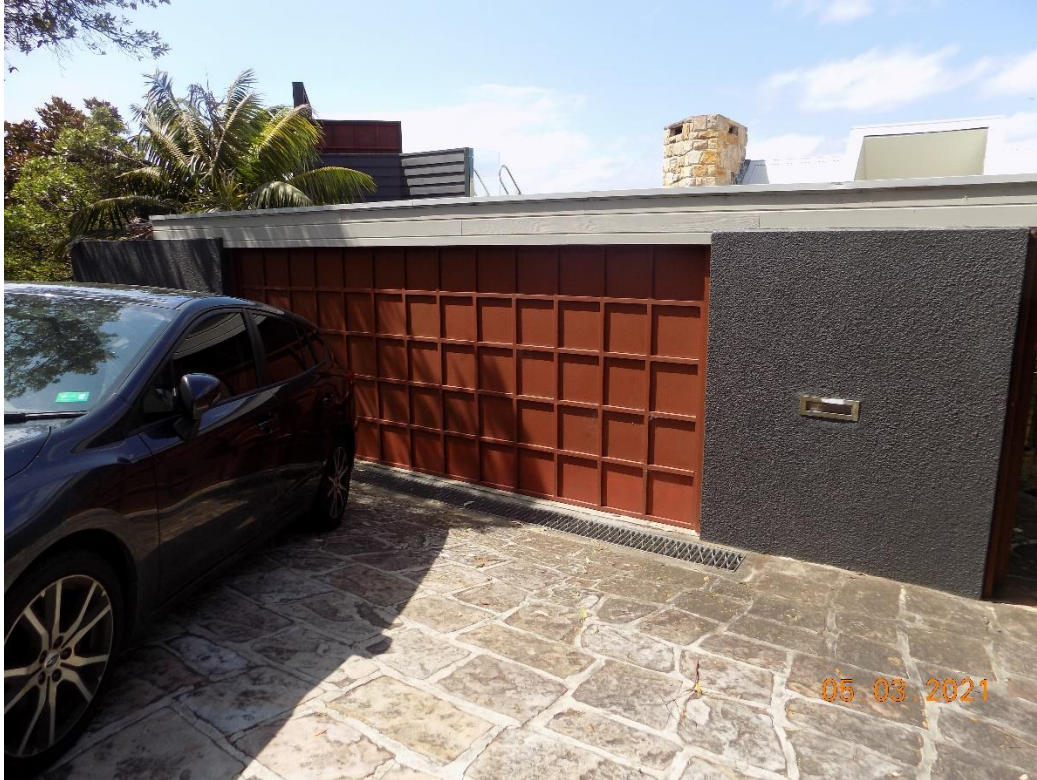
Photo 1

- 2.3** At the road frontage to Sunrise Road, a stone-paved driveway runs to a garage attached to the uphill side of the house (Photo 1). The part three-storey house is supported on brick and concrete block walls and concrete columns (Photo 2). The supporting walls display no significant signs of movement and the supporting columns stand vertical. Some of the supporting walls were observed to be supported directly off competent Medium Strength Sandstone bedrock (Photo 3). A mostly suspended pool has been constructed off the downhill side of the house (Photo 4). The concrete shell of the pool displays no signs of movement related to slope instability and is considered stable. A steep slope falls from the base of the pool to the top of a ~6.0m

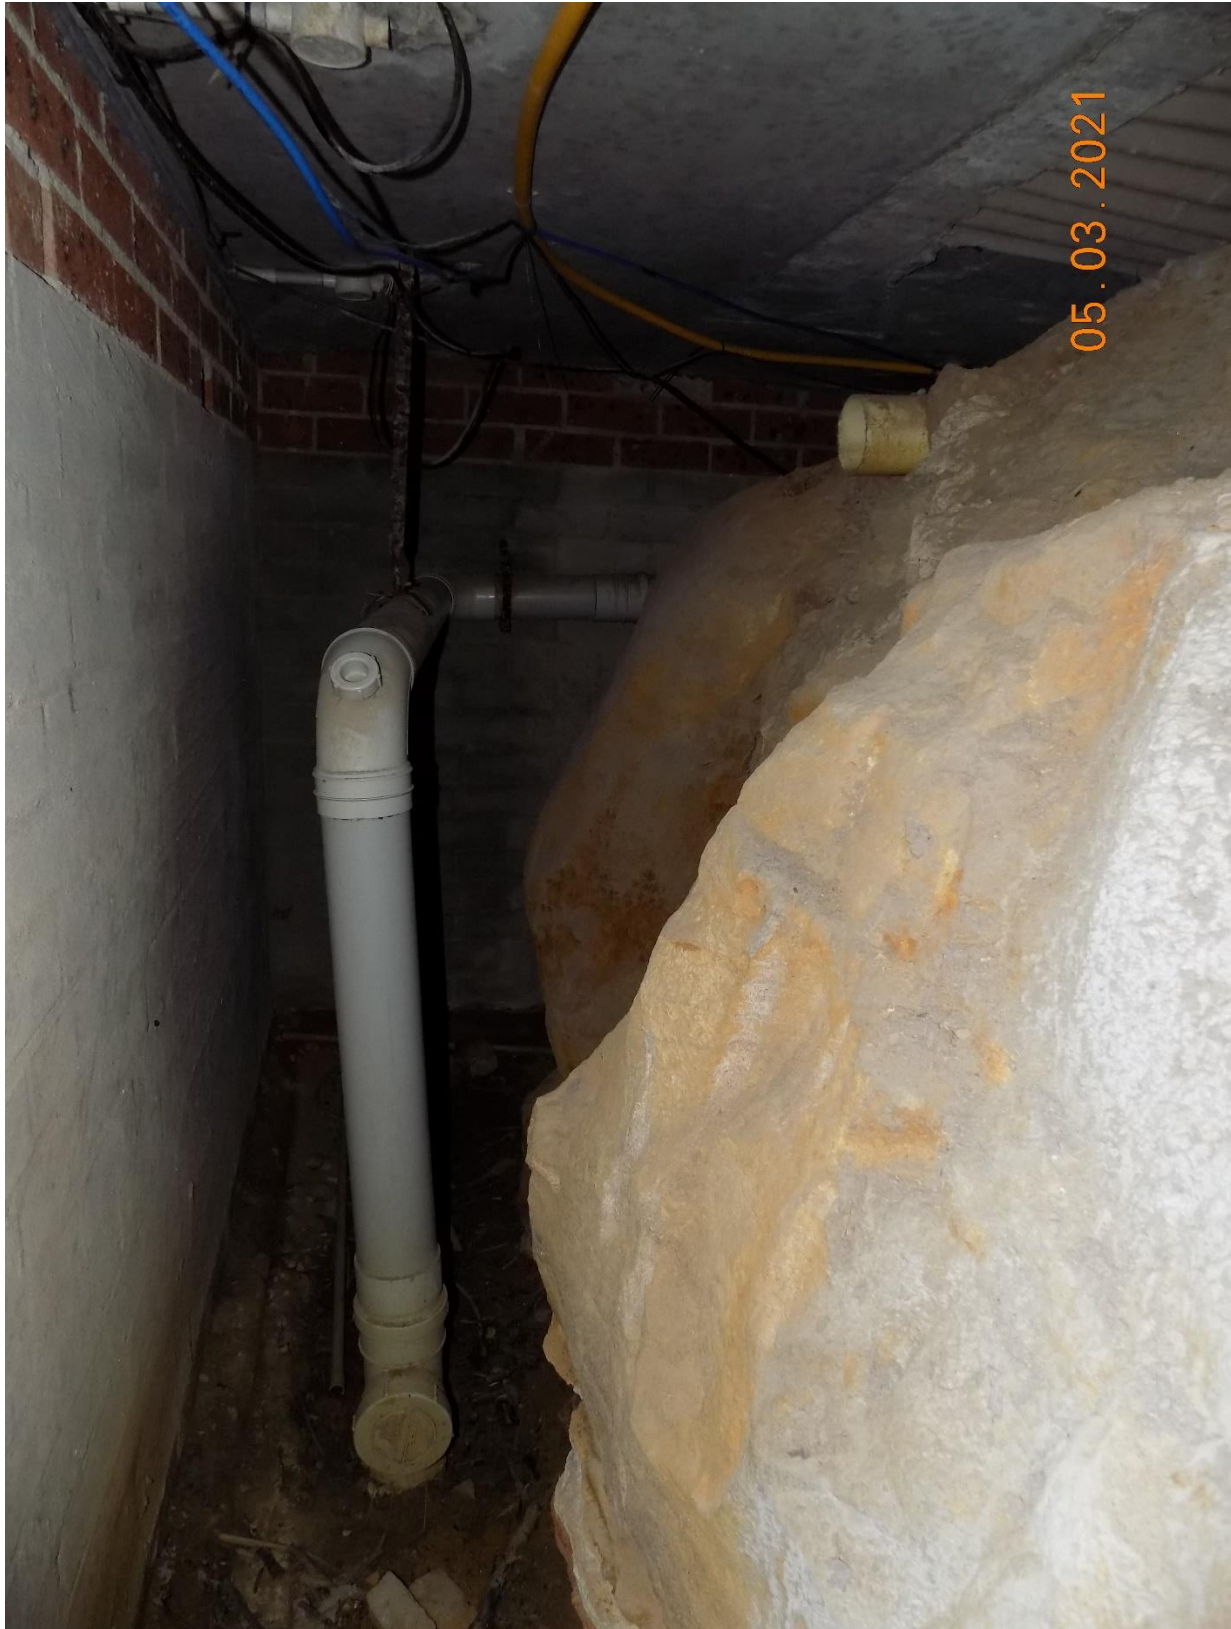
Photo 3

HAZARDS	Hazard Three	Hazard Four
TYPE	A loose boulder, wedge, or similar geological defect toppling onto the work site during the excavation process.	The proposed excavations undercutting the footings of the house causing failure (Photo 3).
LIKELIHOOD	'Possible' (10^{-3})	'Possible' (10^{-3})
CONSEQUENCES TO PROPERTY	'Medium' (20%)	'Medium' (35%)
RISK TO PROPERTY	'Moderate' (2×10^{-4})	'Moderate' (2×10^{-4})
RISK TO LIFE	4.7×10^{-5} /annum	5.3×10^{-5} /annum
COMMENTS	This level of risk to life and property is 'UNACCEPTABLE'. To move risk to 'ACCEPTABLE' levels, the recommendations in Section 13 are to be followed.	This level of risk to life and property is 'UNACCEPTABLE'. To move risk to 'ACCEPTABLE' levels, the recommendations in Section 13 are to be followed.

The excavation will come close to flush with the supporting brick walls of the subject house (Photo 3). However, the excavation will be taken almost entirely through Medium Strength Sandstone and any nearby structures are already supported on the rock. Thus, following the

demolition of the existing courtyard slab, no structures or boundaries will be within the zone of influence of the excavation.

If any supporting walls are required to be removed, the house above is to be propped and supported with beams prior to the excavation through rock commencing.

During the excavation process, the geotechnical consultant is to inspect the excavation as it approaches to not less than 0.7m from the supporting walls of the house to confirm the stability of the cut to go flush with the footings.

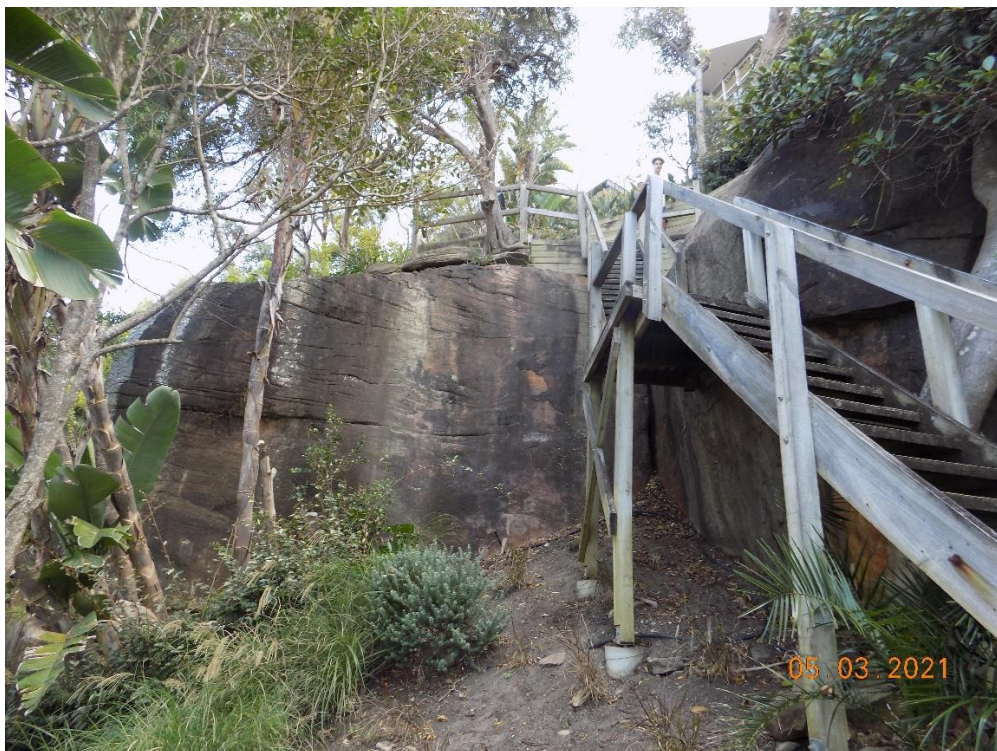
Photo 5

high sandstone cliff (Photo 5). The cliff consists of massive Medium Strength Sandstone and displays no significant geological defects. Thus, it is considered stable. A very steep and very densely-vegetated slope falls from the base of the cliff to the road frontage with Ocean Road (Photo 6). Some stable bands of sandstone were observed to be outcropping through this slope (Photo 7).

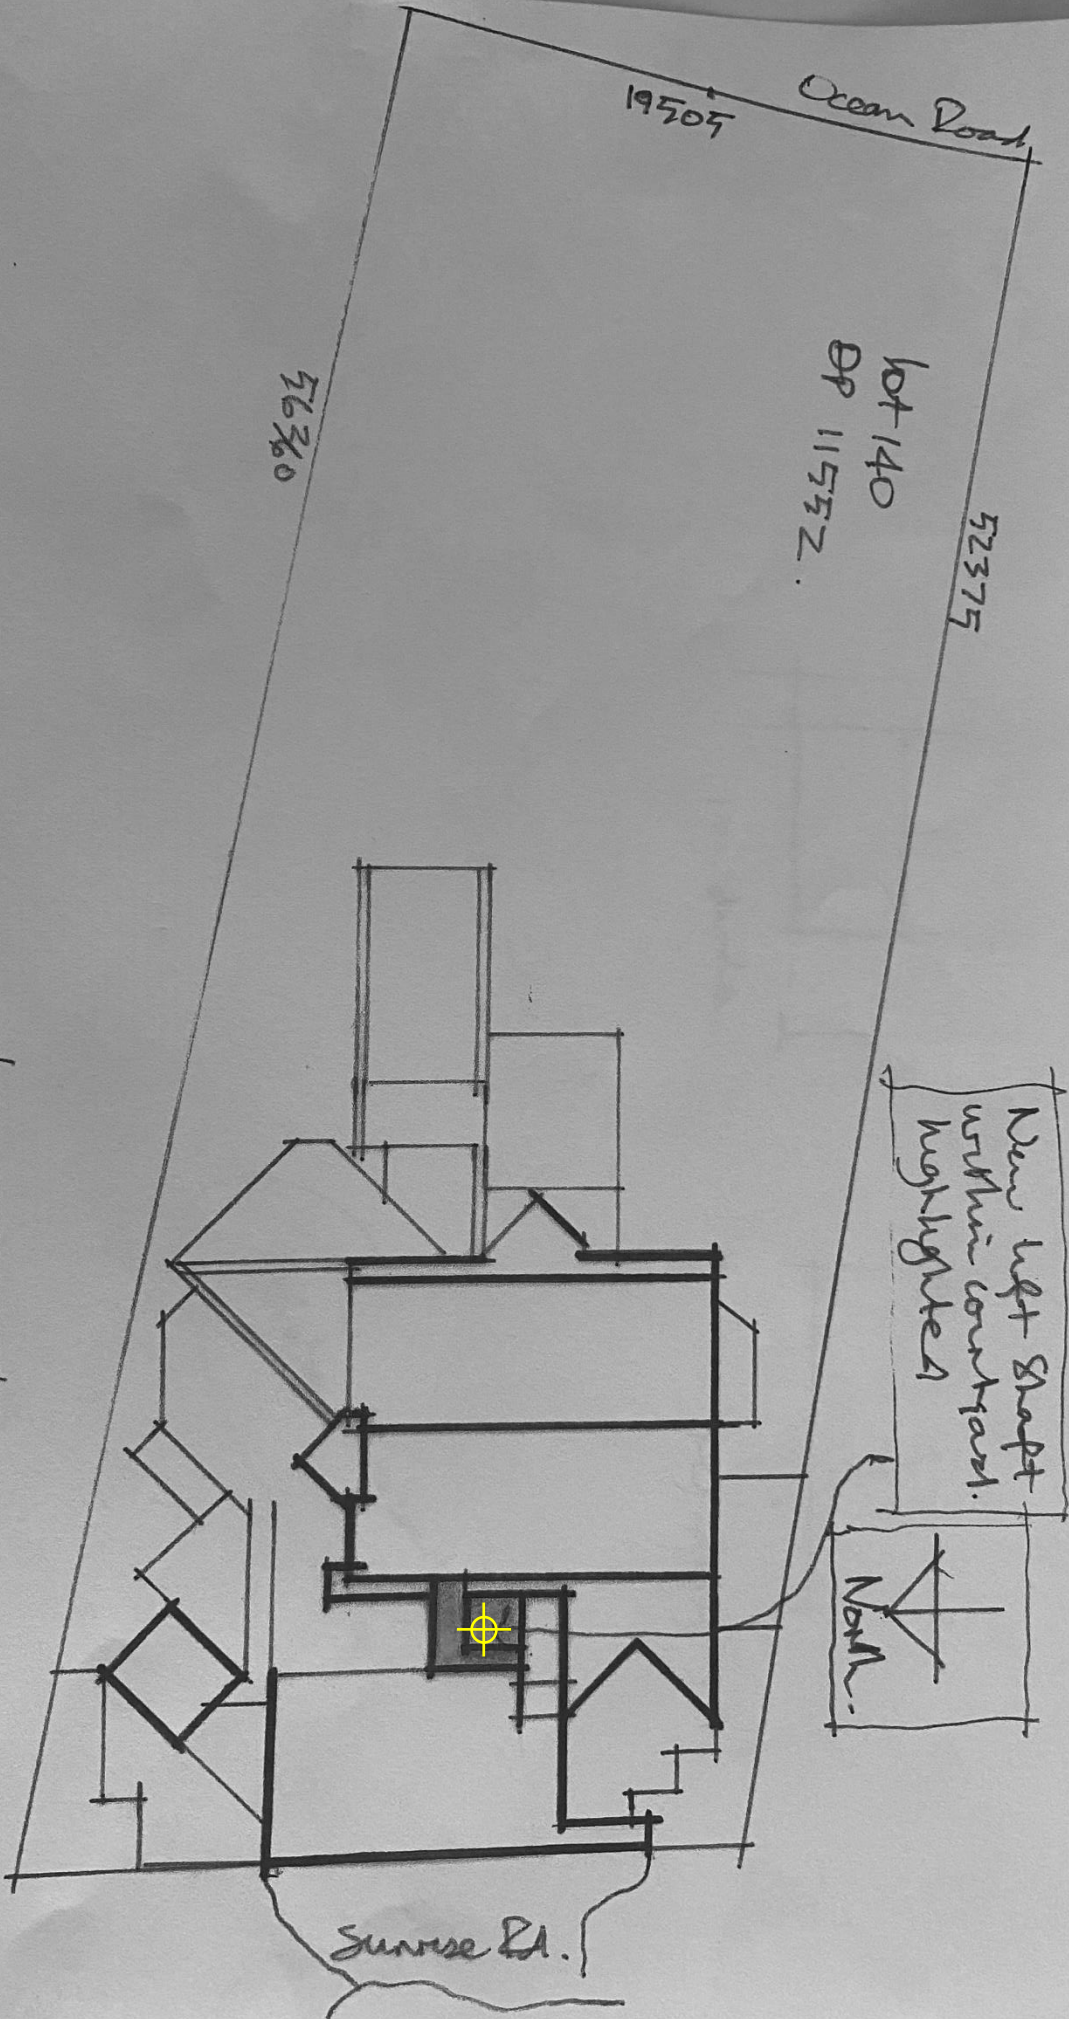
SITE PLAN - showing location where Medium Strength Sandstone was observed to be outcropping

As sandstone bedrock was observed to be outcropping and stepping up the entire property, no subsurface investigation was carried out.

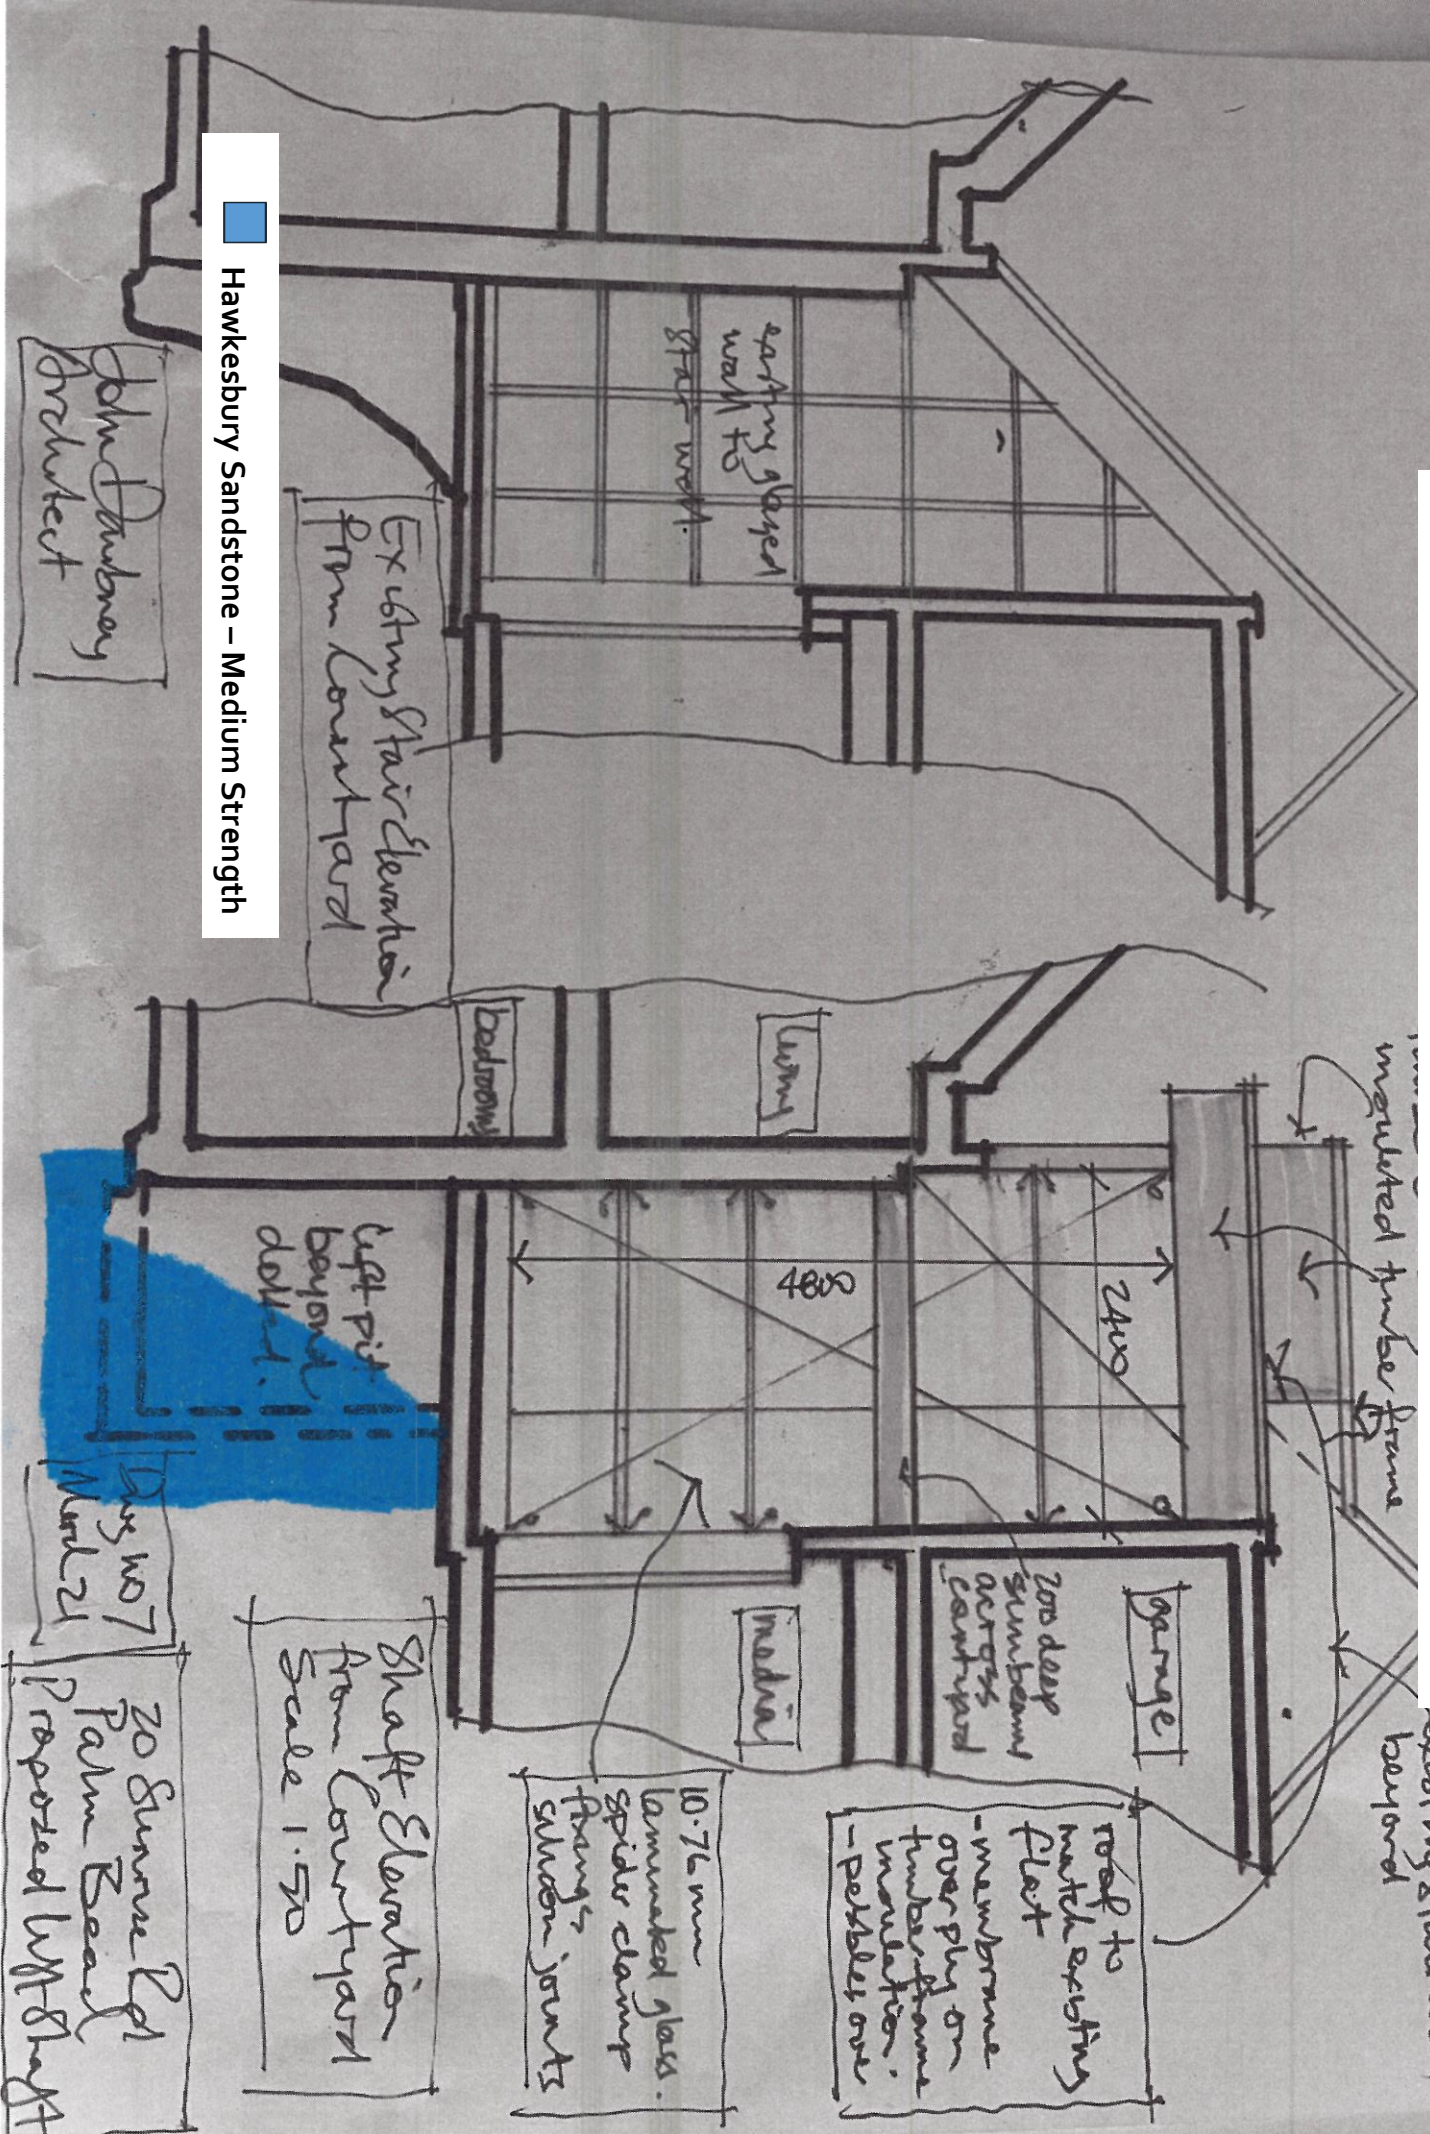
TYPE SECTION - Diagrammatical Interpretation of expected Ground Materials

The surface features of the upper portion of the block are controlled by the outcropping and underlying sandstone bedrock that steps down the property forming sub-horizontal benches between the steps. Where the grade is steeper, the steps are larger and the benches narrower. Where the slope eases, the opposite is true. Where the rock is not exposed, it is overlain by sandy soils over sandy clays that fill the bench step formation. Medium Strength Sandstone was observed to be outcropping in the location of the proposed works. A similar strength rock is expected to underlie the upper portion of the site. See Type Section attached for a diagrammatical representation of the expected ground materials.

Hawkesbury Sandstone - Medium Strength
