Report Title: Geotechnical Report 155 Pacific Road, Palm Beach
Report Date: 26/11/21

GEOTECHNICAL INVESTIGATION:

Alterations and Additions and New Pool and Studio at **155 Pacific Road, Palm Beach**

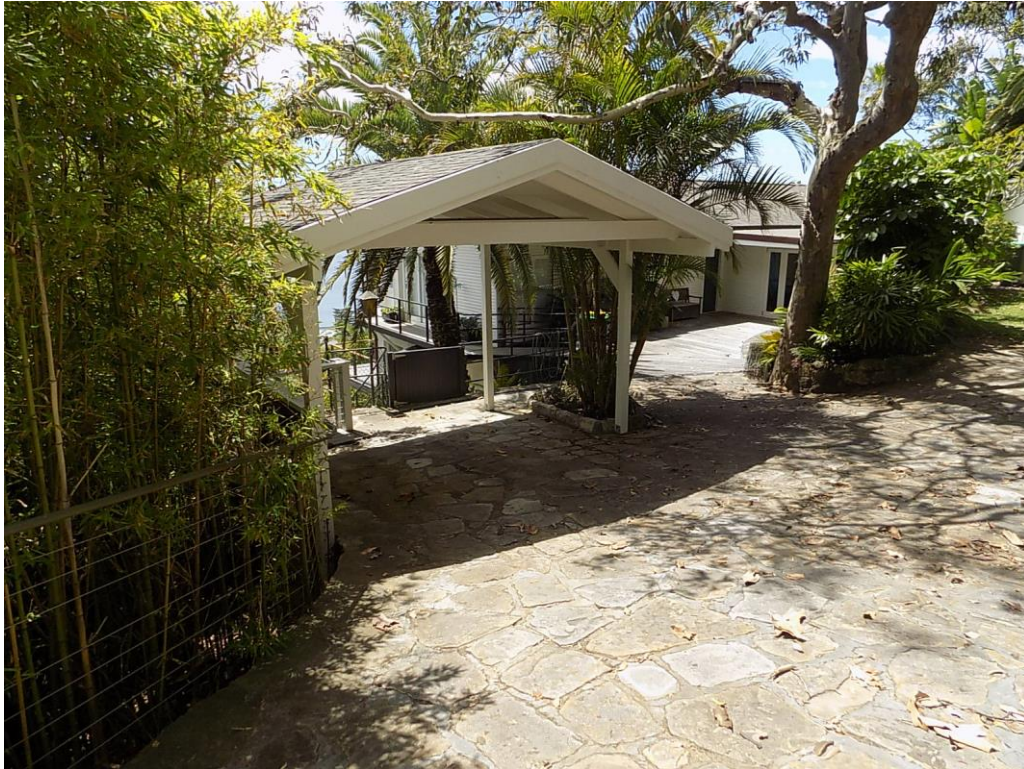
Photo 1

2.3 At the road frontage to Pacific Road, a concrete driveway runs down the slope to a carport and continues to two garages in the SW corner of the property (Photo 1). Between the road frontage and the house is a stable, $\sim 1.0\text{m}$ high sandstone block retaining wall that supports a cut to create a level lawn area (Photo 2). The cut has been partially made through outcropping competent Medium Strength Sandstone. A stable, $\sim 0.5\text{m}$ high sandstone block retaining wall supports the fill for the level lawn area above (Photo 3). The part three-storey timber clad house is supported on brick walls and brick piers. The external brick walls show no significant signs of movement. One of internal brick piers on the downhill side of the house appear to be askew to the bearer (Photo 4). Some of the walls and piers of the house were observed to be supported directly off outcropping Competent Medium Strength Sandstone (Photo 5). An inclined lift runs down the NW side of the property. A series of sandstone block retaining walls of varying heights between $\sim 0.3\text{m}$ and $\sim 1.8\text{m}$ terrace the slope immediately below the house to the NE common boundary. One of the sandstone block retaining walls has started to separate at the mortar due to root action of the palm tree above (Photo 6 & 7). See **Section 16** for advice regarding this wall. Competent Medium Strength Sandstone can be seen outcropping in various places and some of the walls are supported directly on this ground material. On the E corner of the property is a timber shed. The cut for the shed is supported by a concrete block and sandstone block retaining wall reaching up to $\sim 1.7\text{m}$ high. The shed and retaining wall are to be demolished as part of the proposed works. A $\sim 3.0\text{m}$ high sandstone rockface that falls to the neighbouring property on the NE common boundary is undercut to $\sim 1.0\text{m}$ (Photo 8 & 9). Given the thickness of the supporting cantilever arms with no visible defects, the undercut rock is considered to be stable. A moderately to

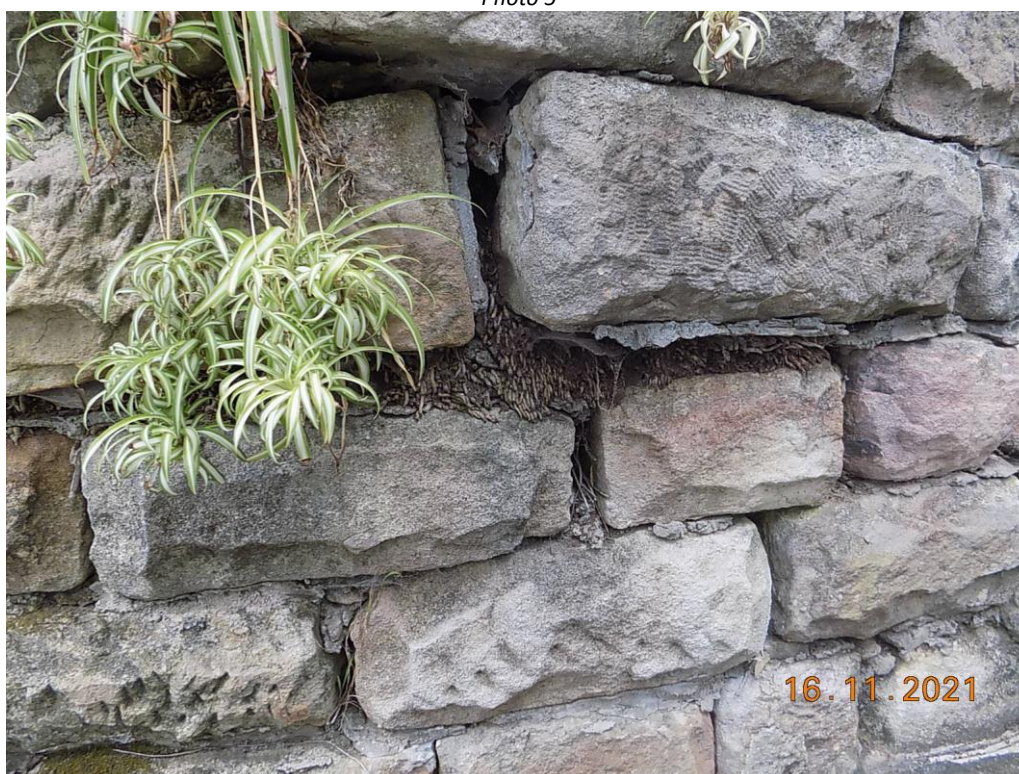
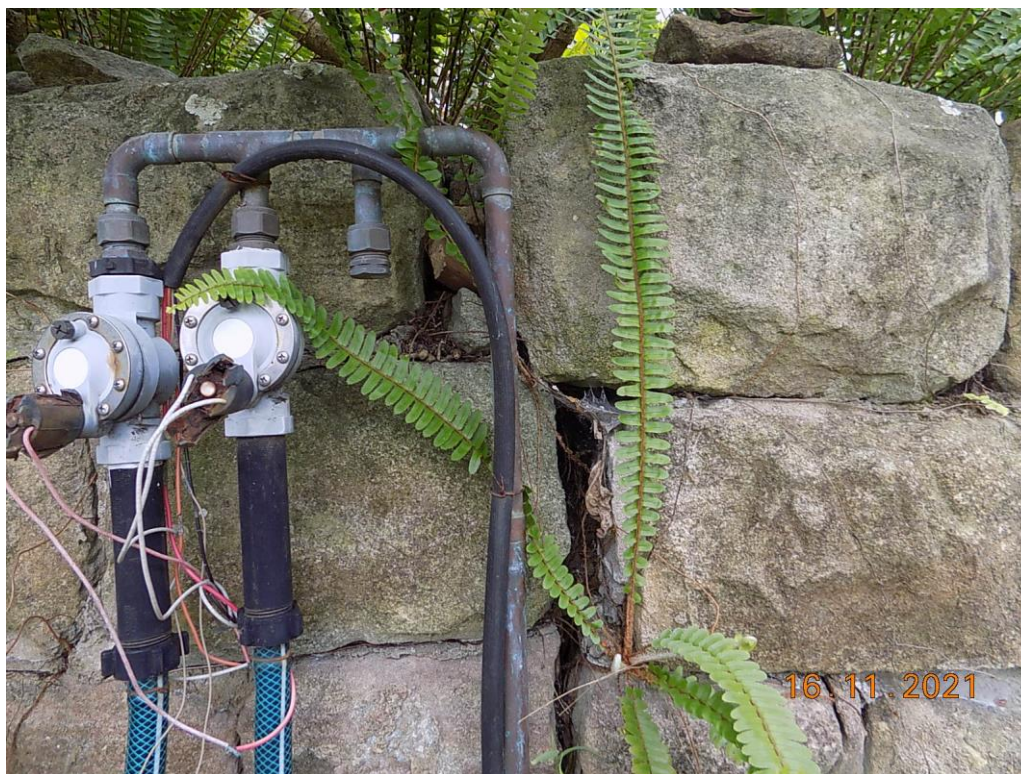
Photo 6

No geotechnical hazards were observed above or beside the property. The moderate to steeply graded slope that falls across the property and continues below is a potential hazard (**Hazard One**). The cracked retaining wall below the house is a potential hazard (**Hazard Two**). The vibrations from the proposed excavations are a potential hazard (**Hazard Three**). The proposed excavations are a potential hazard until retaining walls are in place (**Hazard Four**).

The ~1.8m high sandstone block retaining wall has started to crack through the mortar due to root action of the tree above (Photos 6 & 7). We recommend consideration be made to repairing/replacing the retaining walls during the proposed works. Alternatively, the retaining walls can to be inspected by the owners on an annual basis or after heavy prolonged rainfall, whichever occurs first, keeping a photographic record of the inspections. We can carry out these inspections upon request. Should any new movement be observed, the retaining walls are to be remediated or rebuilt to current engineering standards.

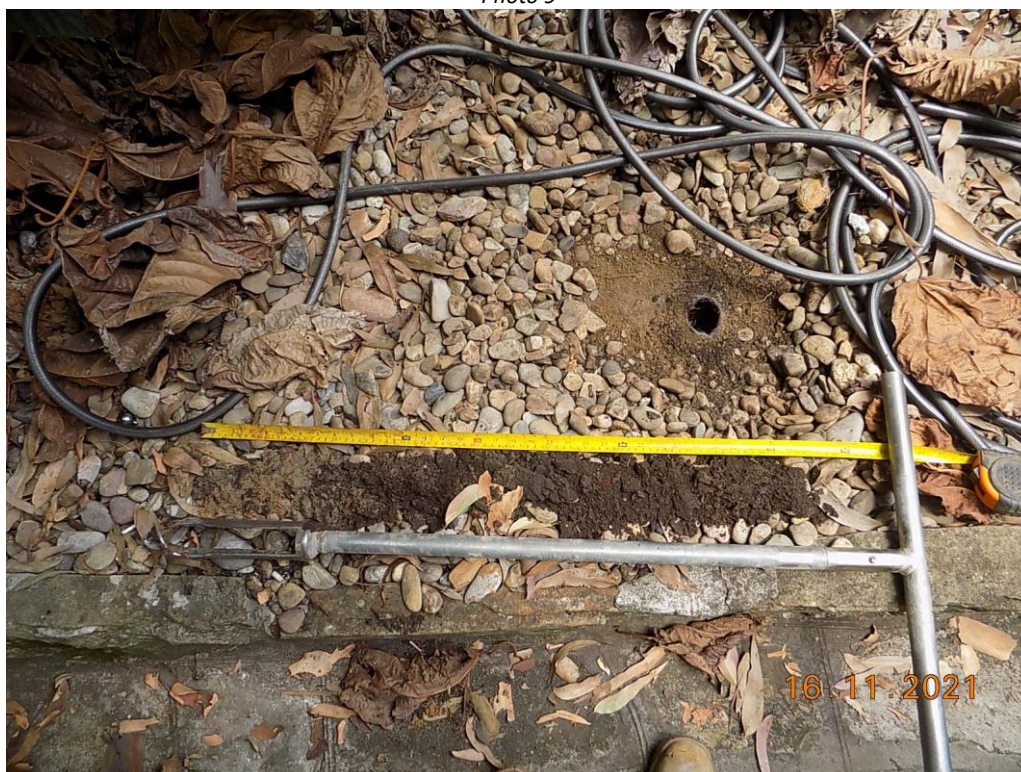
Photo 10 (Right to Left)

AUGER HOLE 1 (~RL68.1) – AH1 (Photo 10)

Depth (m)	Material Encountered
0.0 to 0.6	FILL , sandy, dark brown, loose, dry, medium grained, fine trace of organic matter.
0.6 to 0.7	SOIL , dark brown, loose, medium to coarse grained, dry.
0.7 to 0.9	SAND , grey with orange and white intermixed, medium dense, coarse grained, damp.

End of test @ 0.9m. No watertable encountered.
