PRELIMINARY GEOTECHNICAL ASSESSMENT:

116 Beatrice Street, Balgowlah Heights

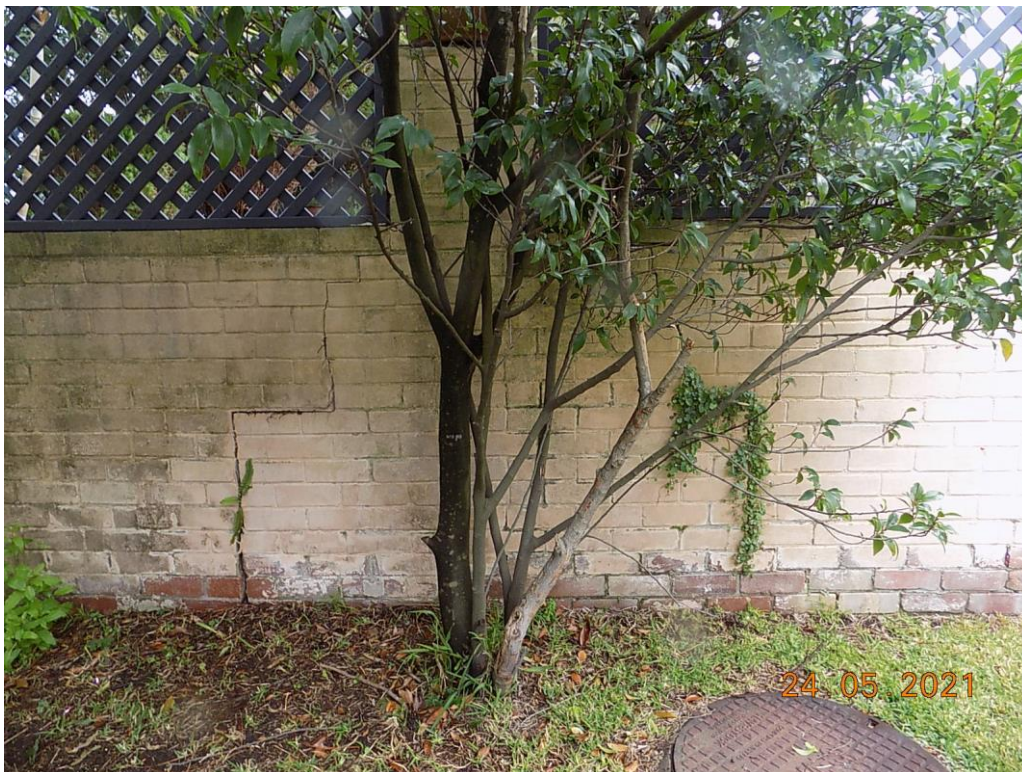
Photo 2

The brick retaining wall supporting the fill on the S neighbouring property is cracked and shows deflection of ~30mm (Photo 2). To be prudent, we recommend the retaining wall be

inspected by the owners on an annual basis or after heavy prolonged rainfall, whichever occurs first, keeping a photographic record of the inspections. We can carry out these inspections upon request. Should any new movement be observed, a plan is to be formulated with the owners of the S neighbouring property so that the boundary wall may be remediated or rebuilt so it meets current engineering standards.
