J4376. 25th July, 2022. Page 1.

GEOTECHNICAL INVESTIGATION:

New House and Pool at 28 Bangaroo Street, North Balgowlah

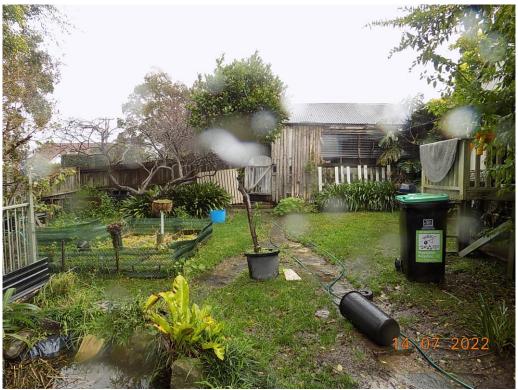
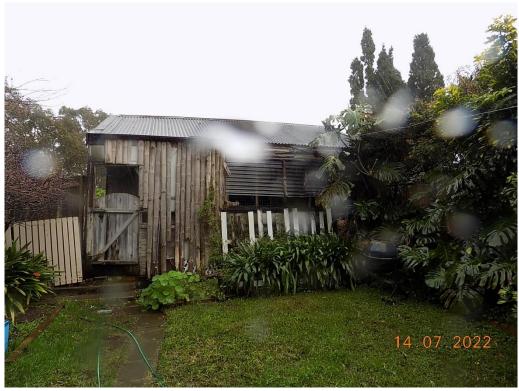
side of the property (Photos 3 & 4). The garage will also be demolished as part of the proposed works.

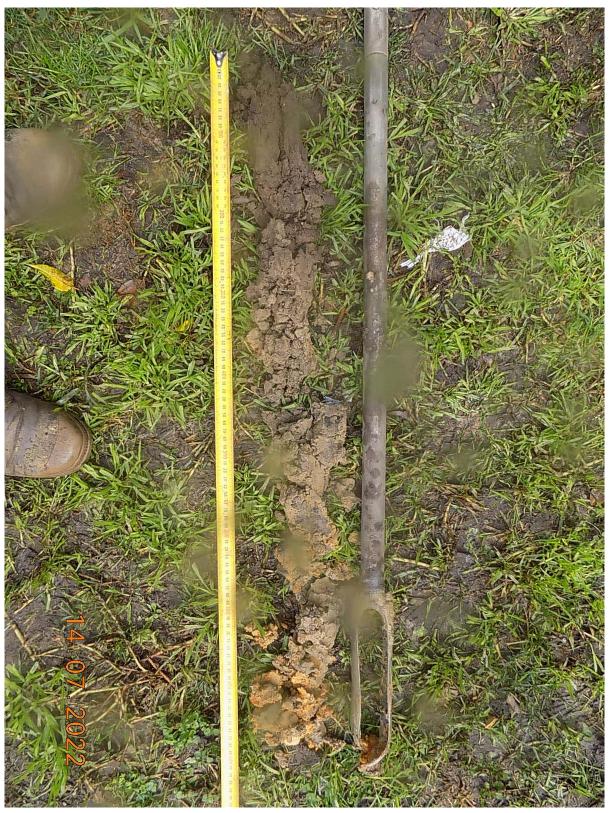
AUGER HOLE 1 (~RL67.1) – AH1 (Photo 5)

Depth (m)	Material Encountered	
0.0 to 0.2	CLAYEY SOIL , dark brown, medium dense, damp, fine to medium grained with fine trace organic matter.	
0.2 to 0.6	SANDY CLAY, brown, dense, damp, fine to medium grained.	
0.6 to 0.9	CLAY, derived from weathered sandstone, orange, stiff, damp, fine to	
	medium grained with sugary texture.

End of test @ 0.9m in clay derived from weathered sandstone. No water table encountered.

Photo 5: AH1 – Downhole is from top to bottom

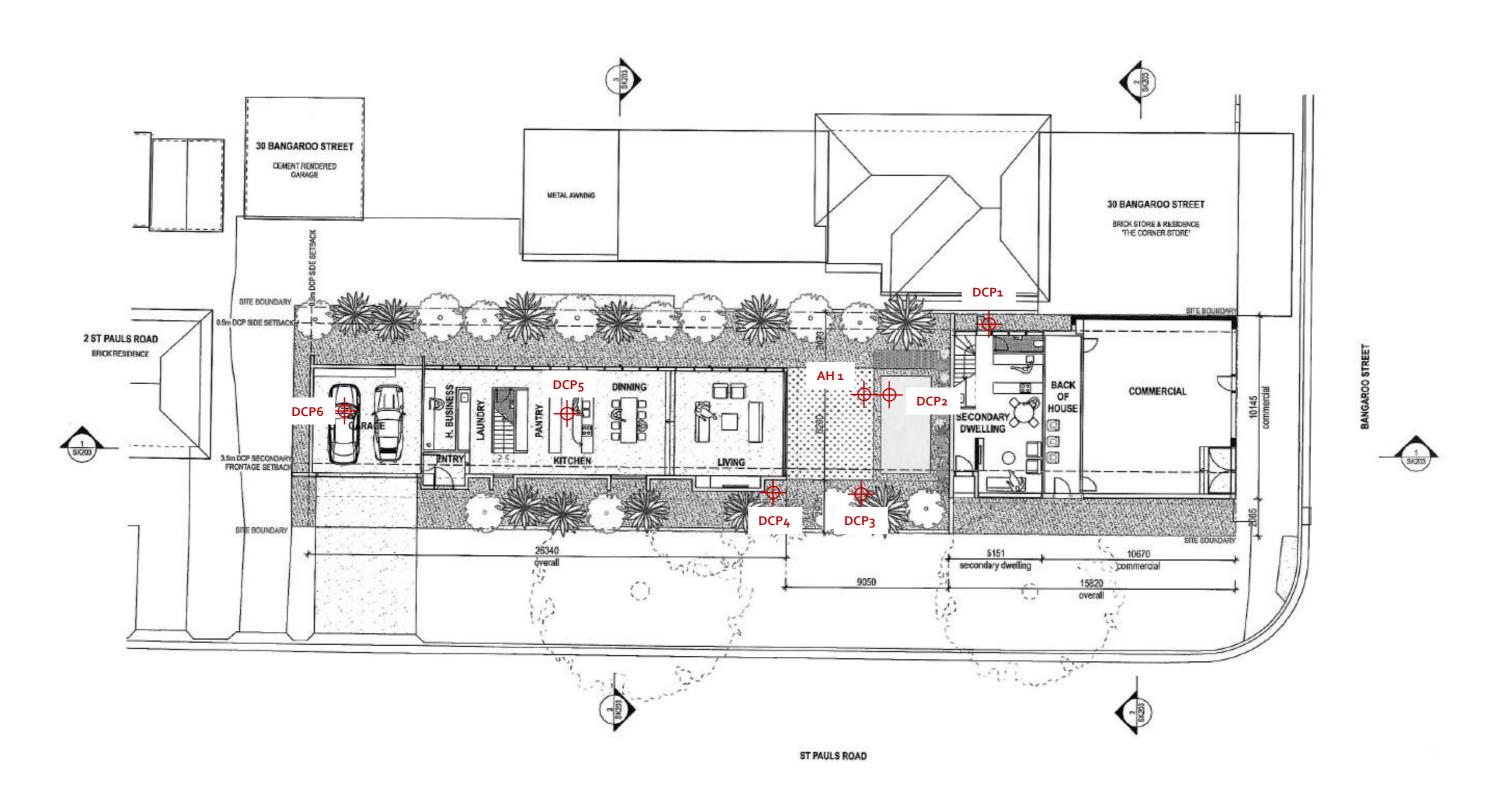
PROPOSED GROUND FLOOR PLAN
Scale: 1:200

One hand Auger Hole (AH) was put down to identify the soil materials. Six DCP (Dynamic Cone Penetrometer) tests were put down to determine the relative density of the overlying soil and the depth to bedrock. The locations of the tests are shown on the site plan attached. It should be noted that a level of caution should be applied when interpreting DCP test results. The test will not pass through hard buried objects so in some instances it can be difficult to determine whether refusal has occurred on an obstruction in the profile or on the natural rock surface. This is not expected to be an issue for the testing on this site. However, excavation and foundation budgets should always allow for the possibility that the interpreted ground conditions in this report vary from those encountered during excavations. See the appended "Important information about your report" for a more comprehensive explanation. The results are as follows:

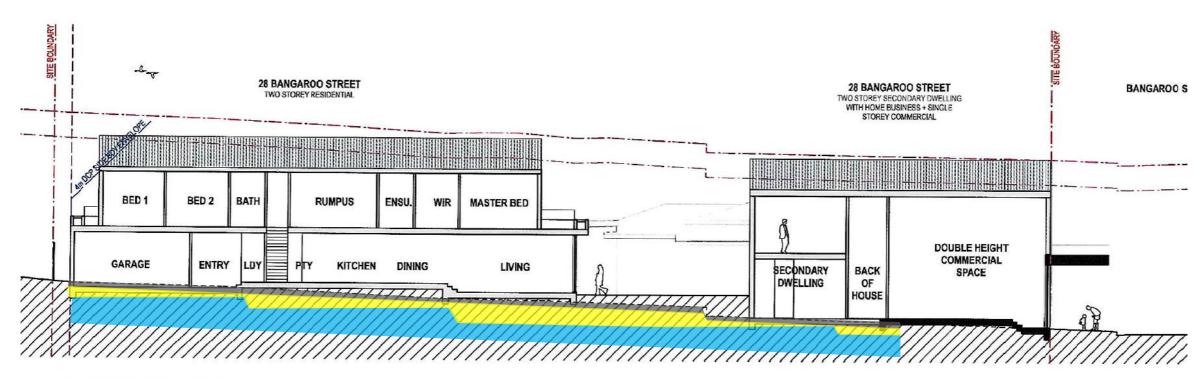
PROPOSED LONG SECTION
Scale: 1:200

expected to underlie the entire site. See Type Section attached for a diagrammatical

representation of the expected ground materials.

Clayey Topsoil
Sandy Clay and Clay
Hawkesbury Sandstone – Medium Strength
