**REPORT TO
STRATA REAL ESTATE SERVICES**

**ON
PRELIMINARY SITE ASSESSMENT**

**FOR
EXISTING GARAGES**

**AT
11 LODGE LANE, FRESHWATER, NSW**

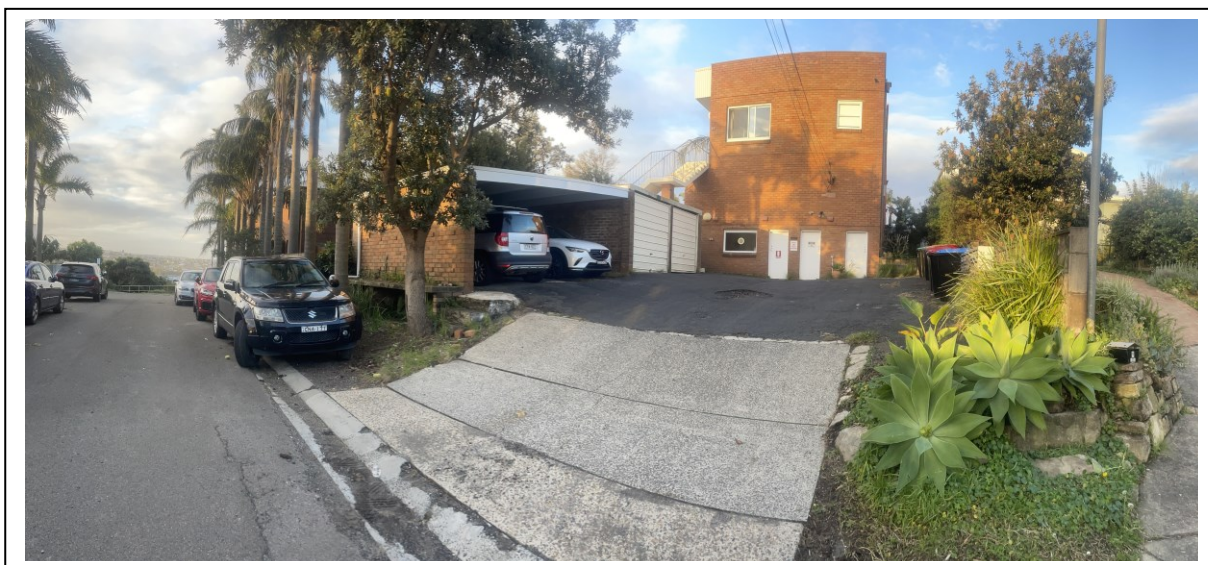
The site is located on the crest of Freshwater headland in relatively flat topography. The site is roughly rectangular in shape. A two-storey brick apartment block, that appears in good structural condition, occupies most of the site, with the exception of a relatively small section of land at its western end that contains four garages adjoining the northern site boundary with an asphaltic concrete paved driveway and turning area on the southern side of the garages. The garages have typically been constructed at existing levels, with the exception of the westernmost one, which is slightly raised above existing levels, and is retained by a brick retaining wall that appeared in good condition and had a maximum height of 0.8m. Sandstone outcrops are visible across the property.
