2 May 2023

**RE: SP7795 80-82 PACIFIC PARADE, DEE WHY NSW 2099 –
RETAINING WALL STRUCTURAL ASSESSMENT**

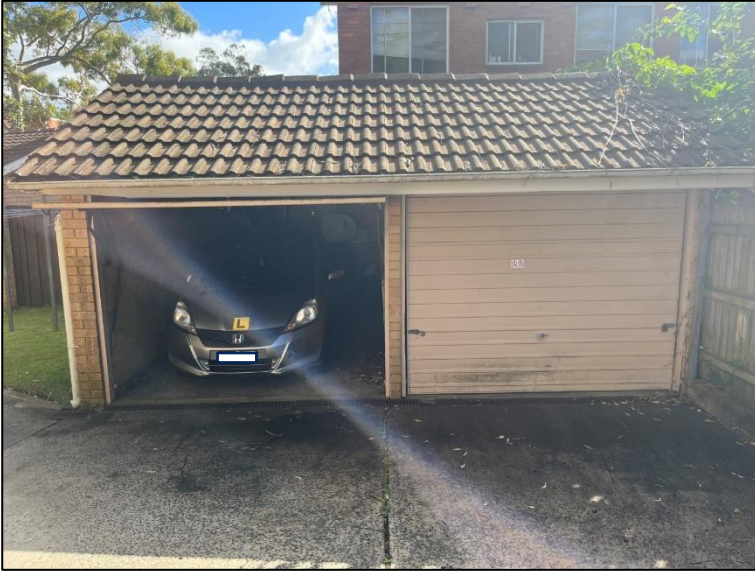
The wall in question is located on the north-east of the property and forms the north wall of the two-tenancy garage (Photograph 1).

Photograph 1 – Overview of two-tenancy garage

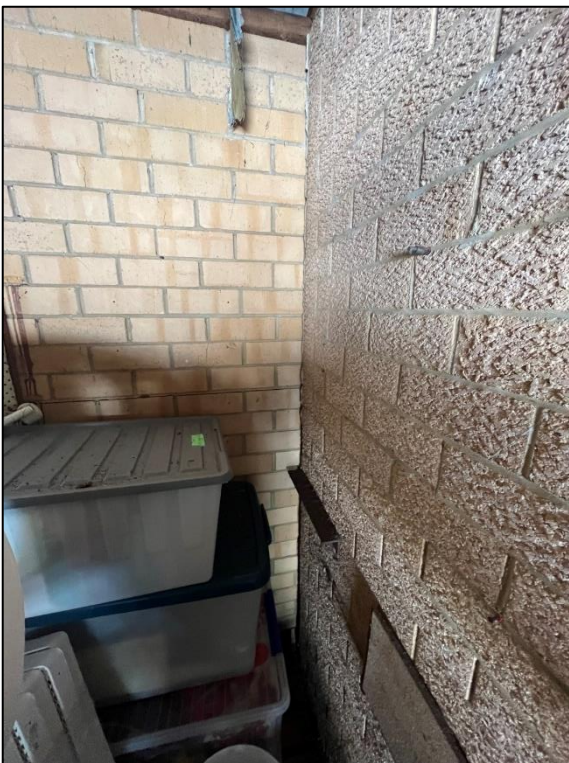
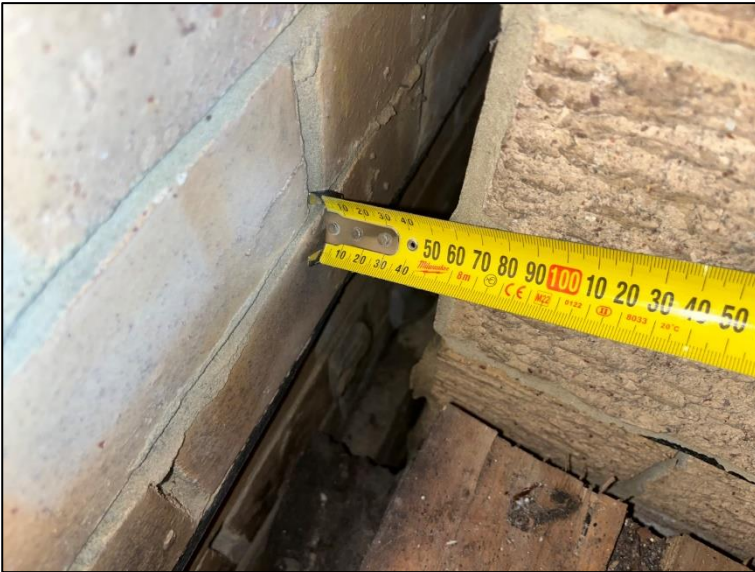
Upon initial inspection of the Unit 21 garage, it was observed that the rear north wall has separated from the partition wall approximately 55 mm at the damp proof course level (Photographs 2 & 3).

Photograph 2 – Overview of rear garage wall and partition wall

Photograph 3 – Separation between rear garage wall and partition wall

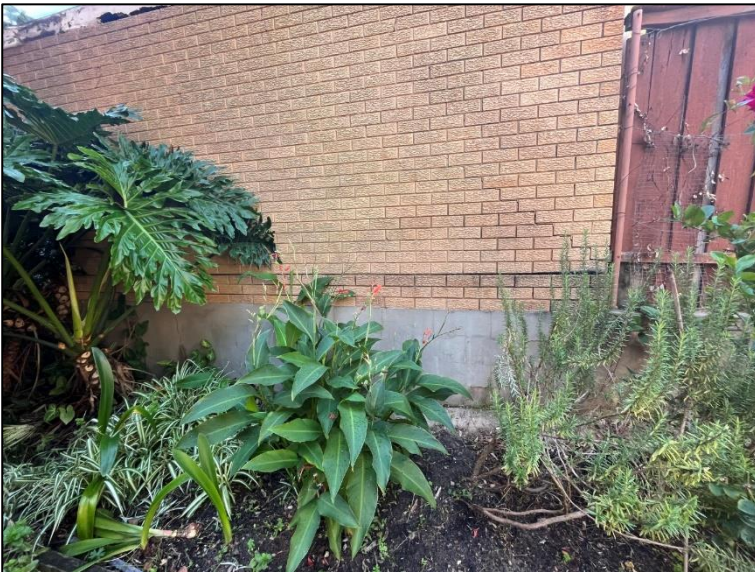
An inspection was then conducted of the external face of the wall in question from the neighbouring property. It was observed that the masonry wall is a retaining wall and is approximately retaining 1000 mm of soil. (Photograph 4). Furthermore, the lower portion of the wall was rendered, so it's unclear on the exact construction of this section of wall, however based on the moisture markings it appears that this is some sort of concrete masonry block construction.

Photograph 4 – Overview of retaining wall

The defective retaining wall should be removed and replaced with a compliant retaining wall.

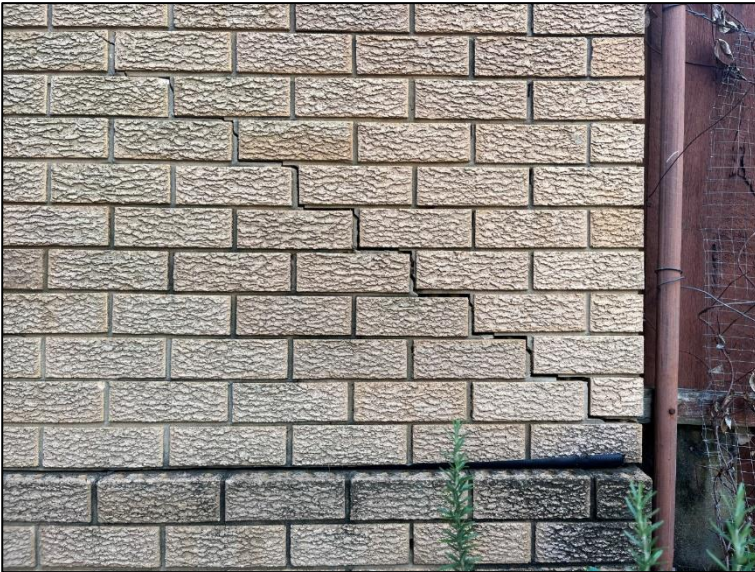
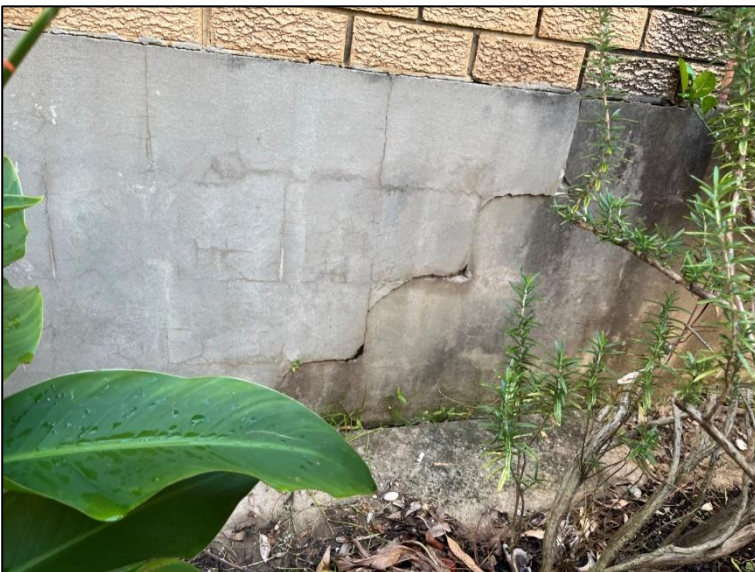
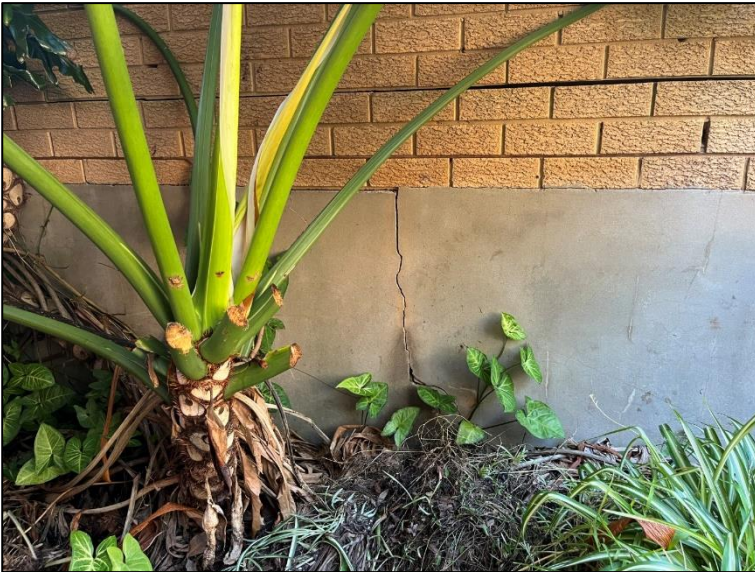
Stepped cracking was observed to the wall in addition to a vertical crack and horizontal crack. This would suggest that the lower section of wall, despite likely being a concrete block, is unreinforced masonry. (Photographs 5, 6 & 7).

The rotation and observed displacement of the wall appears to have caused the observed cracking to the wall.

Photograph 5 – Step cracking

Photograph 6 – Step cracking

Photograph 7 – Vertical and horizontal cracking

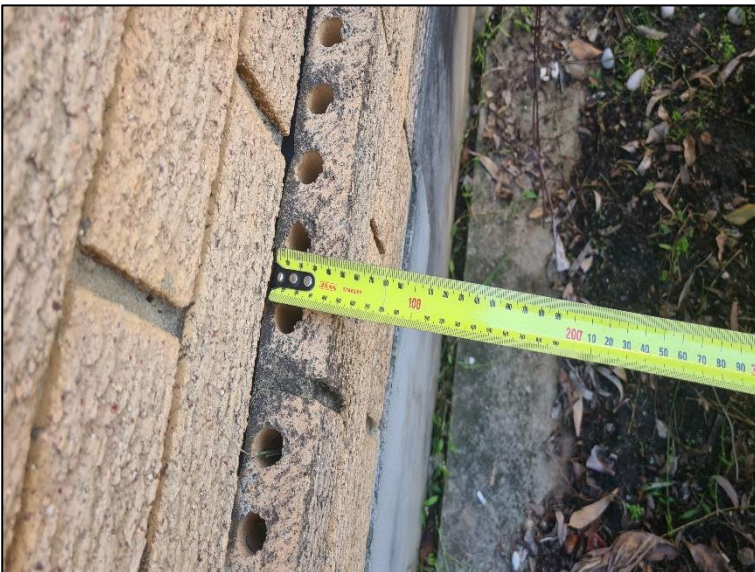
Furthermore, the masonry below damp proof course level was observed to be displaced approximately 50 mm from the remainder of the wall, indicating the wall has rotated outwards. (Photograph 8).

As the wall is retaining soil, it is supporting lateral earth pressure which is the horizontal pressure applied to the wall. As there is a car storage unit above, the wall is subject to an additional vehicular surcharge load which is acting laterally against the wall. This lateral pressure from the combination of the retained soil and car storage unit above, has induced a tensile stress in the masonry likely causing the wall to rotate and crack due to overstress.

Due to the lateral pressure, the footing needs to resist the overturning force. It is possible that the footing is under-designed as extensive rotation and displacement was observed to the wall the footing size and construction is unknown as it could not be inspected on site without destructive works. It is also possible that the soil underneath the footing may be poorly compacted or fill.

Photograph 8 – Displacement and rotation of masonry along damp proof course level

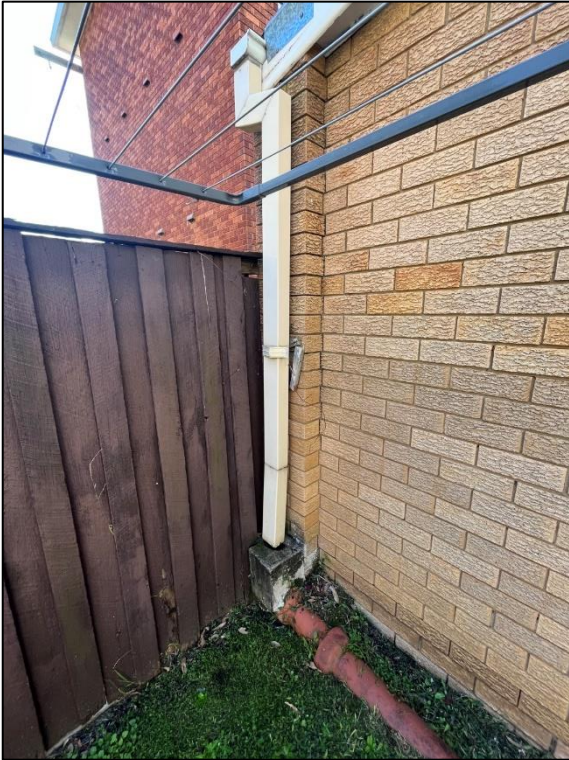
In addition, it was observed that the roof downpipe was connected to a partially embedded clay pipe that serves as part of the stormwater system on site (Photograph 9). Clay pipes, as opposed to PVC, have a weak tensile strength and more susceptible to cracking when imposed to ground movement. Clay pipes do not fit perfectly together and are often susceptible to tree roots entering through the section joints and causing damage.

It is therefore possible that water is leaking into the ground system from the pipe, resulting in soil erosion around the footing system, and playing a role in the observed movement and rotation.

Photograph 9 – Overview of clay pipe and water system

Given how the garage is a standalone structure, and the timber roof is showing early signs of deterioration it is recommended that a complete demolition and rebuild of the garage structure is carried out. During these works the tree roots and clay pipe should be investigated by a plumber to ensure there are no leaks and that the roots have not caused damage to clay pipes in the area.

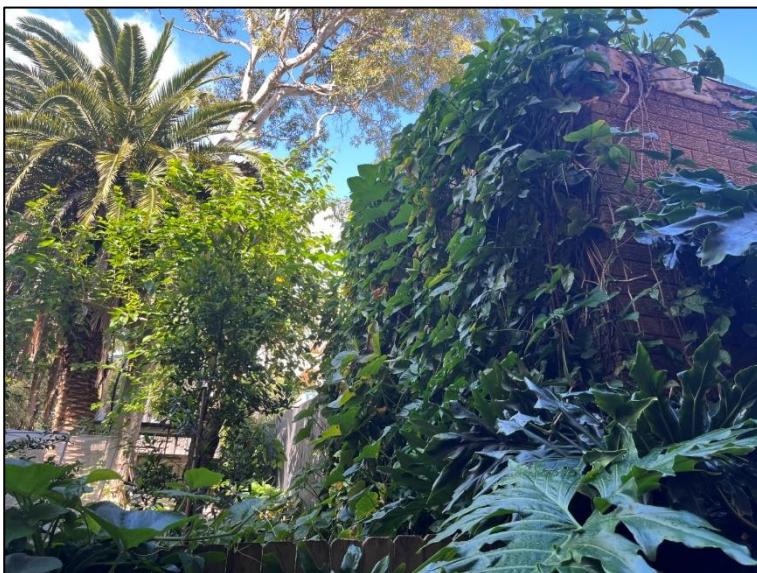
Large trees were observed within the vicinity of the garage (Photograph 10). It is possible that the tree roots have infiltrated the area and damaged the retaining wall footing system. As stated previously, the roots may have damaged the existing clay pipe in the area causing water to leak.

Photograph 10 – Overview of large trees in the vicinity on the north-east boundary
