Preliminary Geotechnical Assessment

Project: Alterations & Additions
3 Paruna Place, Cromer NSW

Ref: AG 24557
11 December 2024

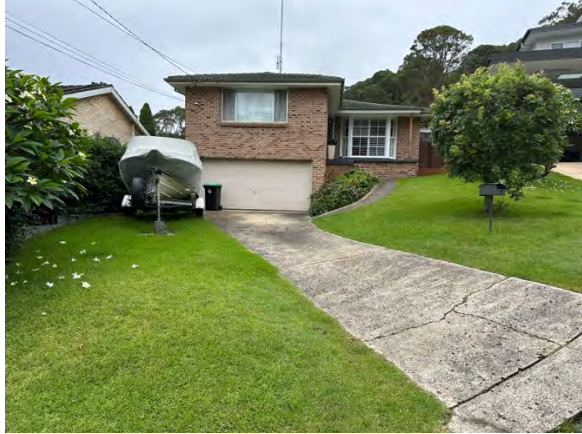
Photo 1: Frontage of the dwelling facing south-west.

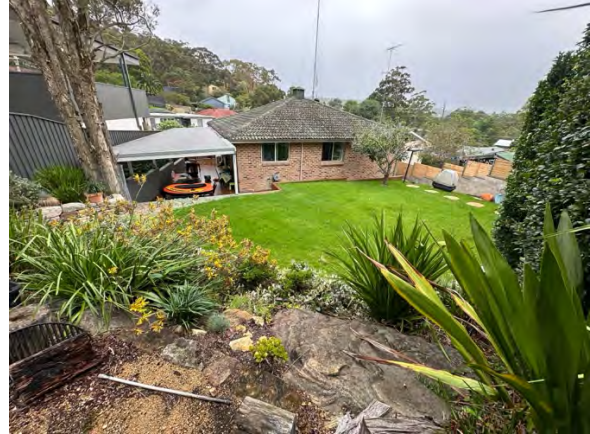
Photo 2: Rear of the dwelling facing north-east.

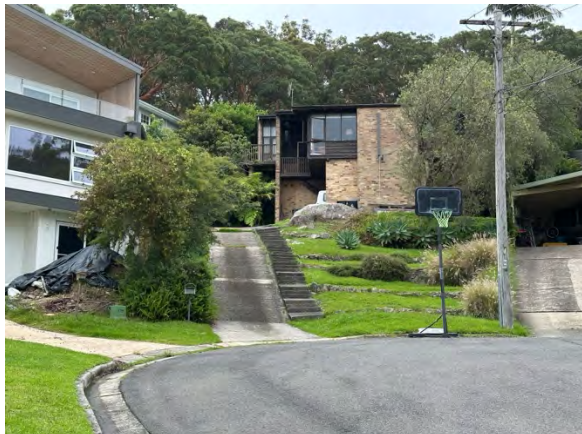
Photo 3: Outcropping sandstone bedrock on the adjoining site, 5 Paruna Place.

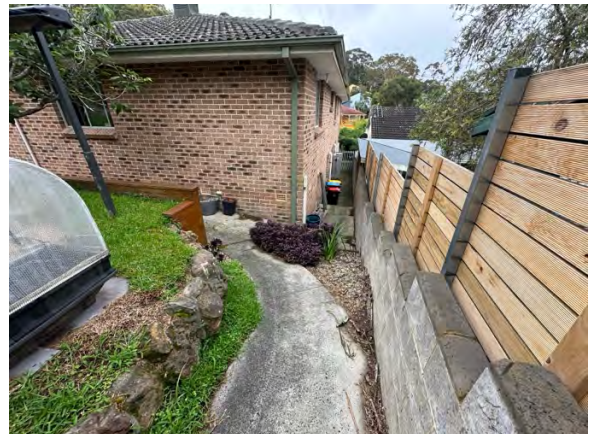
Parameter	Description
Retaining Structures	Stackrock, rendered masonry, and timber landscaping walls in good condition. The masonry wall on the eastern boundary is showing an ~5-degree rotation from vertical but is otherwise in reasonable condition.
Neighbouring Environment	Residentially developed to the south, east, and west. Paruna Place to the north.
Geology	The Sydney 1:100,000 Geological Sheet 9130 (NSW Dept. Mineral Resources, 1983) indicates that the site is underlain by the Middle Triassic Hawkesbury Sandstone (Rh). The Hawkesbury rocks do not outcrop on the subject slope but are seen further up the slope in the surrounding properties.
Potential Geotechnical Hazards	No evidence of significant settlement, slope instability, undercutting, jointing or other geotechnical hazards were identified at the time of our assessment.
Groundwater	Due to the position of the site relative to the slope and the underlying geology, no significant standing water table is expected to influence the site.

Photo 4: Masonry landscaping wall (right) showing an ~5-degree rotation from vertical.
