## **Geotechnical Assessment**

**Project:** New Swimming Pool  
6 Lido Avenue, North Narrabeen NSW.

**REF: AG 21239**  
9 August 2021

For New Swimming Pool and Associated Works at  
6 Lido Avenue, North Narrabeen NSW

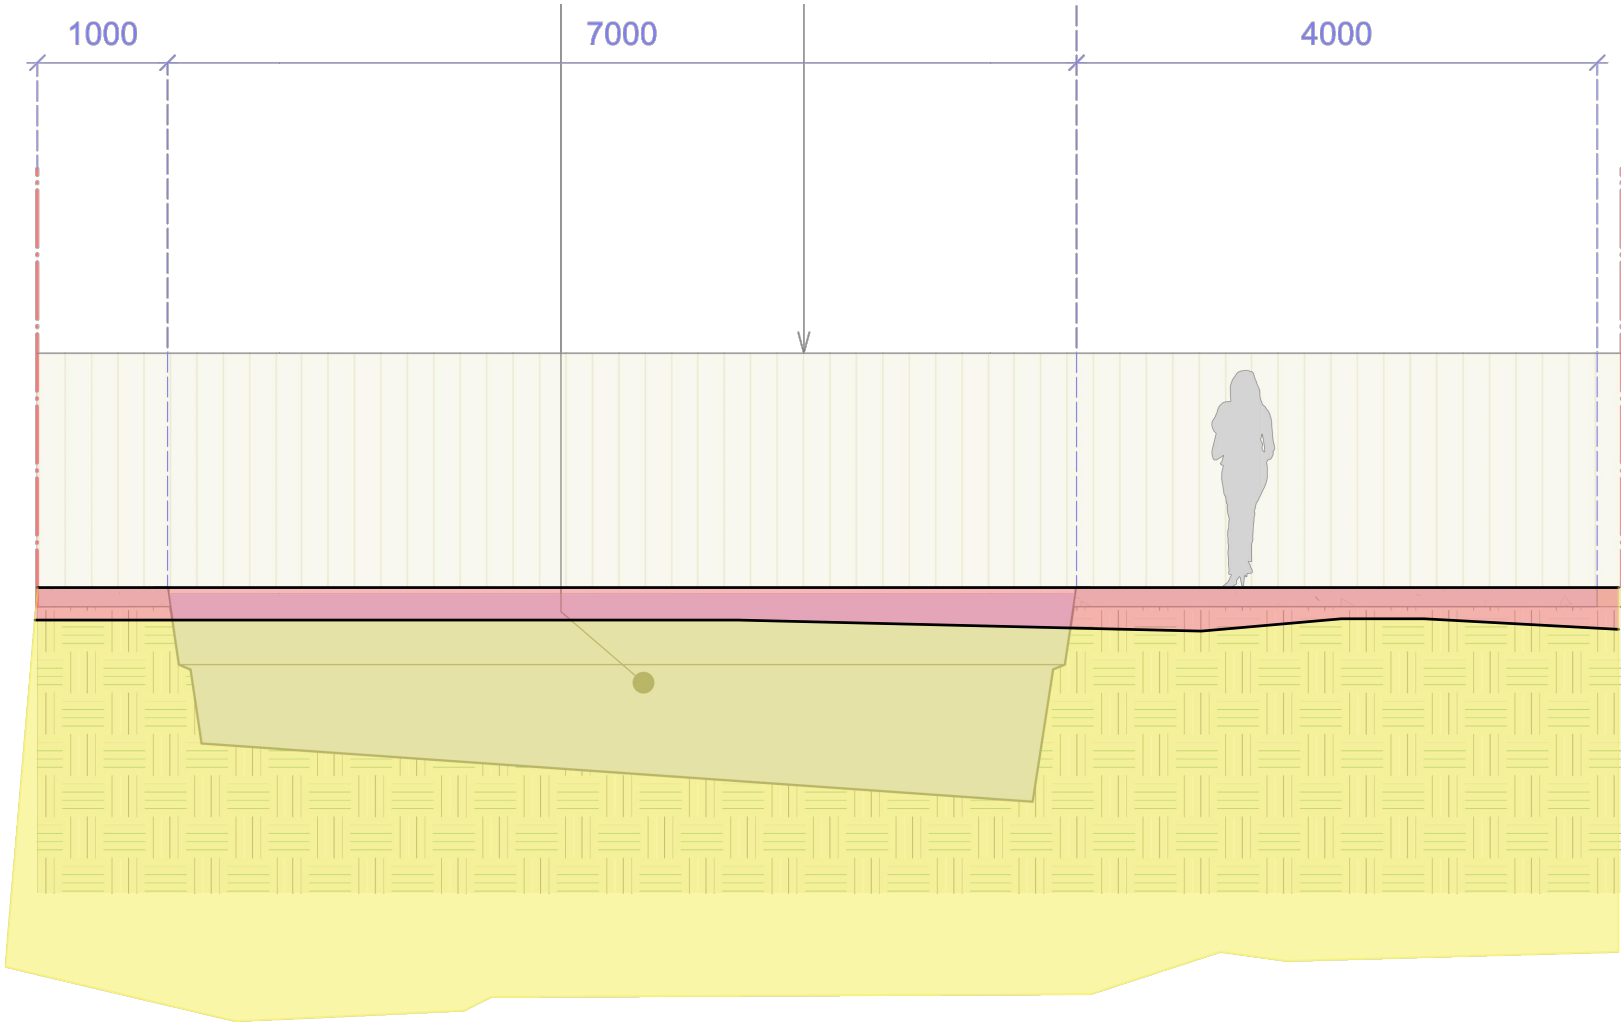
**INFERRED GEOLOGICAL SECTION**  
SCALE NTS

The slope across the subject site is <5 degrees with no geotechnically significant gradient noted. The soil profile is interpreted to be comprised of shallow uncontrolled sandy fill/top soil, with well graded marine sands overlying weathered bedrock at unknown depths, in excess of 4.2m across the site.

INTERPRETED SUBSURFACE SECTION ONLY.  
ACTUAL GROUND CONDITIONS MAY VARY.

- UNCONTROLLED FILL/SANDY TOP SOIL
- WELL GRADED QUARTZ MARINE SAND
