Geotechnical Assessment

Project: Alterations & Additions
11 Plateau Road, Avalon Beach NSW

Prepared for:
Mrs S. Mander, c/ TCDG

Ref: AG 24549
17 December 2024

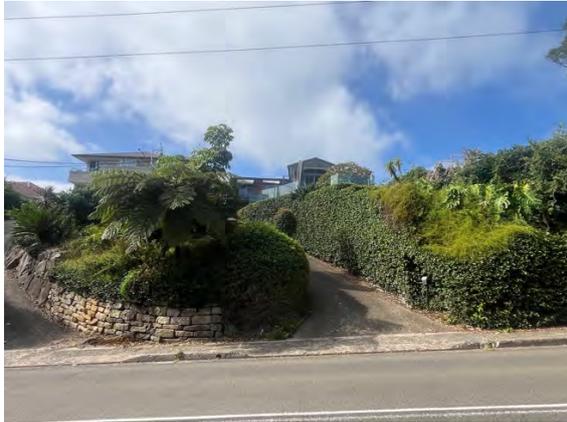
Photo 1: Site frontage, area of the proposed works

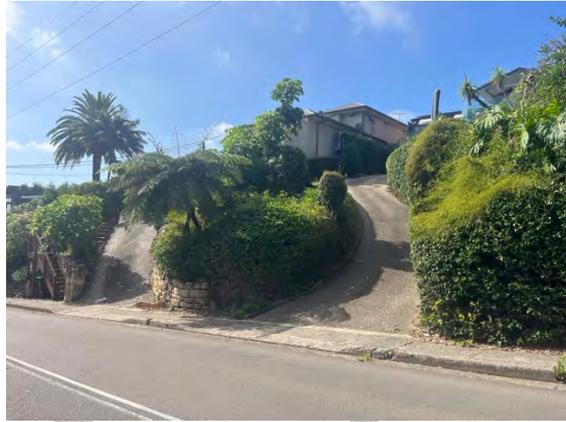
Photo 2: Site frontage, area of the proposed works

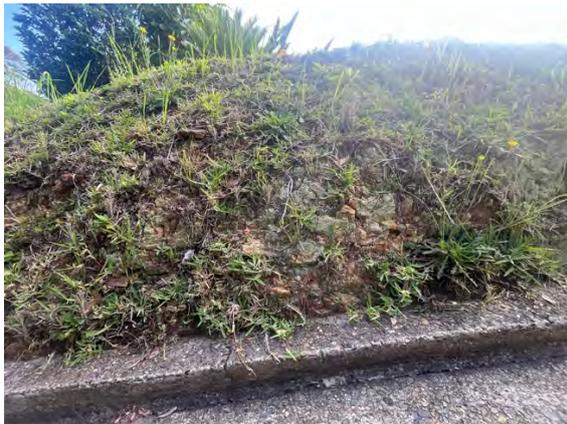
Photo 3: Extremely weathered shale bedrock outcropping in the driveway cutting

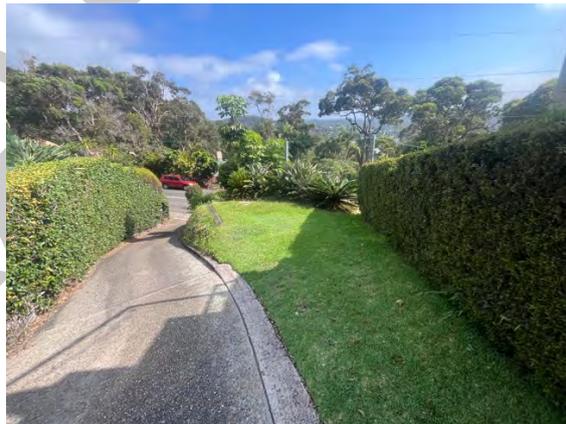
Photo 4: Looking from the front of the house towards the street frontage

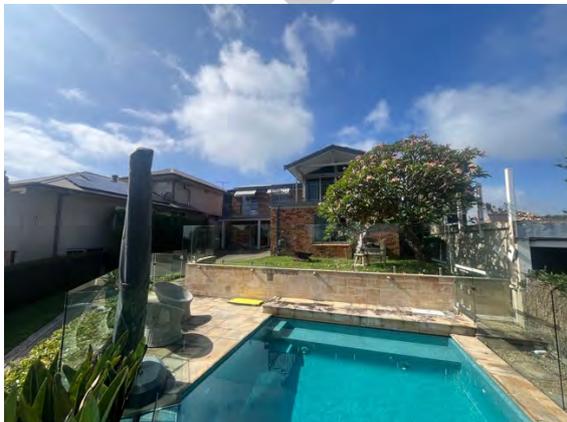
Photo 5: Pool & house frontage

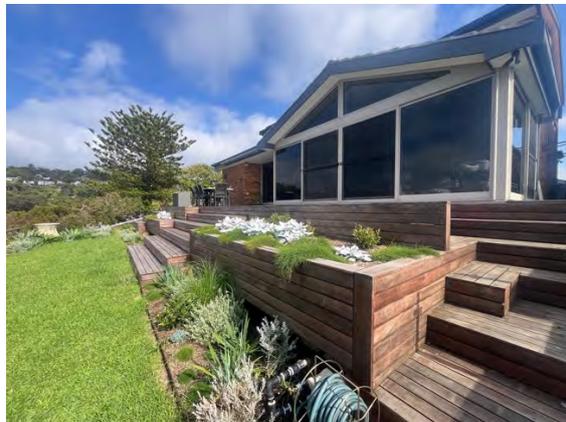
Photo 6: House rear
