**GEOTECHNICAL RISK MANAGEMENT POLICY FOR PITTWATER
FORM NO. 1 – To be submitted with Development Application**

100A & 102 Wakehurst Parkway, Elanora Heights

Minor Works Assessment

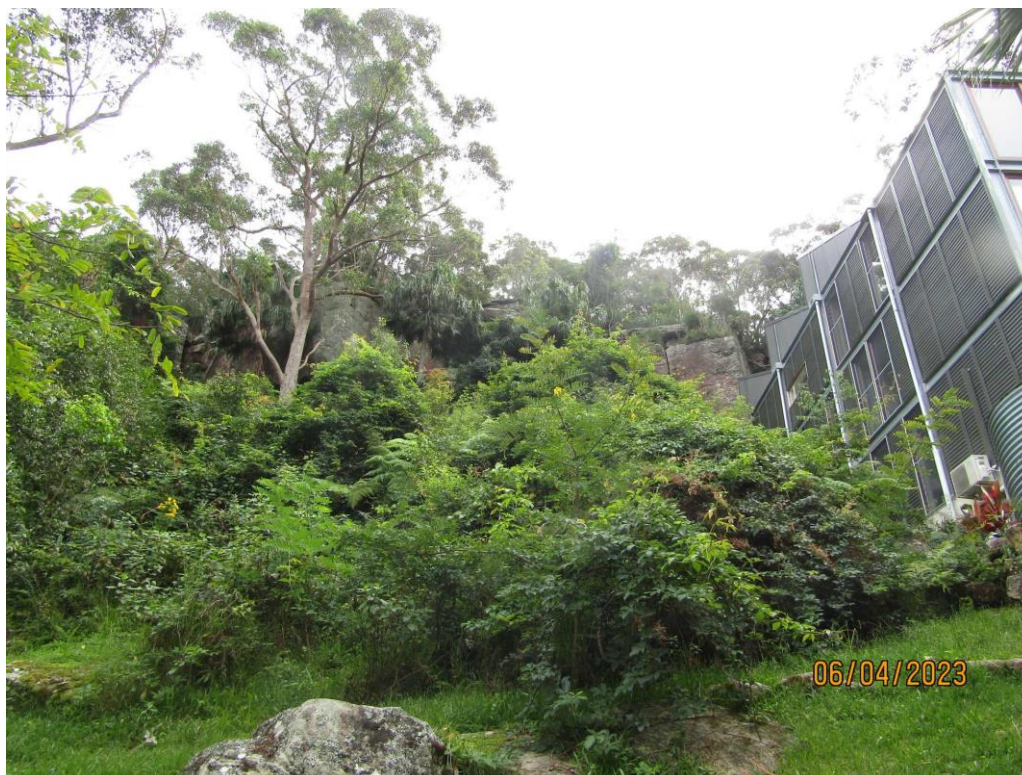
Photo 1

the uphill side of the lawn area to the base of a ~6.0m high sandstone cliff face (Photos 1 to 3). The cliff face is made up of widely jointed massive medium strength sandstone. Some minor undercutting was observed along a bedding plane halfway up the rock face (Photo 2) but no significant geological defects that could impact the stability of the rock face were observed above the property. The rock face is considered to be currently stable in this location. The property continues for another ~40m to the uphill boundary and could not be accessed due to the rock face. No significant signs of movement that could have occurred in recent geological history were observed on the property.

No evidence of significant movement was observed on the property that could have occurred in recent geological history. The large rock face (Photos 1 to 3) appears to be currently stable.

HAZARDS	Hazard One
TYPE	The steeply graded slope and large rock face midway up to the properties (Photos 1 to 3) mass failing and impacting on the properties.
LIKELIHOOD	'Unlikely' (10^{-4})
CONSEQUENCES TO PROPERTY	'Medium' (15%)
RISK TO PROPERTY	'Low' (2×10^{-5})
RISK TO LIFE	$8.3 \times 10^{-7}/\text{annum}$
COMMENTS	This level of risk is 'ACCEPTABLE', provided the recommendations in Section 3 are carried out.

Where slopes are steep and approach or exceed 30° , such as midway up the properties, it is prudent for the owners to occasionally inspect the slope (say annually or after heavy and prolonged rainfall events, whichever occurs first). Should any of the following be observed: movement or cracking in retaining walls, cracking in any structures, cracking or movement in the slope surface, tilting or movement in established trees, leaking pipes, or newly observed flowing water, or changes in the erosional process or drainage regime, then a geotechnical consultant should be engaged to assess the slope. We can carry out these inspections upon
