Geotechnical Assessment

Project: Secondary Dwelling
21 Yachtsmans Paradise, Newport NSW

REF: AG 21229
16 July 2021

21 Yachtsmans Paradise, Newport NSW

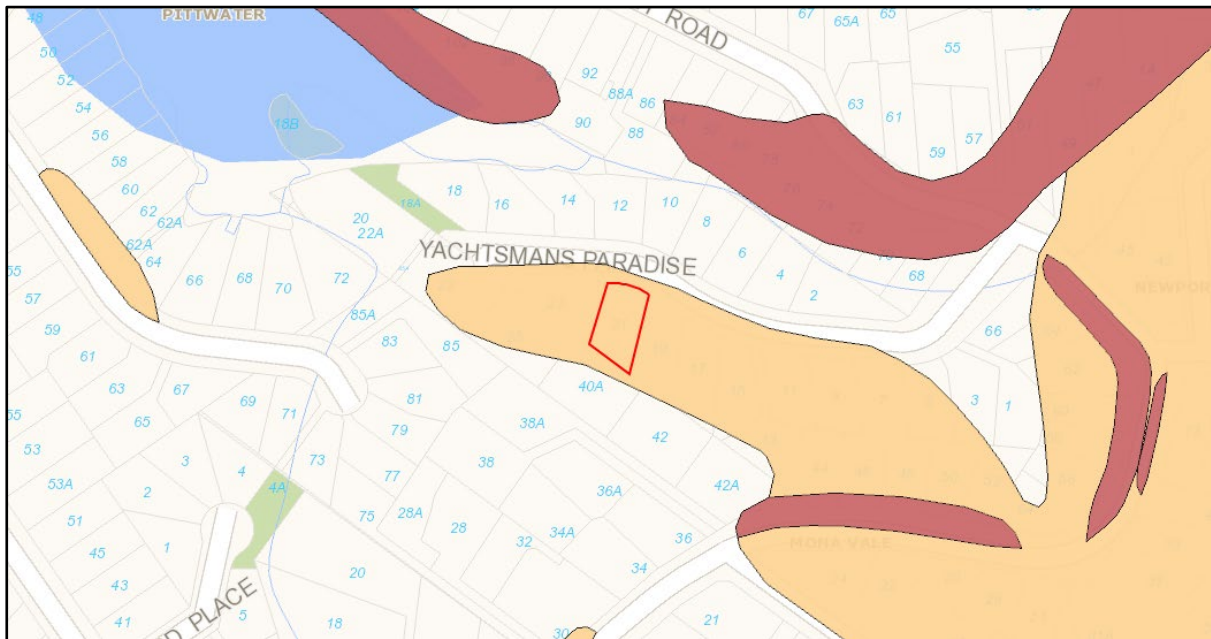
Image 2. PLEP Geotechnical Hazard Map
– 21 Yachtsman Paradise, Newport

- No evidence of significant soil creep, tension cracks or landslip instability were identified across the site or on adjacent properties as viewed from the subject site at the time of our inspection.
- The existing structures displayed no evidence of significant cracking or settlement that could be attributed to slope instability.
- Based on reference to the plan entitled “Geotechnical Hazard Mapping” (Ref. P21DCP-BC-MDCP2002, dated 2007) prepared by GHD LONGMAC on behalf of Pittwater Council, the site is located within **Geotechnical Hazard Zone H2**.

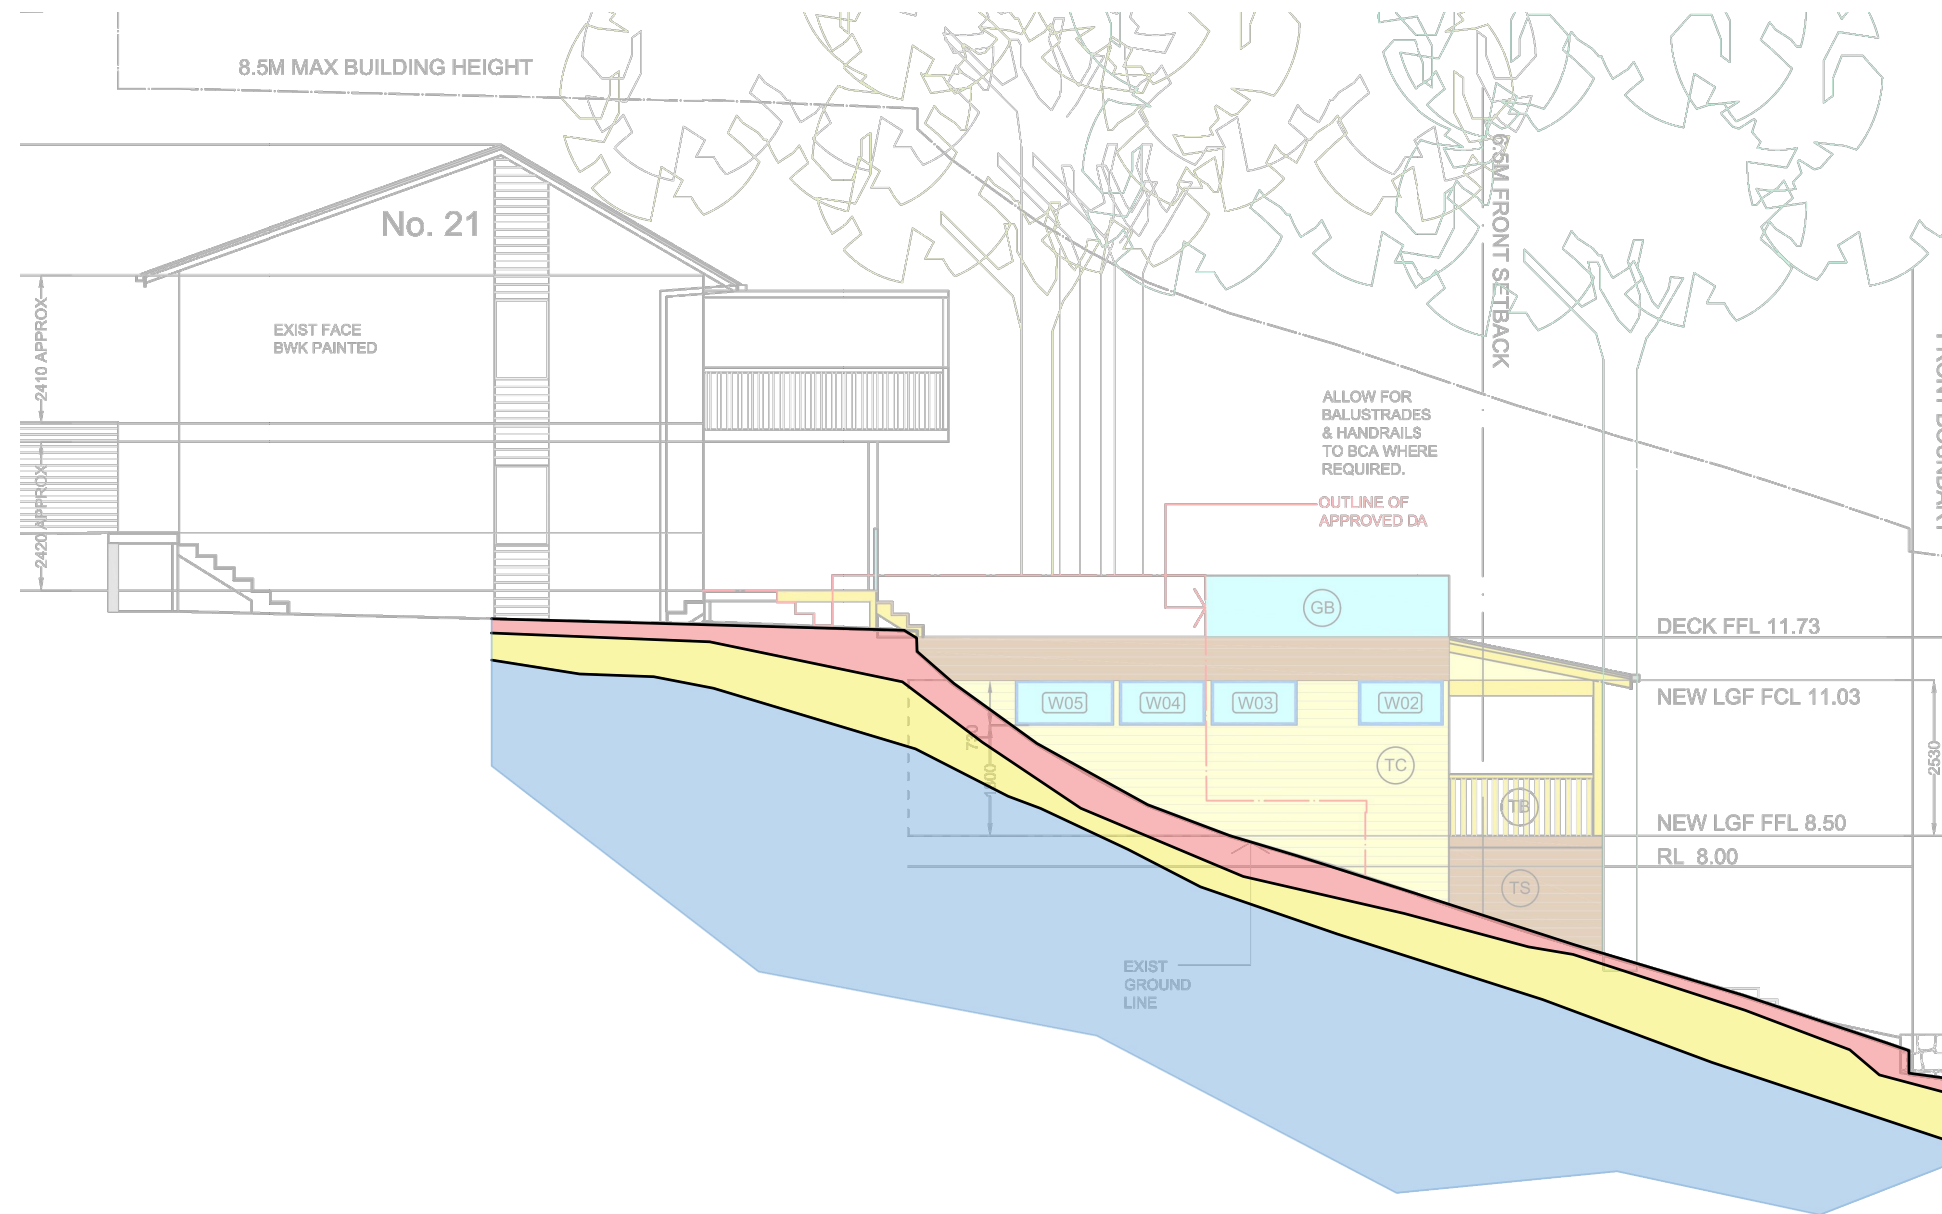
INFERRED GEOLOGICAL SECTION
SCALE NTS

The soil profile consists of shallow uncontrolled fill and silty topsoil (O & A Horizons), silty clay (B Horizon), and weathered bedrock (C Horizon). Based on our observations and the results of testing on site, we would expect weathered shale bedrock, to be found within 1.5 to 2.2 m below current surface levels across the area of the proposed works.

- SILTY TOPSOIL/SHALLOW UNCONTROLLED FILL
- SILTY CLAY
- NEWPORT FORMATION GEOLOGY
